UNDERWATER BRIDGE INSPECTION REPORT

STRUCTURE NO. 31512

CSAH NO. 18

MISSISSIPPI RIVER

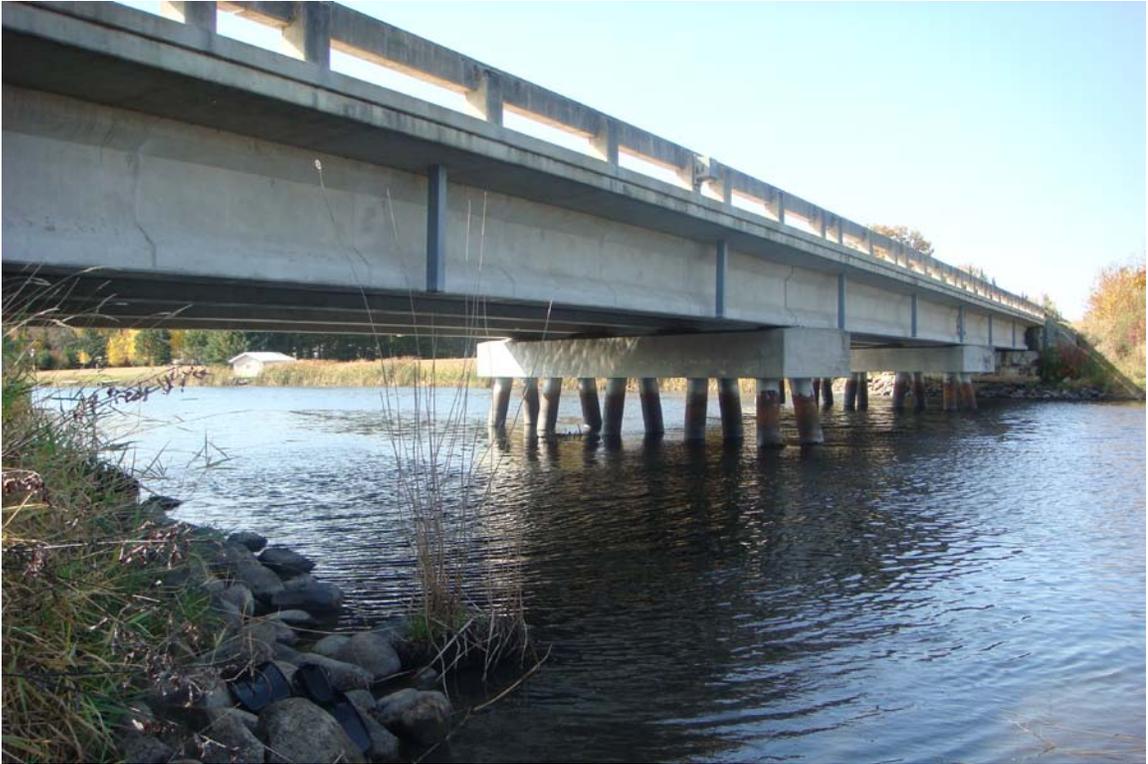
Photograph 1. Overall View of Bridge, Looking Southwest.

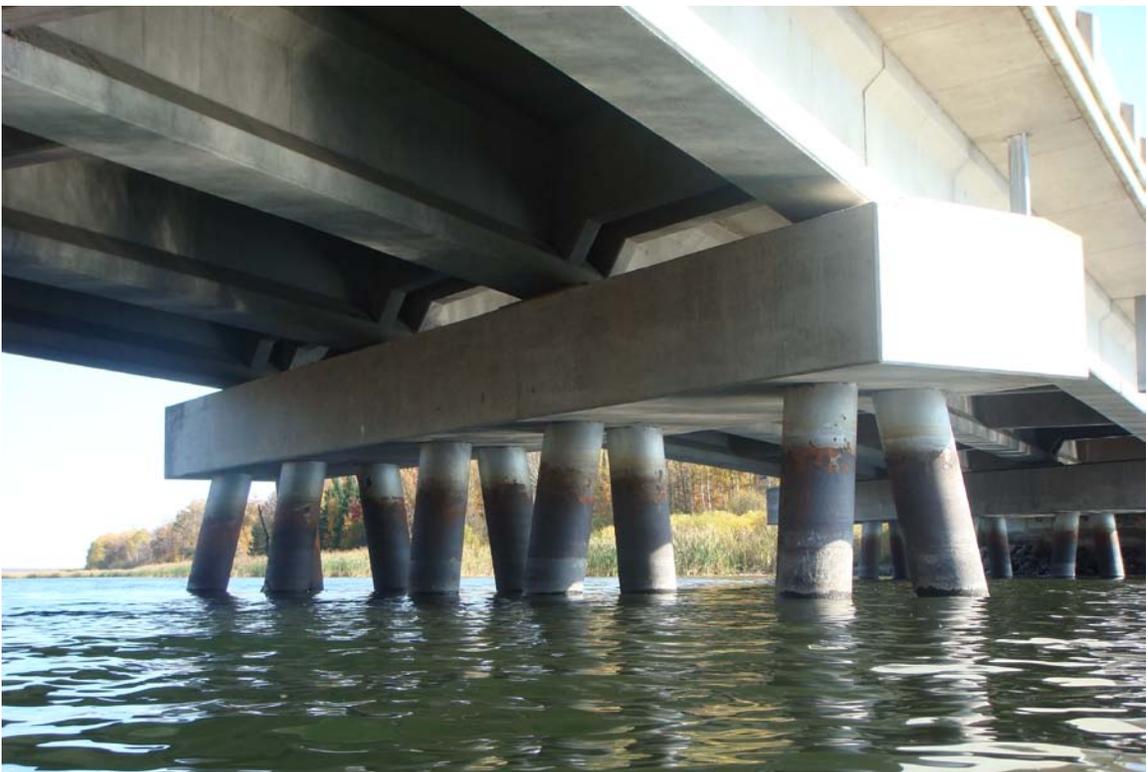
Photograph 2. View of Pier 1, Looking Northeast.

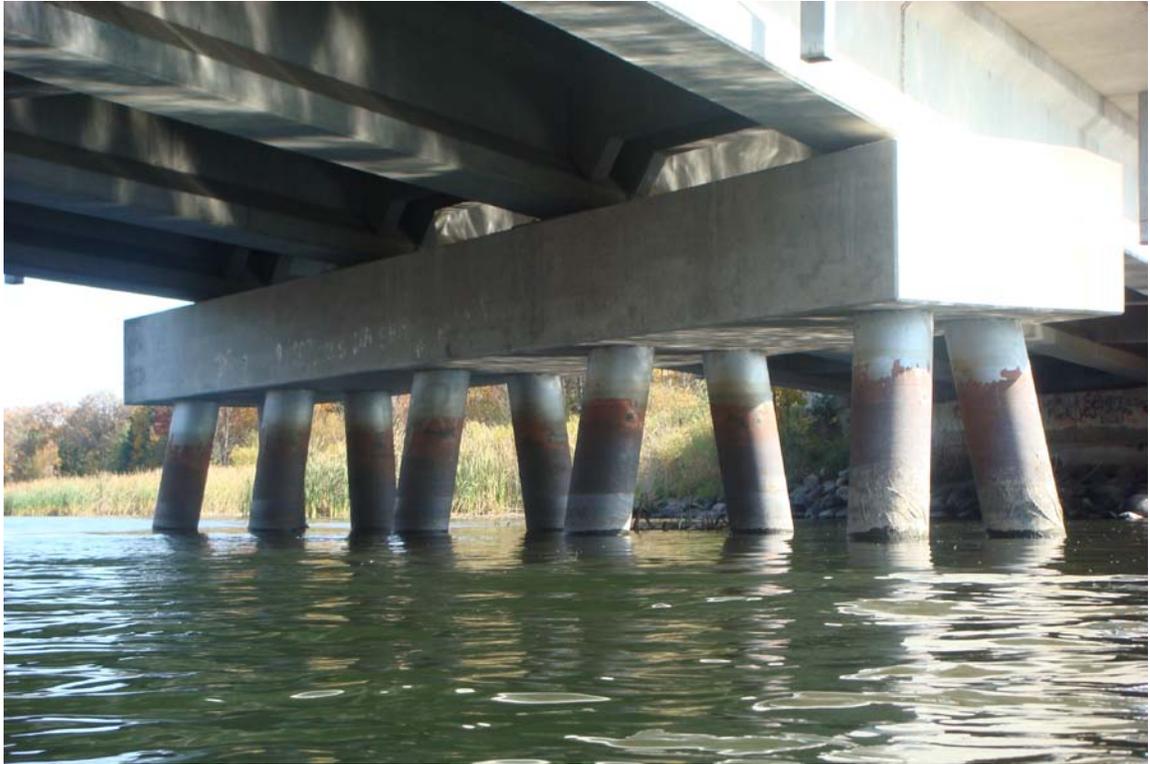
Photograph 3. View of Pier 2, Looking Northeast.

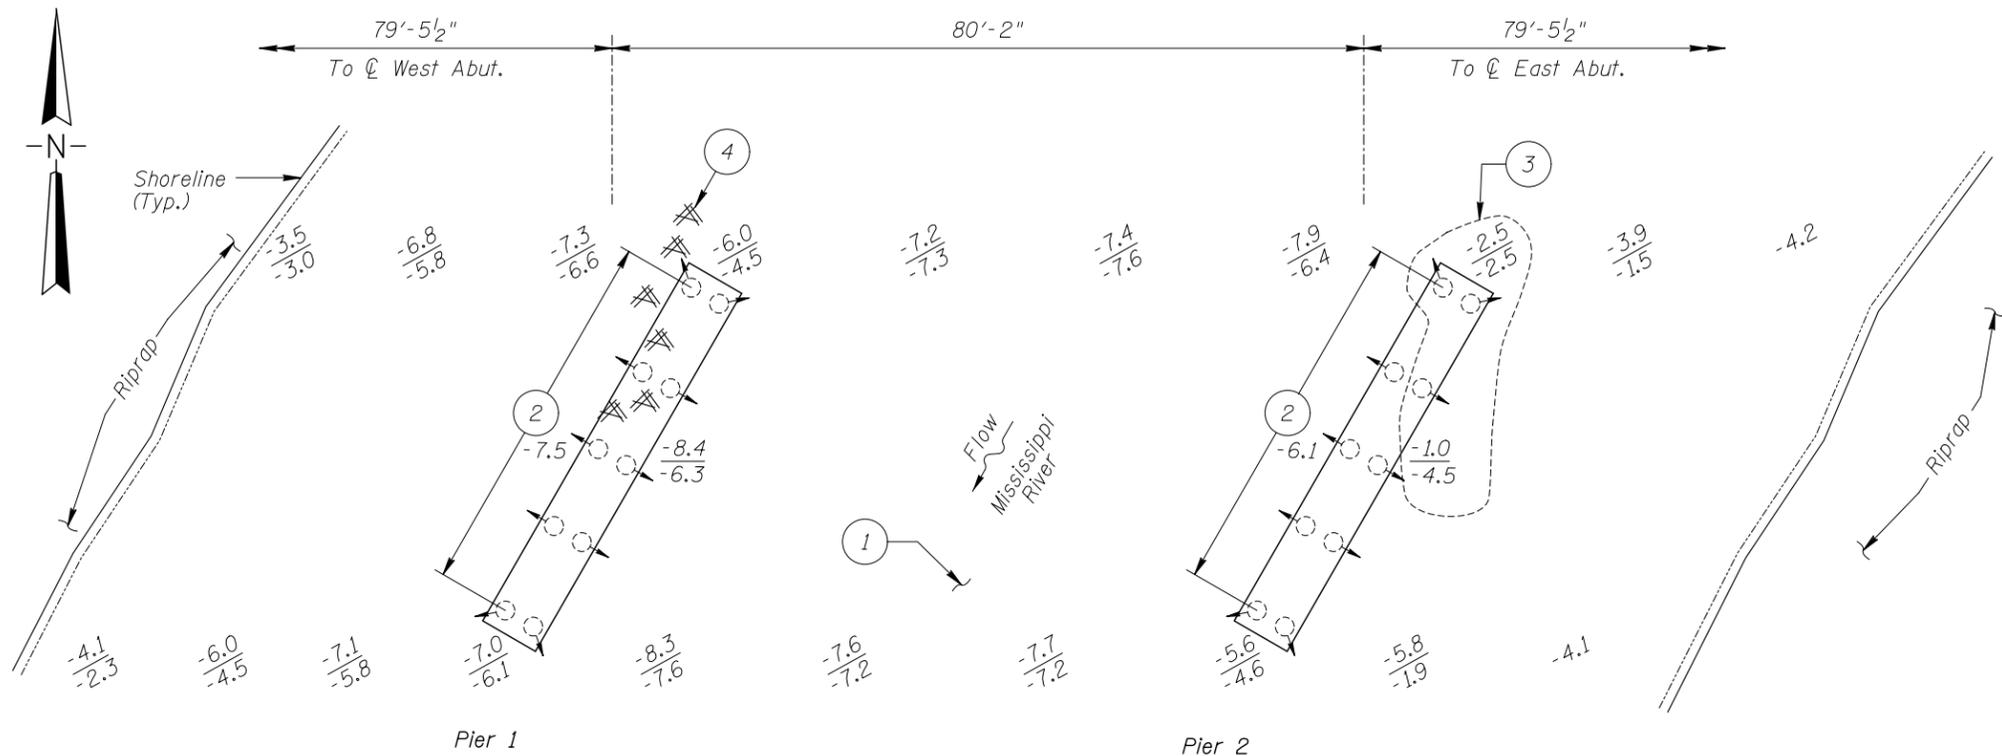
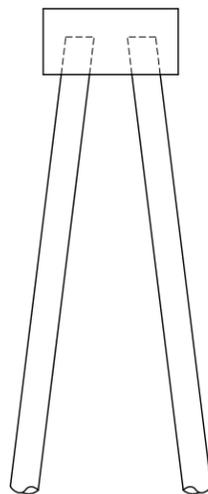
SOUNDING PLAN

- 1 The channel bottom material typically consisted of firm sandy gravel with scattered 6 inch cobbles and a maximum probe rod penetration of approximately 2 inches.

- 2 All piles exhibited coating failure, corrosion, and rust nodules covering 50 to 100 percent of the surface area, from 3 feet above the waterline to the channel bottom. The heaviest corrosion (+/- 100 percent) was located from 3 feet above to 2 feet below the waterline with random pitting up to 1/32 inch deep.

- 3 There was a moderate accumulation of silted in aquatics/organics and small branchy material, approximately 4 to 5 feet high allowing a maximum probe rod penetration of 1 foot, mounded up at the upstream end and upstream half of the east face of Pier 2 extending from approximately 1 to 2.5 feet below the waterline to the channel bottom.

- 4 A 6 inch diameter tree trunk with branches was observed at the upstream end of Pier 1 and extended from the channel bottom to the waterline.

Monitor the extent of corrosion on the piles, and if found to be progressing to the point where appreciable section loss is occurring, corrective measures to inhibit further deterioration may be warranted.

Monitor the accumulation of vegetation and timber debris around the upstream piles of Pier 2, to ensure it does not become excessive and exert large lateral loads or influence scour at the pier. If the accumulation progresses in size in the future, removal may be warranted at that time.
