UNDERWATER BRIDGE INSPECTION REPORT

STRUCTURE NO. 31514

MSAS 119

MINNESOTA DEPARTMENT OF TRANSPORTATION
UNDERWATER BRIDGE INSPECTION

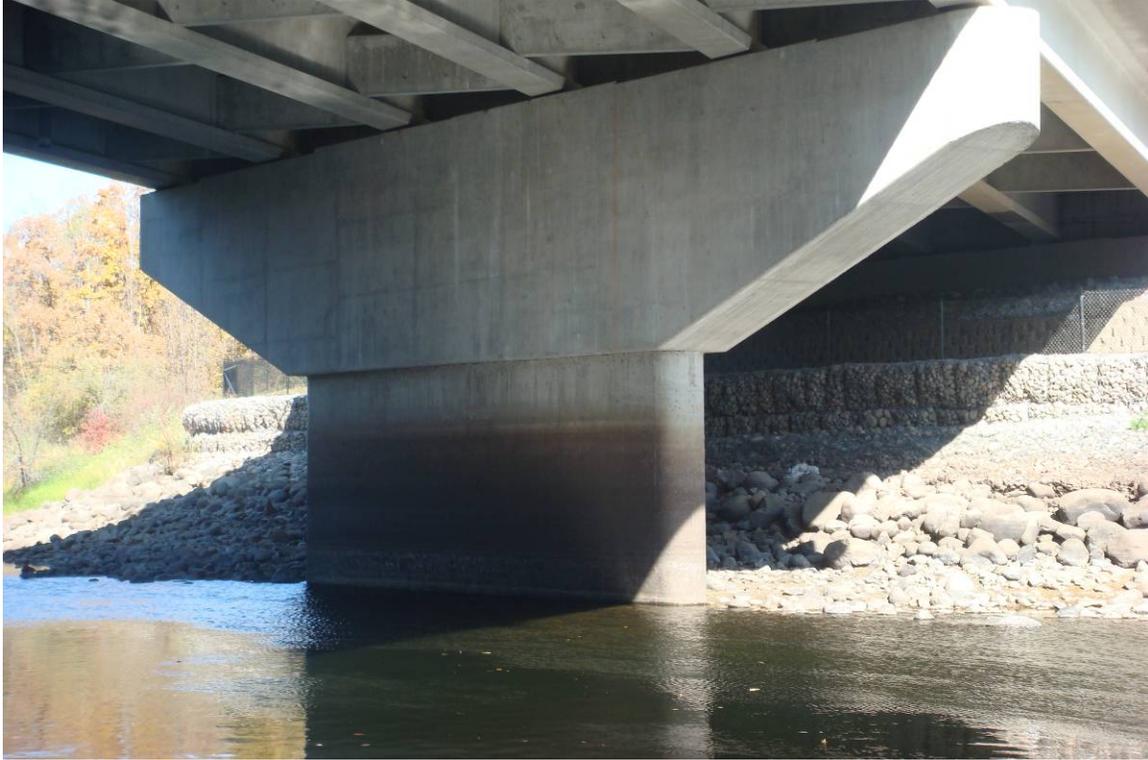
Photograph 3. View of the Pier 2, Looking Northeast.

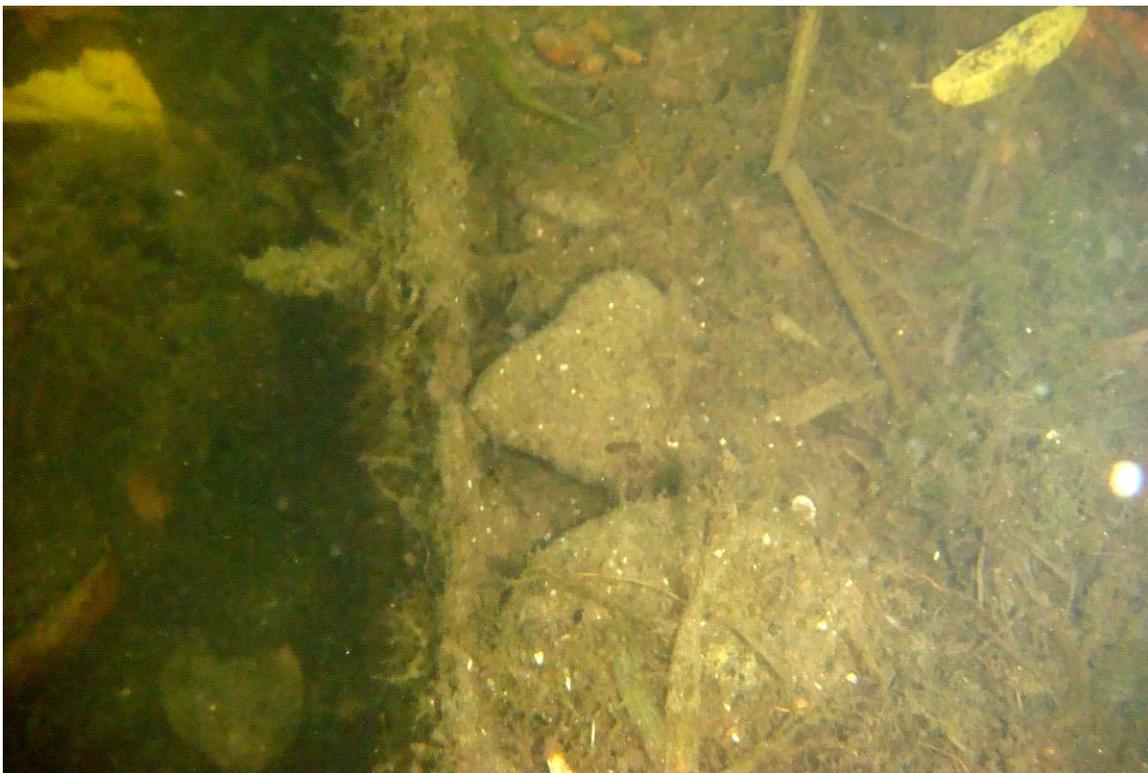
- (A) The concrete of the Piers 1 and 2 was smooth and sound with no significant deterioration.
- (B) Light scaling on the pier shafts was observed from 4 feet above the waterline to the channel bottom with maximum penetrations of 1/4 inch on both piers.
- (C) The footing and original formwork was observed to be exposed and/or protruding from the channel bottom on the channel side of both piers. The top of both footings were typically exposed in and around the edges of the footing, with sand on top of the footing closer to the pier shafts. The maximum vertical exposure was 3 feet and 1 foot at Piers 1 and 2, respectively.

Photograph 4. View of the Pier 2 Footing Exposure, Looking Down.

- 4 Footing and formwork was exposed 6 feet out from the west face of Pier 2, with the top at 2.4 feet below waterline. The footing (and formwork) was exposed from 8 feet down of the upstream nose to 6 feet from the downstream end of Pier 2. The maximum vertical exposure was 1 foot.

- (A) Reinspect the submerged substructure units at the normal maximum recommended (NBIS) interval of sixty (60) months.

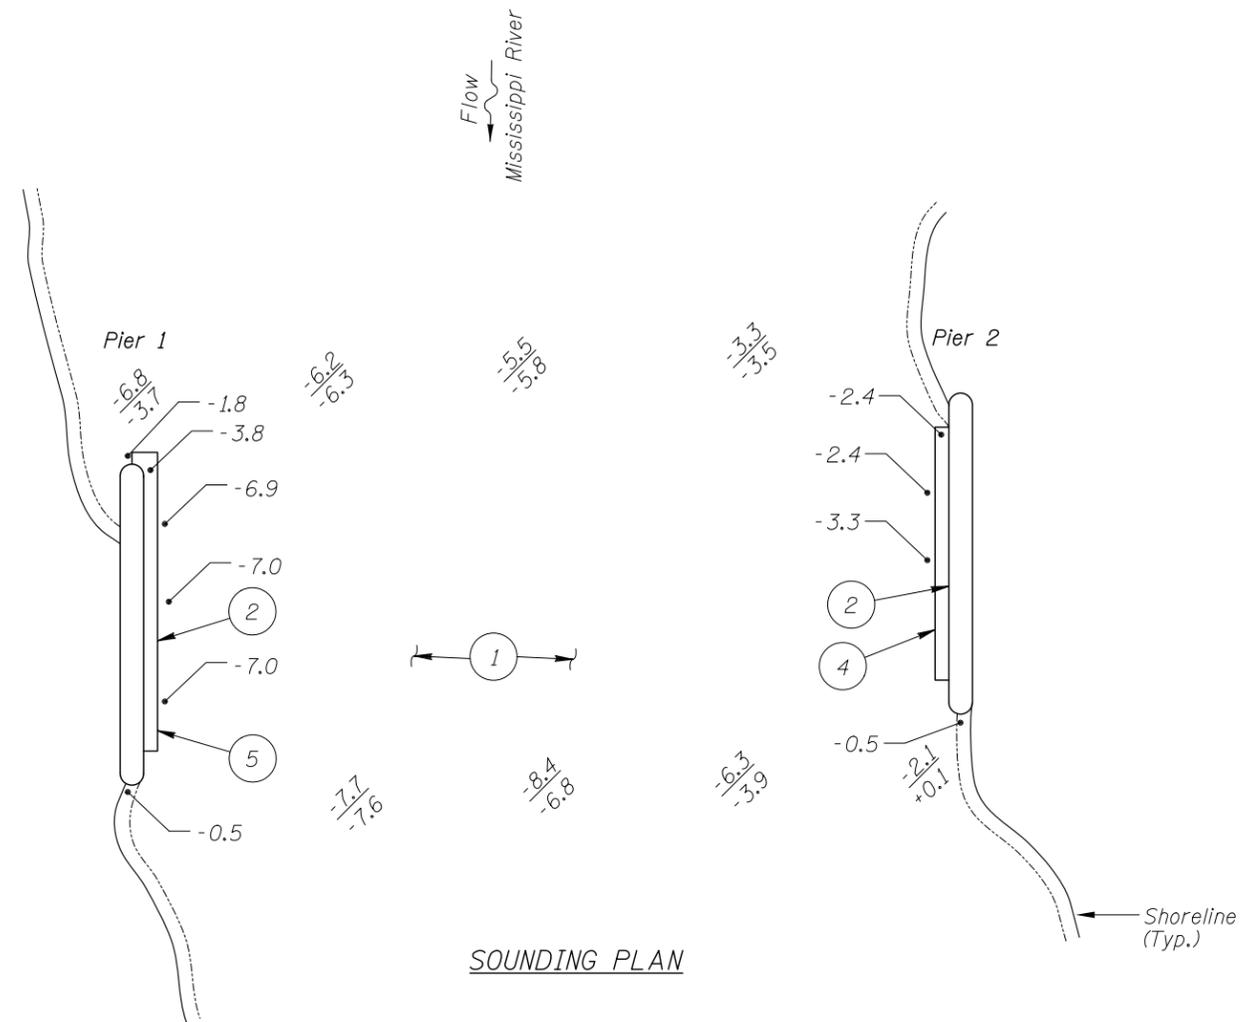
SOUNDING PLAN

- 1 The channel bottom material consisted of sand with scattered 1 foot diameter and smaller rocks allowing a 2 inch maximum probe rod penetration. 2 foot diameter rocks were observed at the upstream and downstream noses of the piers.

- 2 Overall the concrete was relatively smooth and sound with no significant deterioration.
- 3 Light scaling was observed from 4 feet above the waterline to the channel bottom with a typical penetration of 1/8 inch.

- 5 Footing and formwork was observed 6 feet out from the entire east face of Pier 1. The maximum vertical exposure was 3 feet and was located at the middle of the pier. The footing (and formwork) was observed for a short distance also at the upstream nose of Pier 1. The top of the footing was at 3.8 feet below the waterline and was covered by a layer of sand, from the upstream nose to the downstream 1/4-point of Pier 1.
