UNDERWATER BRIDGE INSPECTION REPORT

STRUCTURE NO. 31516

CR 441

OCTOBER 2, 2012

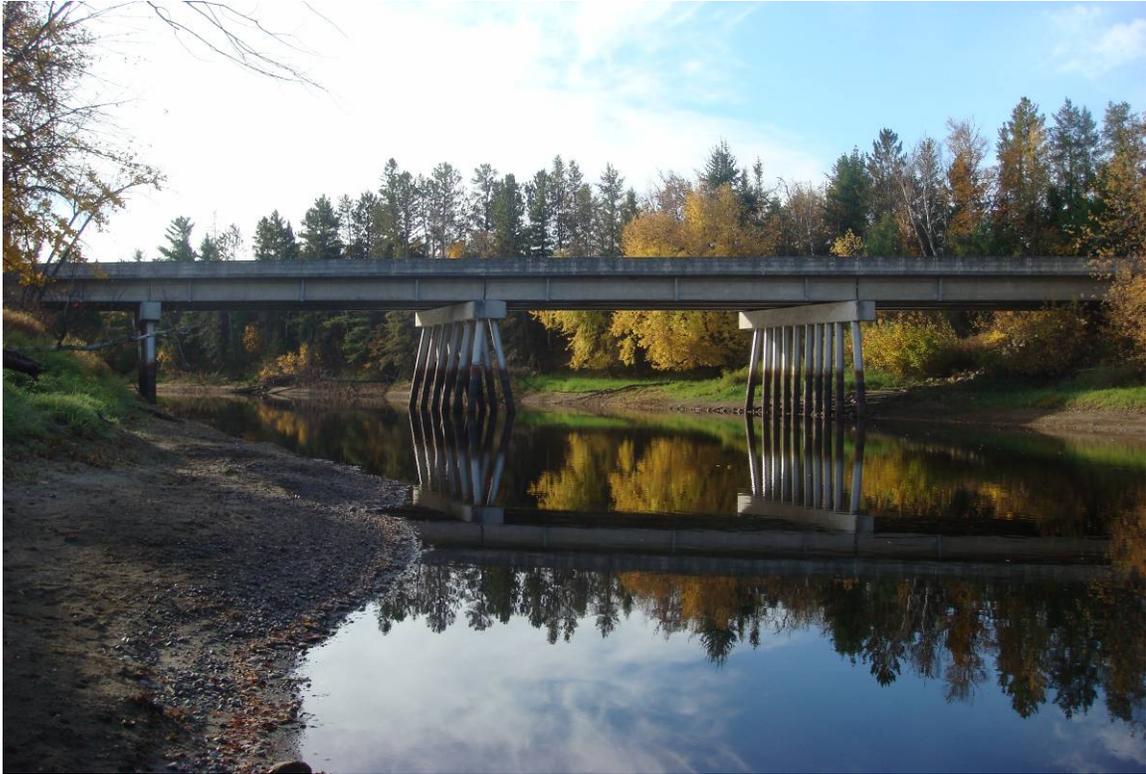
Photograph 1. Overall View of the Structure, Looking Southwest.

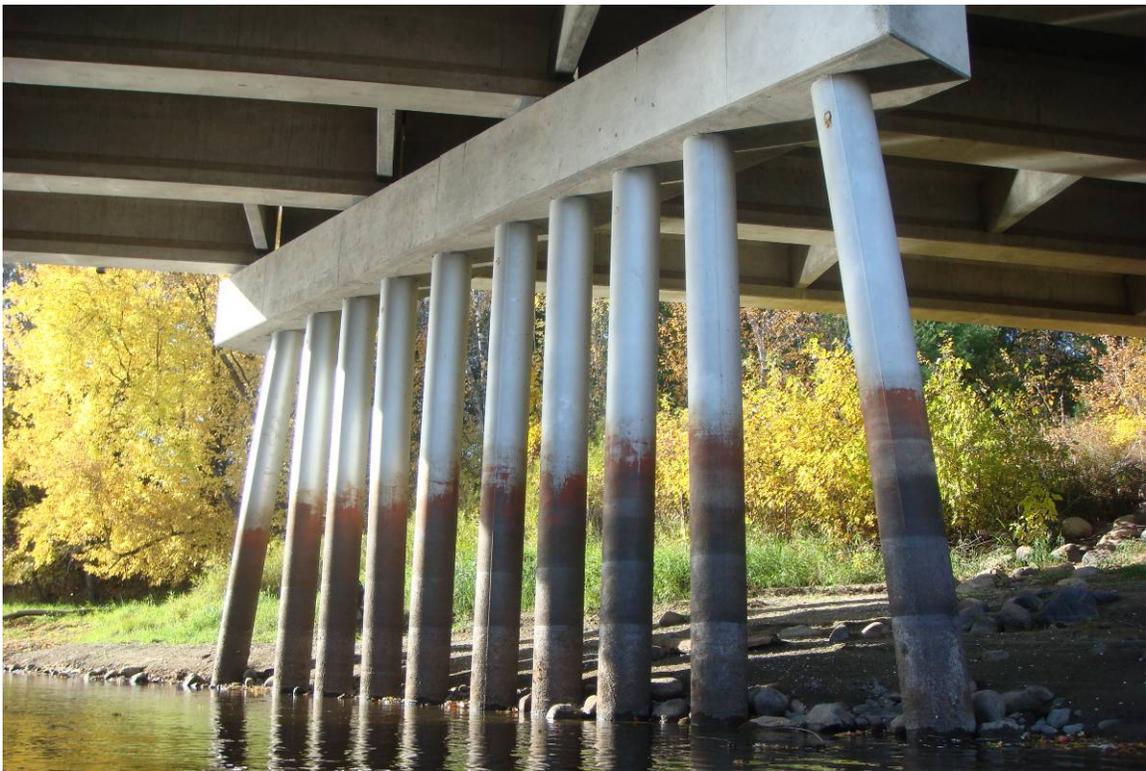
Photograph 2. View of Pier 1, Looking Southwest.

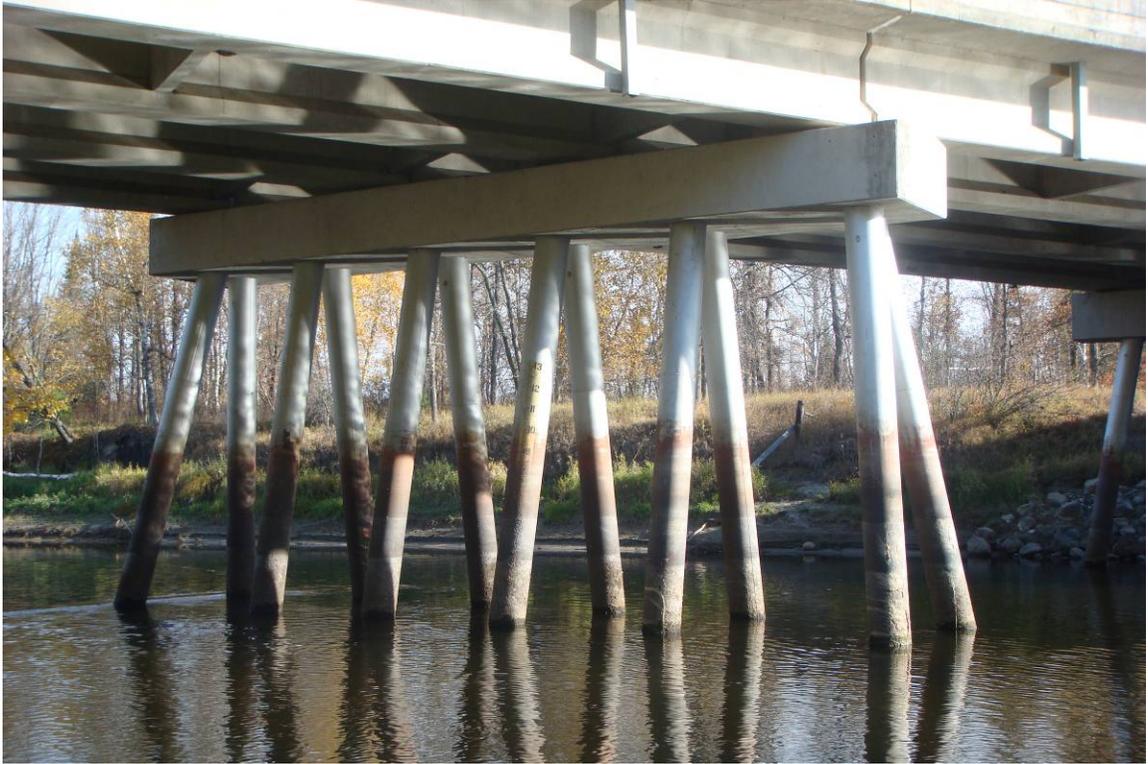
Photograph 3. View of Pier 2, Looking Northeast.

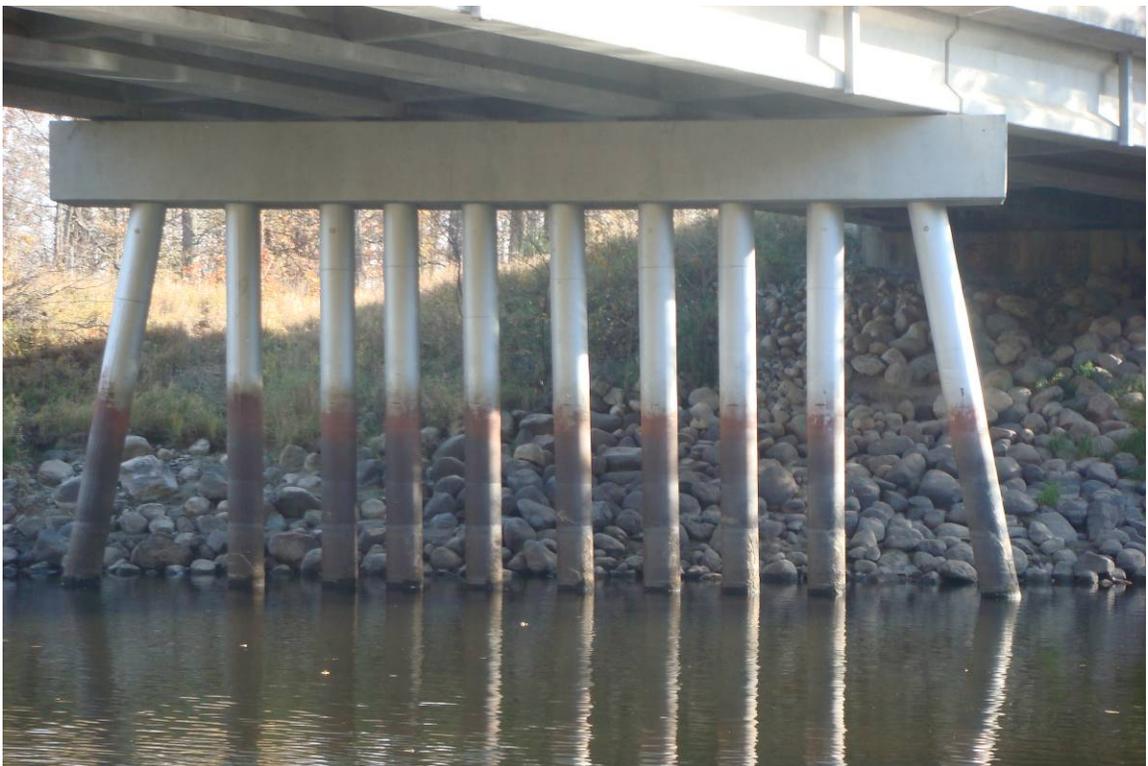
Photograph 4. View of Pier 3, Looking Northeast.

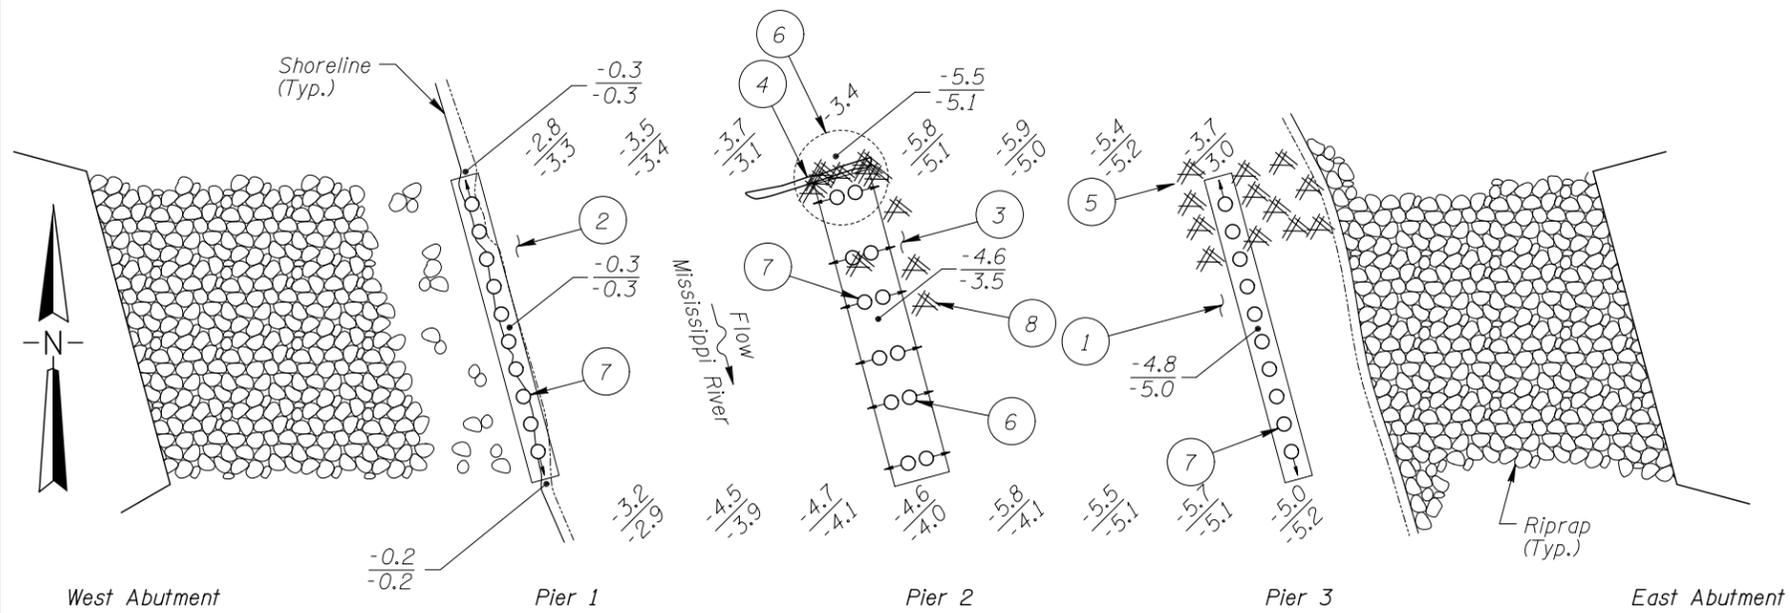
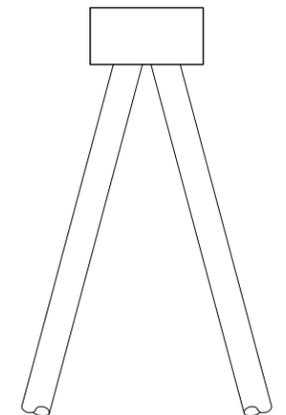
SOUNDING PLAN

- 1 The channel bottom material consisted of firm sandy gravel with cobbles and 1 foot diameter riprap allowing 2 to 3 inches of probe rod penetration.

- 2 The channel bottom material consisted of silty sand with cobbles and scattered riprap allowing up to 6 inches of probe rod penetration.
- 3 The channel bottom consisted of silty sand allowing up to 1 foot of probe rod penetration.

- 4 Moderate accumulation of up to 1 foot diameter timber debris extending from the channel bottom to waterline. Also 1 foot and 6 inch diameter logs across both upstream piles of Bent 2 that extend off to the west of pier.

- 5 Light random accumulation of timber debris consisting of 4 inch diameter and smaller logs and branches on the channel bottom in and around all piles of the pier.

- 6 Minor scour pockets, 1 to 2 feet deep with 1 to 2 feet radius, were observed at all piles. At upstream end of Pier 2 scour was 2 feet deep and 5 feet in radius.

- 7 Steel pipe piles exhibited 100% coating failure from 8 feet above the waterline to the channel bottom with 50 to 100% coverage of typically 1/4 to 1/2 inch diameter rust nodules and up to 1 1/2 inch diameter rust nodules from the waterline to the channel bottom of Piers 2 and 3. From 6 feet above waterline to waterline corrosion was moderate with delaminations and pitting 1/16 inch to 1/8 inch maximum in depth. From waterline to channel bottom there was minimal loss of section with pitting that was typically 1/32 inch to maximum 1/16 inch deep.

- 8 A light random accumulation of timber debris consisting of 8 inch diameter and smaller logs and branches on the channel bottom east of the pier extending from the upstream nose to the pier midpoint.
