UNDERWATER BRIDGE INSPECTION REPORT

STRUCTURE NO. 3381

CR 422

MINNESOTA DEPARTMENT OF TRANSPORTATION  
UNDERWATER BRIDGE INSPECTION

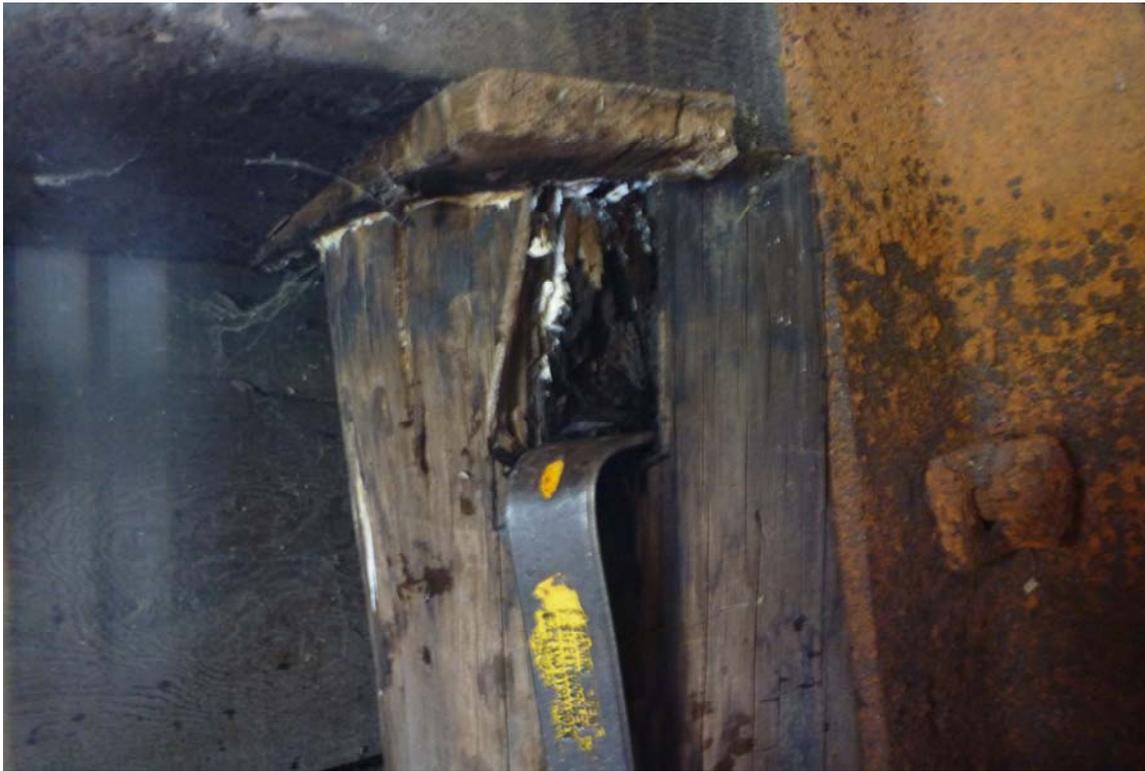
- (B) A 6 inch wide by 2 inch deep area of soft/rotted (decayed) timber was observed on the north face of Pile C of the East Abutment at approximately 8 inches below the pile cap.

Photograph 5. View of Soft/Rotted Timber at Pile C of the East Abutment, Looking Southeast.

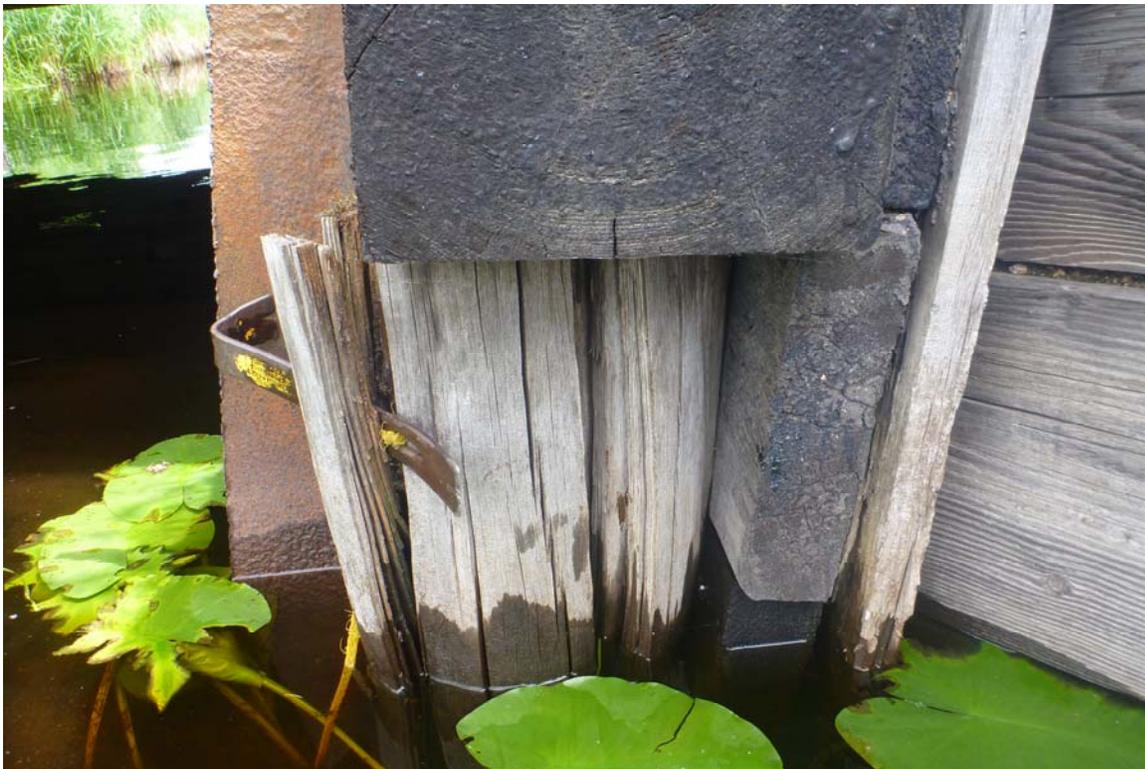
- (C) Pile A of the East Abutment exhibited approximately 60 percent loss of section extending from the pile cap down 3.5 feet.
- (D) An 8 inch wide area of splintered and soft timber extending 2 inches into the outer shell was observed on the south face of Pile A of the West Abutment. The defected area extended from the pile cap down 1.5 feet.

Photograph 6. View of Split/Splintered Timber on Pile A of the East Abutment, Looking North.

- (A) Consideration should be given to evaluating the abutment load carrying capacities in light of the significant number of deficient, heavily deteriorated piling. Based on that evaluation, additional piling or other corrective measures will likely be warranted.

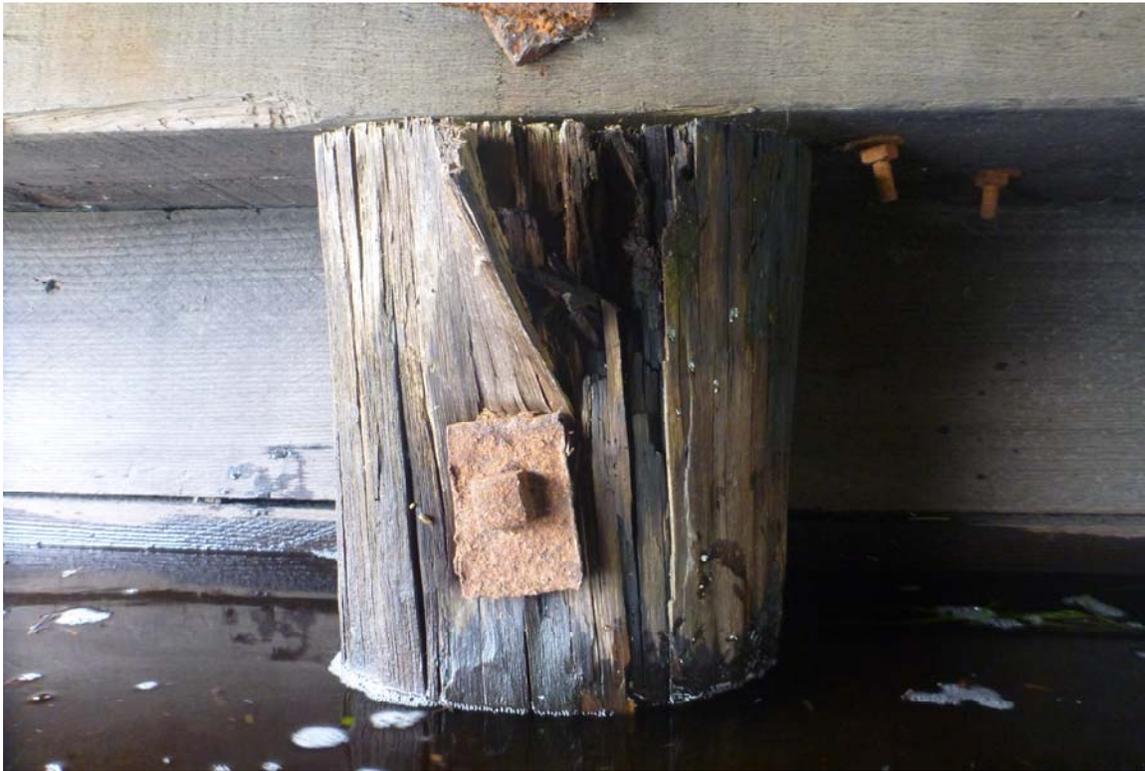
- (E) A 15 inch wide area of splintered and soft timber extending 2 inches into the outer shell was observed on the south and east faces of Pile B of the West Abutment and extended from the pile cap down 1.5 feet.

Photograph 7. View of Typical Outer Shell Splintering, Splitting, and Deterioration at Pile B of the West Abutment, Looking West.

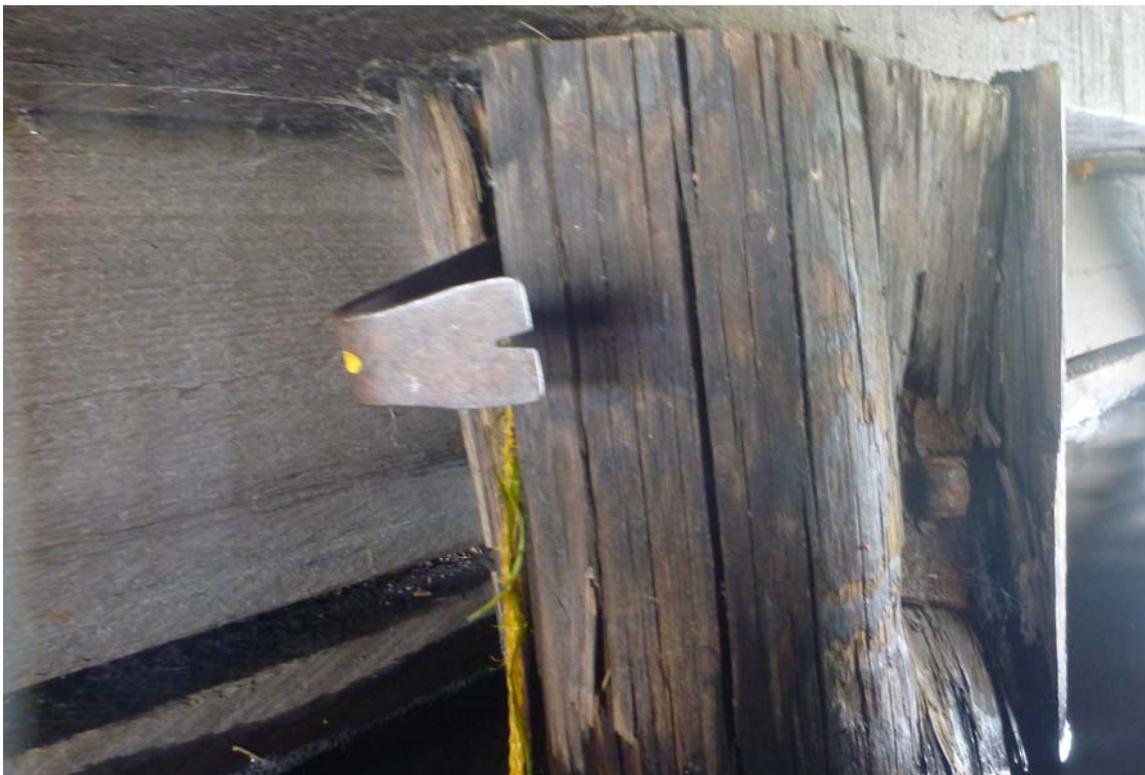
- (H) Pile D of the West Abutment was severely split/splintered. Approximately 90 percent of the total cross-sectional area of the pile was observed to be unsound with areas of heavy decay.

Photograph 8. View of Severe Splintering, Splitting, and Deterioration at Pile D of the West Abutment, Looking Northwest.

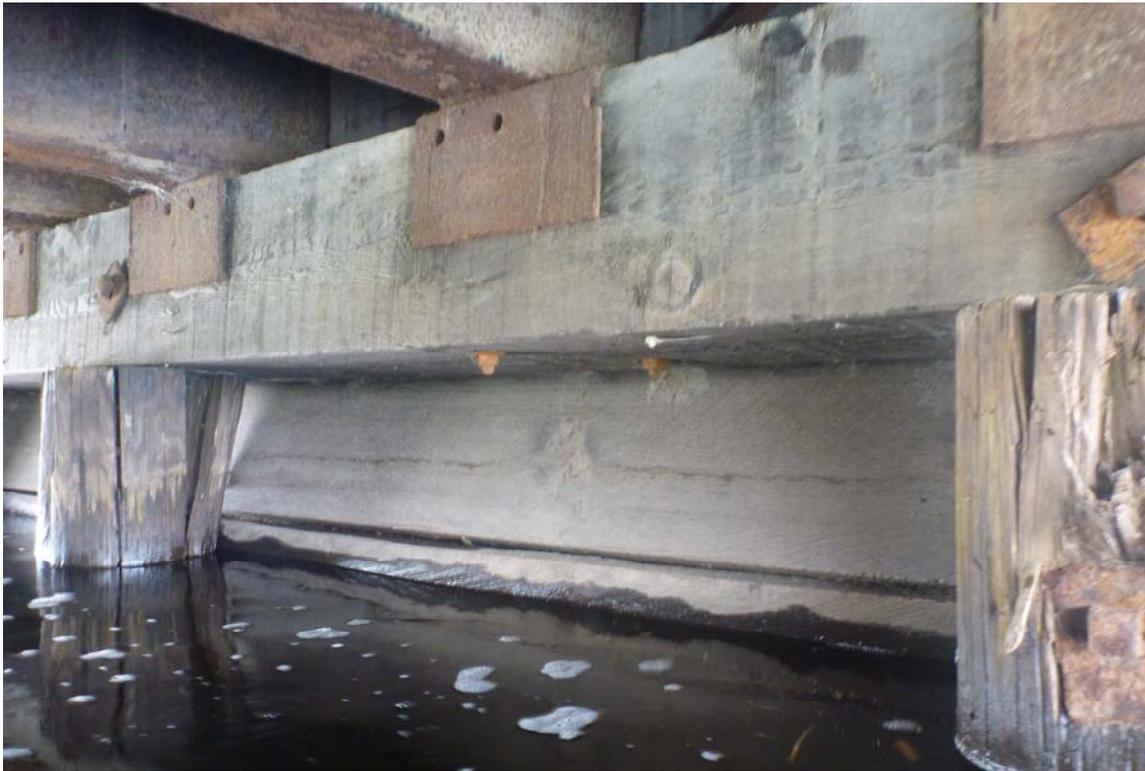
Photograph 9. View of Typical Backwall Condition at the West Abutment between Piles D and E, Looking Southwest.

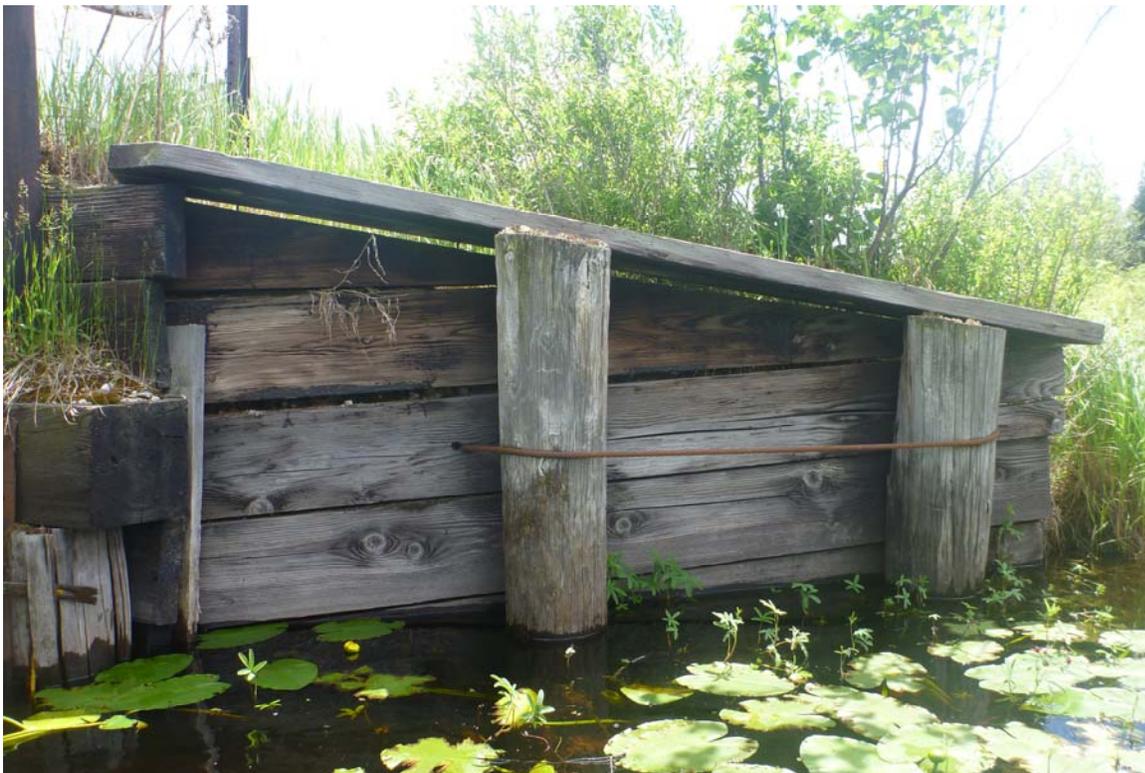
Photograph 10. View of Typical Wingwall Condition at the Upstream end of the East Abutment, Looking Northeast.

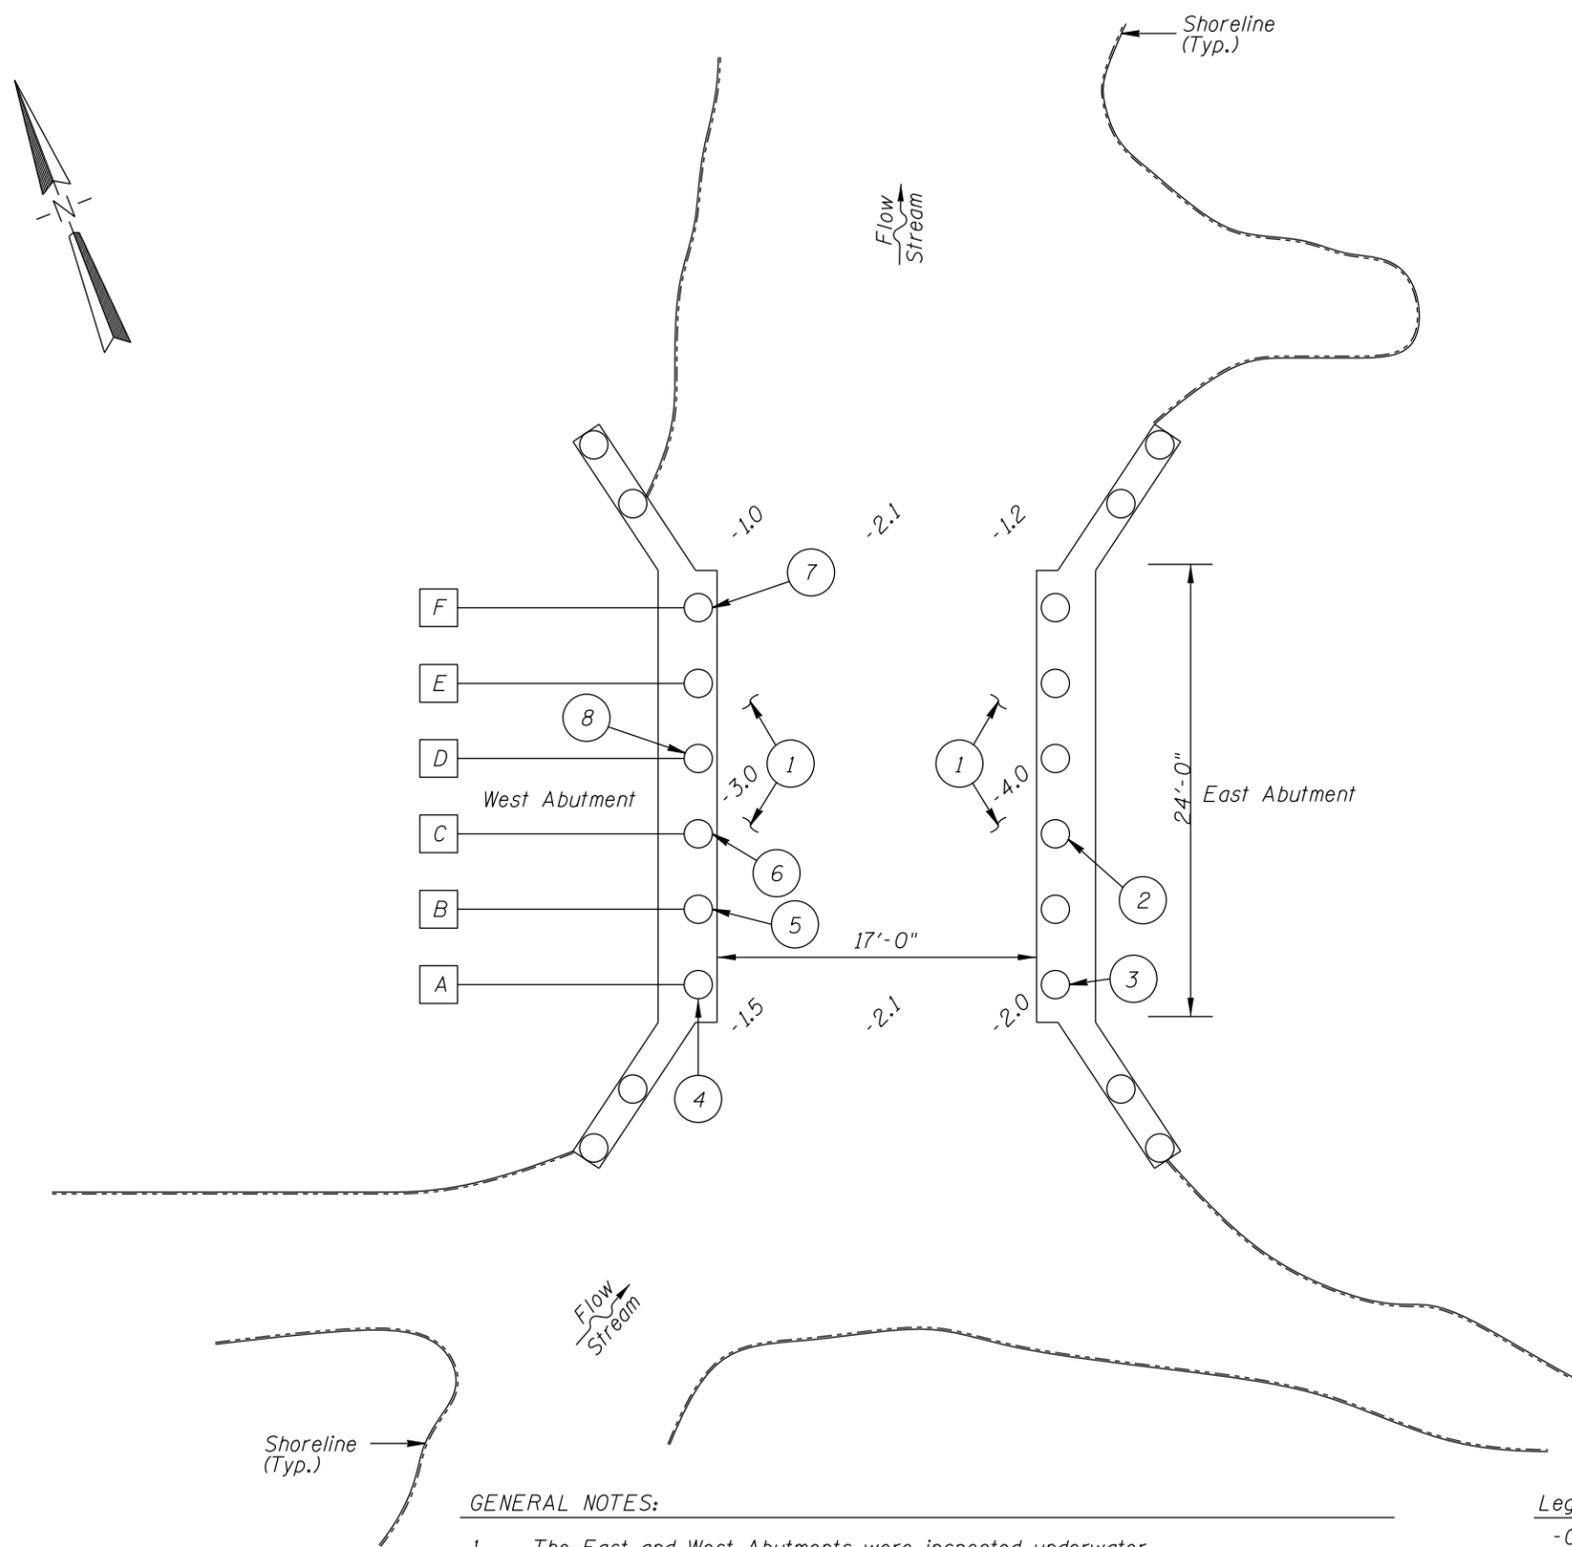
- 1 Channel bottom consisted of soft silty gravel typically allowing 2 feet of probe rod penetration. Near the middle of the abutments the silty gravel was more firm allowing 1 foot of probe rod penetration.

- 2 A 6 inch wide by 2 inch deep area of soft/rotted (decayed) timber was observed on the north face of Pile C of the East Abutment at approximately 8 inches below the pile cap.

- 3 Pile A of the East Abutment exhibited approximately 60 percent loss of section extending from the pile cap down 3.5 feet.
- 4 An 8 inch wide area of splintered and soft timber extending 2 inches into the outer shell was observed on the south face of Pile A of the West Abutment. The defected area extended from the pile cap down 1.5 feet.

- 5 A 15 inch wide area of splintered and soft timber extending 2 inches into the outer shell was observed on the south and east faces of Pile B of the West Abutment and extended from the pile cap down 1.5 feet.

- 6 An 15 inch wide area of splintered and soft timber extending 2 inches into the outer shell was observed on the east face of Pile C of the West Abutment and extended from the pile cap down 1.5 feet.

- 7 Pile D of the West Abutment was severely split/splintered. Approximately 90 percent of the total cross-sectional area of the pile was observed to be unsound with areas of heavy decay.

- 8 An area of splintered and soft timber extending 1.5 inches into the outer shell was observed on the east half of Pile F of the West Abutment and extended from the pile cap down 1.5 feet.
