UNDERWATER BRIDGE INSPECTION REPORT

STRUCTURE NO. 36503
CR NO. 145
OVER THE
RAT ROOT RIVER
DISTRICT 1 - KOOCHICHING COUNTY

AUGUST 13, 2012
PREPARED FOR THE
MINNESOTA DEPARTMENT OF TRANSPORTATION
BY
COLLINS ENGINEERS, INC.
JOB NO. 7423

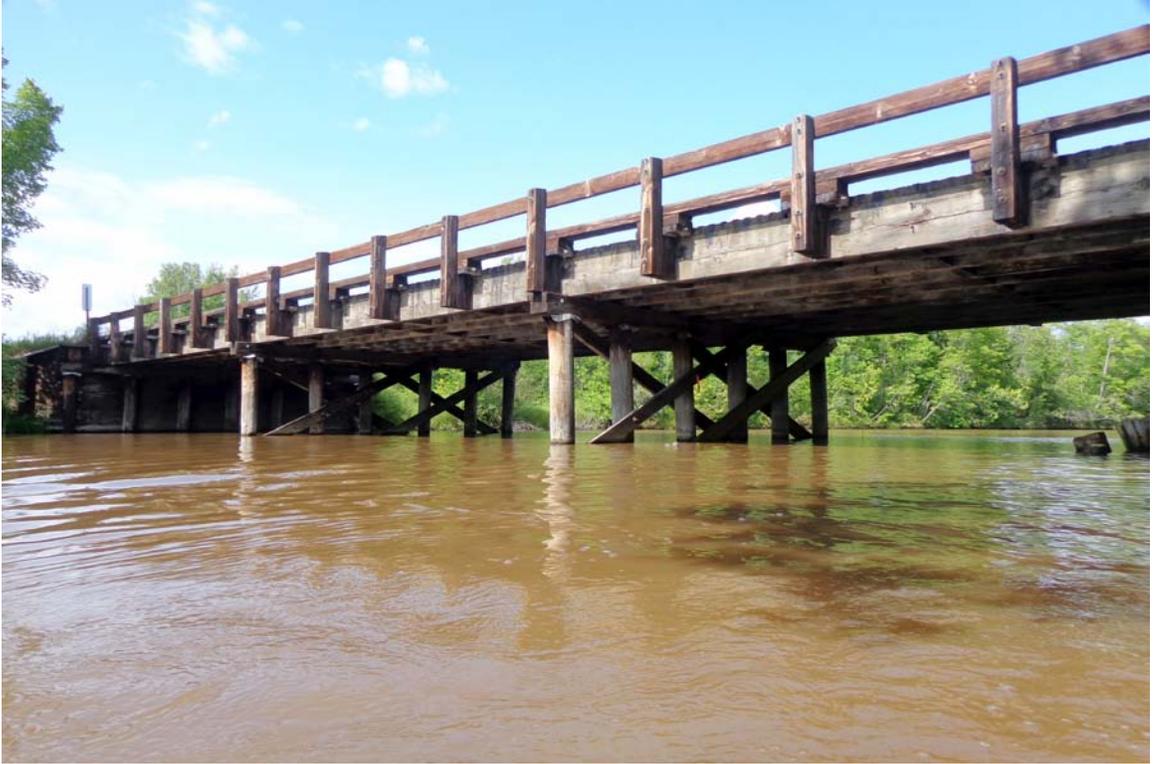
Photograph 1. Overall View of the Structure, Looking Northwest.

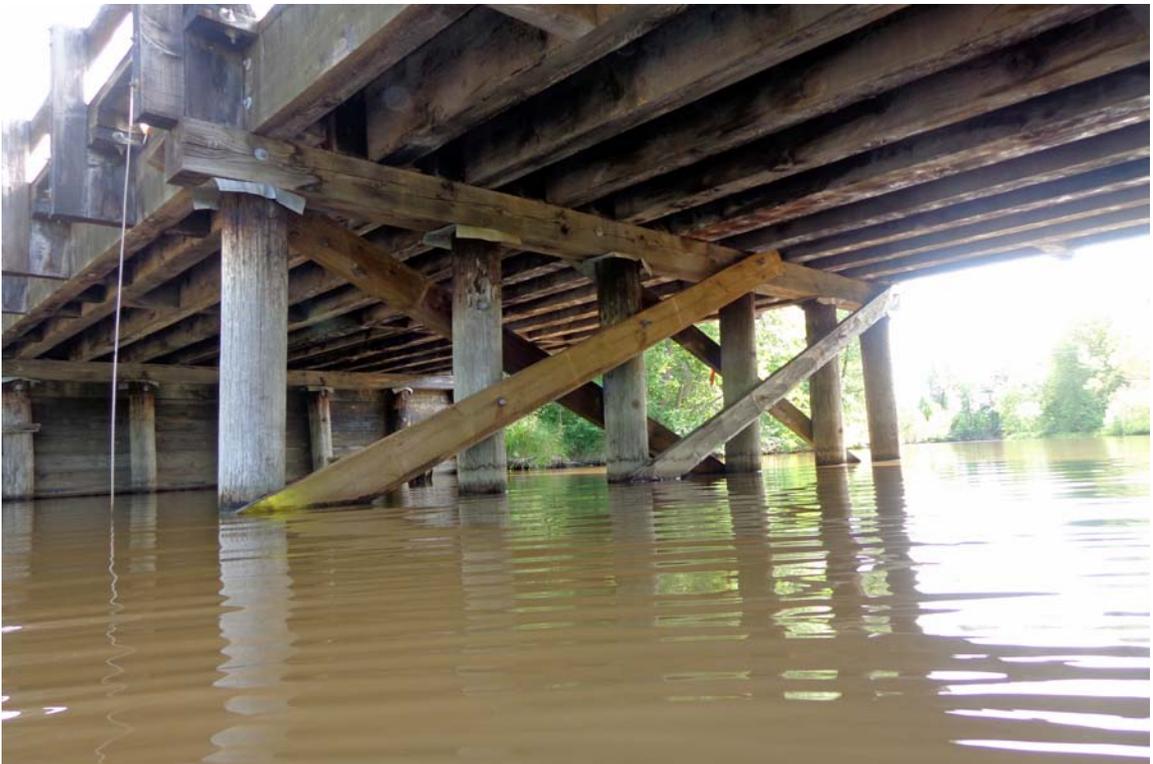
- (C) A timber pile at the Southwest wingwall had a 1/2 inch wide crack from the top down 6 feet with 4 inches penetration.
- (D) Random timber piles at Pier 1 and 2 exhibited a 10 inch wide to half the pile circumference wide area of splintering and delaminating with up to 1.5 inch penetration from the channel bottom to 2 feet above the waterline. (ice abrasion damage)

Photograph 2. View of Pier 1, Looking Southeast.

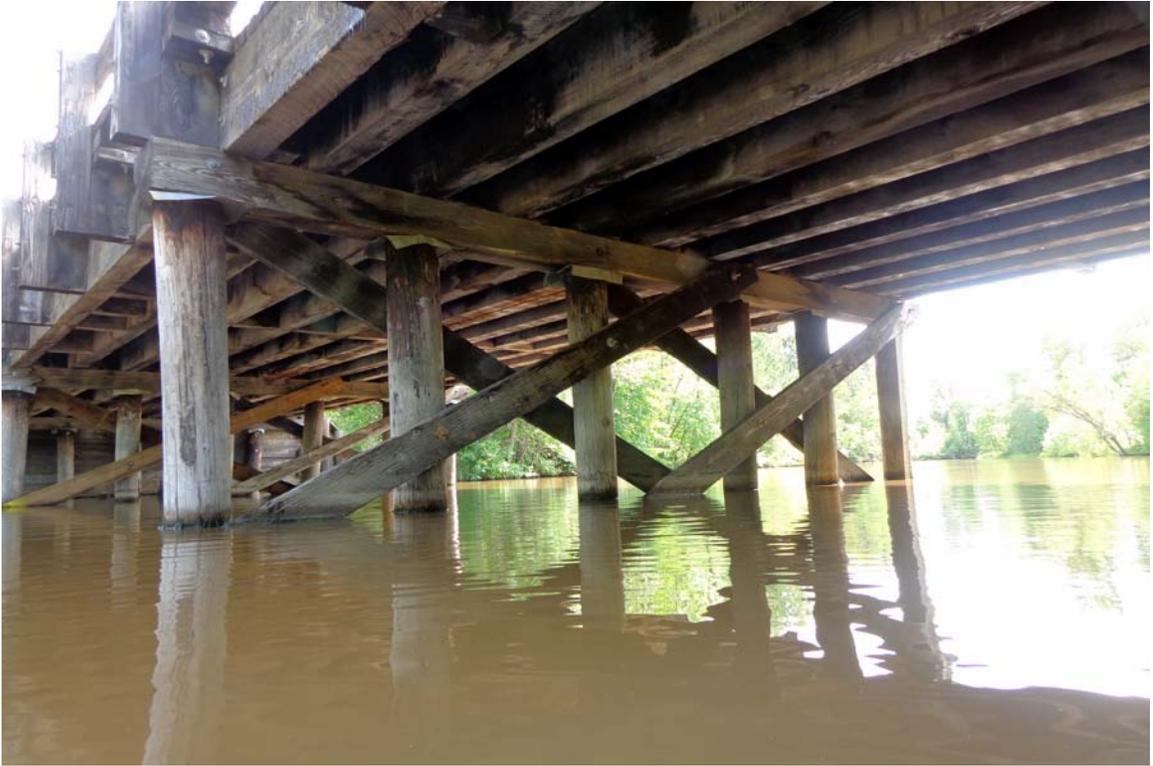
- (E) Timber cross bracing at the east face of Pier 2 exhibited up to 3 foot long split below the fastener.
- (F) Timber pile at the downstream end of the east abutment had a 1 inch wide split from the top down 6 feet with penetration through 1/2 of the pile.

- (G) A moderate accumulation of timber debris consisting of 6-inch-diameter and smaller branches was observed at Pier 2 and extended from the channel bottom up to 2 feet.

- (I) Timber cross bracing is no longer attached to Pile 2 on the west side of Pier 2.
- (J) The pile cap over Piles 1 and 2 of the West Abutment was rotated slightly to the west, with some minor diagonal torsional cracking along the south side, and as a result the cap was only bearing on 50 percent of the top of the piles.

- (K) Timber cross bracing had a 3 inch by 1-1/2 foot area of timber missing and the fastener to Pile 3 was no longer engaged to the cross bracing on the west side of Pier 2.

Photograph 3. View of Pier 2, Looking Southeast.

The timber cross bracing members that exhibited cracking or loss of section should be repaired or replaced during routine maintenance.

Monitor the drift accumulations at the bridge during future inspections, and if found to be progressing, removal may be warranted at that time.

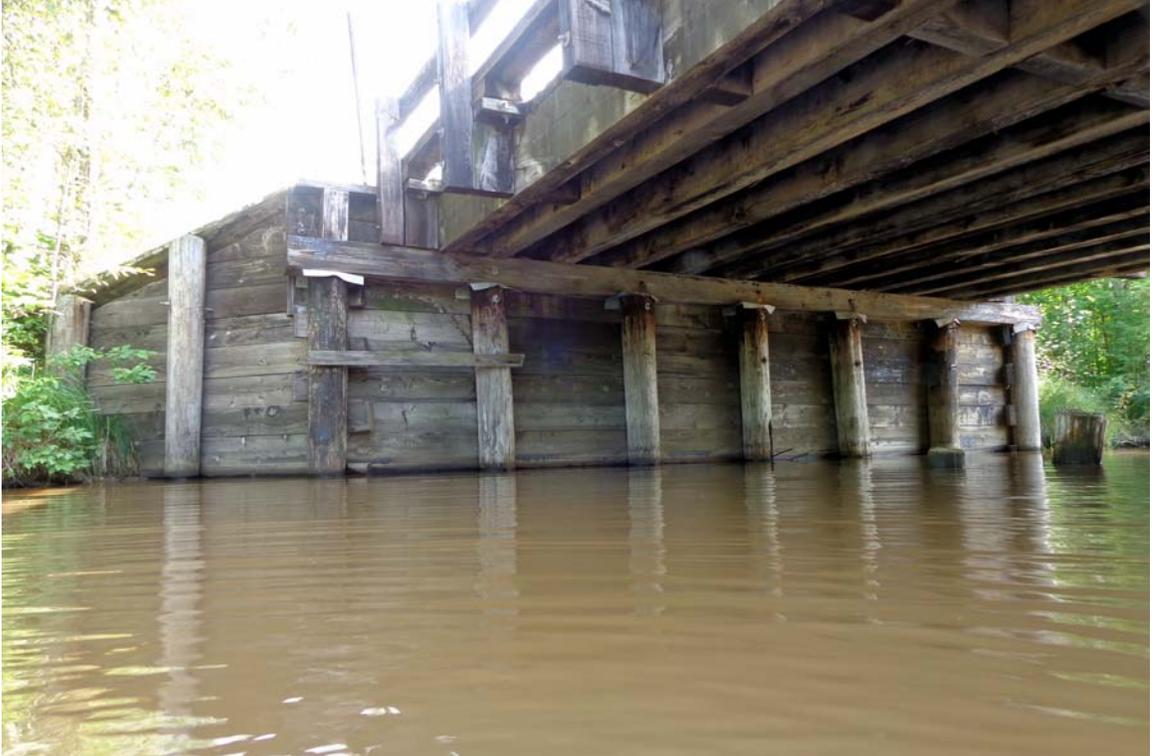
Photograph 4. View of East Abutment, Looking Southeast.

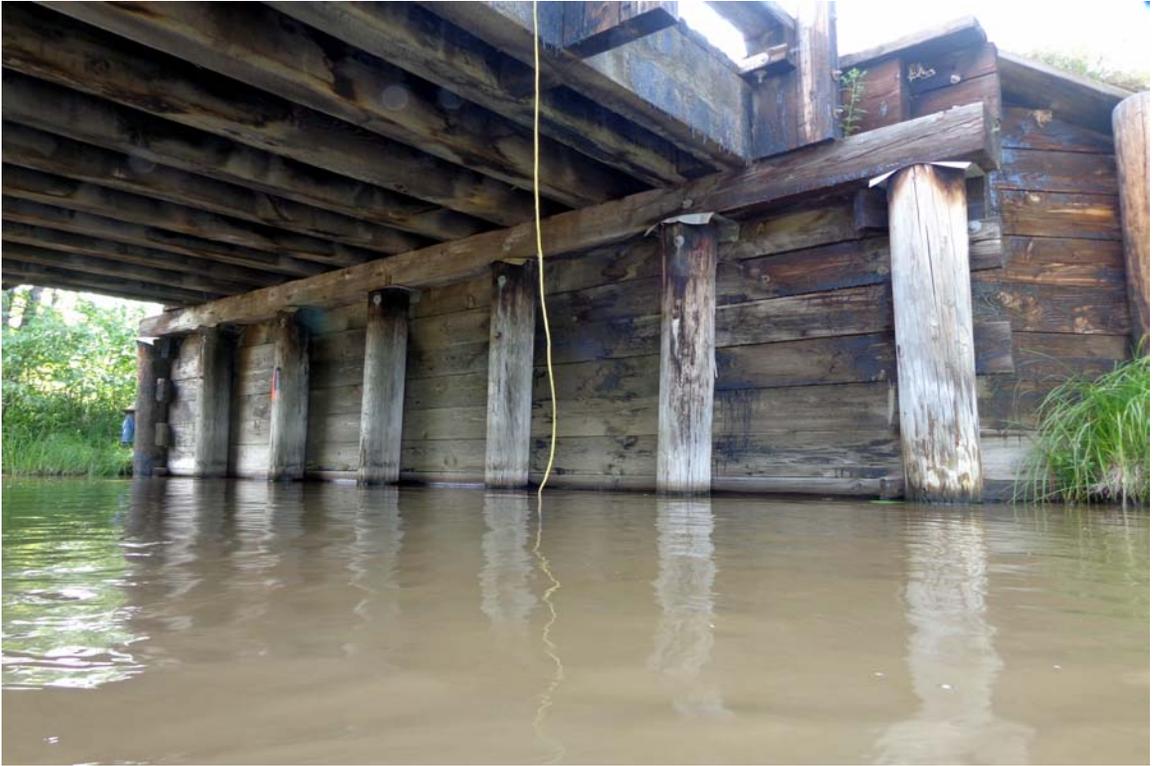
- (L) A 1/2 inch wide split with 6 inches of penetration, extended 3 feet down from the top of Pile 7 at the West Abutment.
- (M) Piles 4, 5, and 6 at the West Abutment exhibited a 3 inch wide are of splintering and delamination with up to 1 inch penetration from the channel bottom to 2 feet above the waterline. (ice abrasion damage)

Photograph 5. View of West Abutment, Looking West.

Monitor the extent of the pile cap rotation at the West Abutment during future inspections and repair if bearing loss becomes excessive.

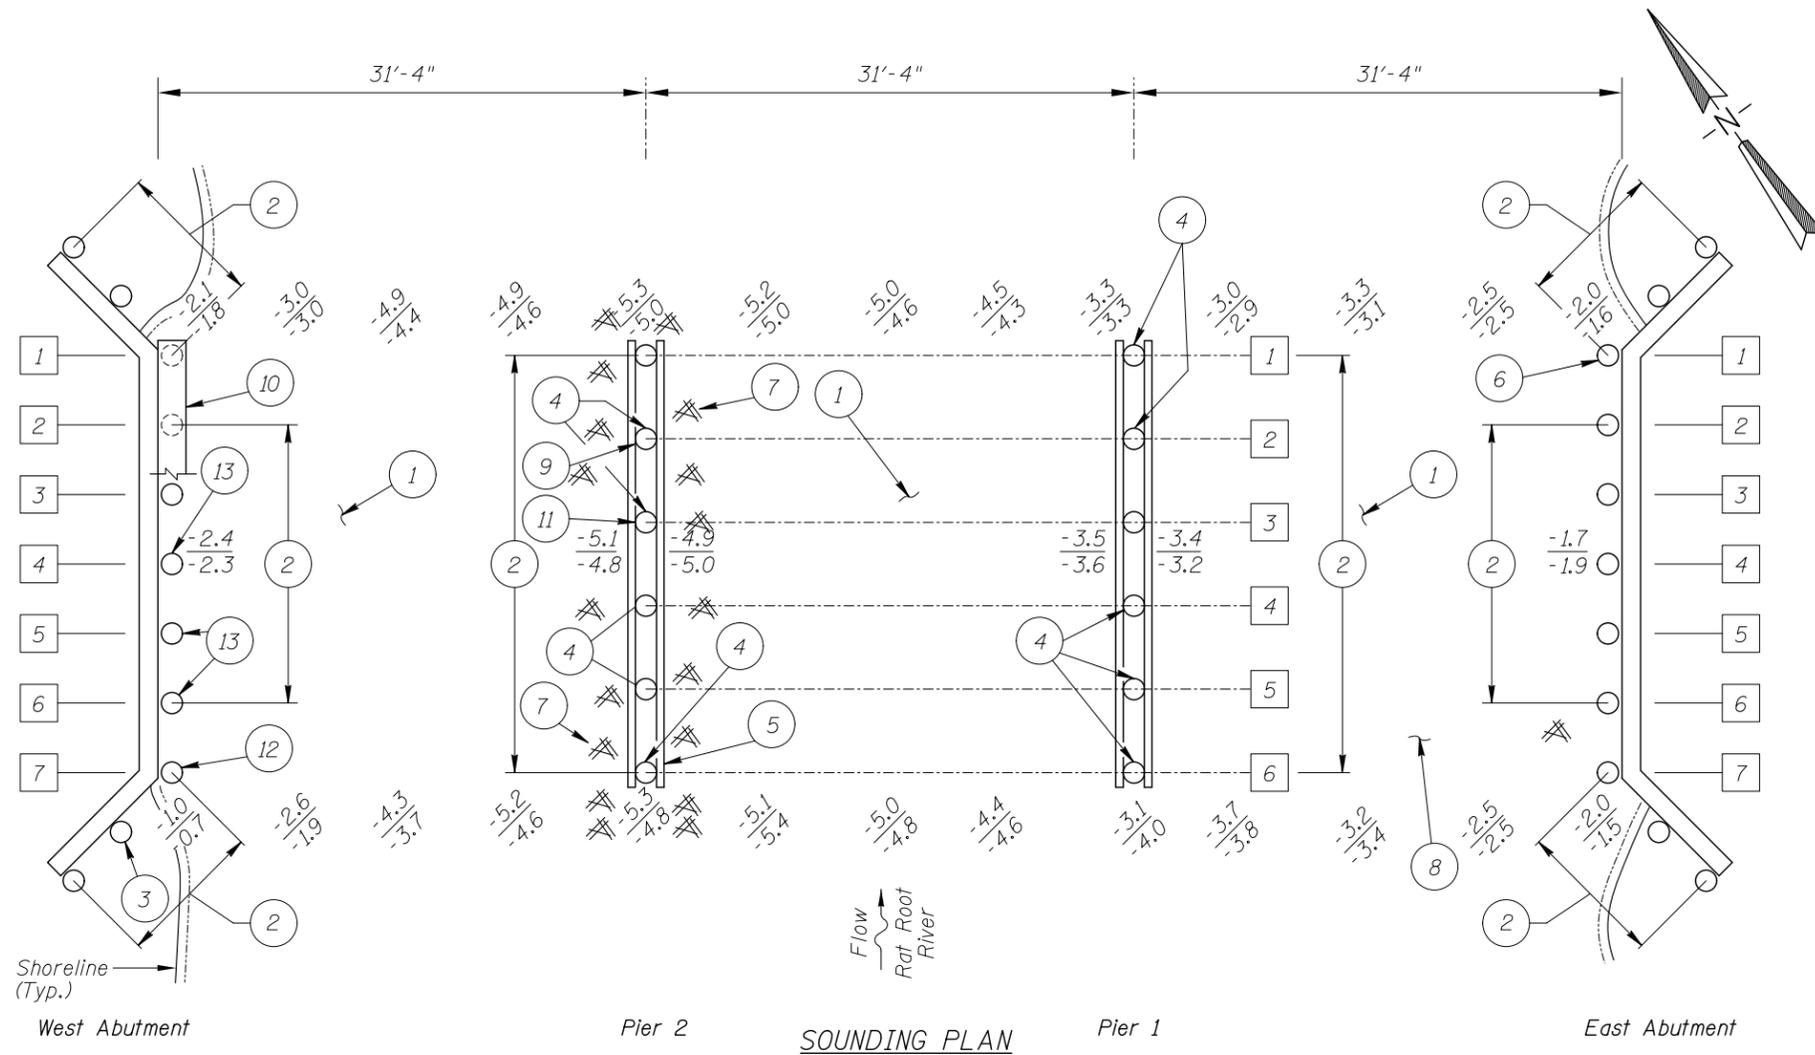
| <p>1 The channel bottom material consisted of soft silty clay with random 1 foot in diameter and smaller rock with 1 foot of probe rod penetration.</p> <p>2 All piles exhibited random 1/8 inch wide typical and 1/4 inch wide maximum checking unless otherwise noted.</p> <p>3 A timber pile at the Southwest wingwall had a 1/2 inch wide crack from the top down 6 feet with 4 inches penetration.</p> <p>4 Random timber piles at Pier 1 and 2 exhibited a 10 inch wide to half the pile circumference wide area of splintering and delaminating with up to 1.5 inch penetration from the channel bottom to 2 feet above the waterline. (ice abrasion damage)</p> <p>5 Timber cross bracing at the east face of Pier 2 exhibited up to 3 foot long split below the fastener.</p> <p>6 Timber pile at the downstream end of the east abutment had a 1 inch wide split from the top down 6 feet with penetration through 1/2 of the pile.</p> | <p>7 A moderate accumulation of timber debris consisting of 6-inch-diameter and smaller branches was observed at Pier 2 and extended from the channel bottom up to 2 feet.</p> <p>8 Light timber drift accumulation between East Abutment and Pier 1 hung up on cut off piles. In addition, light timber debris up to 6 inches in diameter was scattered around Pier 1.</p> <p>9 Timber cross bracing is no longer attached to Pile 2 on the west side of Pier 2.</p> <p>10 The pile cap over Piles 1 and 2 of the West Abutment was rotated slightly to the west, with some minor diagonal torsional cracking along the south side, and as a result the cap was only bearing on 50 percent of the top of the piles.</p> <p>11 Timber cross bracing had a 3 inch by 1-1/2 foot area of timber missing and the fastener to Pile 3 was no longer engaged to the cross bracing on the west side of Pier 2.</p> <p>12 A 1/2 inch wide split with 6 inches of penetration, extended 3 feet down from the top of Pile 7 at the West Abutment.</p> <p>13 Piles 4, 5, and 6 at the West Abutment exhibited a 3 inch wide area of splintering and delamination with up to 1 inch penetration from the channel bottom to 2 feet above the waterline. (ice abrasion damage)</p> |

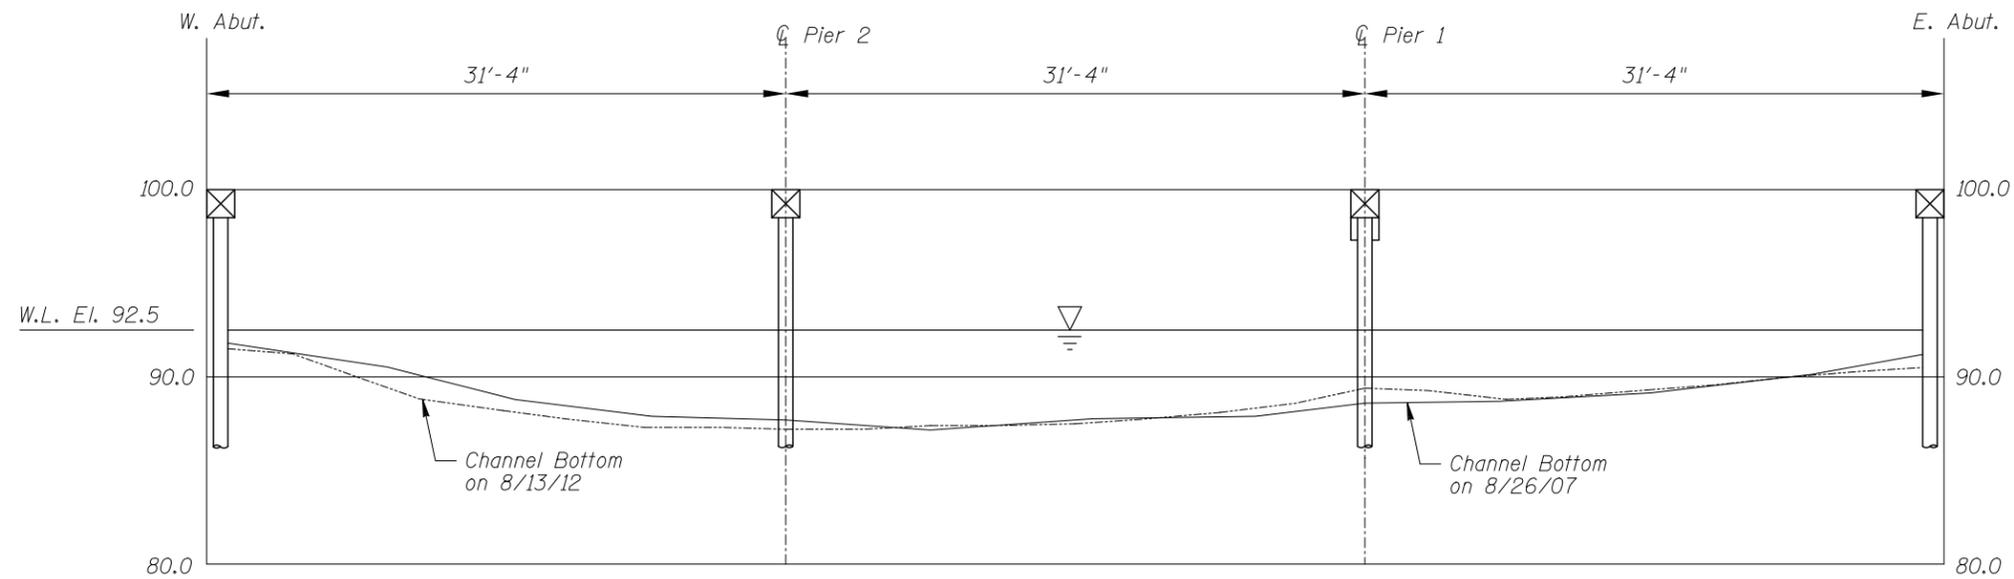
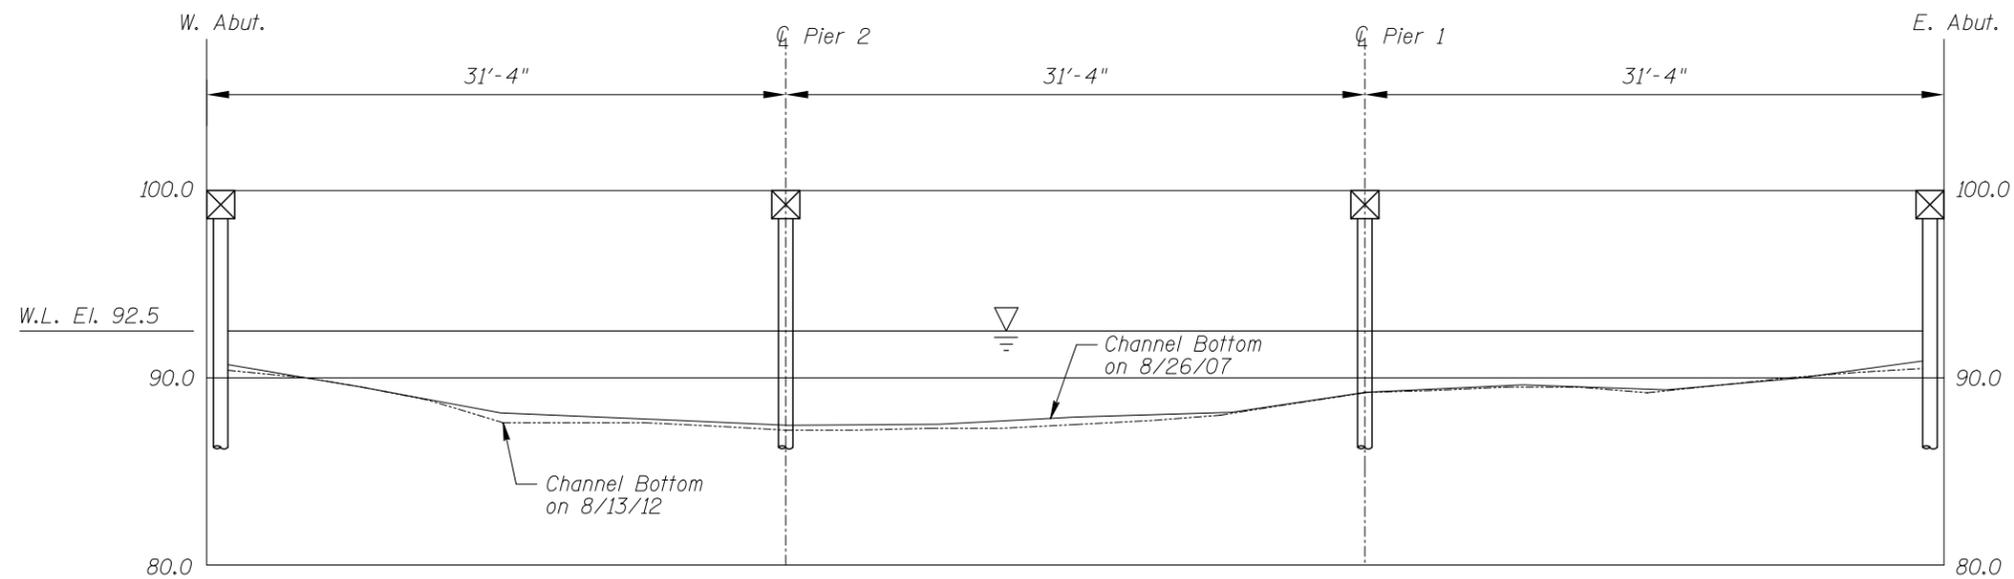
UPSTREAM FASCIA PROFILE
Vertical Scale: 1"=10'-0"

DOWNSTREAM FASCIA PROFILE
Vertical Scale: 1"=10'-0"
