UNDERWATER BRIDGE INSPECTION REPORT

STRUCTURE NO. 36504

RAT ROOT RIVER

COLLINS ENGINEERS, INC.

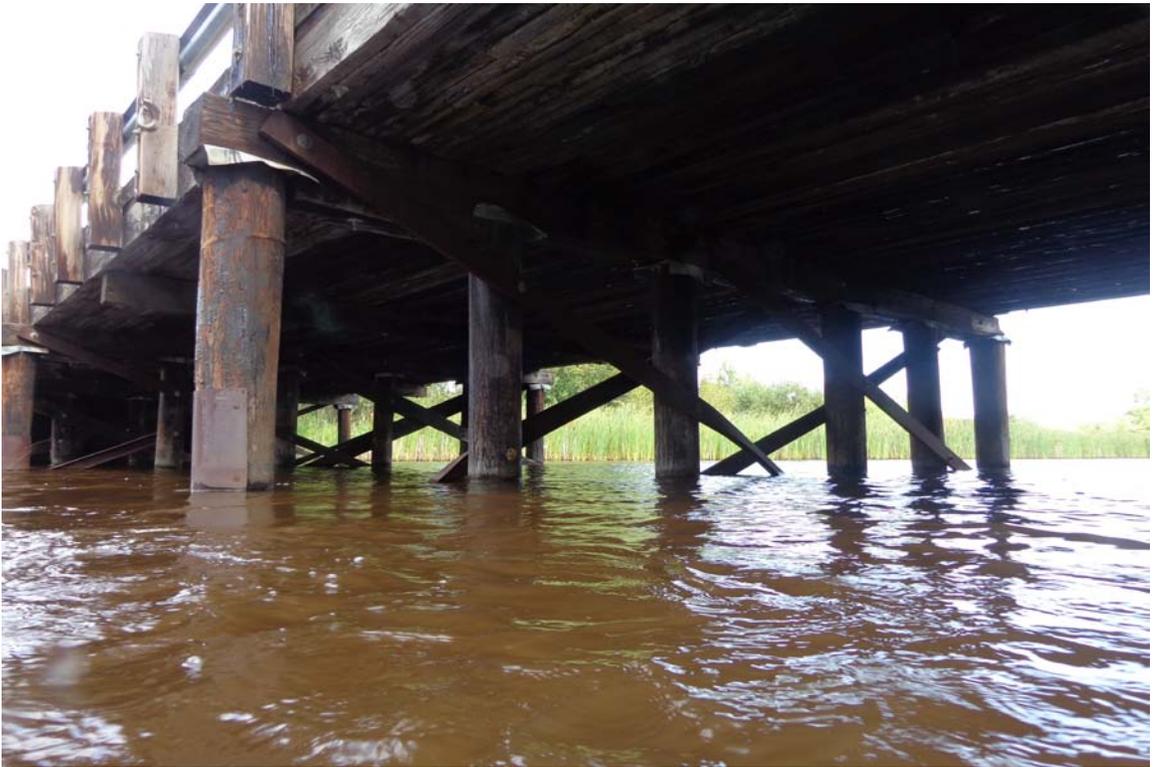
Photograph 4. View of Pier 2, Looking Northeast.

4. Approximately 10 feet of cap above Pile 6 of Pier 2 has been crushed. The pile appears to have shifted downstream.
5. Heavier surface splintering and delamination, typically extending 1 foot above the waterline to channel bottom with penetration/depth of 1 inch at Pile 2 of Pier 1.

9. The south steel channel at Pier 2 was deformed between Piles 3 and 4, and was not engaged to Pile 4.
10. The south steel channel at Pier 2 was no longer engaged to the upstream pile and had been deformed by ice flow and drift.

11. Pile 4 at Pier 2 exhibited a 3 inch diameter, with 1 inch penetration, area of abrasion that was caused by rubbing contact with the unconnected steel channel, and was located 1-1/2 feet below the waterline.

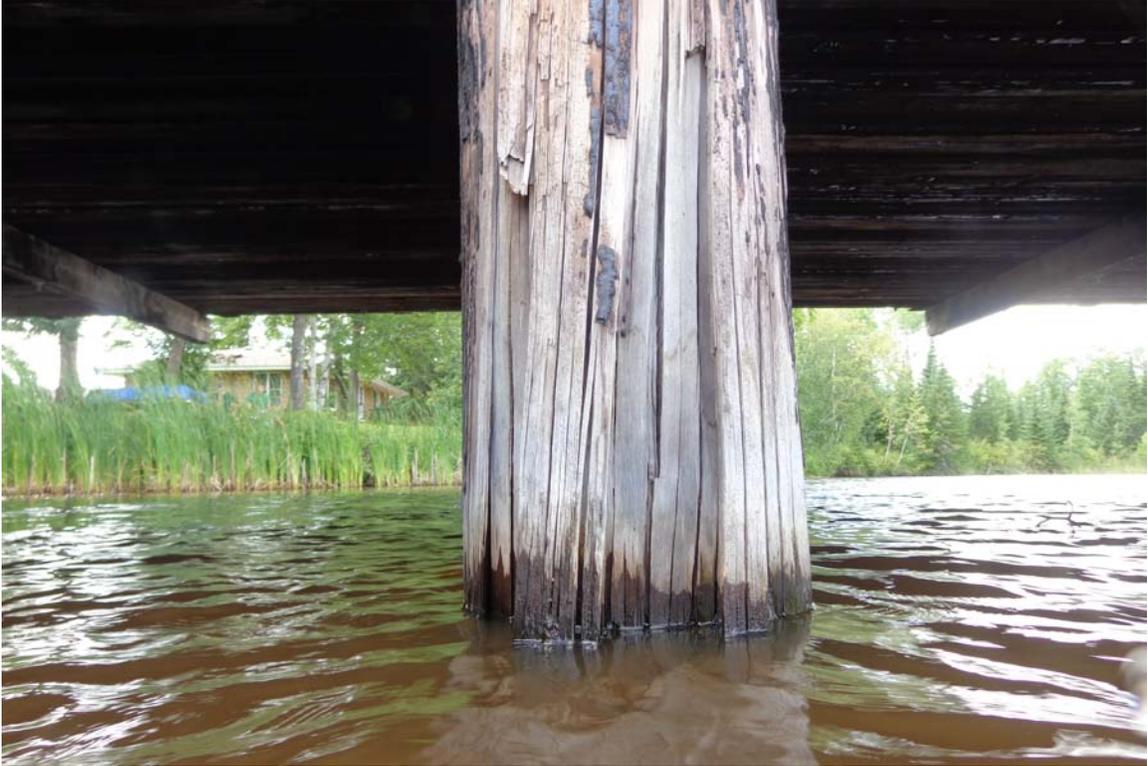
Photograph 7. View of Pier 1, Pile 6 splintering, Looking West.

3. Outer layer of Piles 5 and 6 at Pier 1 were softer than typical with approximately 1 inch surface delamination from 3 feet above the waterline to the channel bottom. (ice related damage)

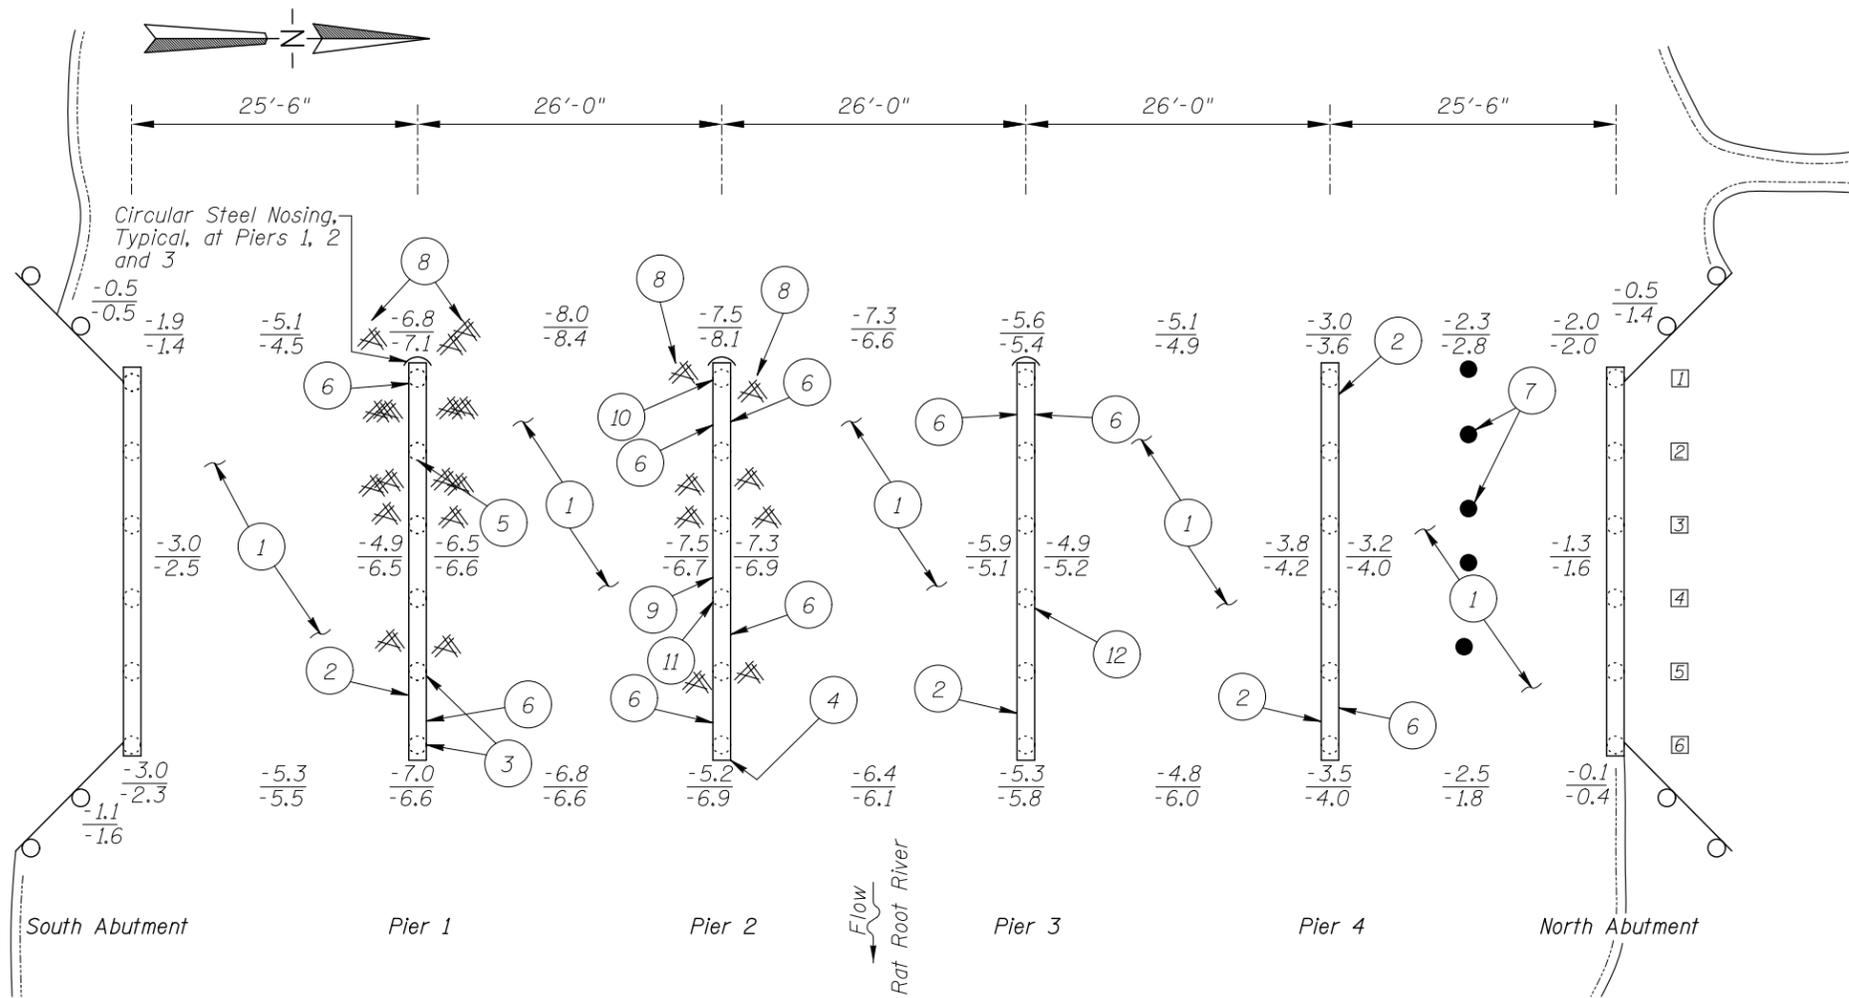
SOUNDING PLAN

1. The channel bottom material around all of the piers typically consisted of sand and gravel with a maximum probe rod penetrations of 6 inches.
2. Bracing split over length of 10 feet and separated through pile fastener at south side of Pier 1, 3, and 4 and the north side of Pier 4.

6. Steel channel replacement cross bracing was used to replace the old timber cross bracing on the downstream north side of Pier 1, the upstream south side of Pier 1, all of the timber cross bracing at Pier 2, on the upstream north and south sides of Pier 3, and at the downstream north side of Pier 4.

7. Old abandoned timber piles were protruding 2 to 6 feet above the mudline at midspan between Pier 4 and the north abutment.
8. Light timber debris consisting of branches up to 6 inches in diameter was present around Piers 1 and 2. Most of the debris extended from the channel bottom to 1 foot above the channel bottom.

12. A 6 feet long by 2 inch wide split in timber bracing through the pile fastener was present at the north side of Pier 3 near Pile 4.

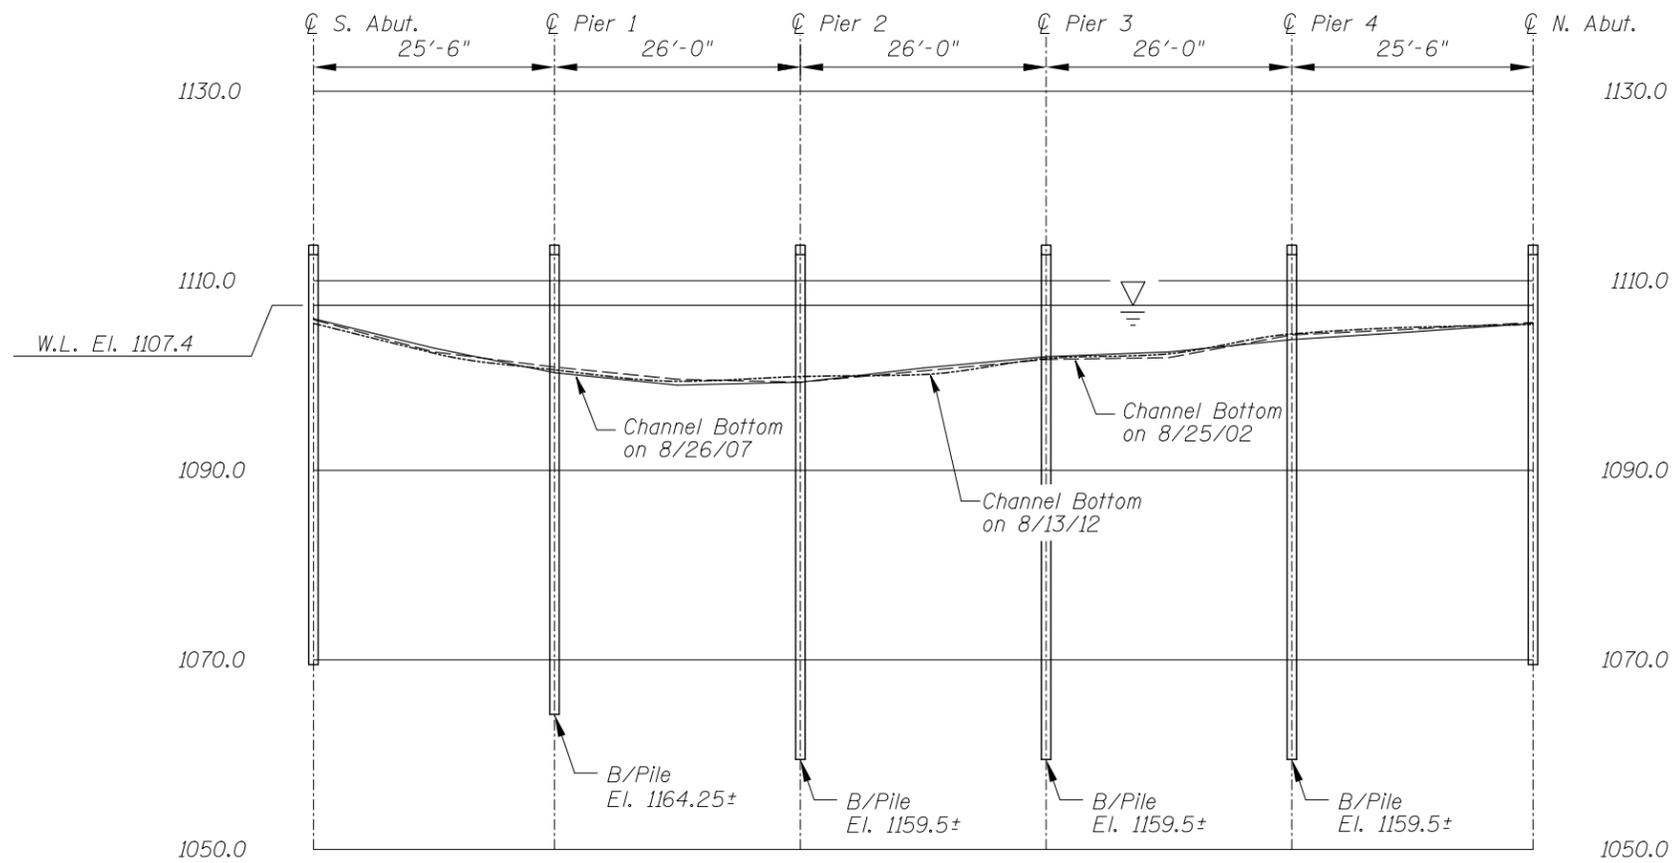
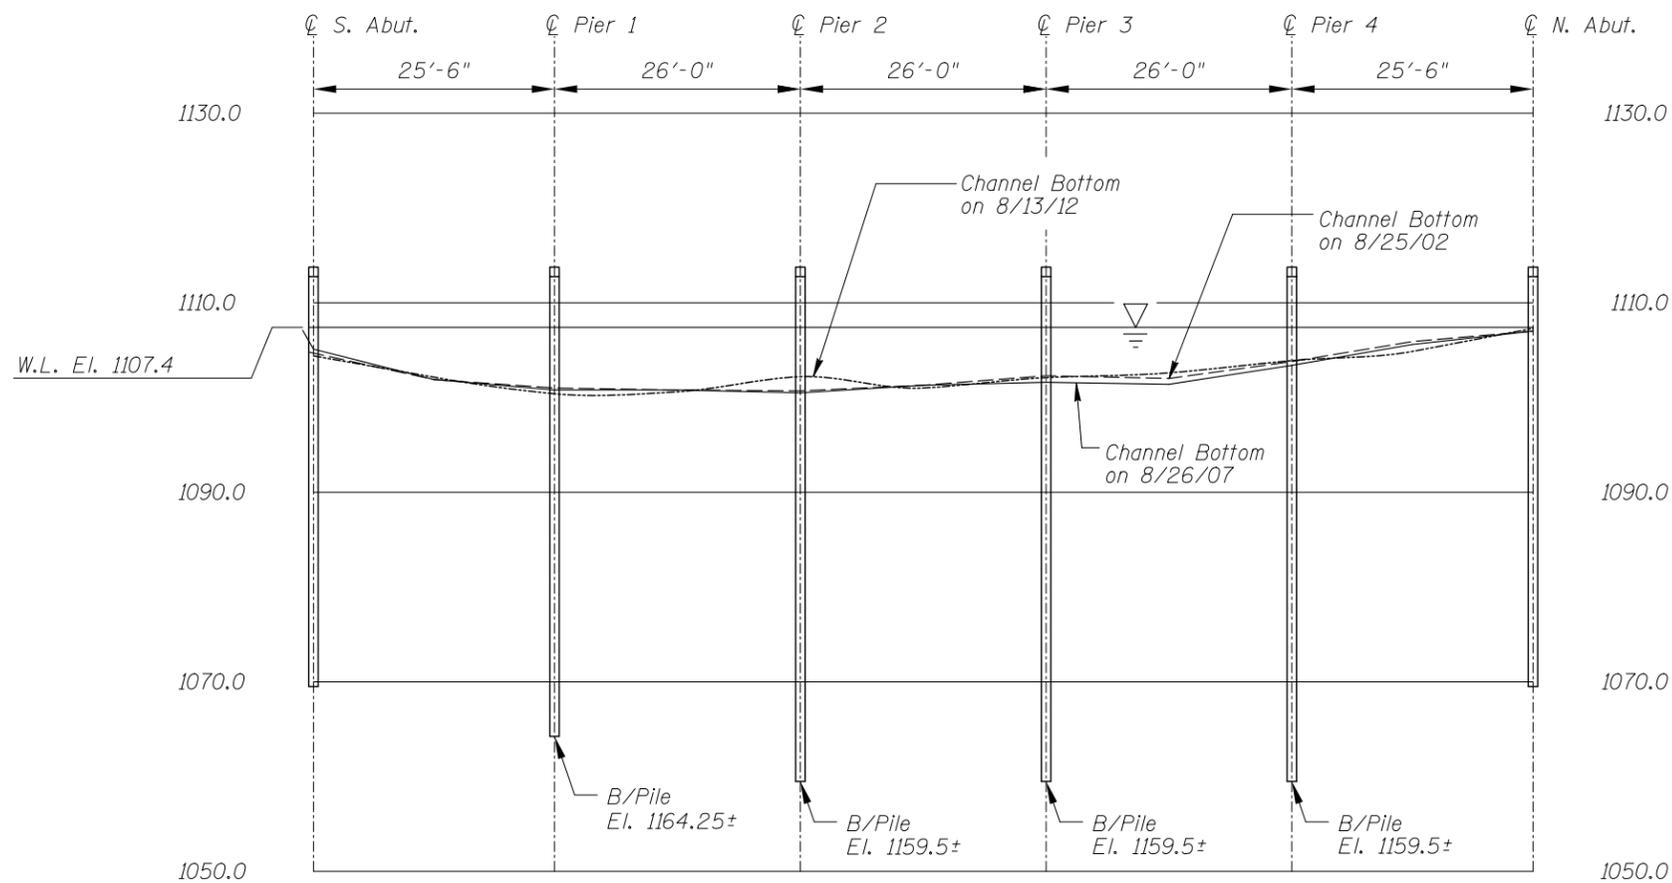
UPSTREAM FASCIA PROFILE

DOWNSTREAM FASCIA PROFILE
