UNDERWATER BRIDGE INSPECTION REPORT

STRUCTURE NO. 36516

BEAVER BROOK

AUGUST 13, 2012

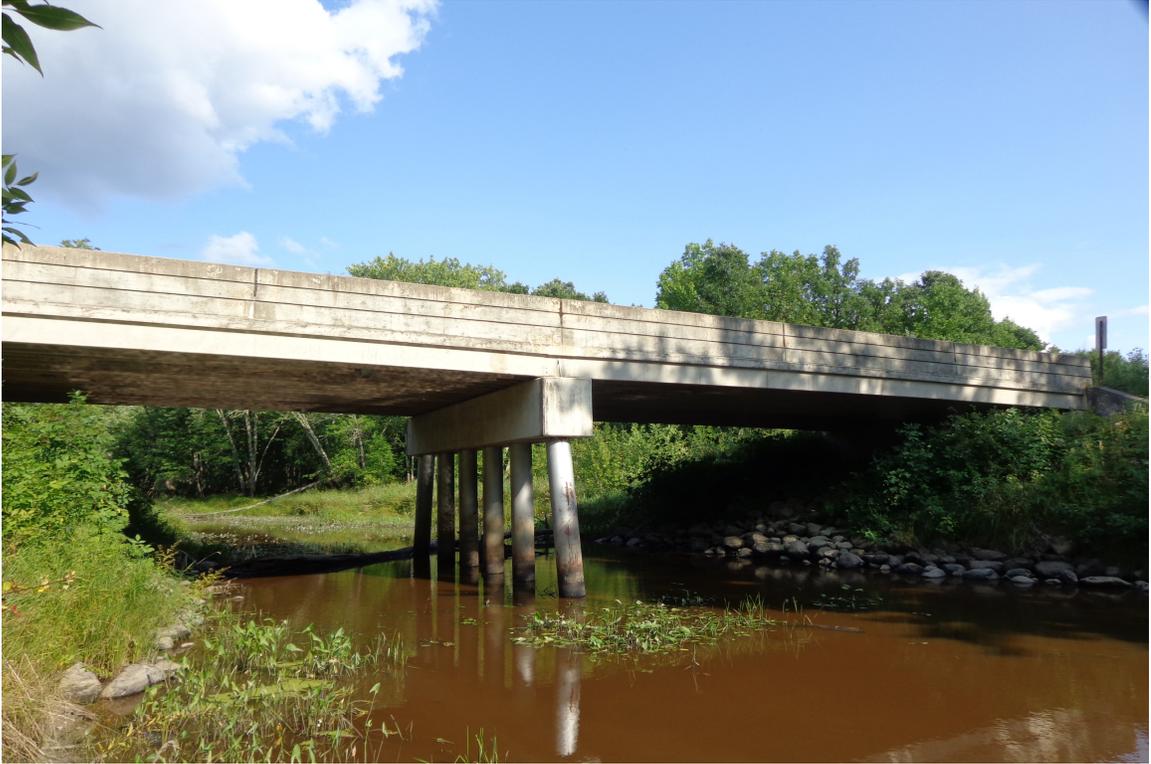
Photograph 1. Overall View of the Bridge, Looking East.

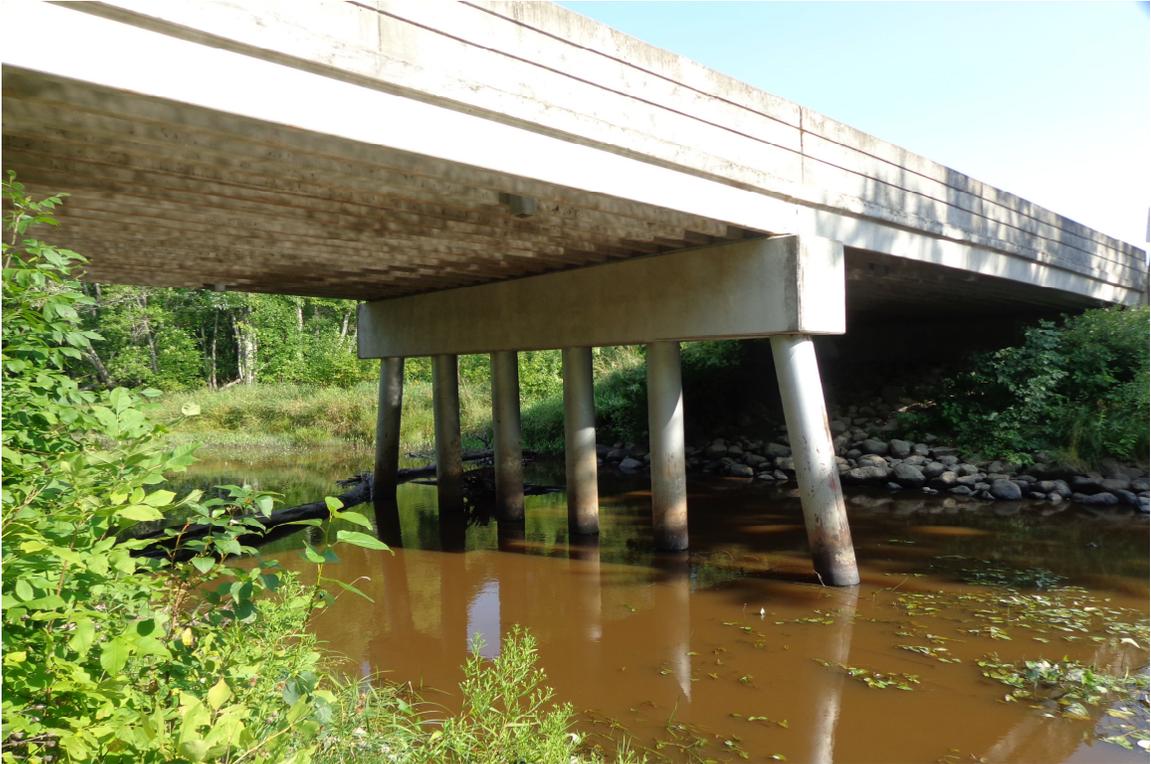
Photograph 2. View of Pier 1, Looking Southeast.

REMARKS: The steel shell piles were in good, sound condition, with 50% coating failure, and up to 25% nodular corrosion, with nodules ranging in size from 1/4 inch diameter to a maximum of 2 inch diameter. When removed, nodules revealed typical pitting with depths ranging from 1/32 inch penetration to 1/8 inch penetration. Channel bottom appeared stable with no significant changes since the last inspection.

The inspection of the submerged substructure units of Structure No. 36516 can most likely be accomplished in the future without using a dive team. To perform the underwater inspection, a properly equipped qualified inspector will have to enter the water during a period of low flow. As channel bottom contours and depths of flow can change quickly, it is recommended that lead line soundings of water depth be taken along the upstream and downstream fascias to determine whether wading is possible prior to beginning the inspection. If conditions are unsafe for inspection by wading, then an underwater inspection with the use of a dive team will be required.

Reinspect the submerged substructure units at the normal maximum recommended (NBIS) interval of sixty (60) months.

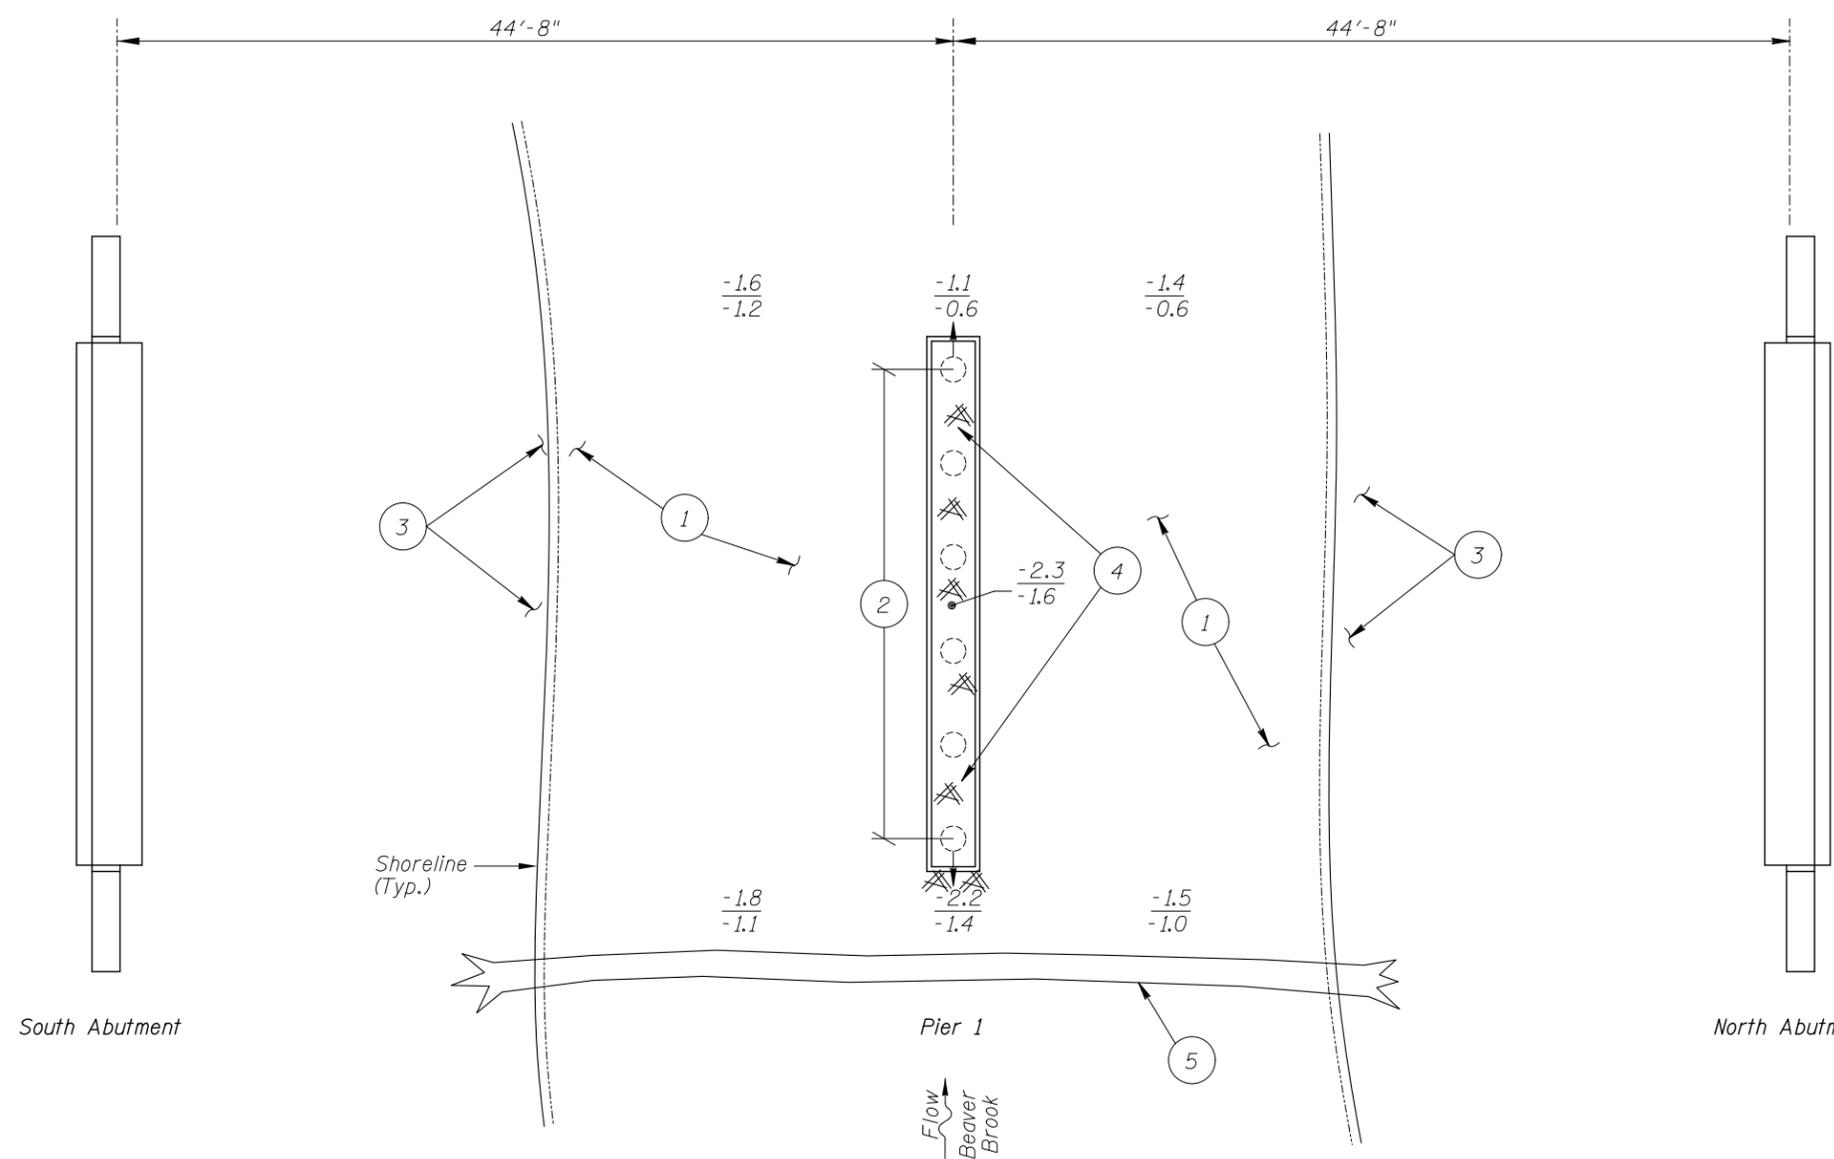
- 1 The channel material consisted of silty sand and random scattered riprap with a maximum probe rod penetration of 6 inches.
- 2 Up to 50 percent coating failure and up to 25 percent nodular corrosion ranging in size from 1/4 inch to 2 inches in diameter was observed from 3 feet above the waterline to the channel bottom on all of the steel shell piles. Typical depth of pitting under the nodules was 1/32 inch with a maximum pitting of up to 1/8 inch deep.
- 3 The banks were protected by 6 inch to 3 feet diameter riprap.
- 4 Light timber debris consisting of branches and logs ranging from 6 inches to 1 foot in diameter was observed scattered among the piles.
- 5 There was an accumulation of timber debris consisting primarily of an 18 inch diameter log extending from shore to shore across the upstream fascia.
