UNDERWATER BRIDGE INSPECTION REPORT

STRUCTURE NO. 36517
CSAH NO. 75
OVER THE
LITTLE FORK RIVER
KOOCHICHING COUNTY

SEPTEMBER 17, 2012
PREPARED FOR THE
MINNESOTA DEPARTMENT OF TRANSPORTATION
BY
COLLINS ENGINEERS, INC.
JOB NO. 7423

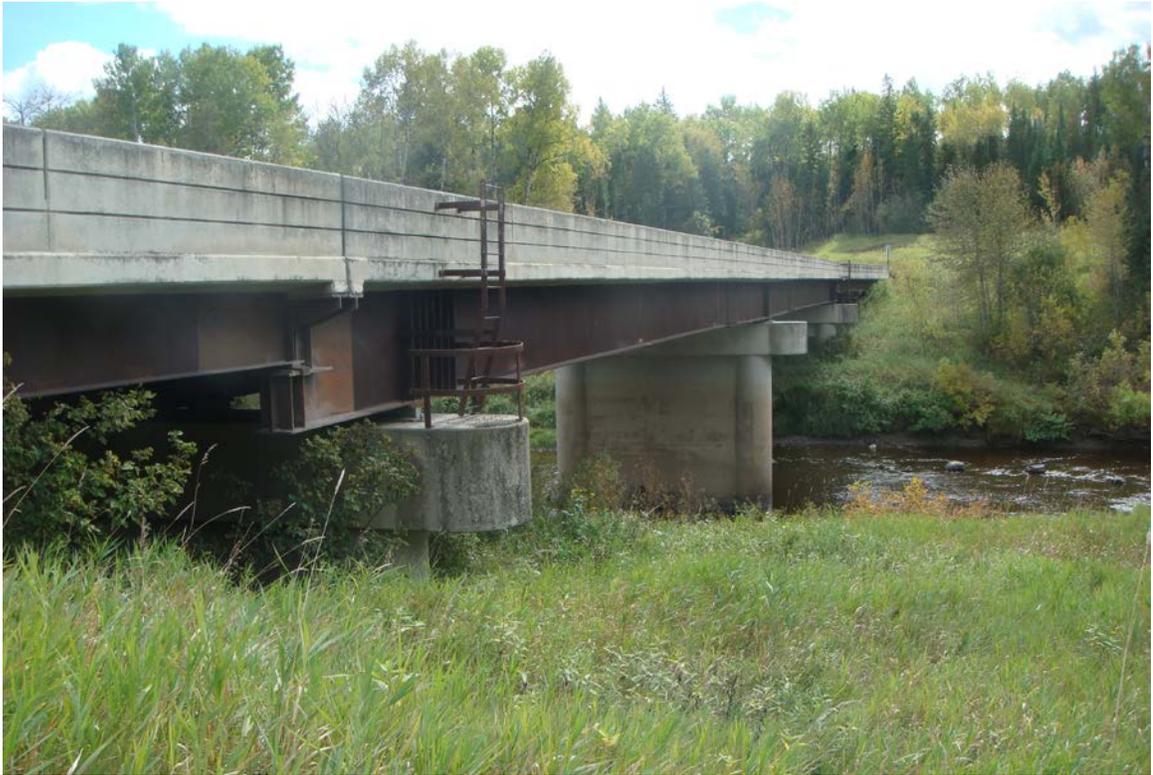
Photograph 1. Overall View, Looking Southeast.

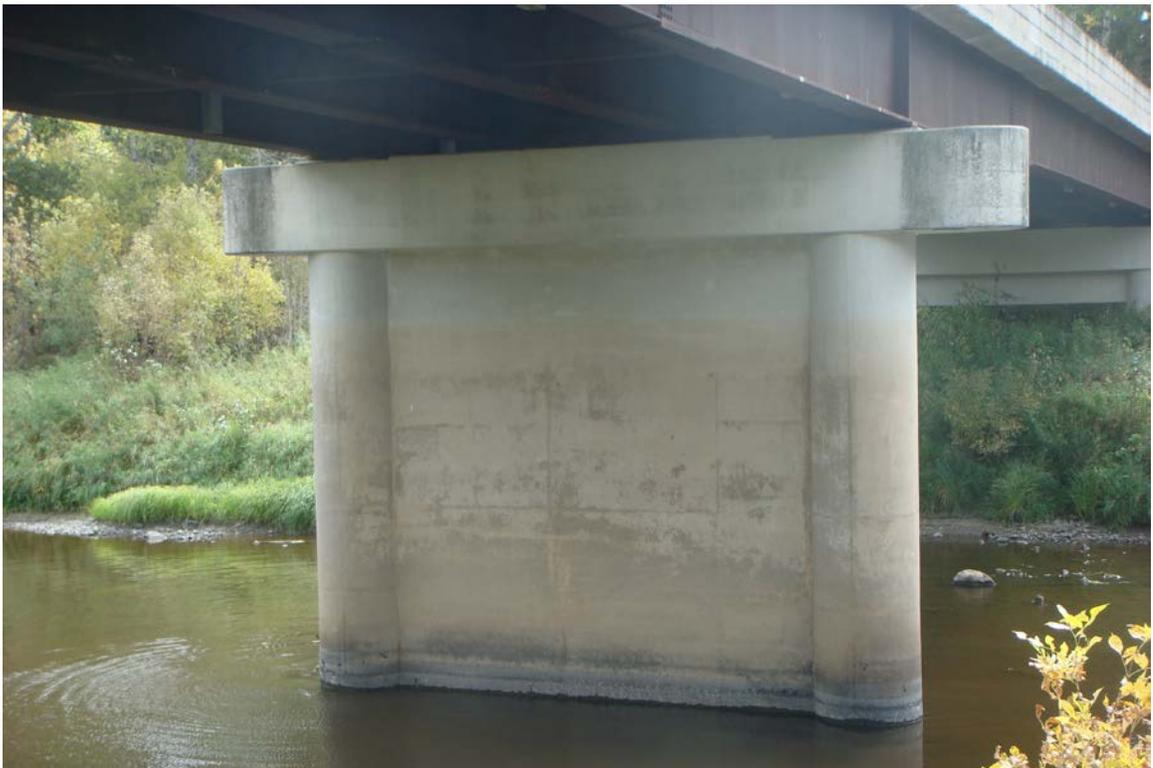
The substructure unit inspected at Bridge No. 36517, Pier 2, was found to be in good condition below water with no defects of structural significance. The channel bottom around Pier 2 was firm and appeared stable with no significant changes since the last inspection. The top of the footing was exposed at both the upstream and downstream noses of the pier with no observed vertical exposure.

Photograph 2. Pier 2, Looking Southeast.

- (A) The footing exposure at Pier 2 should be monitored during future inspections.
- (B) Reinspect the submerged substructure units at the normal maximum recommended (NBIS) interval of sixty (60) months.

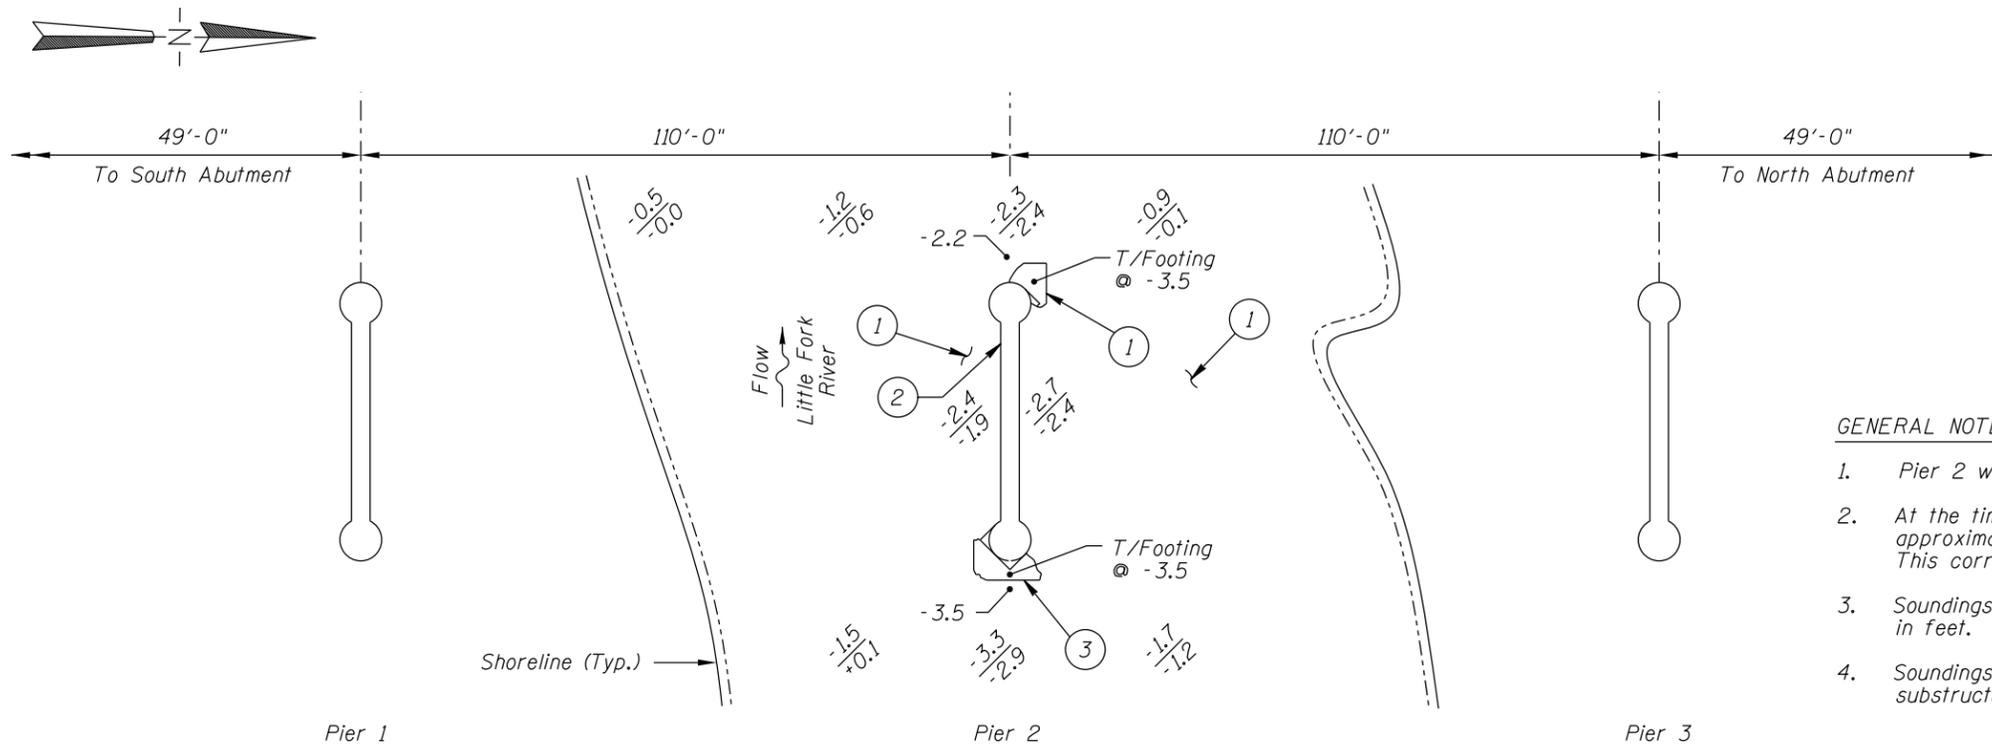
INSPECTION AND SOUNDING PLAN

- ① The channel bottom material consisted of a firm, sandy gravel and riprap up to 1 foot in diameter with up to 1 inch probe rod penetration.
- ② A band of minor scaling 1 foot high was located at waterline with 1/4 inch maximum penetration.
- ③ The footing was exposed at both noses of the pier approximately as shown. The exposure was primarily only the top of the footing with no vertical exposure.
