UNDERWATER BRIDGE INSPECTION REPORT

STRUCTURE NO. 38505

SILVER RAPIDS

JUNE 19, 2012

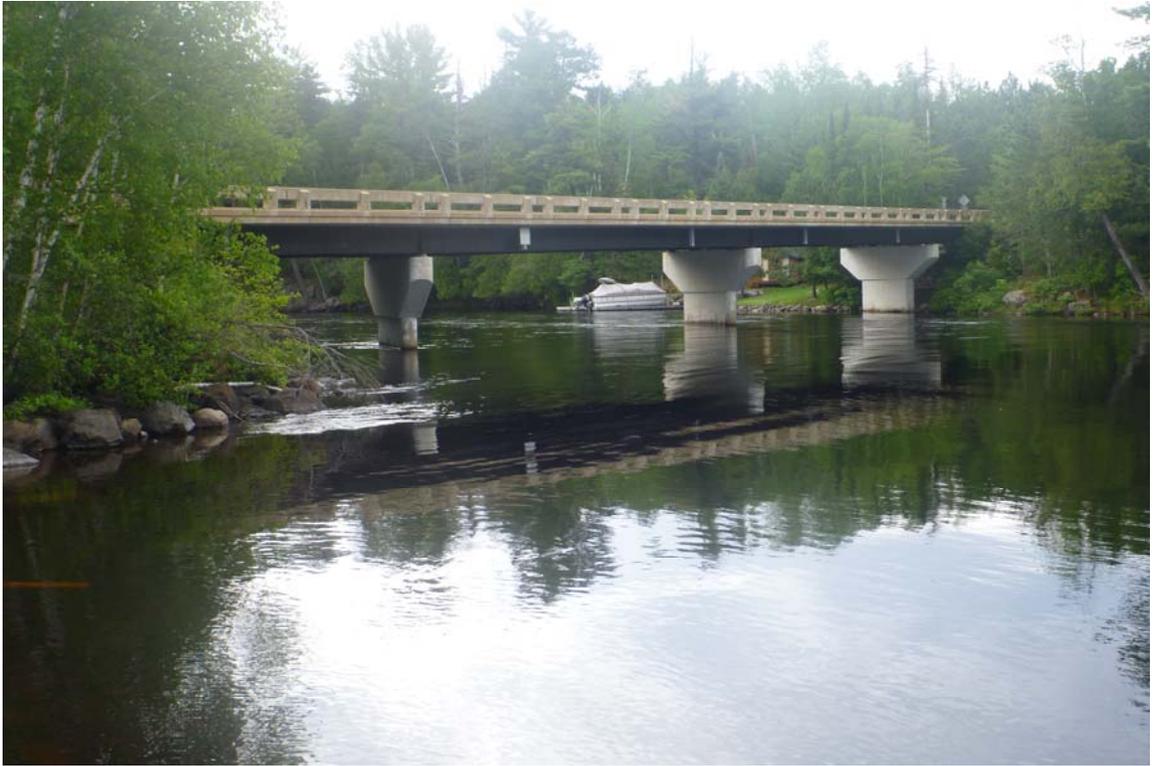
Photograph 1. View of Upstream Fascia, Looking Northeast.

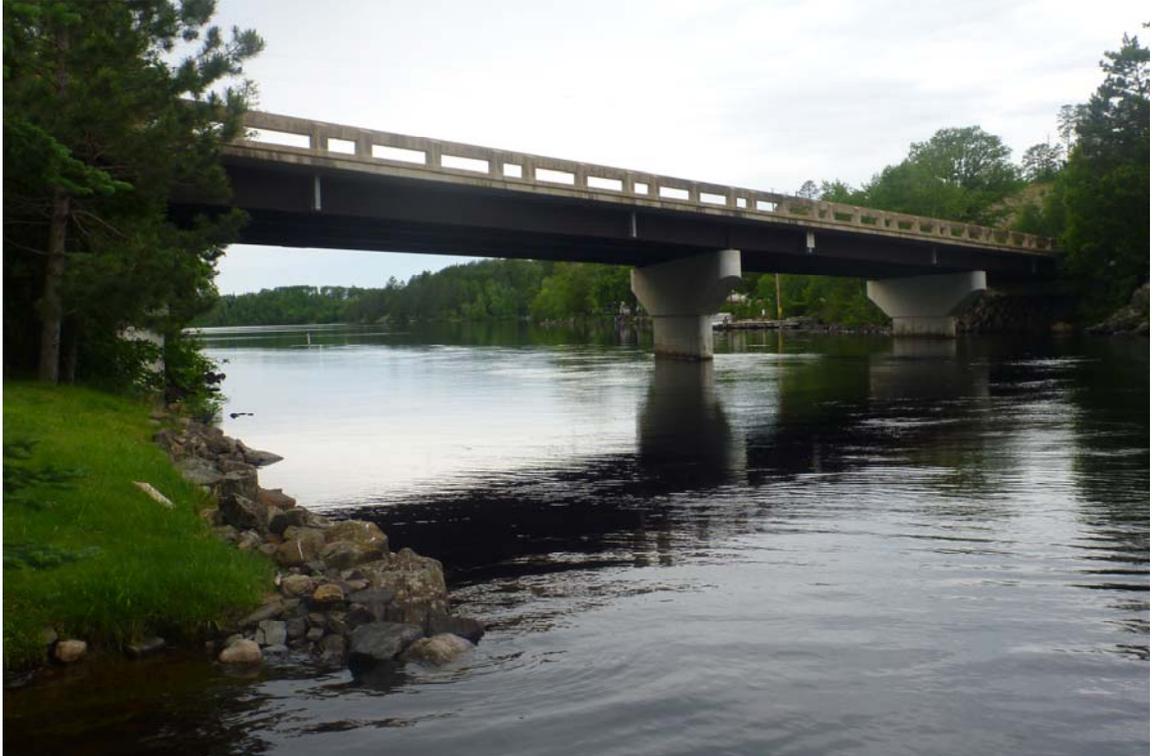
Photograph 2. View of Downstream Fascia, Looking Southwest.

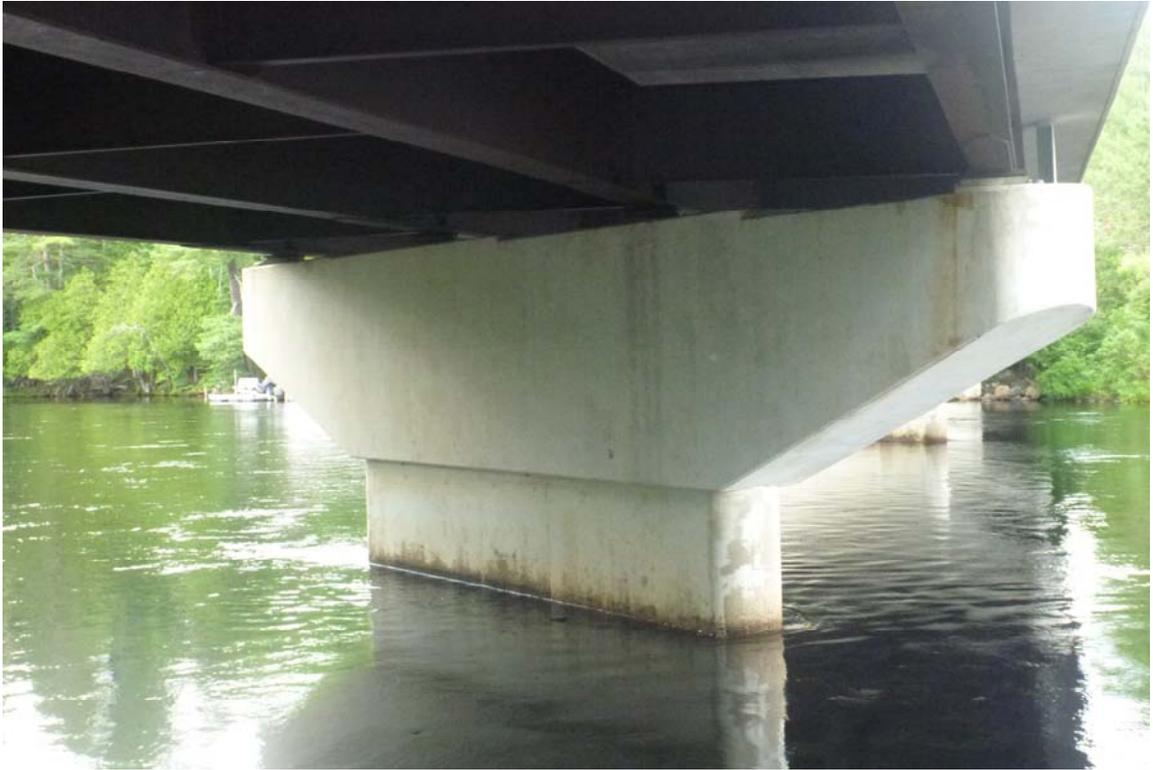
Photograph 3. View of Pier 1, Looking Northeast.

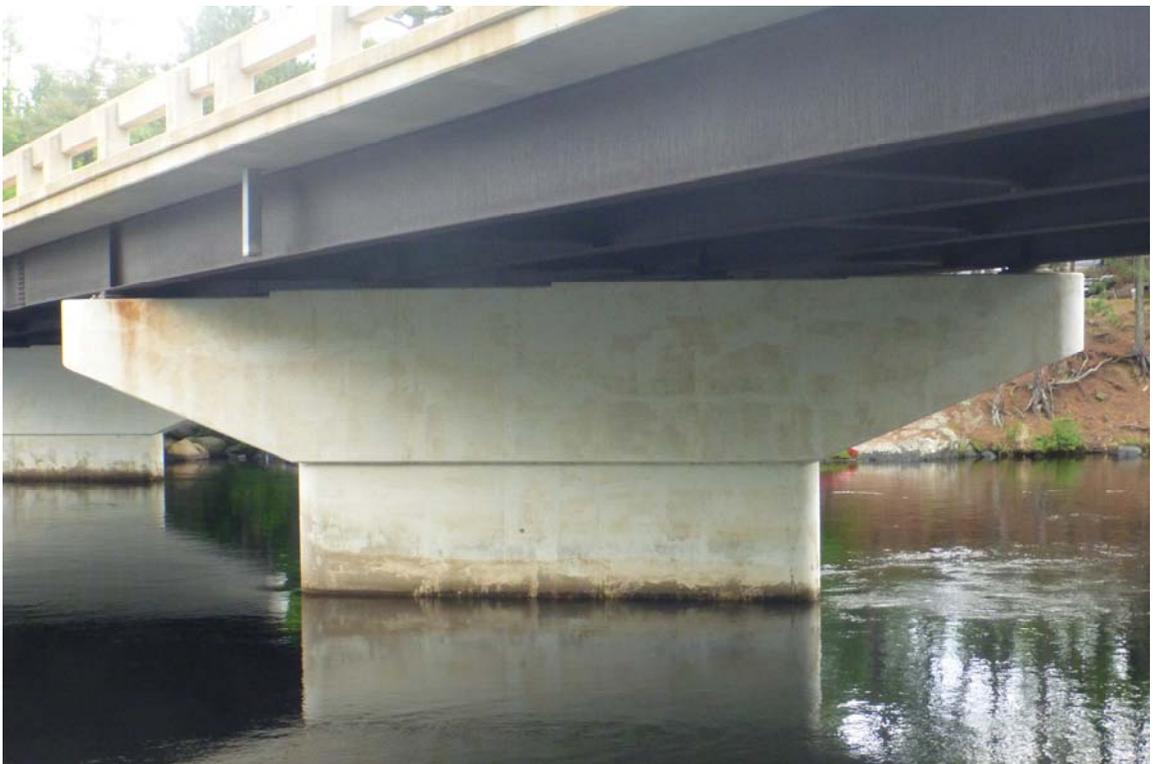
Photograph 4. View of Pier 2, Looking Northwest.

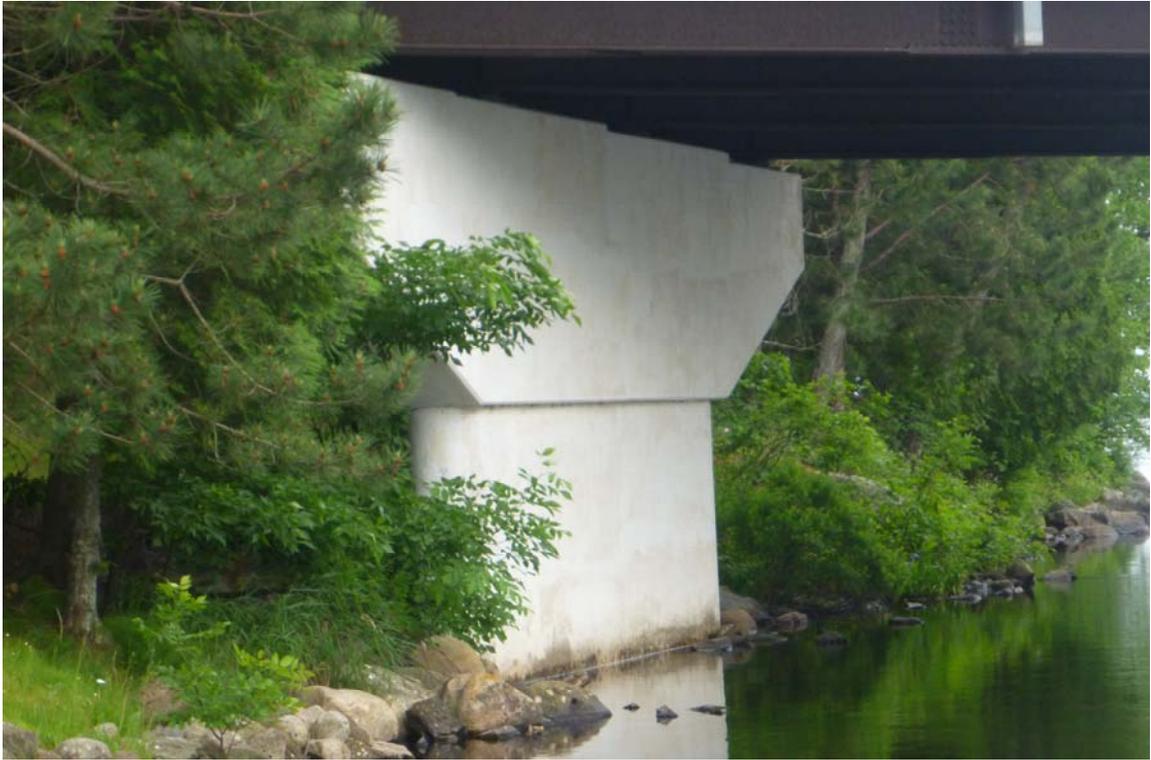
Photograph 5. View of Pier 3, Looking Southwest.

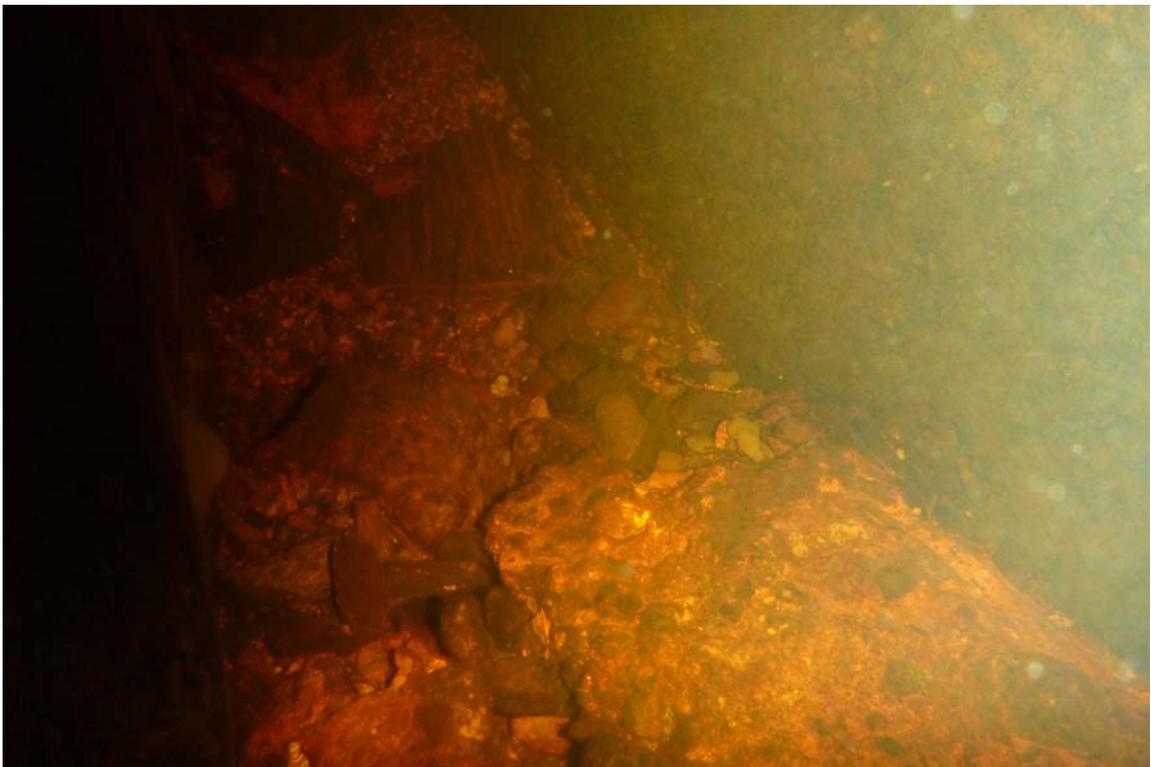
Photograph 6. View of the Footing Exposure on the East side of Pier 1, Looking Down.

- ② The top of the Pier 1 footing was exposed along most of the easterly side of the pier. The top footing was level with the channel bottom, with a maximum width of 2 feet exposed and no footing edge or vertical face exposure present.

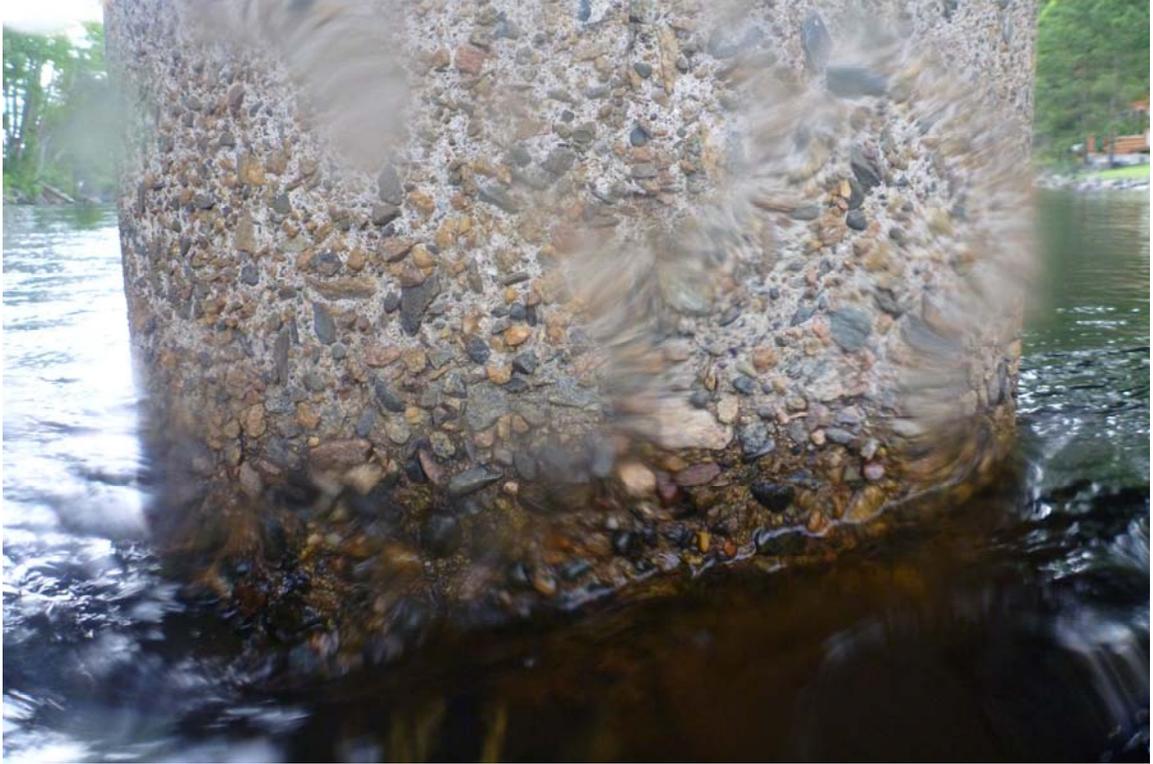
Photograph 7. View of Typical Concrete Condition at the Waterline at the Upstream Nose of Pier 1, Looking North.

- ③ A band of scaling was observed around Piers 1 and 2, extending from 1.5 feet above to 3 feet below the waterline, with typical penetrations of 1/8 to 1/4 inch and maximum penetrations of 1/2 inch at the upstream ends of the piers.

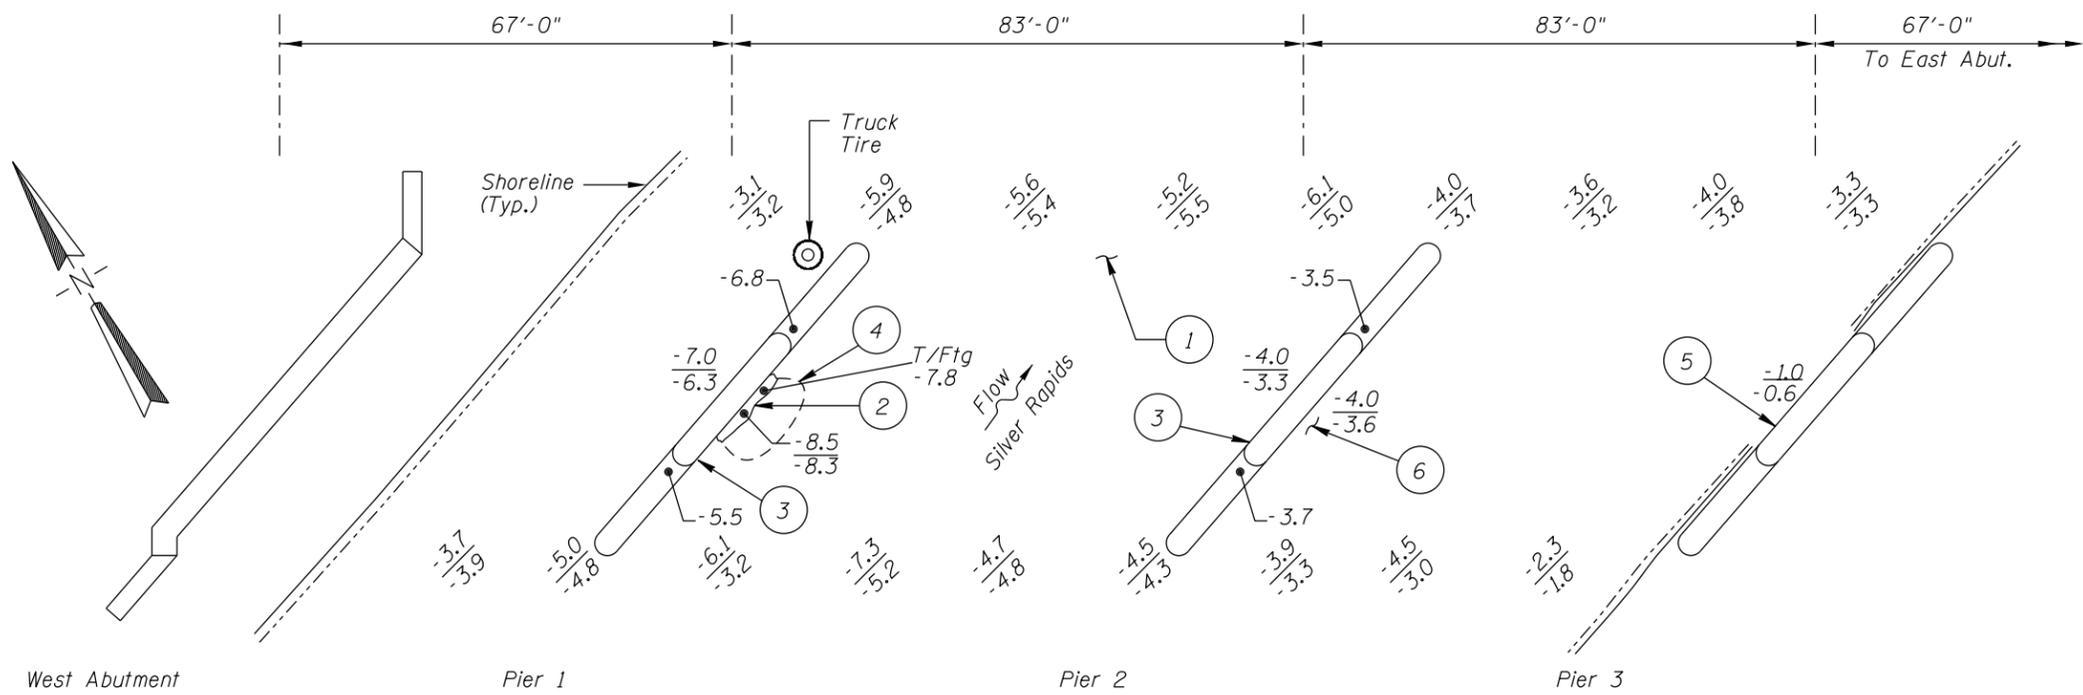
SOUNDING PLAN

- ① The channel bottom material consisted of large riprap with firm sandy gravel and no appreciable probe rod penetration. Riprap sizes typically ranged from approximately 6 inches to 2 feet in diameter.

- ④ A minor scour depression with a width of 4 feet and a depth of 6 inches was observed along the easterly side of Pier 1.
- ⑤ Random light scaling and exposed aggregate was observed at Pier 3 near the waterline.

- ⑥ Larger riprap up to 4 feet in diameter was present along the easterly side of Pier 2.
