UNDERWATER BRIDGE INSPECTION REPORT

STRUCTURE NO. 58506
CSAH NO. 7
OVER THE
SNAKE RIVER
DISTRICT 1 - PINE COUNTY

JUNE 7, 2012
PREPARED FOR THE
MINNESOTA DEPARTMENT OF TRANSPORTATION
BY
COLLINS ENGINEERS, INC.
AND
WSB & ASSOCIATES, INC.
JOB NO. 2107

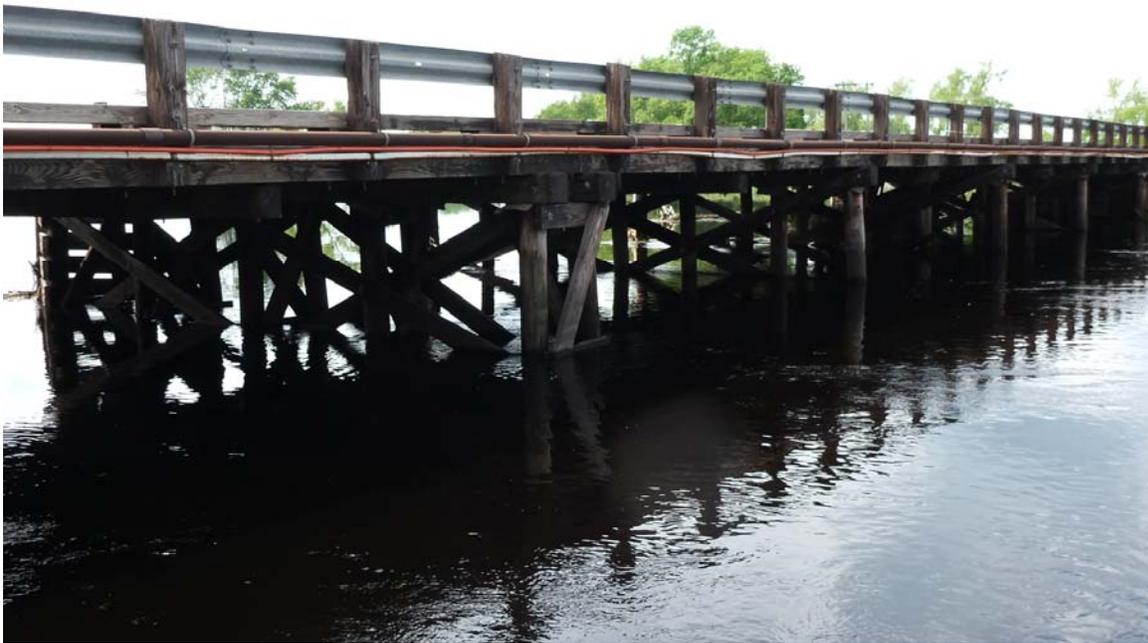
Photograph 1. Overall View of Downstream Fascia, Looking Southwest.

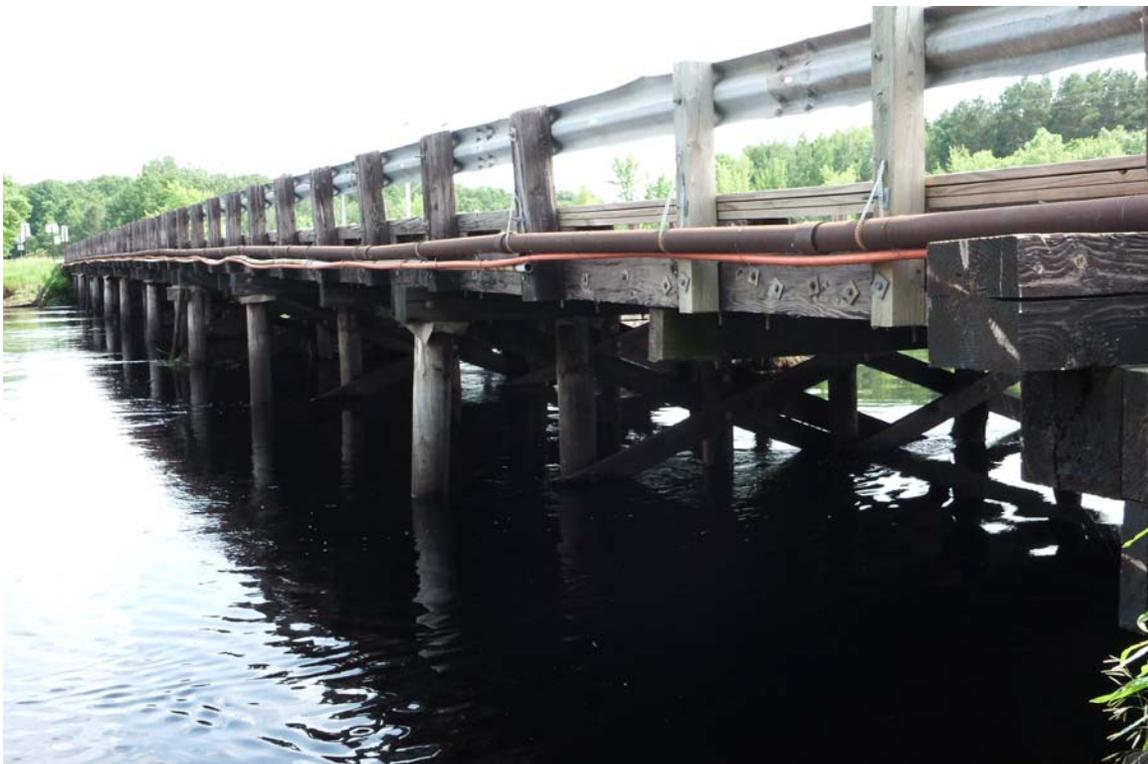
Photograph 2. Overall View of Downstream Fascia, Looking Southeast.

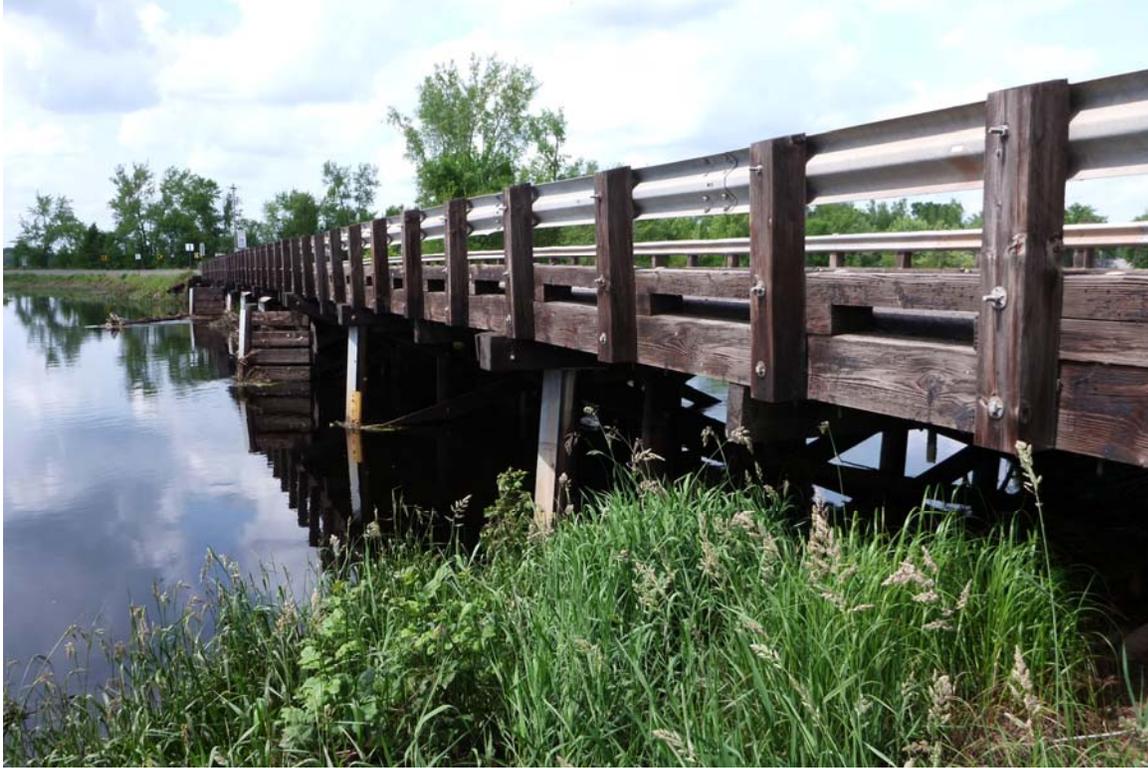
Photograph 3. Overall View of Upstream Fascia, Looking West.

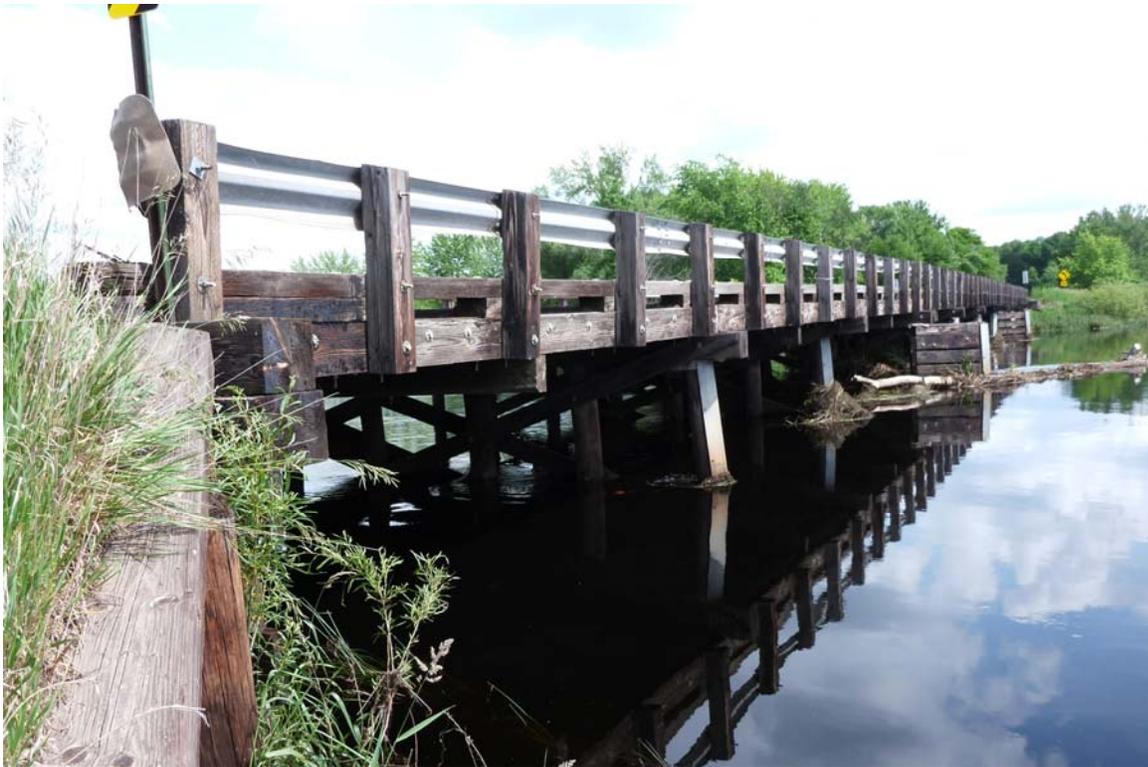
Photograph 4. Overall View of Upstream Fascia, Looking East.

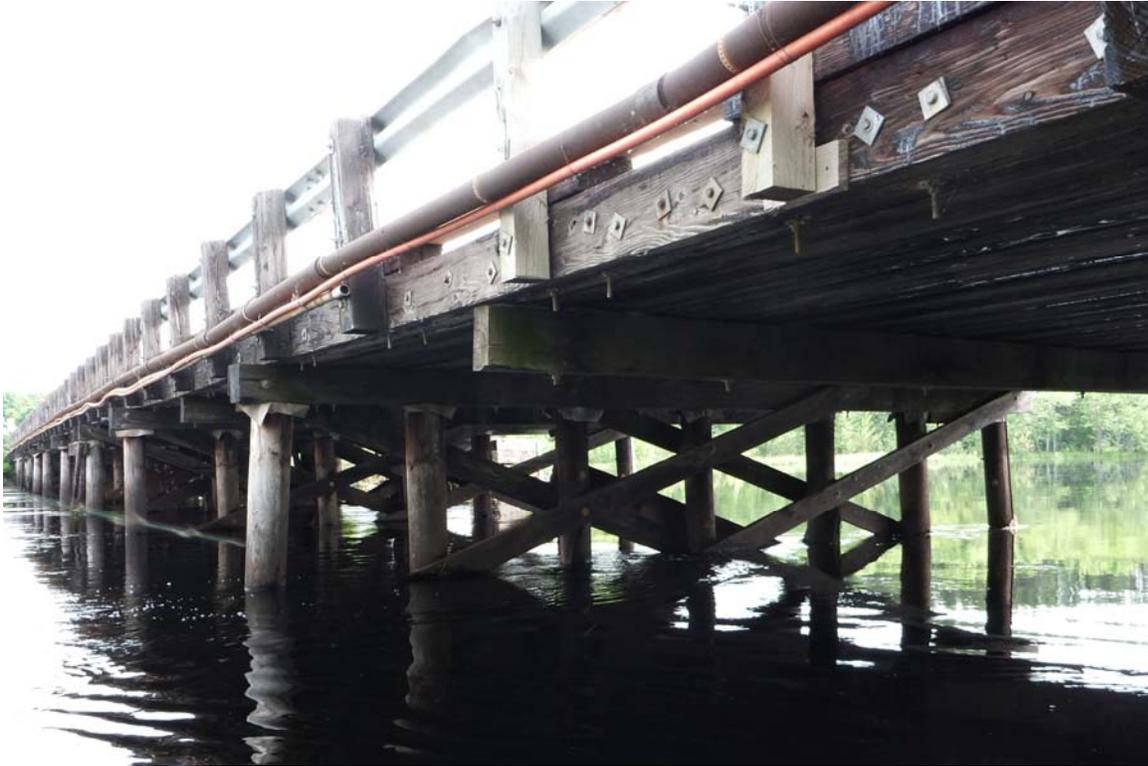
Photograph 5. View of Pier 1, Looking Southeast.

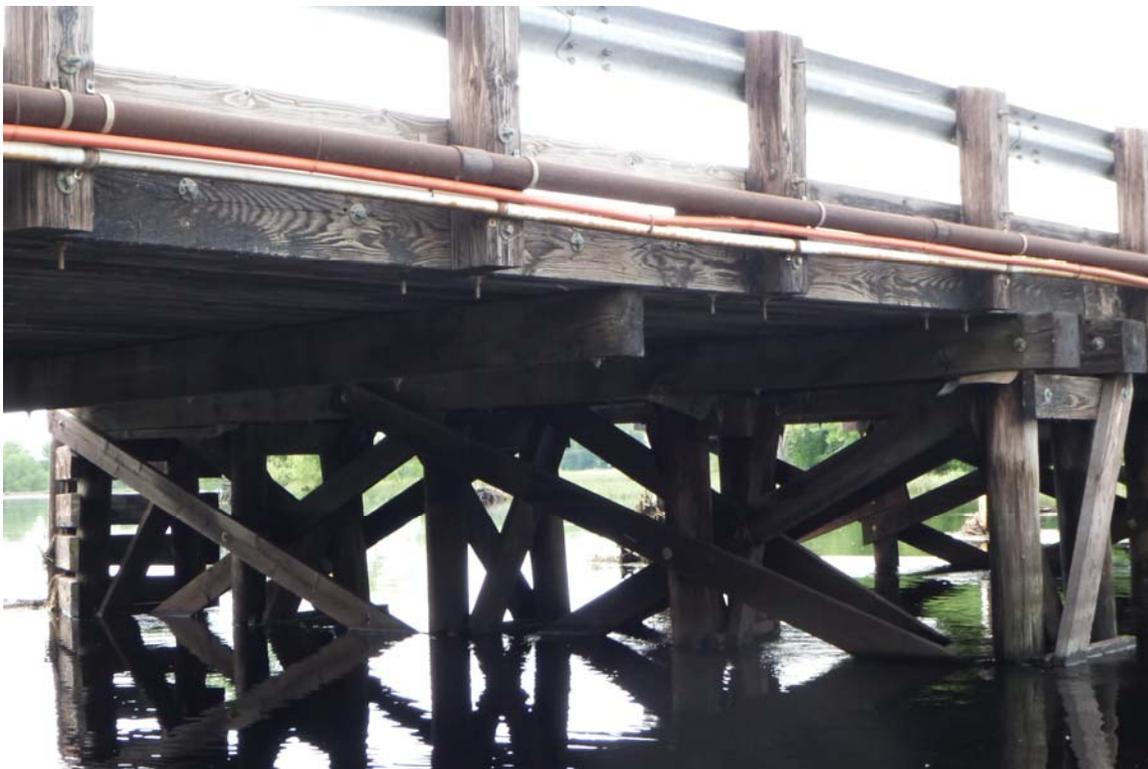
- * The westernmost pile on the south side of Pier 7 was splintered over a 12 inch high by 6 inch wide and 3/4 inch deep area. This area was located 2 feet below the waterline. The material beneath the splintered material was soft to an estimated depth of 1/4 inch. The total loss of cross-section at this location was estimated to be between 10 and 20 percent.

- (D) Light accumulations of timber debris, consisting of 6 inch diameter and smaller limbs and branches, was observed at the upstream noses of Piers 2, 3, and 7.

Photograph 6. View of Pier 7, Looking Southwest.

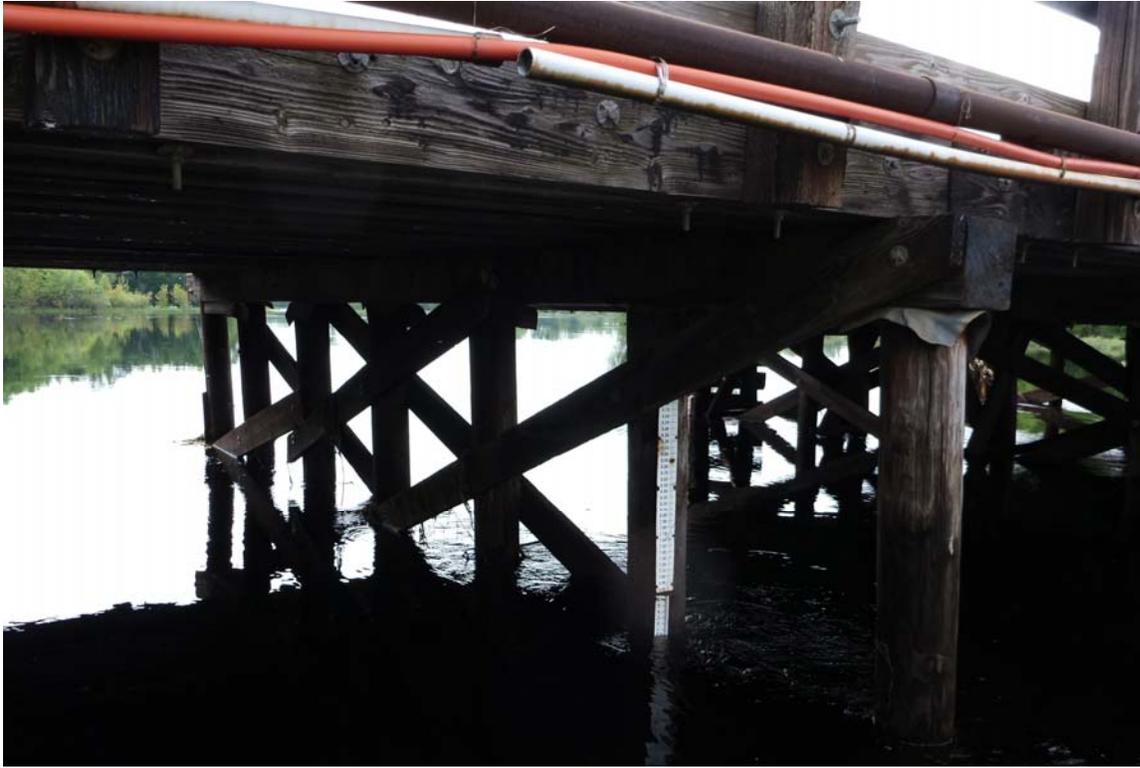
- (A) The retaining wall located east of Pier 8 exhibited excessive deformation and was leaning into the channel.
- (B) The majority of the timber piles were in fair condition with weathering and random vertical checking present with widths of up to 1/4 inch. The only significant pile distress found was as follows:
 - * The middle pile of Pier 2 was cracked, splintered and soft to a depth of 1/2 inch. This condition existed from 1 foot above the waterline to the channel bottom. Below this 1/2 inch softer outer layer, the wood material was sound and firm.
 - * The outer 1 1/2 inch shell of the end pile at west end of Pier 3 was cracked and splintered. This condition was present from 6 inches below the waterline to 1.5 feet above the waterline.
 - * The outer 2 inch shell was cracked, splintered, soft, and delaminated at the second pile from the west end of Pier 4.

Photograph 7. View of Pier 8, Looking Southwest.

- 12 A moderate accumulation of timber debris, consisting of 6 inch diameter and smaller limbs and branches, was observed along the south face of Pier 8. It extended from channel bottom to waterline.

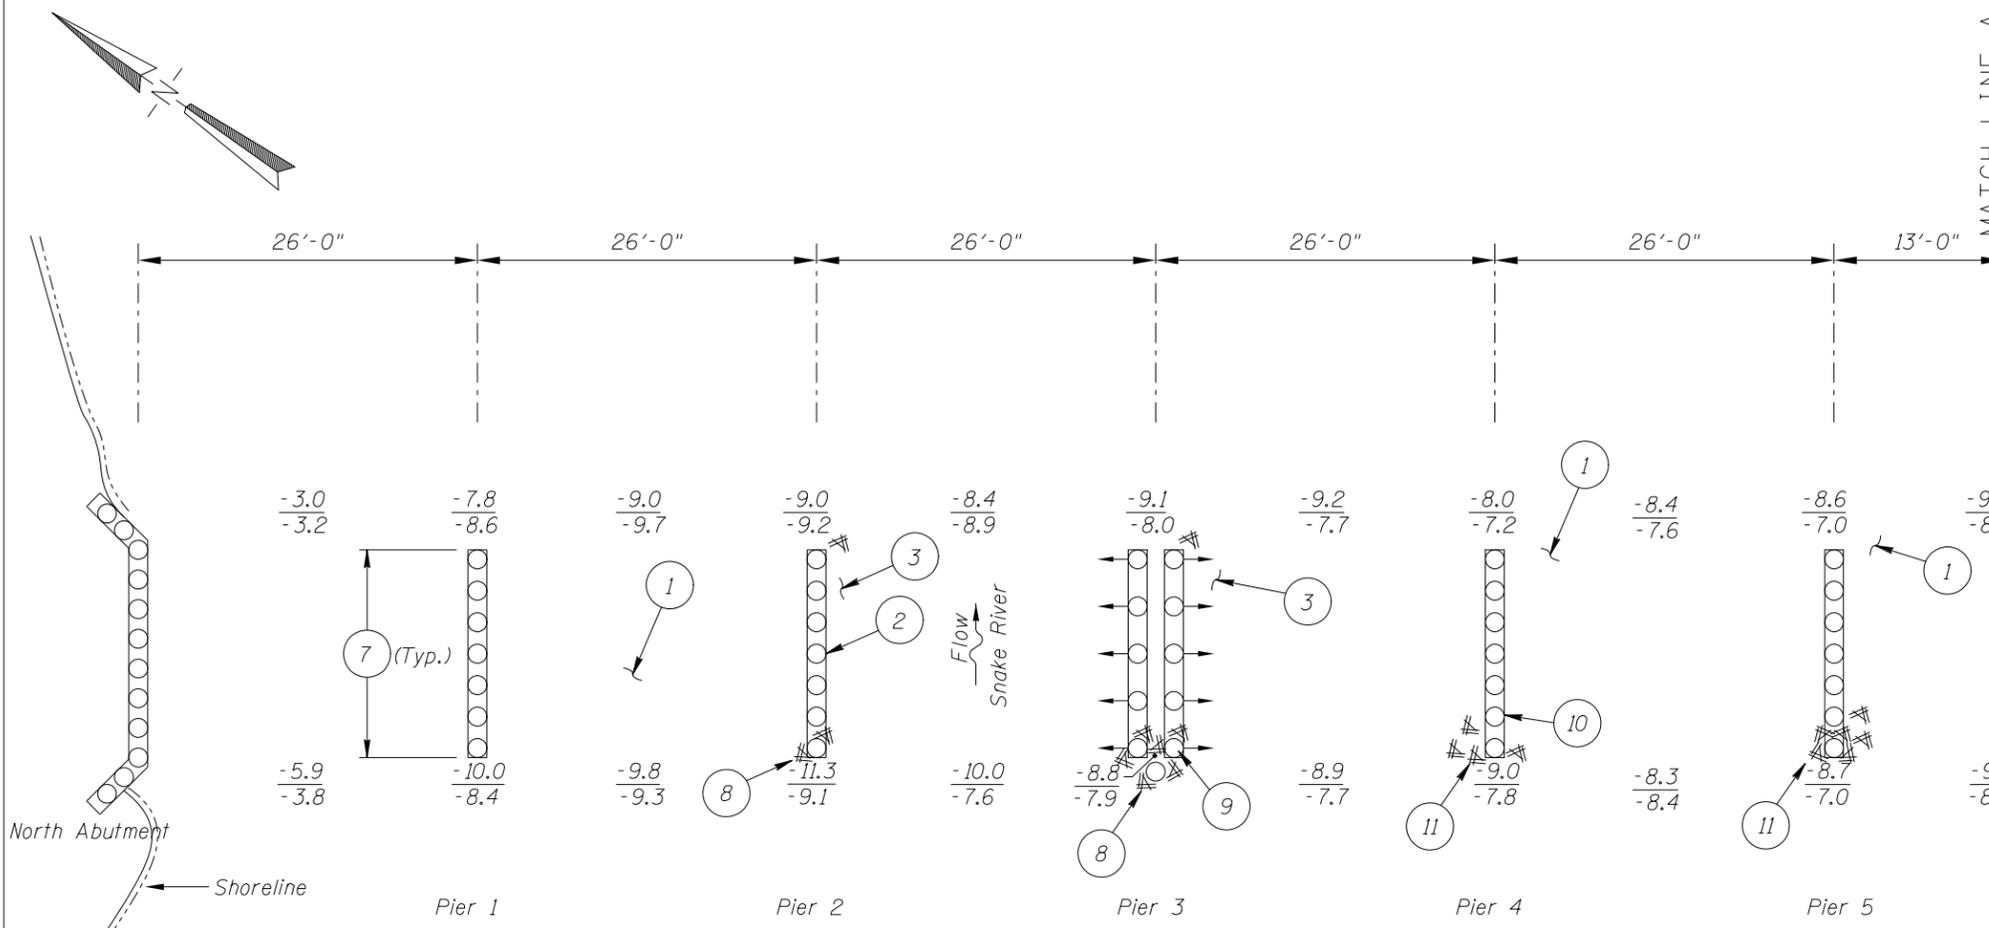
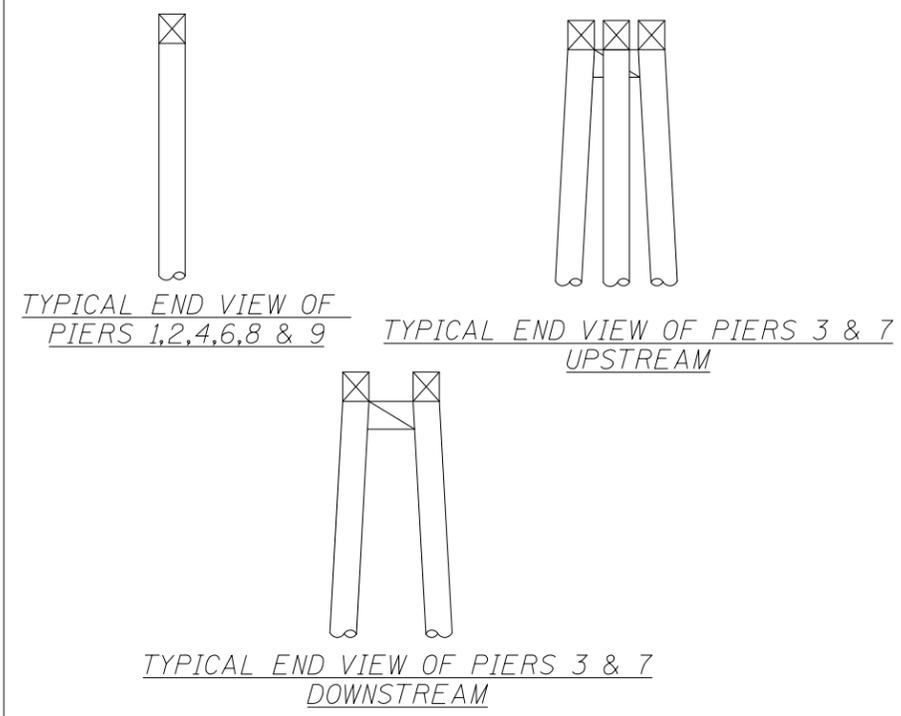
SOUNDING PLAN

- 1 The channel bottom consisted of silty sand with random scattered riprap and up to 6 inches of probe rod penetration.
- 2 The outer shell of the fourth pile from the west end of pier was cracked, splintered, soft, and delaminated. This condition was present from the channel bottom to 1 foot above the waterline. Probing revealed the wood beneath the outer shell to be sound.

- 3 The channel bottom at Piers 2 and 3 consisted of sand and riprap up to 6 inches in diameter with no appreciable probe rod penetration.
- 4 A 12 inch high by 6 inch wide and 3/4 inch deep portion of the outer shell of this pile has splintered outward. The wood beneath this area was soft to a depth of 1/4 inch. The estimated loss in cross sectional area was 10 to 20 percent. This condition occurred at 2 feet below the waterline.

- 5 The channel bottom at Piers 7 through 9 consisted of a mixture of gravel and riprap with no appreciable probe rod penetration.
- 6 The retaining wall exhibited excessive deformation.

- 7 All of the piles exhibited random checking up to 1/4 inch wide, and a softer out pile shell up to 1/4 inch thick with 1/4 inch wide splits.
- 8 Light accumulation of timber debris, consisting of 6 inch diameter and smaller logs and branches, was observed at the upstream noses of Piers 2, 3, and 7.

- 9 The outer 1 1/2 inch shell of end pile at west end of Pier 3 was cracked and splintered. This condition was present from 6 inches below the waterline to 1 1/2 feet above the waterline.

- 10 The outer 2 inch shell was cracked, splintered, soft and delaminated at the second pile from the west of Pier 4. The defect extended from channel bottom to 1.5 feet above the waterline.

- 11 Moderate to heavy accumulation of timber debris, consisting of up to 1.5 foot diameter drift pieces, was observed around the upstream end of Piers 4 and 5 extending from channel bottom to waterline.

- (A) The timber debris accumulations at Piers 4 and 5 may cause excessive scour and lateral loads on the piers, as well as obstruct the channel flow. Therefore, it is recommended to remove the debris at this time.
