UNDERWATER BRIDGE INSPECTION REPORT

STRUCTURE NO. 58510

SNAKE RIVER

JUNE 7, 2012

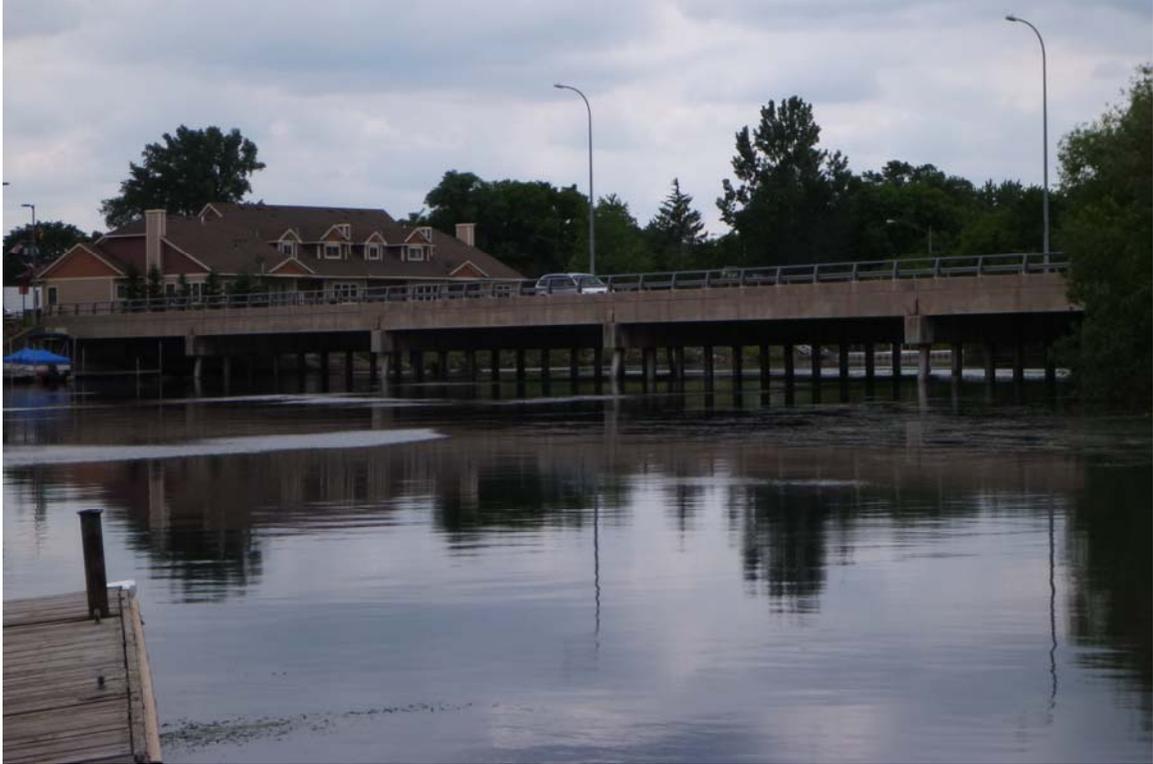
Photograph 1. Overall View of the Downstream Fascia, Looking Southwest.

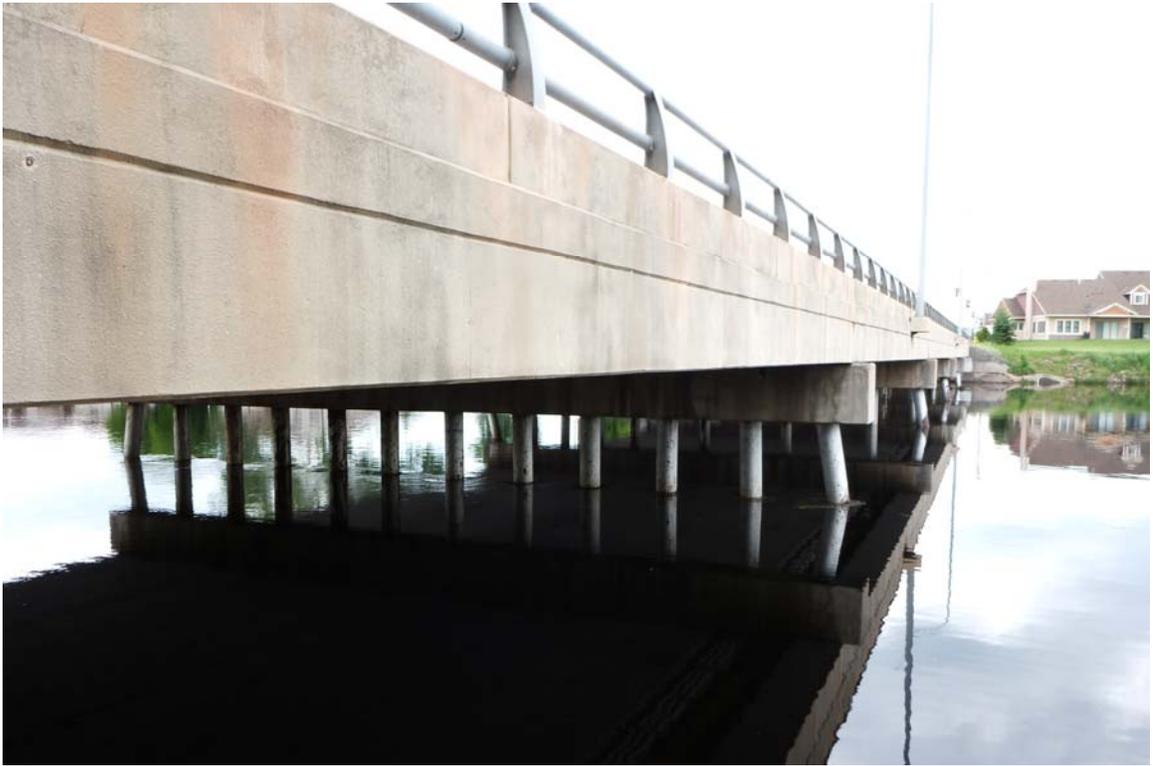
Photograph 2. View of the Upstream Fascia, Looking South.

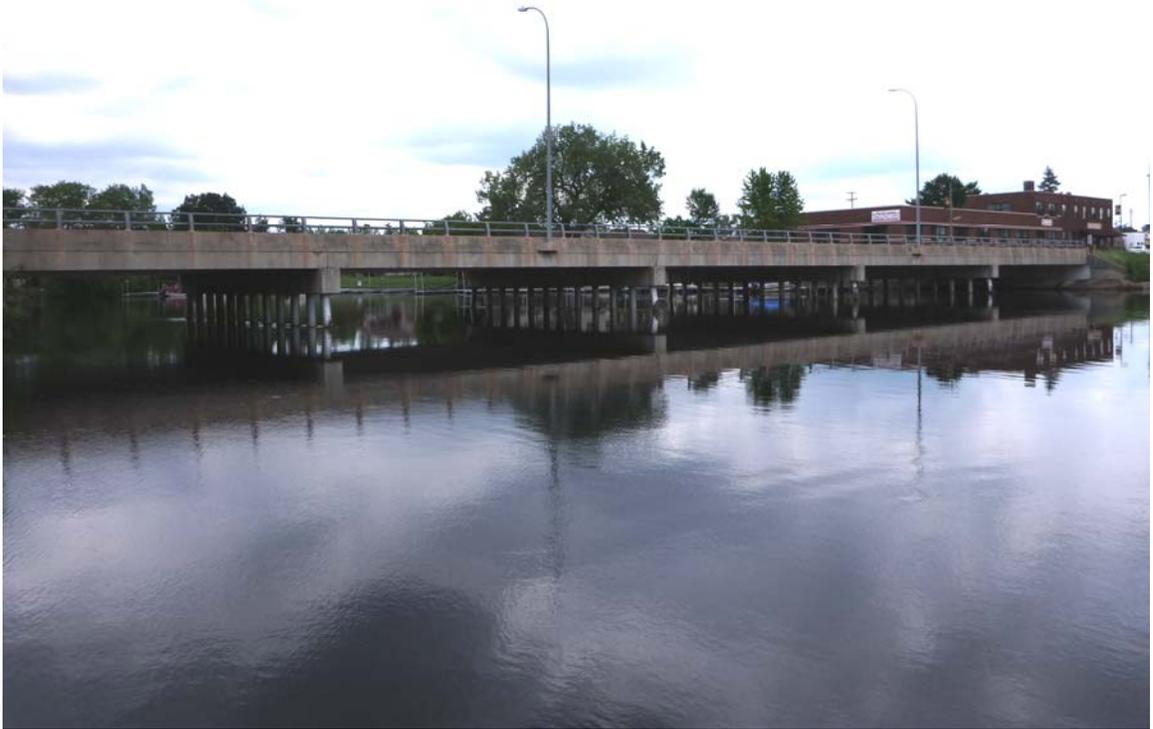
Photograph 3. View of the Upstream Facia, Looking Southeast.

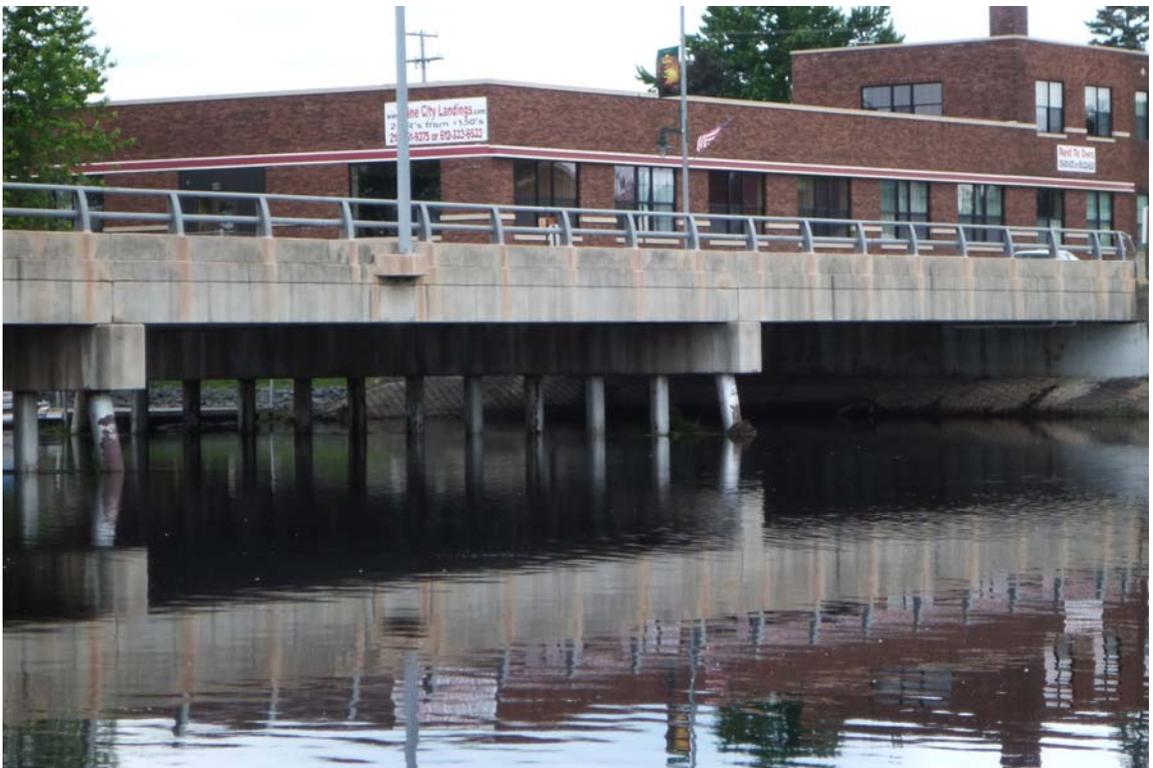
Photograph 4. View of Pier 1 and South Abutment, Looking Southeast.

- Metal dock framing debris was observed around the two upstream piles of Pier 1.

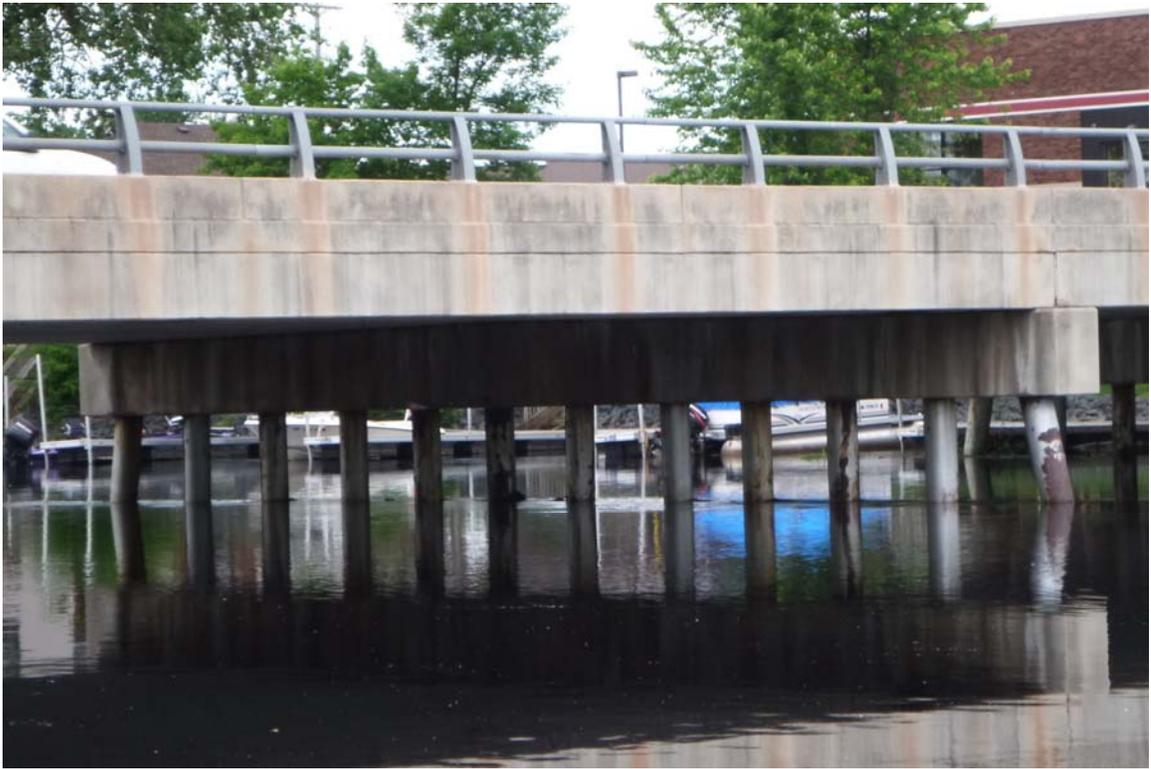
Photograph 5. View of Pier 2, Looking Southeast.

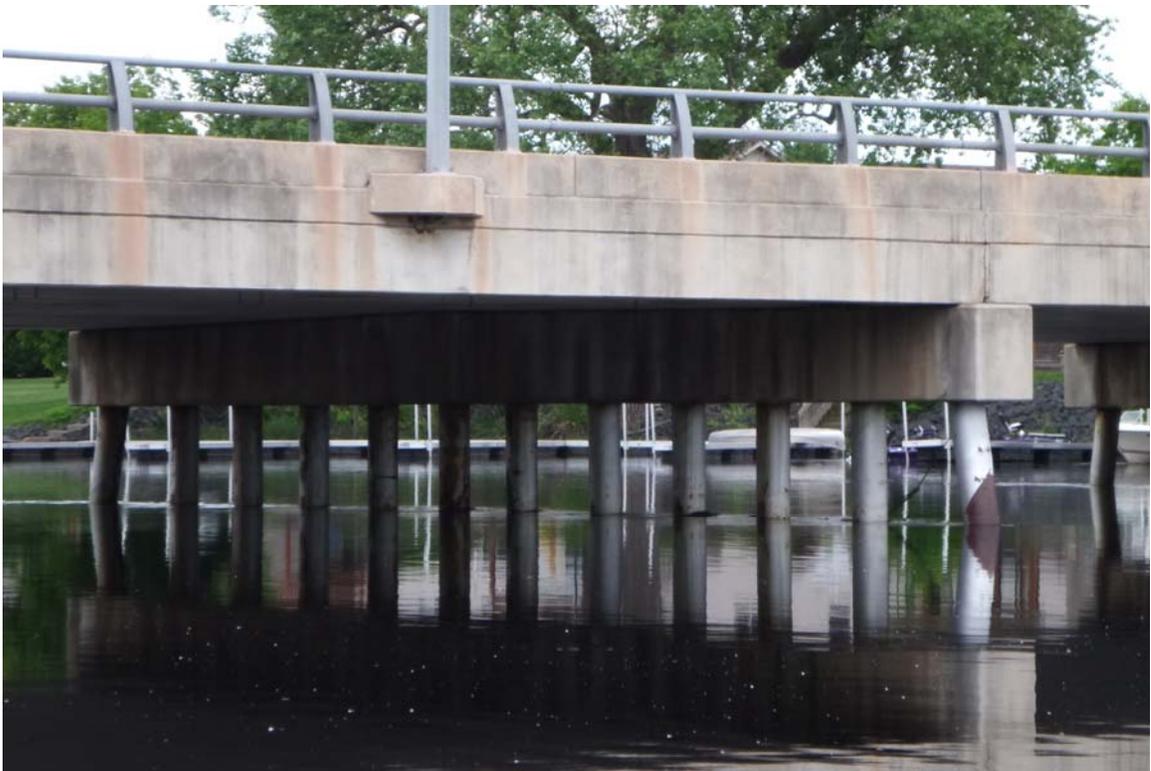
Photograph 6. View of Pier 3, Looking Southeast.

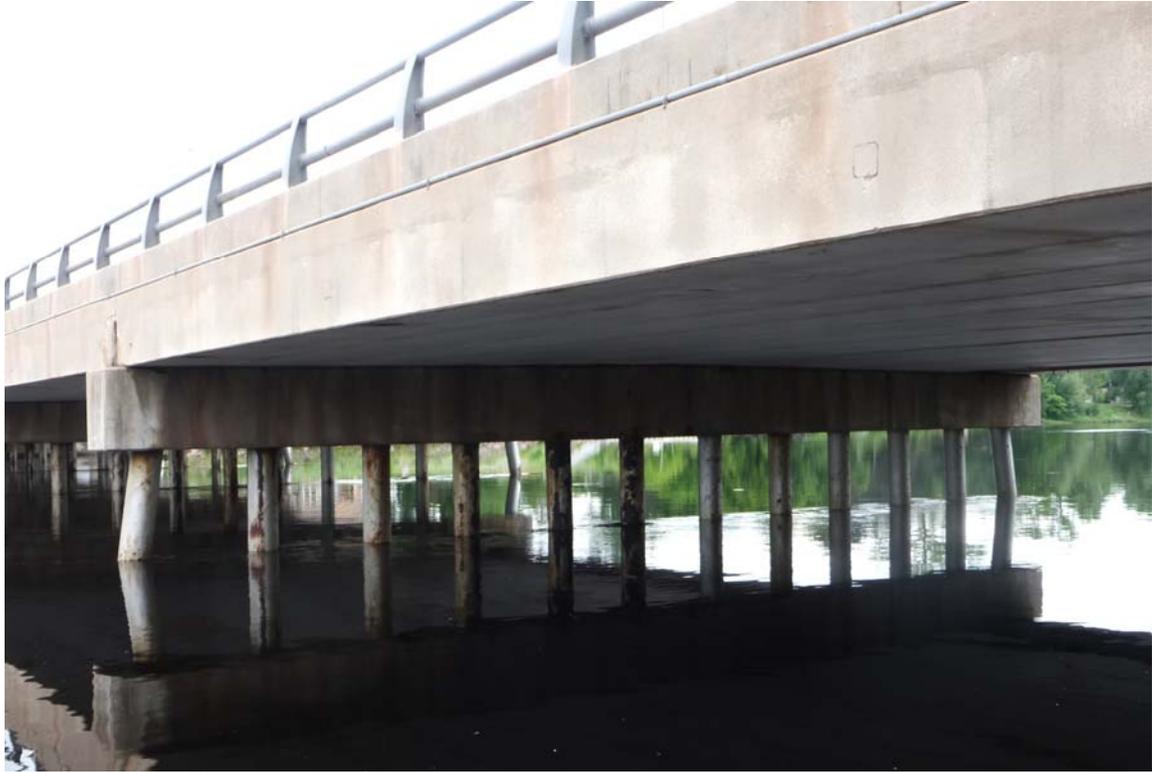
Photograph 7. View of Pier 4, Looking Southwest.

- Four deformations were present on the east and south side of the easternmost pile:
    - A 6 inch wide by 3 inch high by 2 inch deep dent was located 4 feet below water on the south face.

- A 6 inch by 3 inch high by 1 inch deep dent located at 3 feet below the waterline.
    - A 6 inch diameter by 2 inch deep dent located at the waterline. This dent was accompanied by 1/8 inch deep corrosion pitting.

- An 8 inch diameter by 1 inch deep dent located at 1.5 foot below the waterline.
  - Timber piles from an earlier structure were located along the north side of each pier. The tops of the piles were located at 2 feet above channel bottom.

- (A) Monitor corrosion of the steel piles during future underwater inspections.
- (B) Reinspect the submerged substructure units at the normal maximum recommended (NBIS) interval of sixty (60) months.

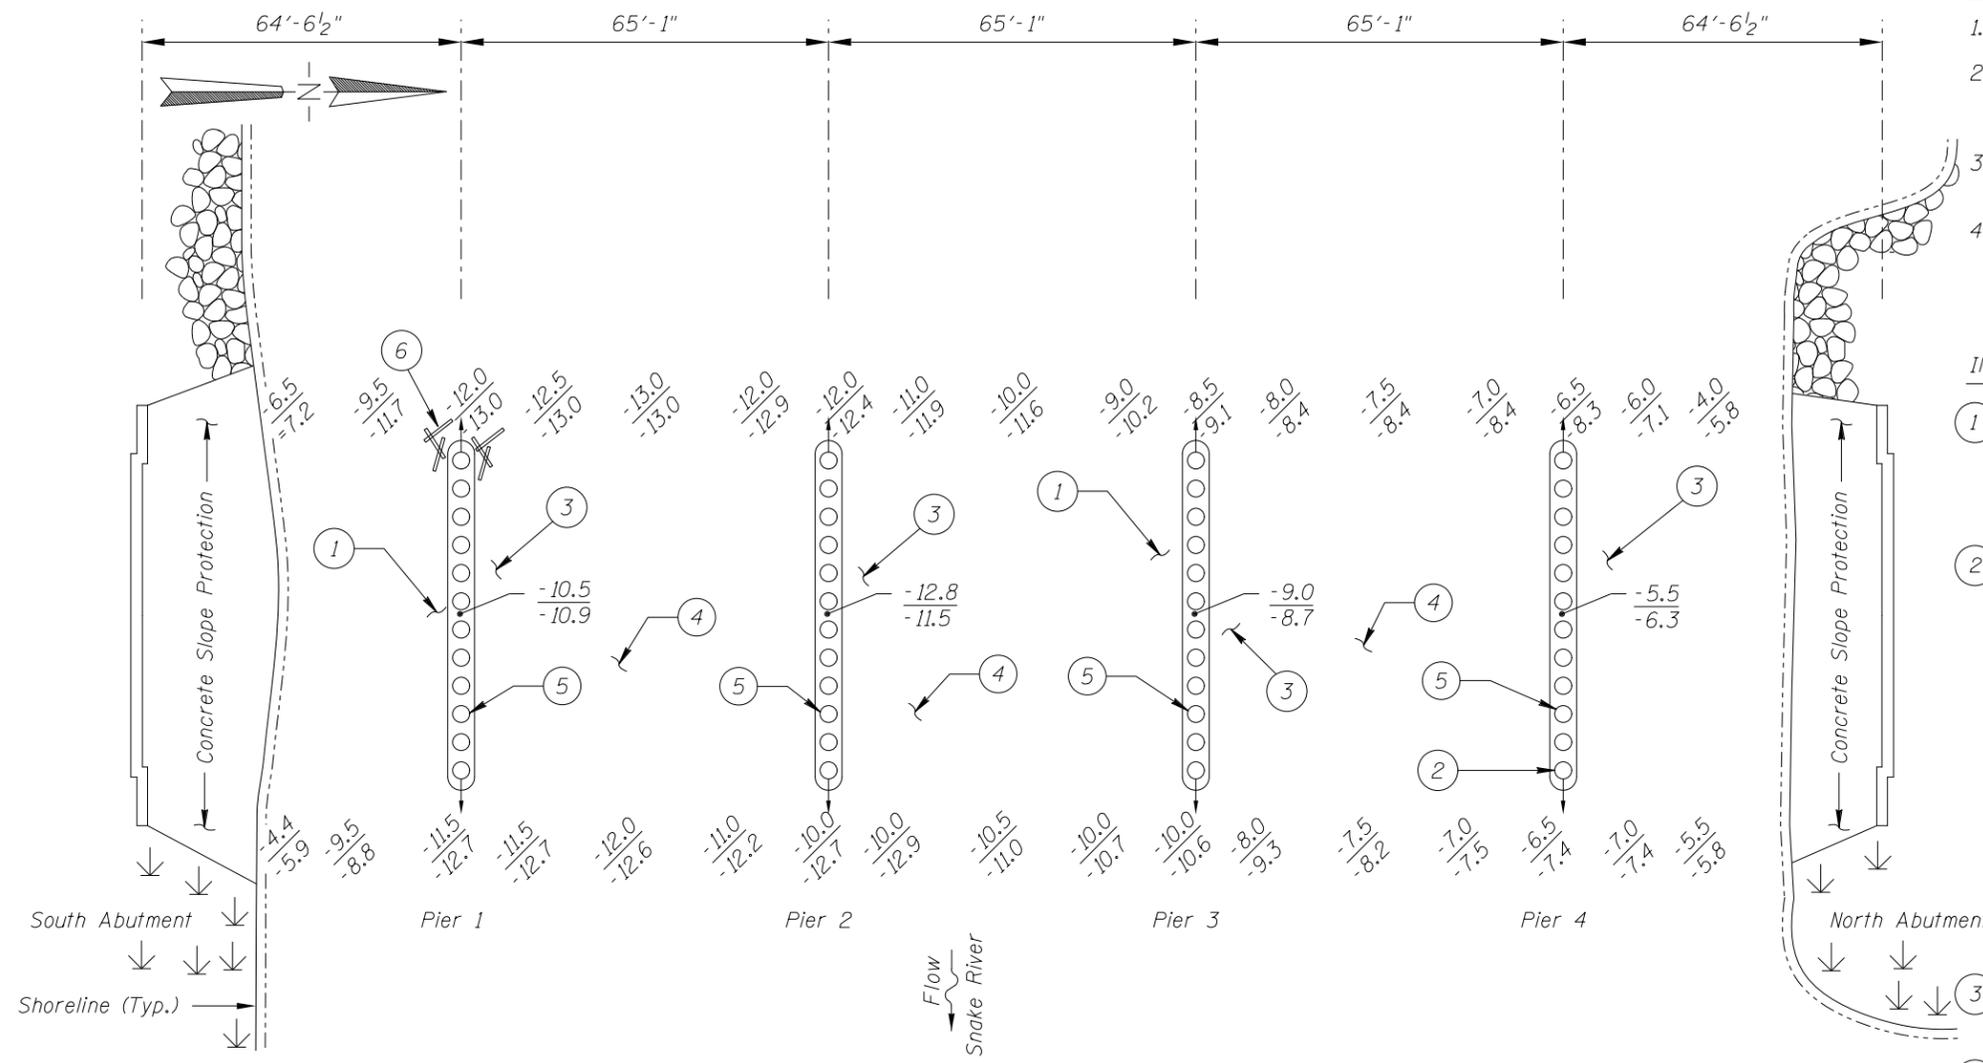
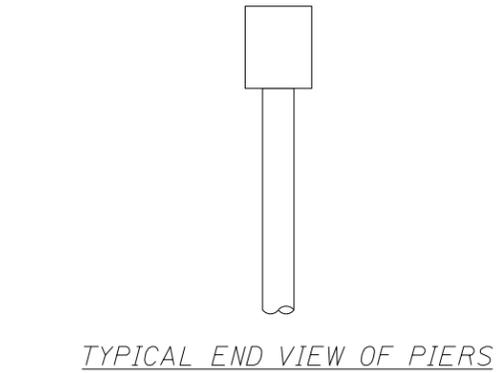
**INSPECTION AND SOUNDING PLAN**

- INSPECTION NOTES:**
- A light amount of scattered timber debris, 3 inch diameter and smaller, was observed along the south side of Piers 1 and 2. A light to moderate accumulation of timber debris 6 inch diameter and smaller, was observed at the upstream half of Pier 3 extending from channel bottom to 3 feet below the waterline.

- Channel bottom material consisted of gravelly sand with scattered riprap and cobbles allowing 2 inches of maximum probe rod penetration.
  - Light to moderate corrosion on all piles from bottom of cap to the channel bottom with up to 1/2 inch diameter rust nodules below water covering approximately 50% to 100% of the surface area of the piles, with a maximum of 1/8 inch deep pitting from 1 foot below waterline to channel bottom.
