UNDERWATER BRIDGE INSPECTION REPORT

STRUCTURE NO. 6413

CSAH NO. 6

CALDWELL BROOK

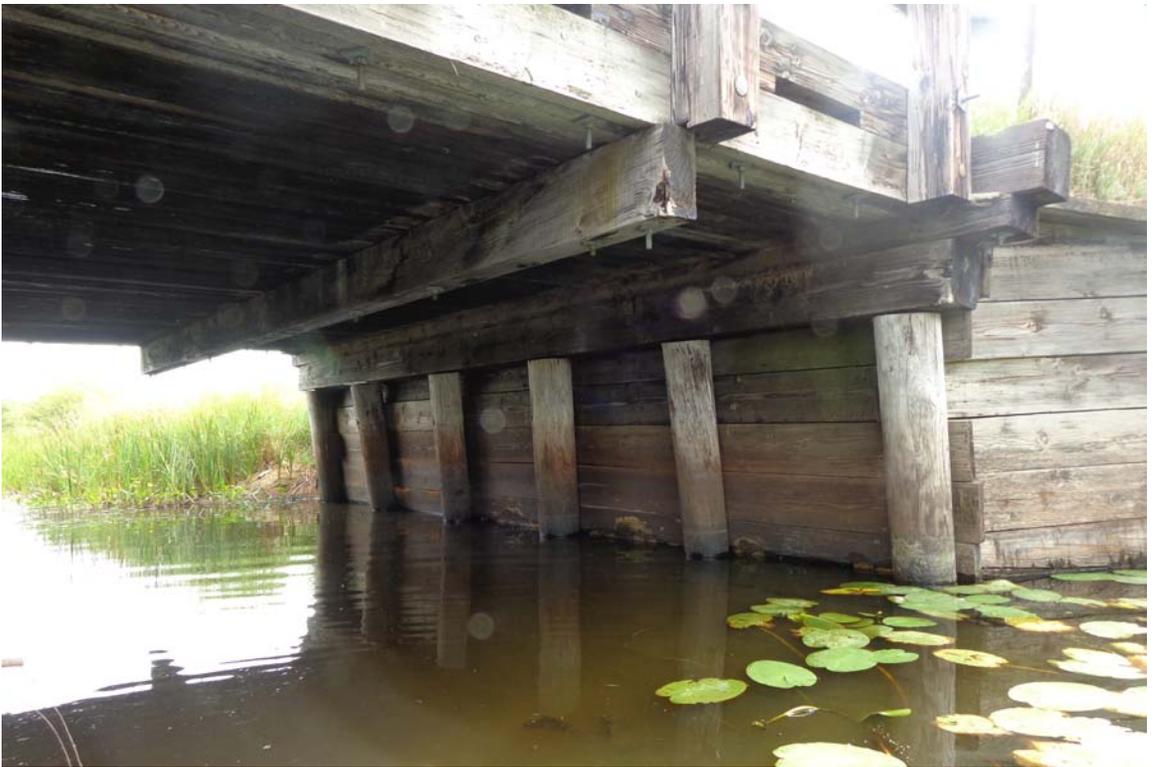
Photograph 2. View of the South Abutment, Looking Southeast.

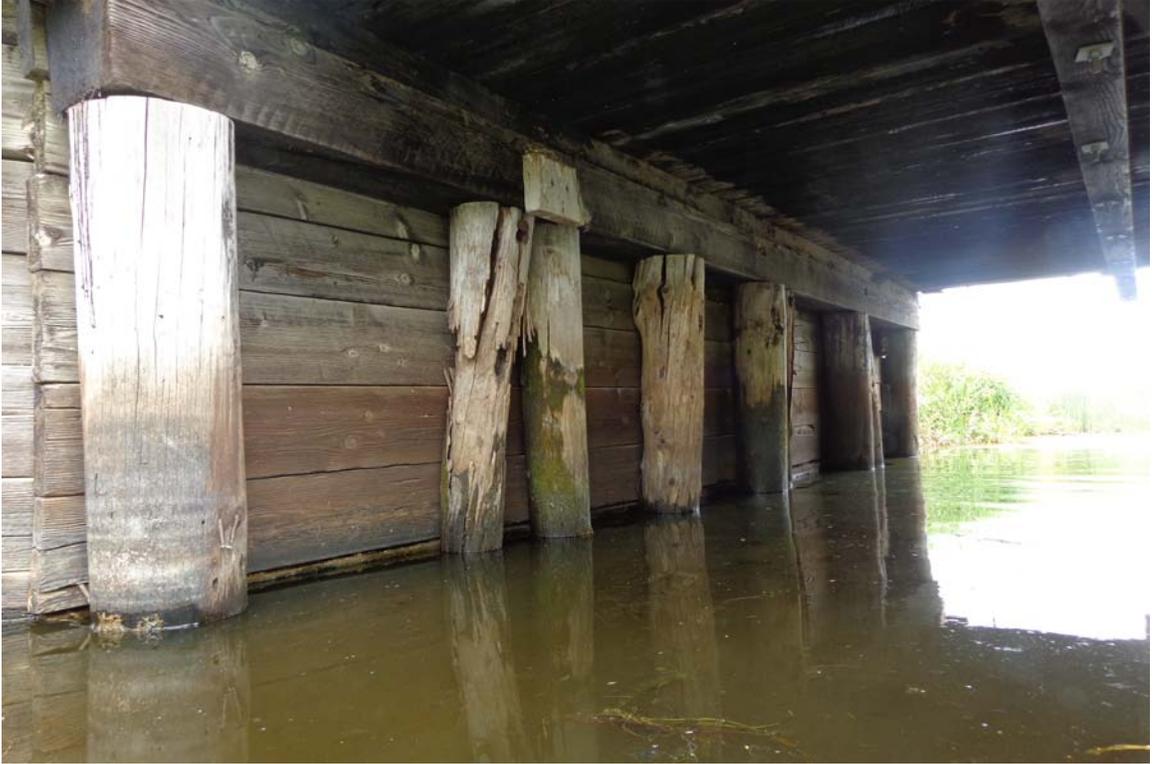
Photograph 5. View of North Abutment, Looking Northeast.

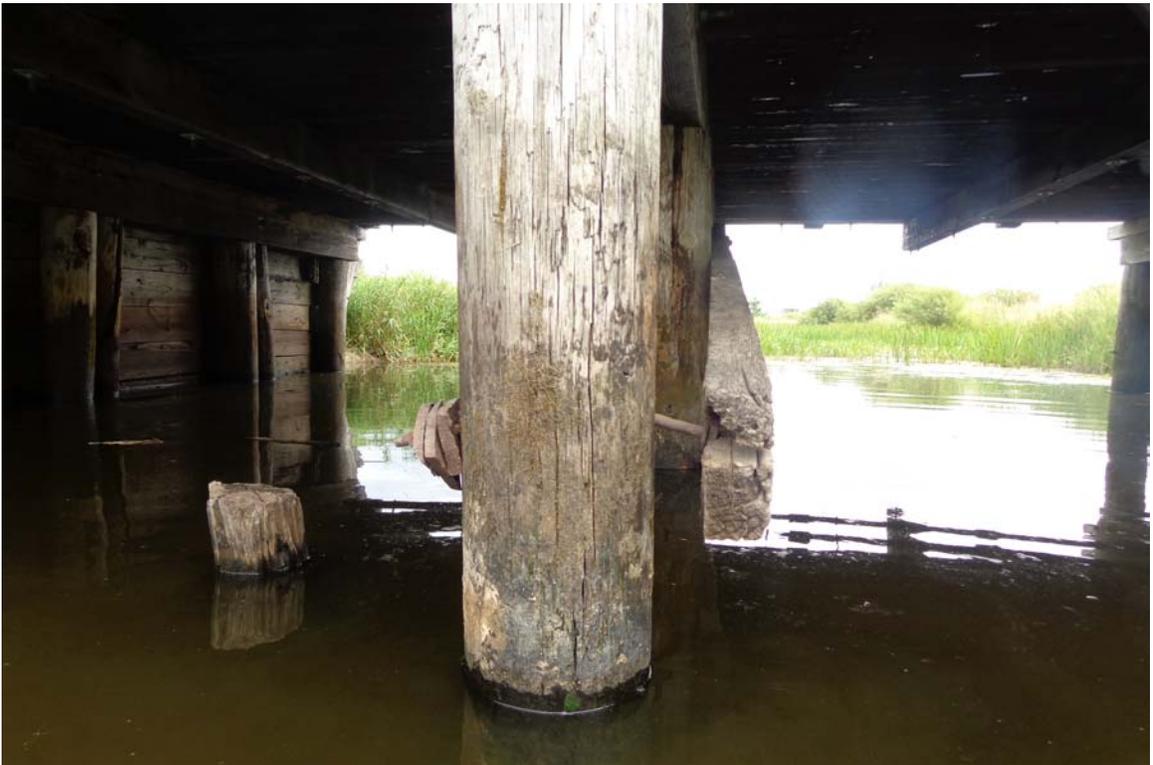
- (E) The top of the northeast wingwall exhibited up to 12 inches of displacement to the South with no active loss of backfill noted.
- (F) The south brace exhibited a 3-foot-long split with a failed connection to the westernmost pile at Bent 2.

Photograph 6. View of Split in Brace on Bent 2 and Failed Connection, Looking East.

- 5 The top of the northeast wingwall exhibited up to 12 inches of displacement to the south with no active loss of backfill noted.
- 6 The south brace exhibited a 3-foot-long split with a failed connection to the westernmost pile at Bent 2.

- (A) The abutment displacement is not excessive; however, it should be monitored, and if found to be progressing, further action may be needed.
- (B) Replace timber cross bracing members with splits and failed connections.
- (C) Reinspect the submerged substructure units at the normal maximum recommended (NBIS) interval of sixty (60) months.

Replace timber cross bracing members with splits and failed connections.

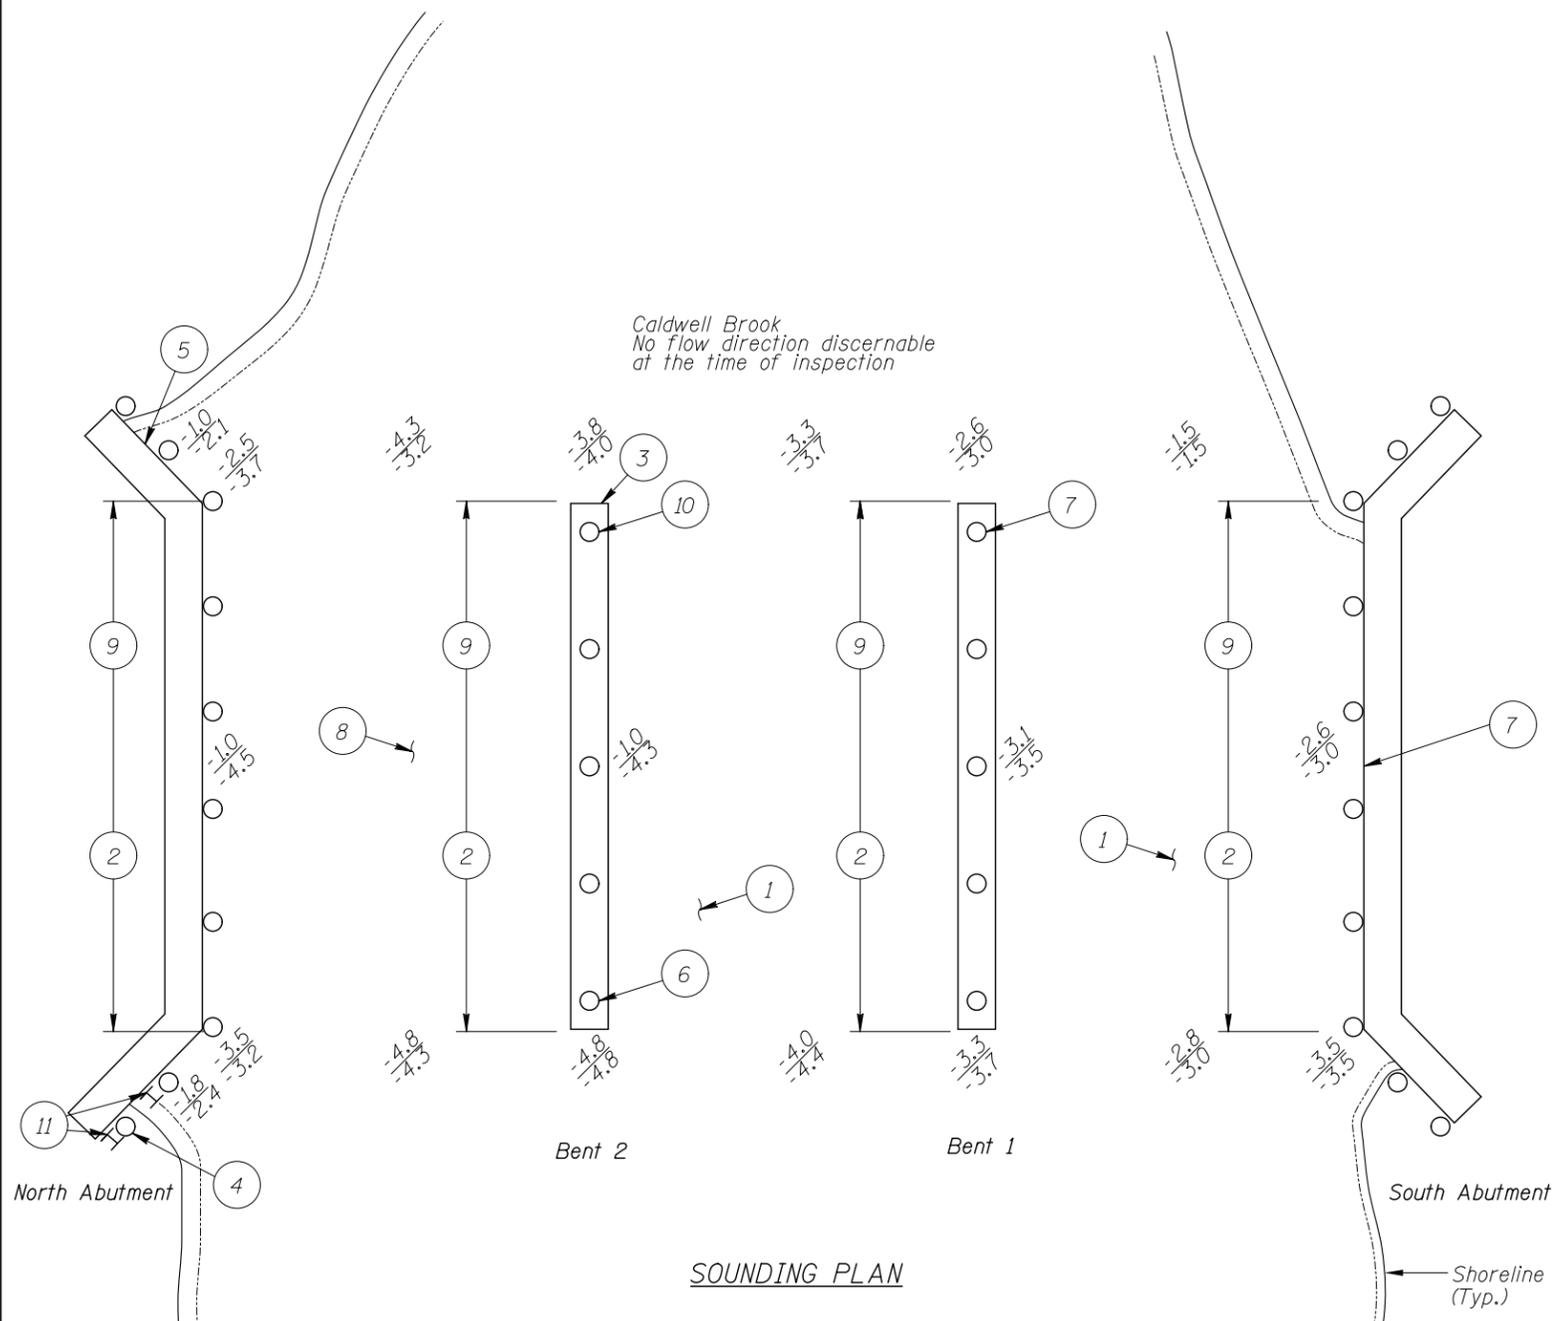
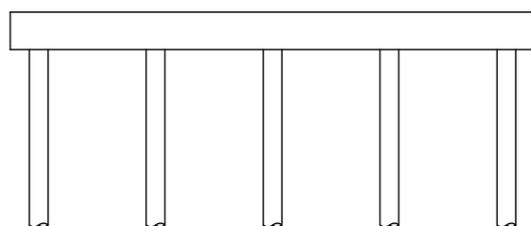
**SOUNDING PLAN**

- 1 The channel bottom material consisted of firm silty clay with less than 3 inches of probe rod penetration.
- 2 The timber piles typically exhibited moderate weathering with random checking up to 1/2 inch wide and 1/8 inch splits.

- 3 The timber pile cap exhibited a 1-inch-wide split along the eastern end of the bent.
- 4 Timber pile exhibited up to 100 percent loss of section in the top 3 feet of pile and delamination with up to 2 inches of awl penetration along the remaining portion of the pile, which has allowed up to 6 inches of wingwall displacement to the south.

- 7 The south brace exhibited a 5-foot-long split with a failed connection to the easternmost pile at Bent 1.
- 8 Channel bottom consisted of soft silt with up to 8 inches of probe rod penetration and random 12 inch riprap.

- 9 The connection hardware typically exhibited corrosion with no appreciable loss of section noted.
- 10 The easternmost pile of Bent 2 was delaminated from the top of the pile down to waterline with up to 3 inches of awl penetration.

- 11 Two steel piles have been added to the Northwest wingwall since the previous inspection.
- 12 The south abutment was displaced 6 inches to the north over 6 feet vertically and piles are leaning. The piles lost approximately 50 percent of bearing area.
