UNDERWATER BRIDGE INSPECTION REPORT

STRUCTURE NO. 69502

WHITEFACE RIVER

JULY 25, 2012

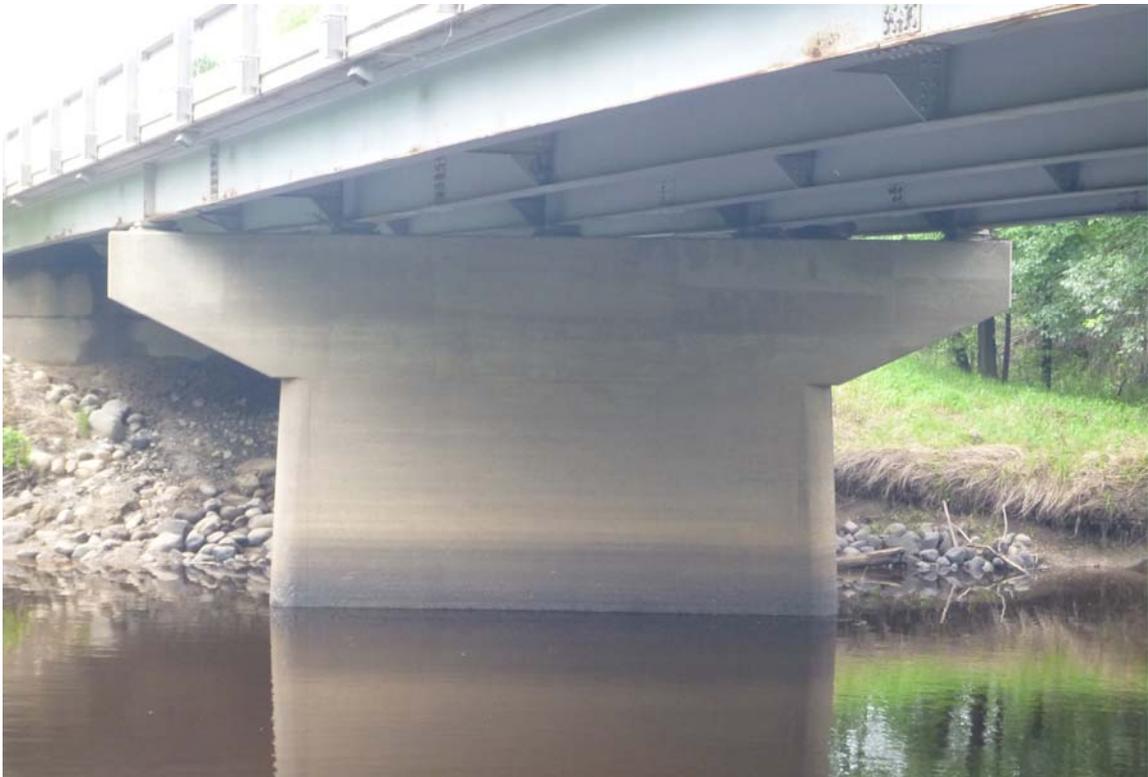
Photograph 1. View of Pier 1, Looking West.

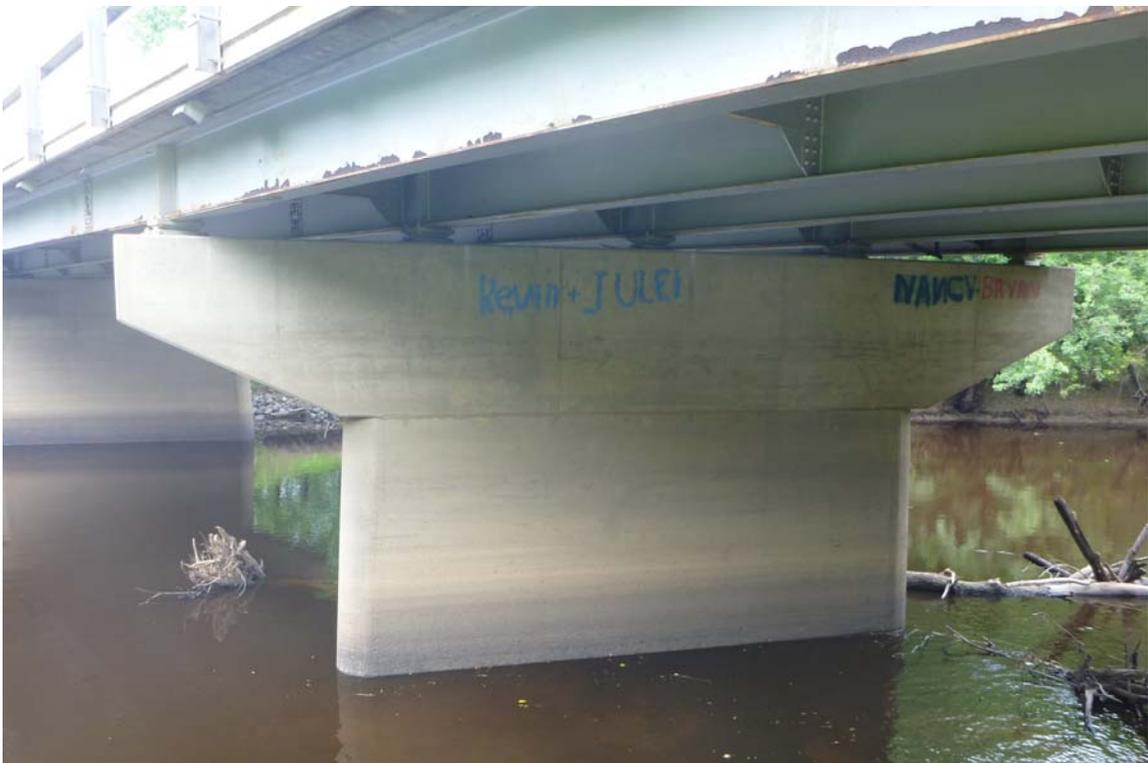
Photograph 2. View of Pier 2, Looking West.

Monitor timber debris during future underwater inspections.

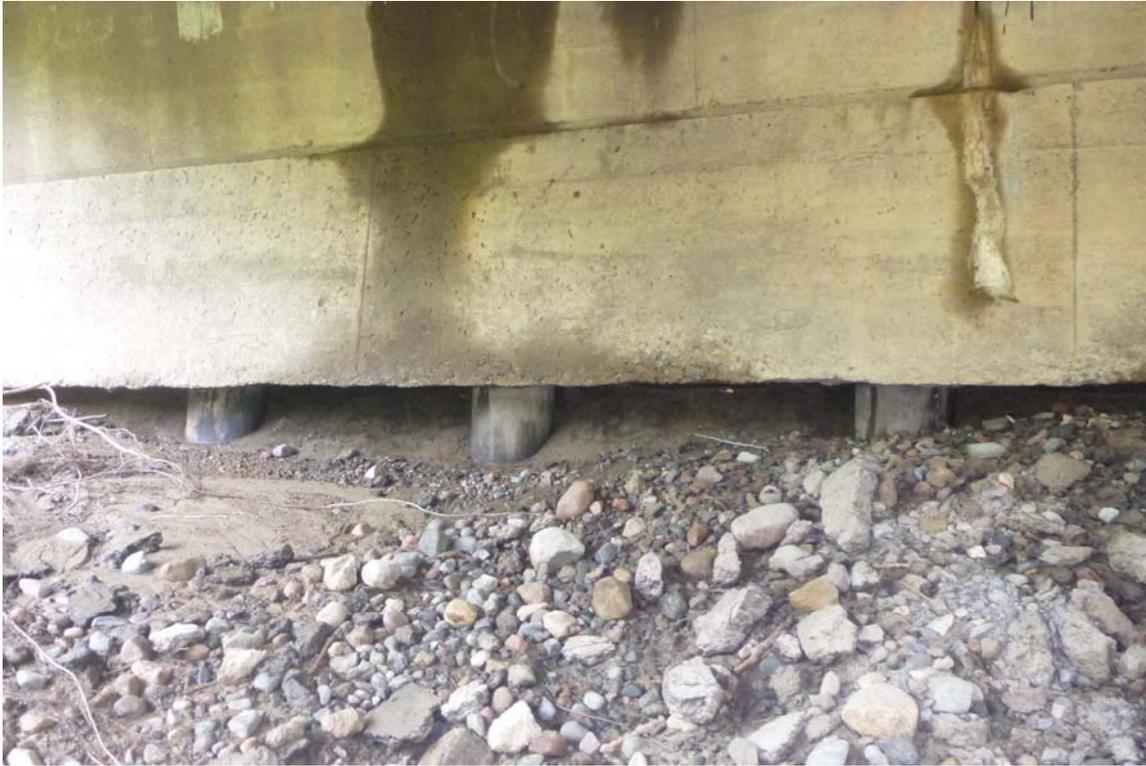
Photograph 3. View of Undermining at the East Abutment, Looking East.

Repair the undermining and slope protection at the East and West abutments.

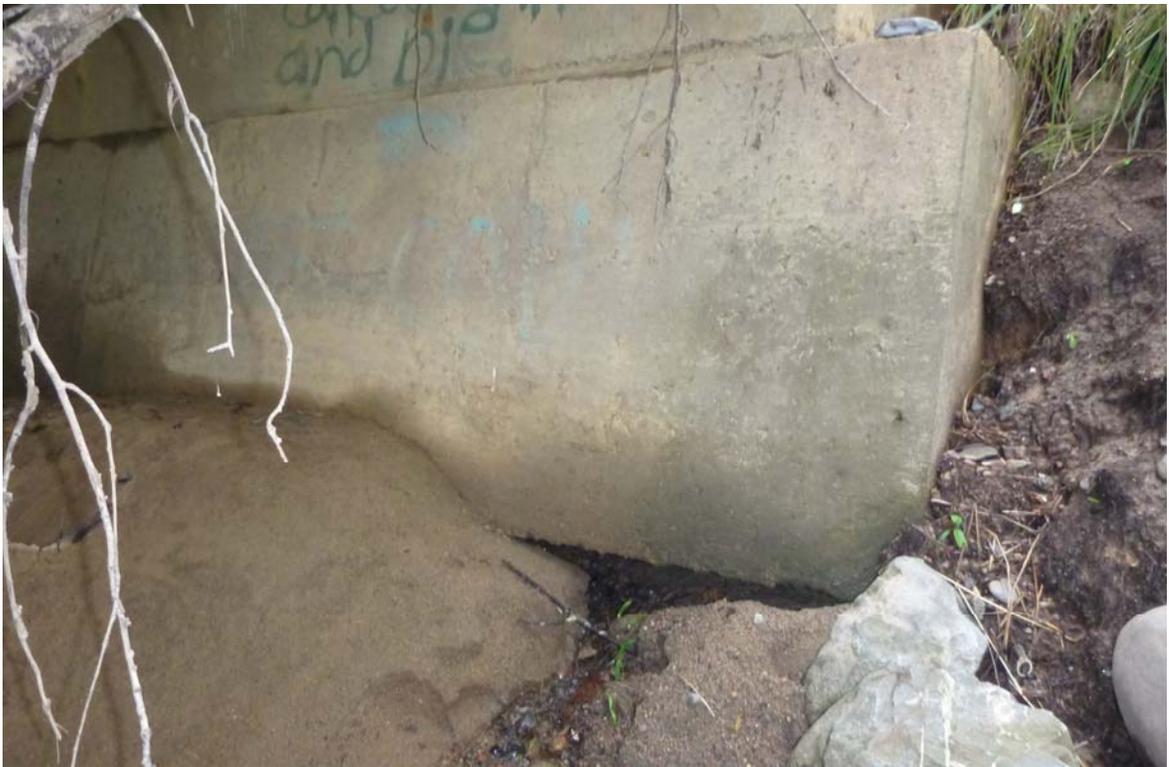
Photograph 3. View of Undermining at the East Abutment, Looking West.

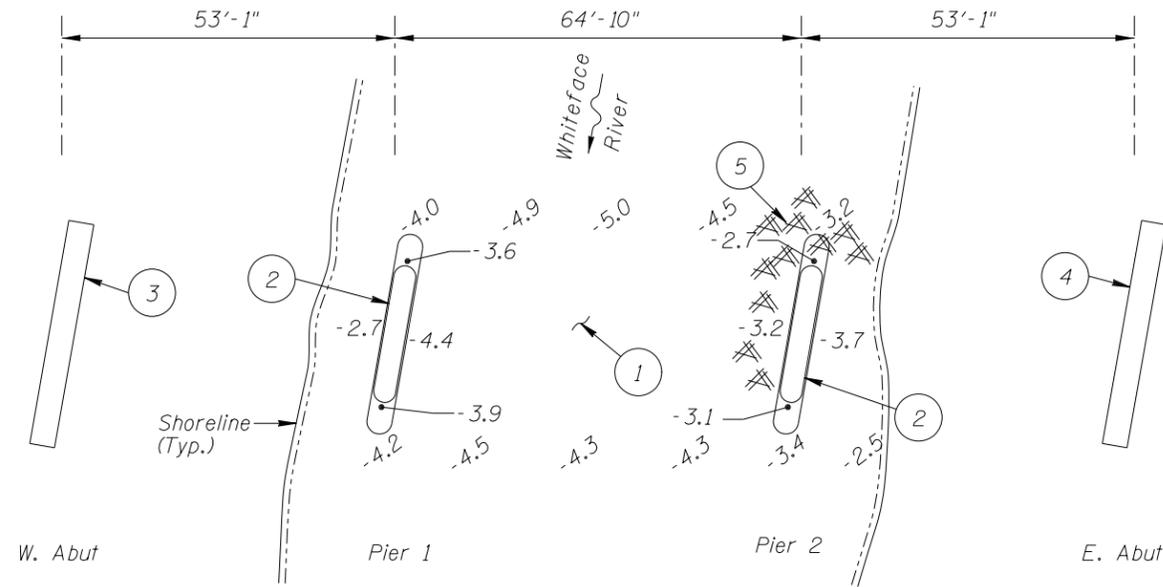
INSPECTION AND SOUNDING PLAN

- ① The channel bottom consisted of sandy silt allowing up to 12 inches of probe rod penetration.
- ② Moderate concrete scaling from 1 foot above to 2 feet below the waterline with 1/8 inch typical penetration, and 1/4 inch maximum.
- ③ West abutment was undermining for a section 5 feet in length, with undermining cavity measuring 4 inch vertical and 4 inch of penetration.
- ④ East abutment was undermined for a section 20 feet in length, with undermining cavity measuring 14 inch vertical and 18 inch of penetration.
- ⑤ A moderate accumulation of timber debris, consisting of logs and branches 12" inch dia. and smaller, was observed around the upstream nose of Pier 2 extending 15 feet off the upstream nose to the shore, along the entire west face and up to 10 feet off the face, and from the channel bottom to 4 feet above the waterline.
