UNDERWATER BRIDGE INSPECTION REPORT

STRUCTURE NO. 69505
CSAH NO. 8
OVER THE
ST. LOUIS RIVER
DISTRICT 1 – ST. LOUIS COUNTY

JULY 25, 2012

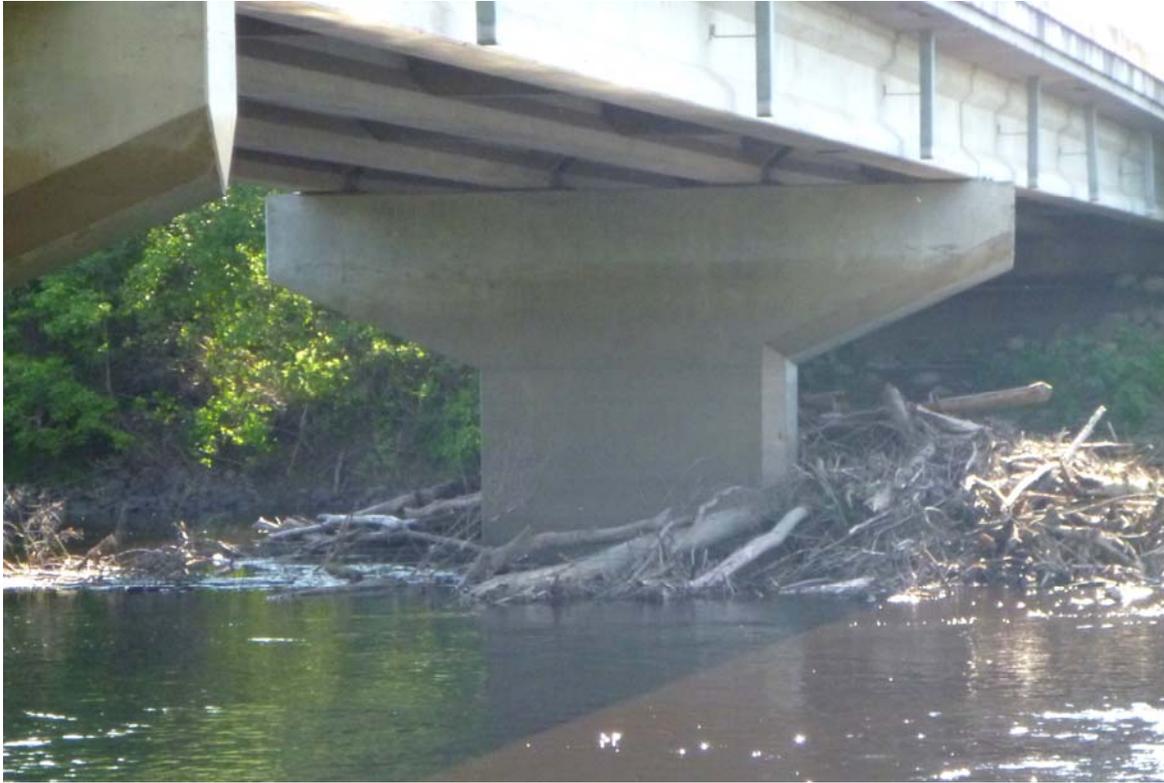
The substructure units inspected at Bridge 69505, Piers 1 and 2, were in good condition with no defects of structural significance observed. A heavy accumulation of timber debris was observed around the perimeter of Pier 1. The channel bottom appeared to be in stable condition with no evidence of significant scour.

Photograph 1. View of Pier 1 and Timber Debris, Looking West.

- (A) Remove timber debris around Pier 1.

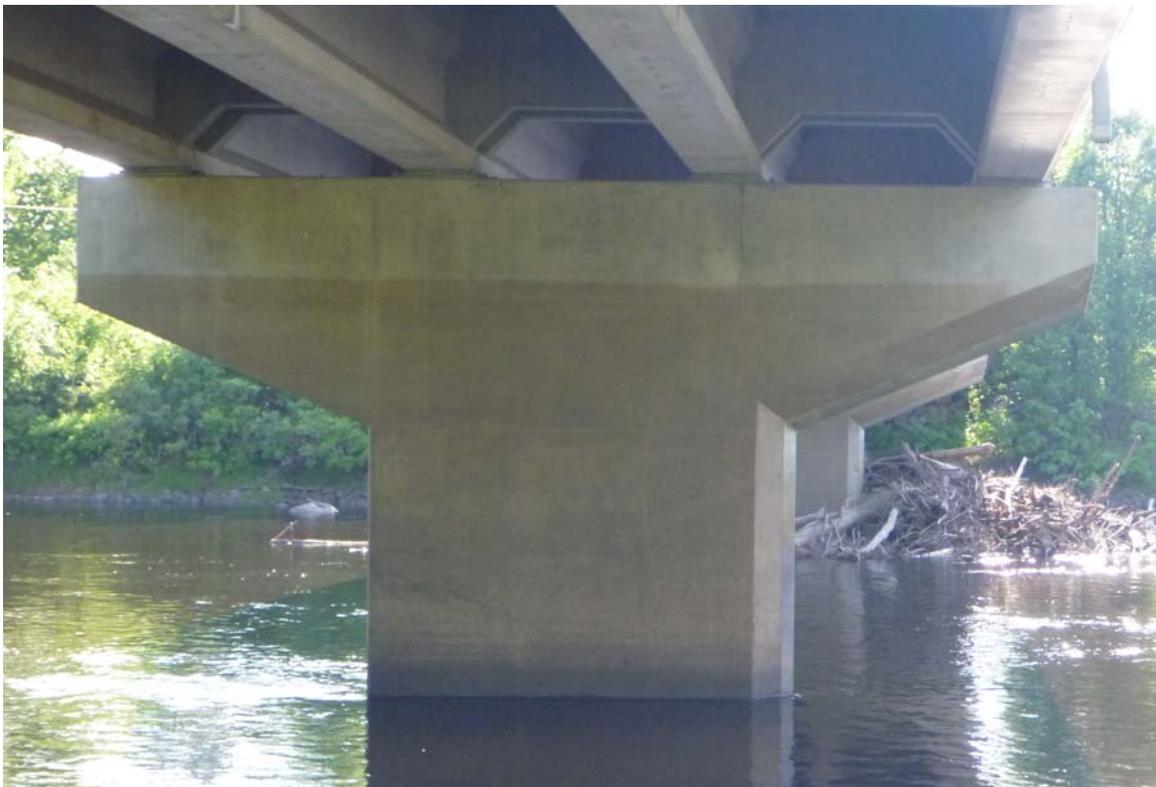
Photograph 2. View of Pier 2, Looking West.

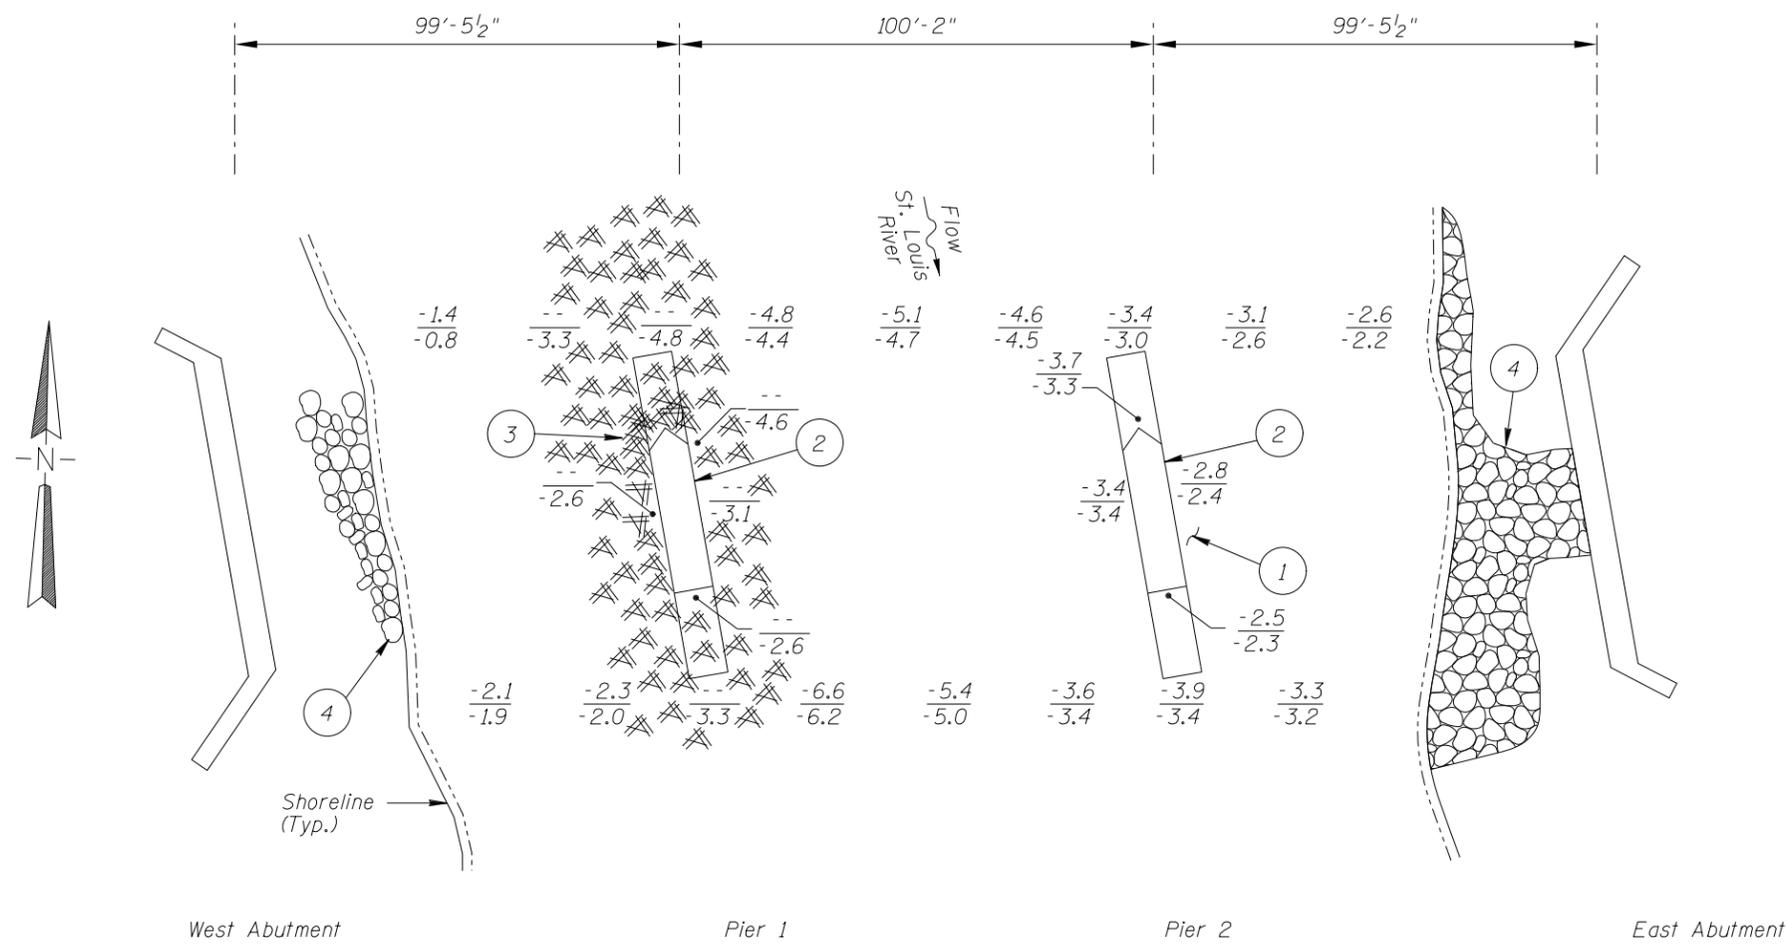
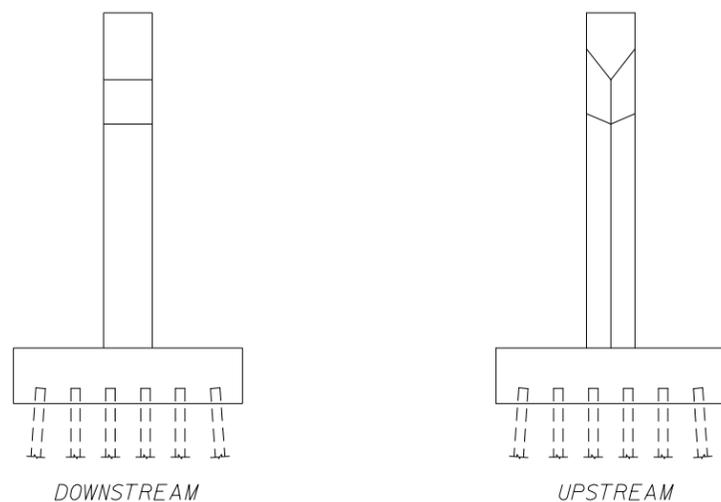
SOUNDING PLAN

- 1 The channel bottom consisted of 1- to 2-foot-diameter riprap and cobbles.
- 2 The concrete exhibited light scaling from 3 feet above the waterline to the channel bottom with exposed aggregate and typical penetrations of 1/8 inch and maximum penetrations ranging from 1/4 inch to 1/2 inch.
- 3 A heavy accumulation of 3-foot-diameter and smaller timber debris was observed around the entire pier extending 50 feet upstream and 25 feet downstream off the noses, 20 feet off the faces of Pier 1, from the channel bottom to 8 foot above the waterline.
- 4 1- to 2-foot-diameter riprap and cobbles were observed along the embankments.
