UNDERWATER BRIDGE INSPECTION REPORT

STRUCTURE NO. 69506

CSAH 133

JULY 25, 2012

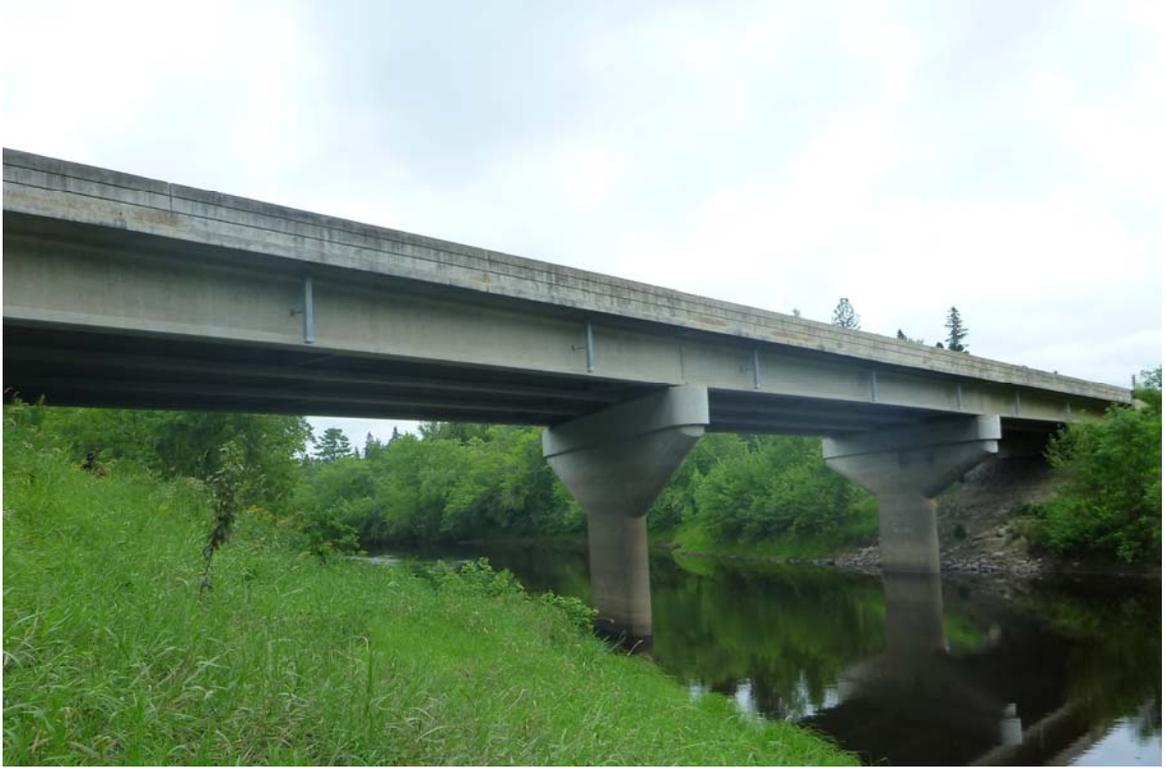
Photograph 1. View of Downstream Fascia, Looking North.

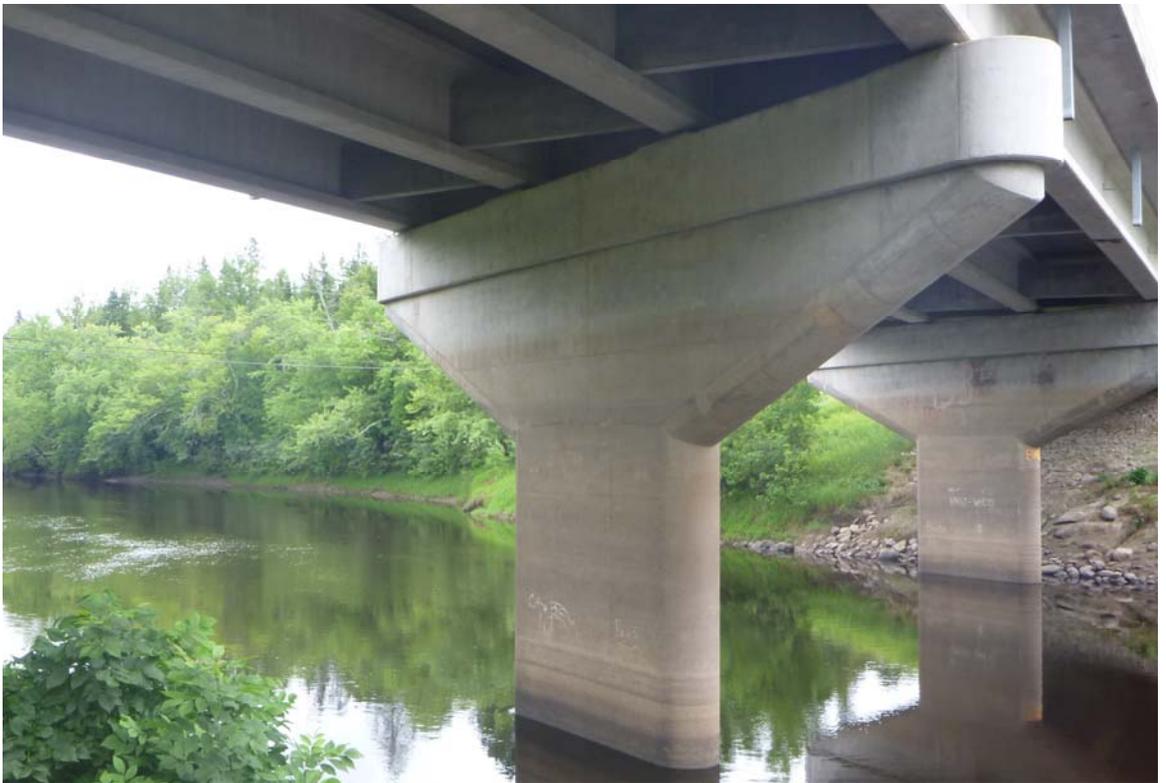
- (A) The concrete surfaces of Pier 1 were unsound and the outer layer (approximately 1/4 inch thick) was easily degradable by the use of hand tools. The concrete defects typically were present from the channel bottom up 4 feet.
- (B) The channel bottom material consisted of rip rap of 2 feet in diameter and smaller with no penetration.

Photograph 2. View of Pier 1, Looking Northwest.

- (A) Monitor the extent of concrete deterioration during future underwater inspections.

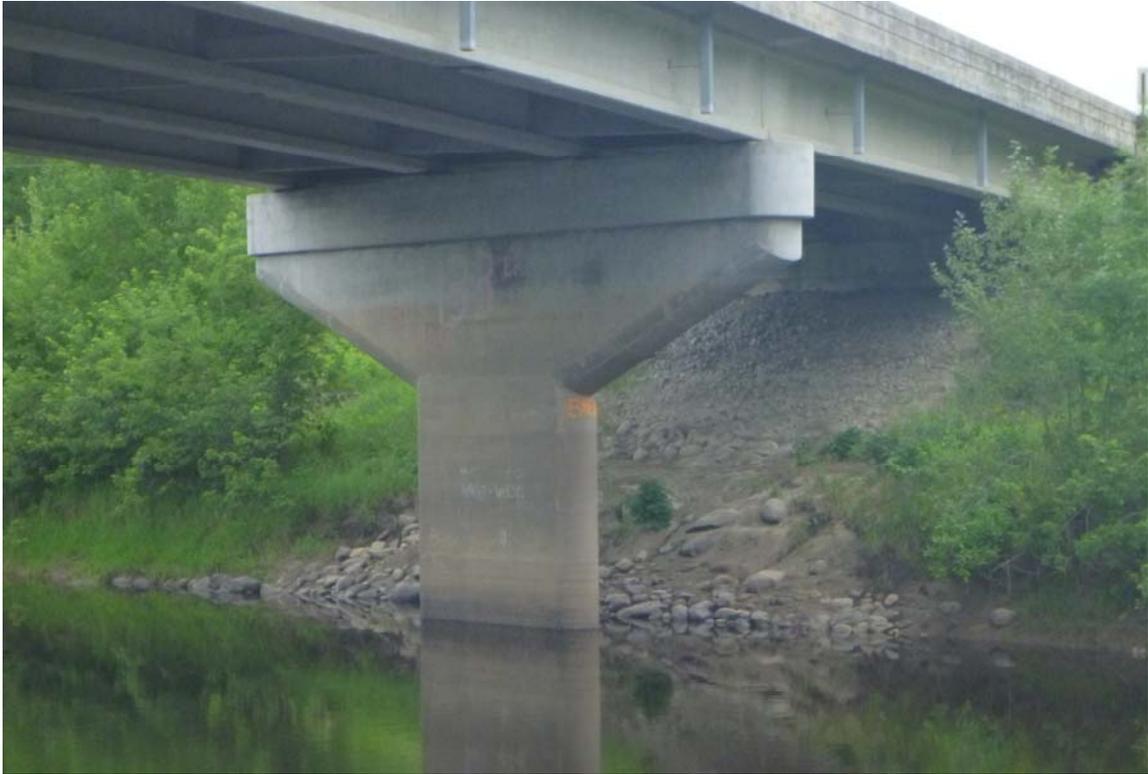
Photograph 3: View of Pier 2, Looking Northwest.

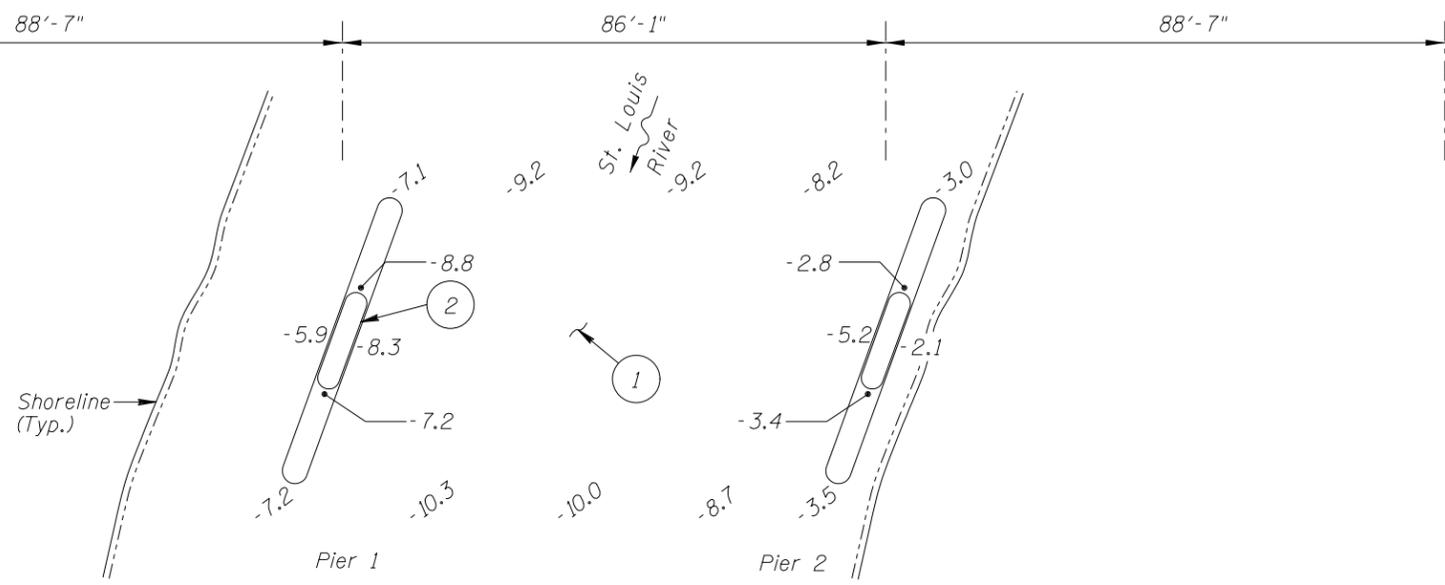
SOUNDING PLAN

- ① The channel bottom consisted of riprap 2 feet dia. and smaller allowing no probe rod penetration.
- ② The outer (approximately 1/4 inch thick) layer of concrete from the channel bottom up 4 feet was unsound and easily degradable by the use of hand tools.
