UNDERWATER BRIDGE INSPECTION REPORT

STRUCTURE NO. 69508

ST LOUIS RIVER

JULY 25, 2012

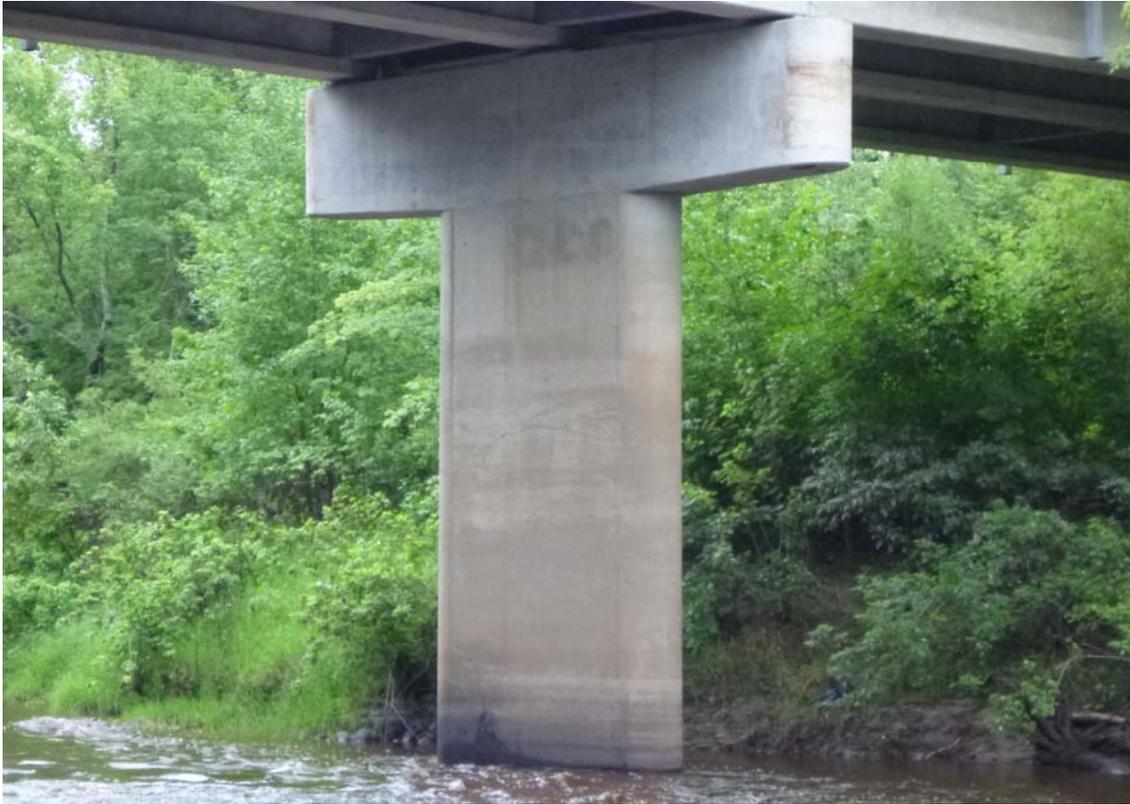
Photograph 1. View of Pier 1, Looking South.

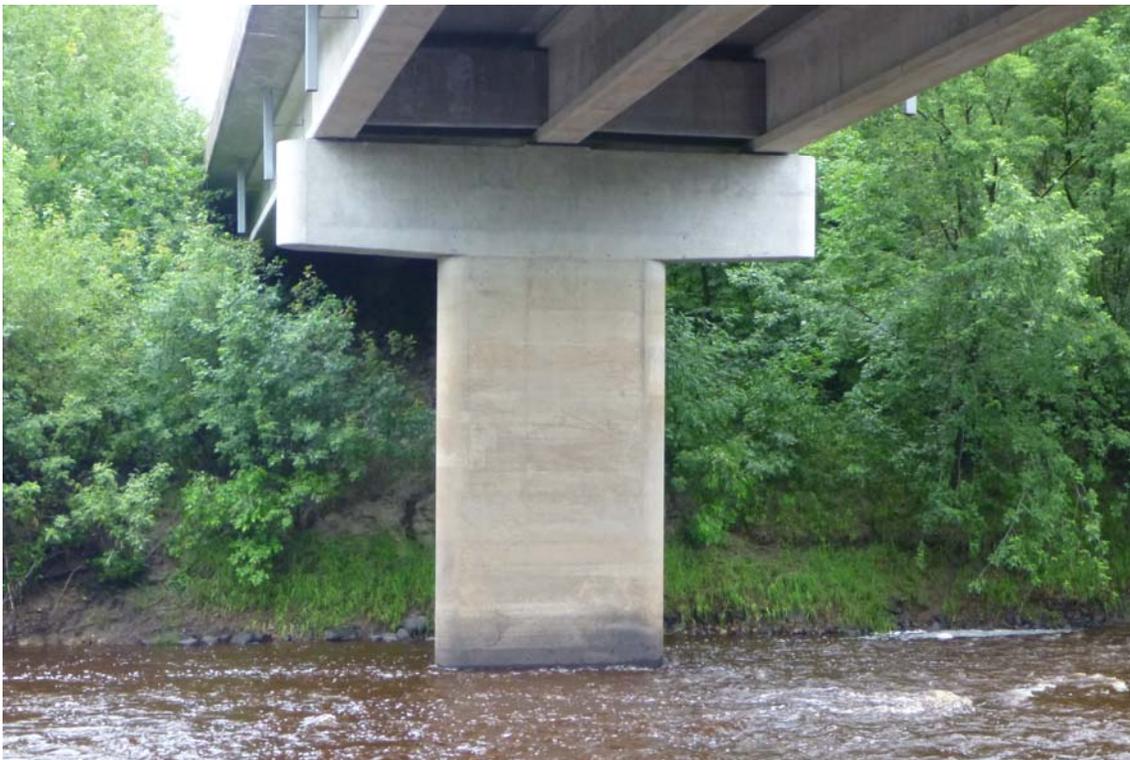
Photograph 2. View of Pier 2, Looking North.

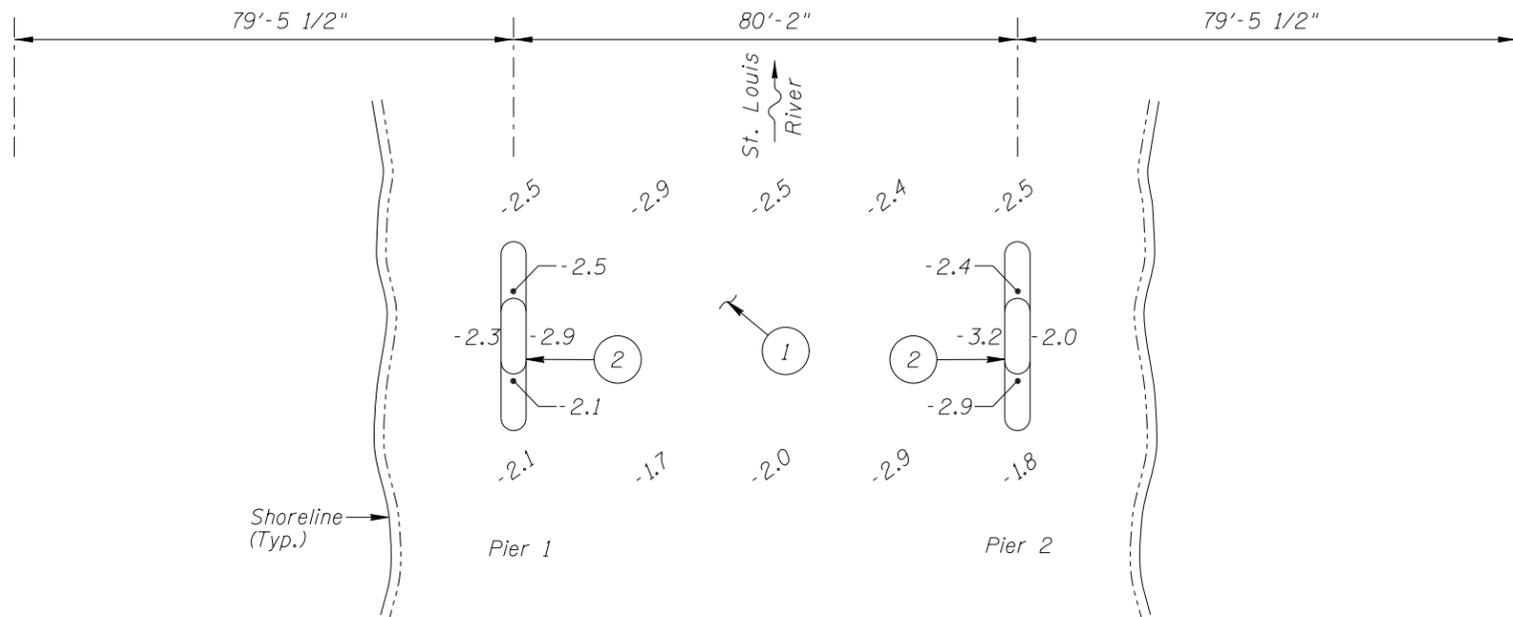
INSPECTION AND SOUNDING PLAN

- ① The channel bottom consisted of riprap of 6 to 8 inch dia. allowing no probe rod penetration.
- ② Light concrete scaling, with 1/8 inch penetration was observed from 3 feet above waterline to channel bottom.
