UNDERWATER BRIDGE INSPECTION REPORT

STRUCTURE NO. 69511

CSAH 15

CLOQUET RIVER

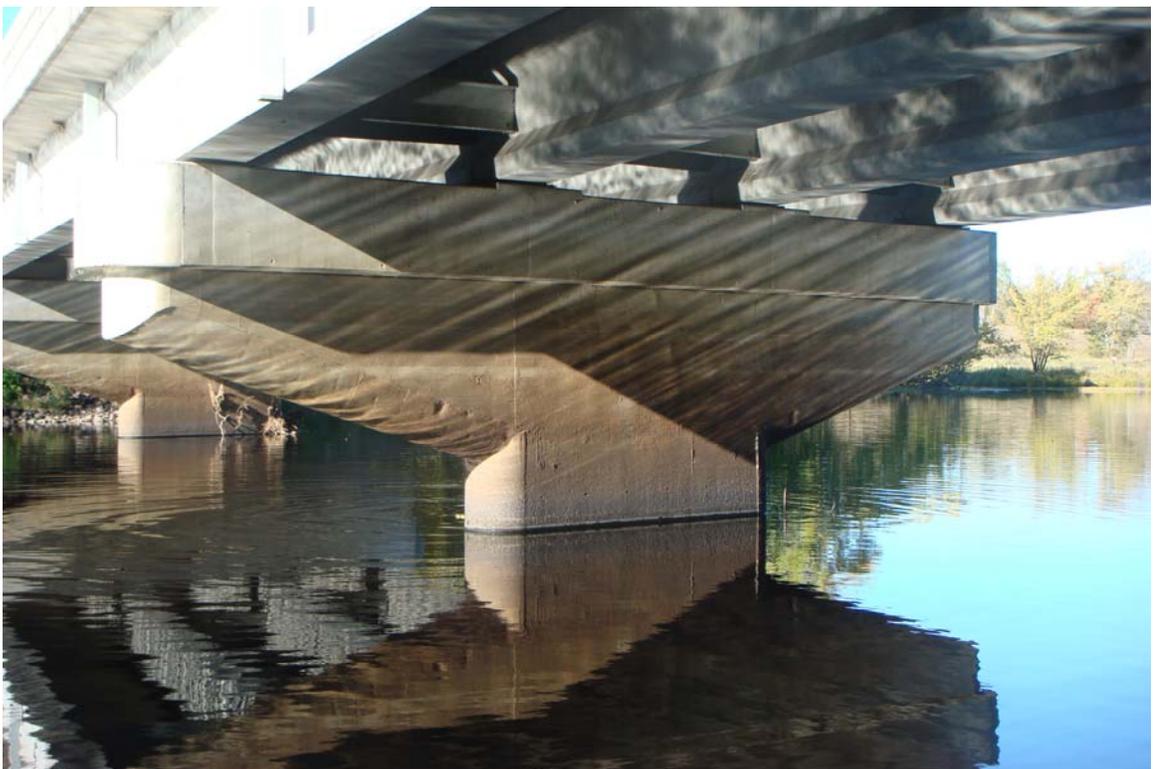
Photograph 2. View of Pier 1, Looking Southwest.

- (C) The top of the footing of Pier 1 was exposed from the north face midpoint to the upstream nose and extending up to 2 feet off the face of the pier. No vertical exposure or edge of footing was observed.

- (D) An 8 inch diameter tree was observed along the upstream nose of Pier 1 that extended 10 feet off the north and south faces and from the channel bottom to the waterline.

- (A) Ideally the timber debris at the piers should be removed to inhibit further accumulation. Until the timber has been removed, monitor the extent of timber accumulations at the bridge.

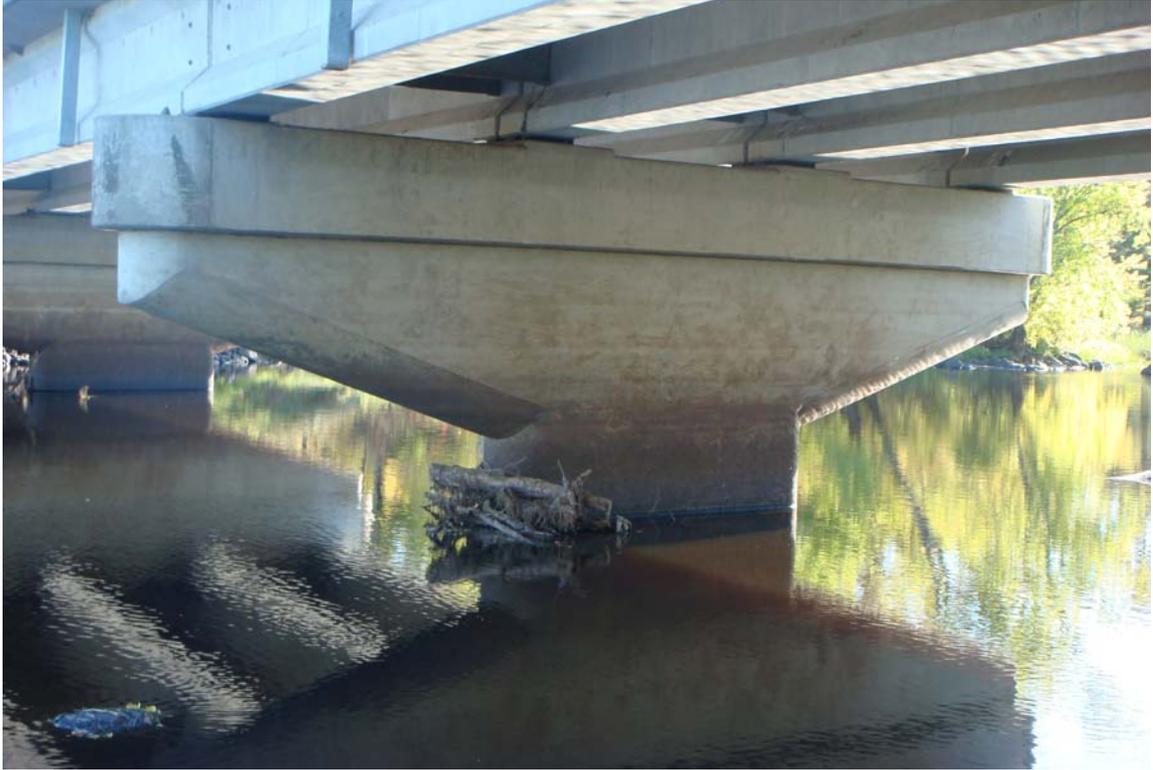
Photograph 3. View of Pier 2, Looking Northeast.

- (E) A heavy accumulation of timber debris consisting of 1 foot diameter and smaller trees and branches was observed around Pier 2 extending from the channel bottom to 2 feet above the waterline, 10 feet off the north and south faces, and 15 feet upstream of the upstream nose.

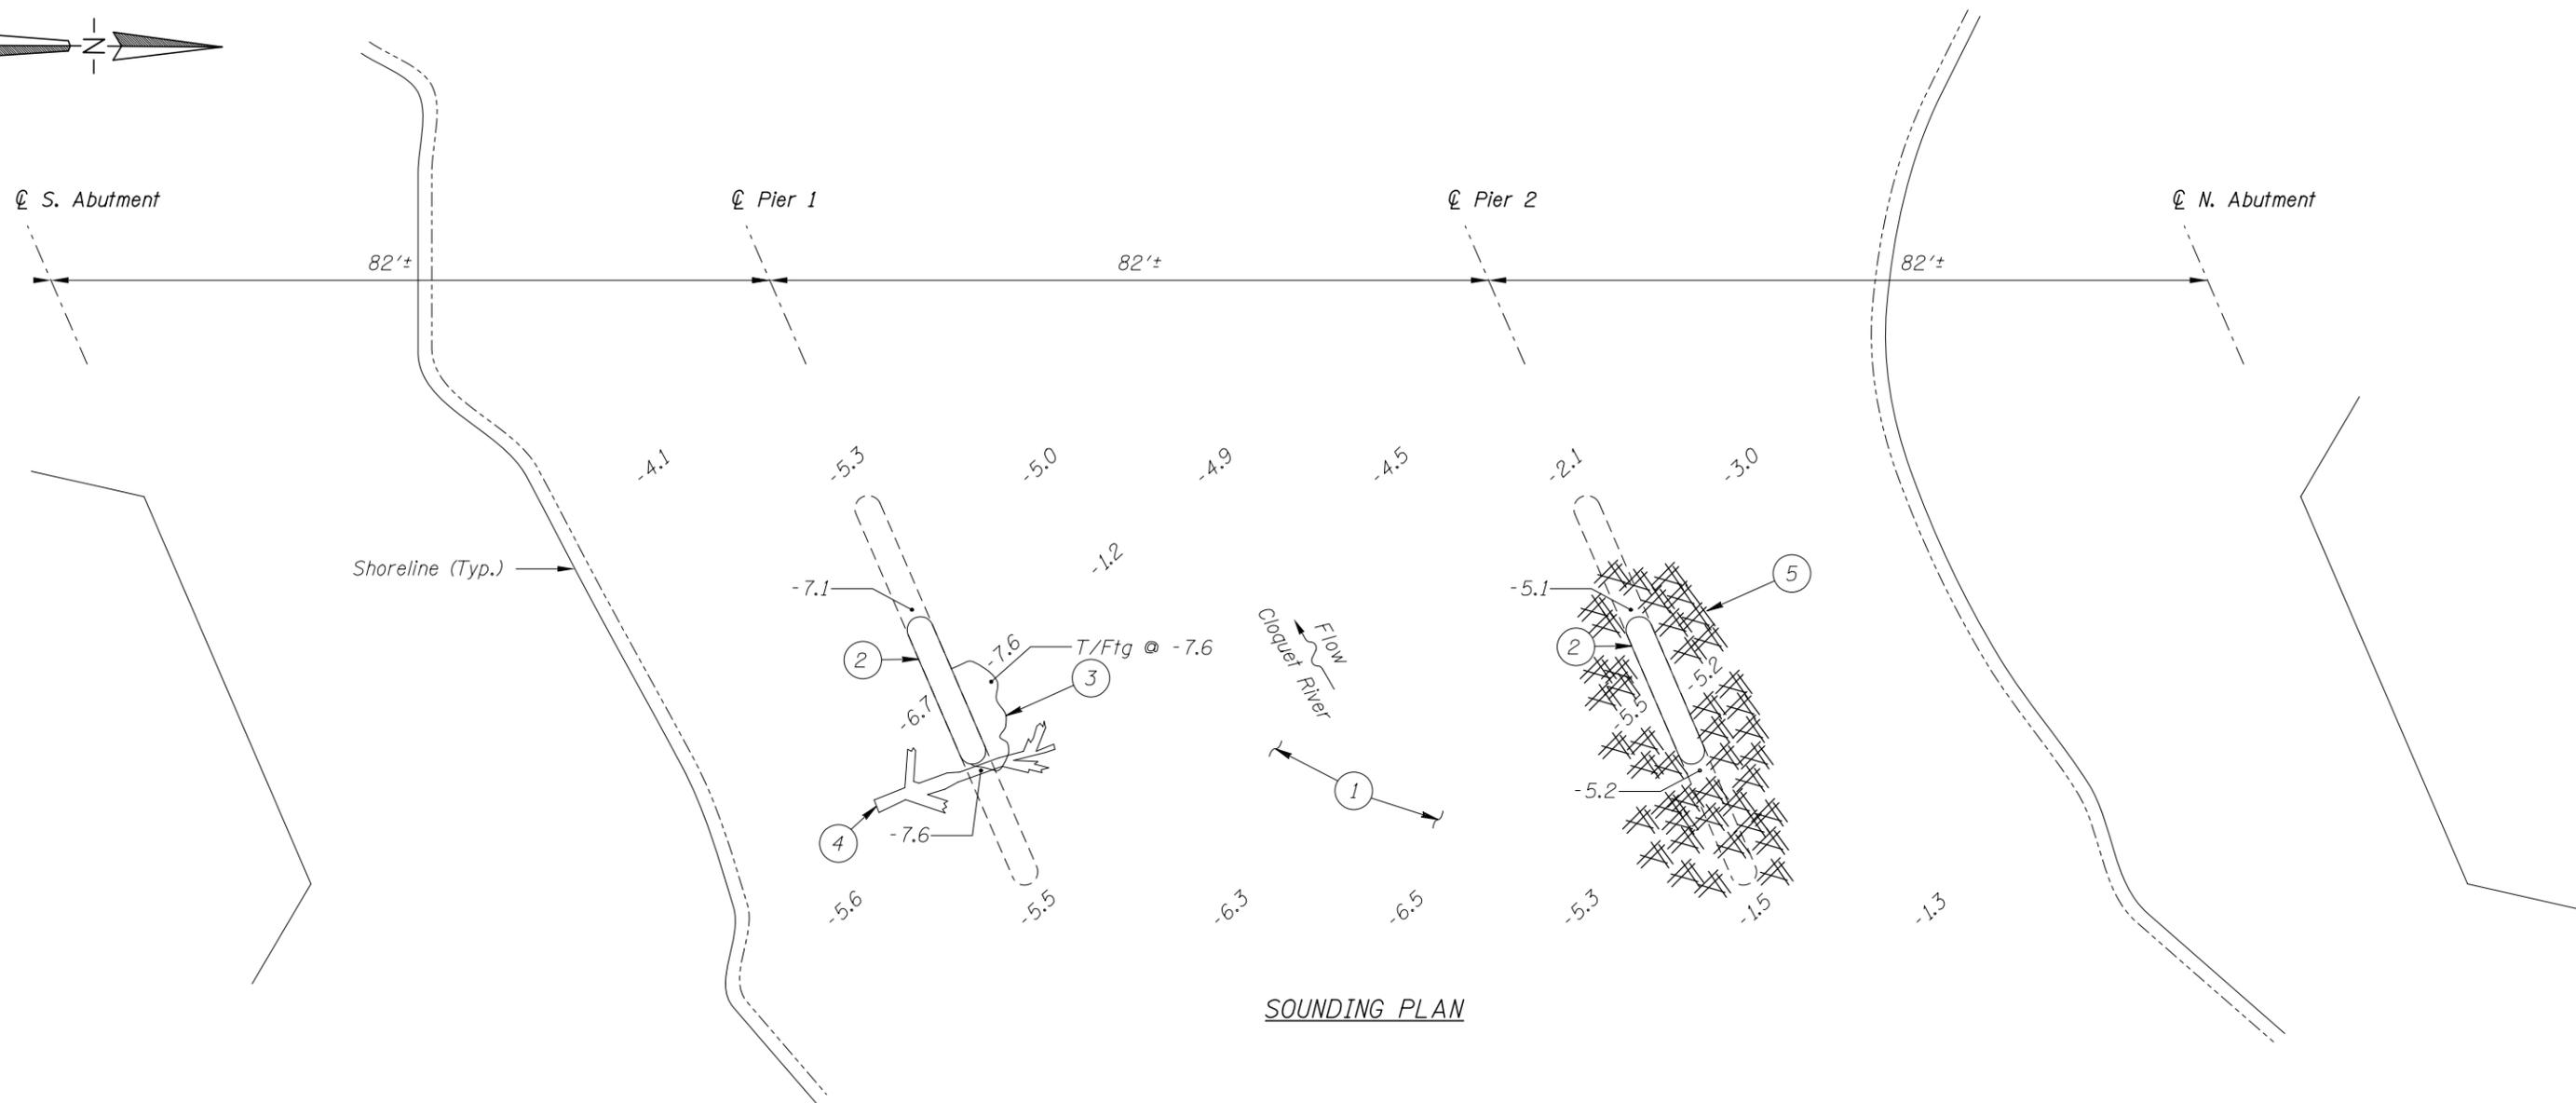
**SOUNDING PLAN**

- ① The channel bottom material consisted of stones and cobbles up to 1 foot in diameter and sand allowing a maximum probe rod penetration of 2 inches.

- ② The concrete of the shafts of Piers 1 and 2 exhibited light scaling with up to 1/8 inch of penetration extending from the waterline to 2 feet above the waterline.

- ③ The top of the footing of Pier 1 was exposed from the north face midpoint to the upstream nose and extending up to 2 feet off the face of the pier. No vertical exposure or edge of footing was observed.

- ④ A 8 inch diameter tree was observed along the upstream nose of Pier 1 that extended 10 feet off the north and south faces and from the channel bottom to the waterline.

- ⑤ A heavy accumulation of timber debris consisting of 1 foot diameter and smaller trees and branches was observed around Pier 2 extending from the channel bottom to 2 feet above the waterline, 10 feet off the north and south faces, and 15 feet upstream of the upstream nose.
