# UNDERWATER BRIDGE INSPECTION REPORT

STRUCTURE NO. 69530

LITTLE FORK RIVER

MINNESOTA DEPARTMENT OF TRANSPORTATION  
UNDERWATER BRIDGE INSPECTION

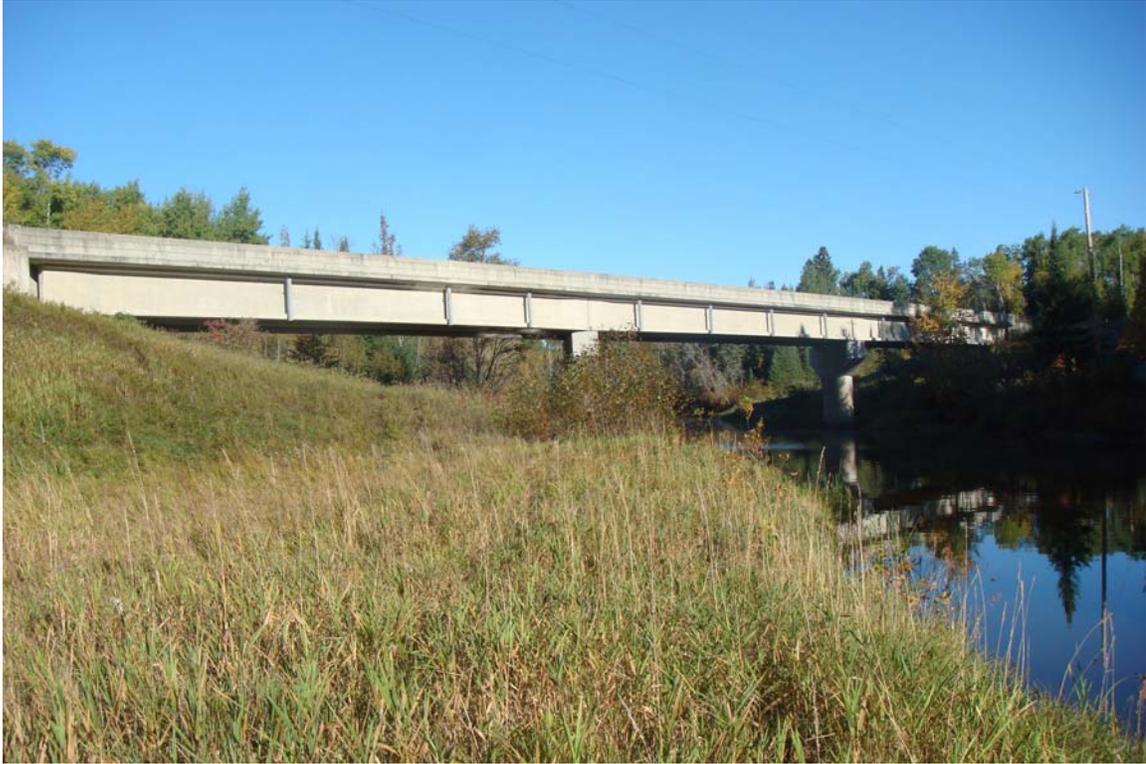
The substructure units inspected at Bridge No. 69530, Piers 1 and 2, were found to be in good condition with no defects of structural significance observed. No footing exposure was detected; however, the footings along the south side of Pier 2 and along the north side of Pier 1 were located below approximately 2.2 feet of soft silt. The channel bottom around the substructure units appeared well established and stable with no evidence of significant scour and no appreciable changes since the previous inspection.

Photograph 1. Overall View of the Structure, Looking Northwest.

- (A) Reinspect the submerged substructure units at the normal maximum recommended (NBIS) interval of sixty (60) months.

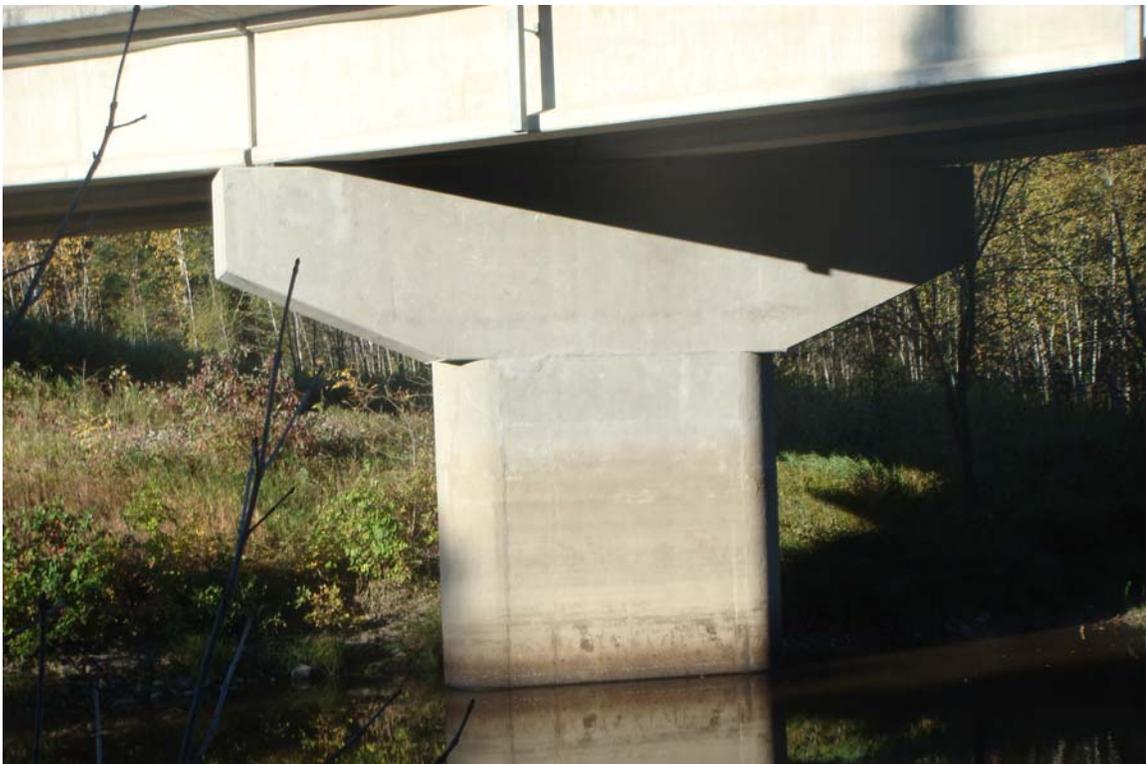
- (B) Scaling at Piers 1 and 2 was observed 1.5 feet above the waterline to 1 foot below the waterline with 1/4 inch maximum penetration along the entire perimeter. Apart from the localized scaling, the concrete of both piers was smooth and sound with only random areas of poor concrete consolidation exhibiting a maximum penetration of 1/2 inch.

Photograph 2. View of Pier 1, Looking Southwest.

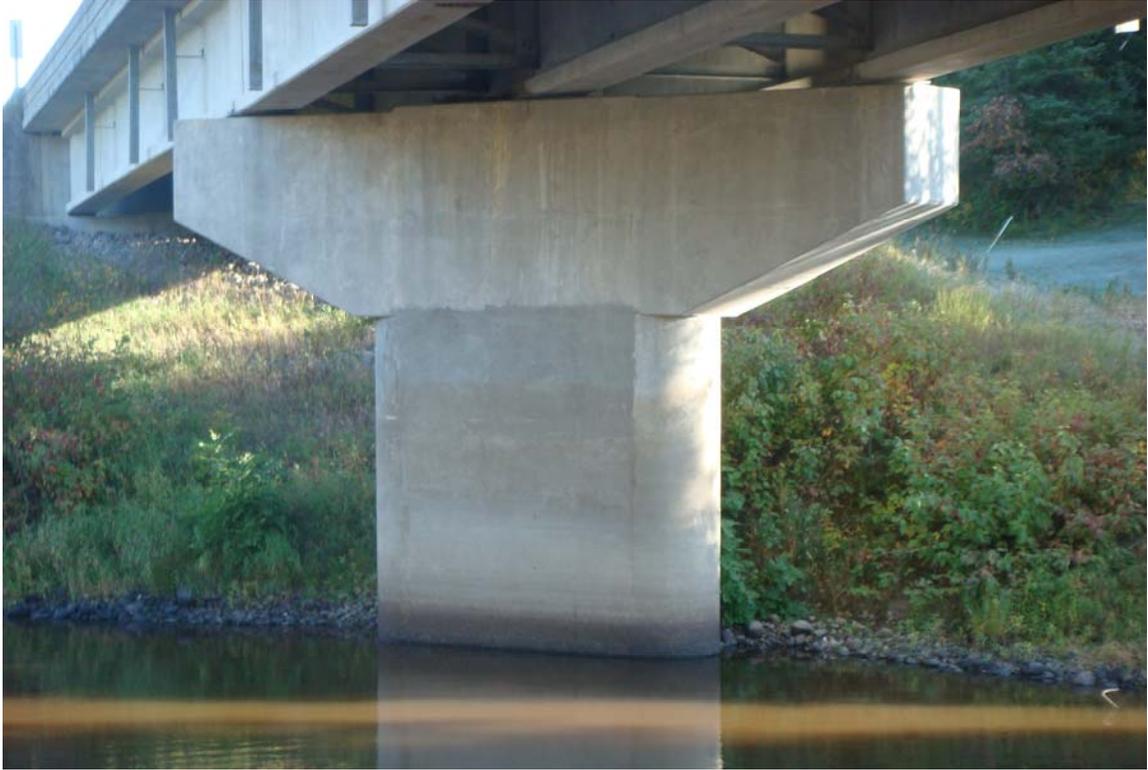
- (A) The footings along the south side of Pier 2 and along the north side of Pier 1 were located (could be encountered) below 2.2 feet of soft silt.

Photograph 3. View of Pier 2, Looking Northeast.

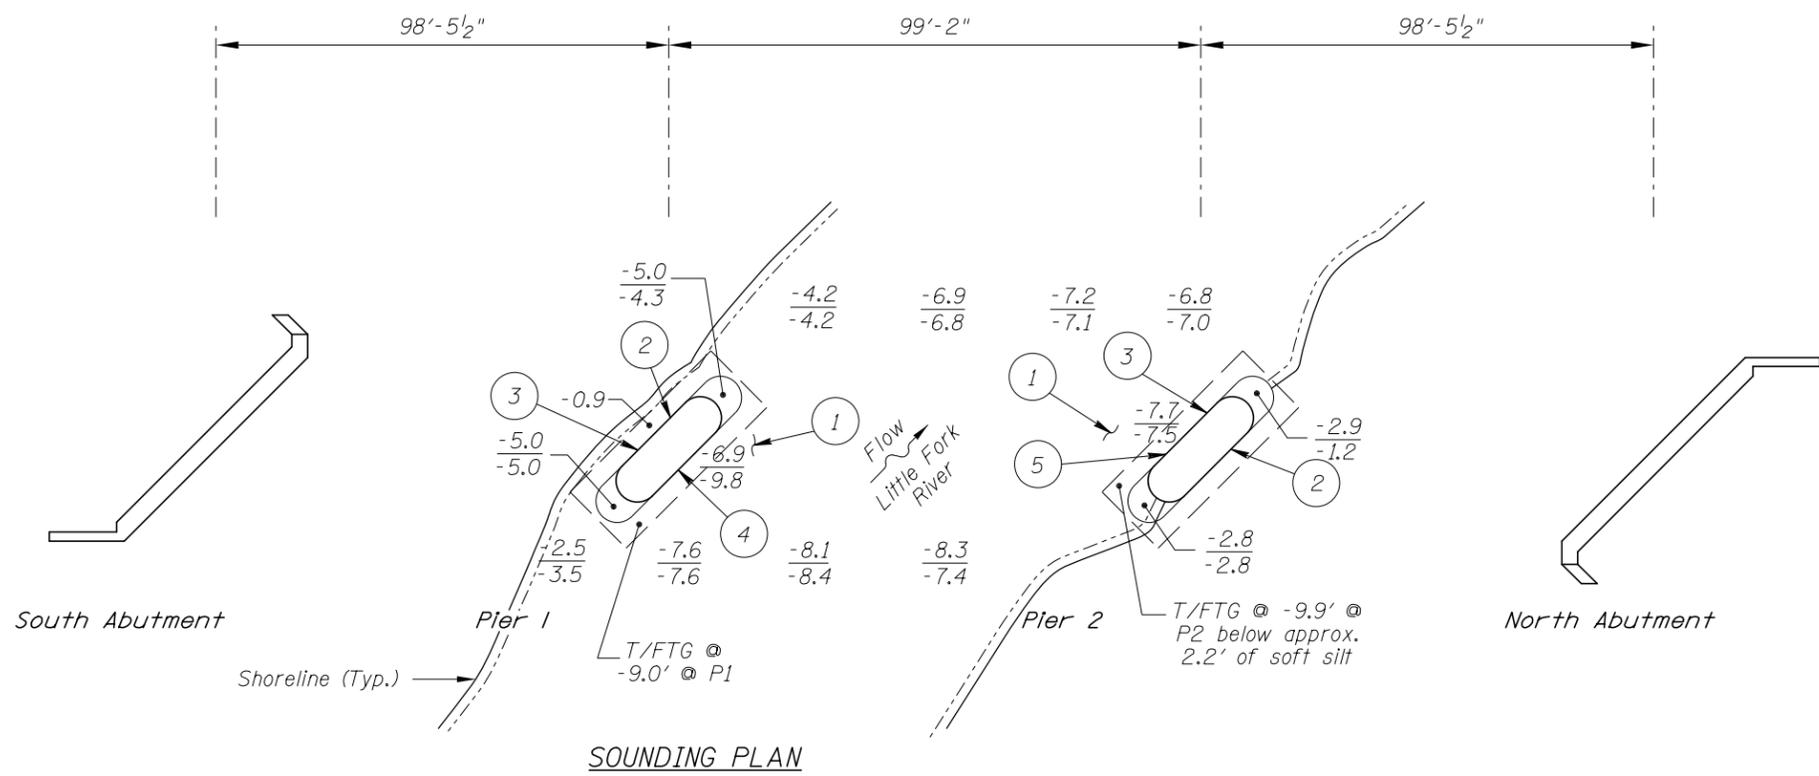
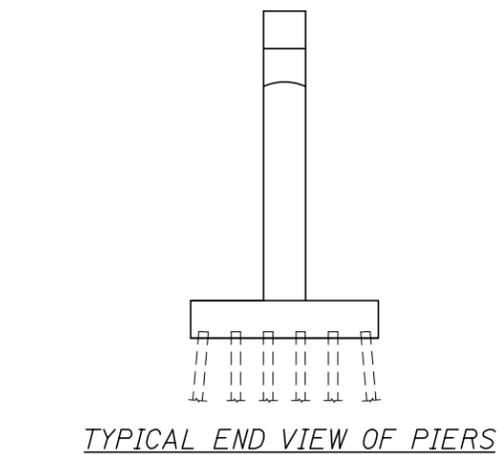
**SOUNDING PLAN**

- ① The channel bottom material consisted of soft silt and scattered rocks and cobbles with probe rod penetrations up to 2 feet at Pier 2 and up to 2.0 feet at Pier 1.
- ② Scaling was observed 1.5 feet above the waterline to 1 foot below the waterline, with 1/4 inch maximum penetration along the entire perimeter of Piers 1 and 2.
- ③ The concrete at both piers was smooth and sound with random areas of poor consolidation with 1/2 inch of penetration above and below band of scaling.
- ④ The top of the footing along the north face of Pier 1 was located with a probe rod below 2.1 feet of soft silt.
- ⑤ The top of the footing along the south face of Pier 2 was located with a probe rod below 2.2 foot of soft silt.
