UNDERWATER BRIDGE INSPECTION REPORT

STRUCTURE NO. 69533

WHITEFACE RIVER

MINNESOTA DEPARTMENT OF TRANSPORTATION
UNDERWATER BRIDGE INSPECTION

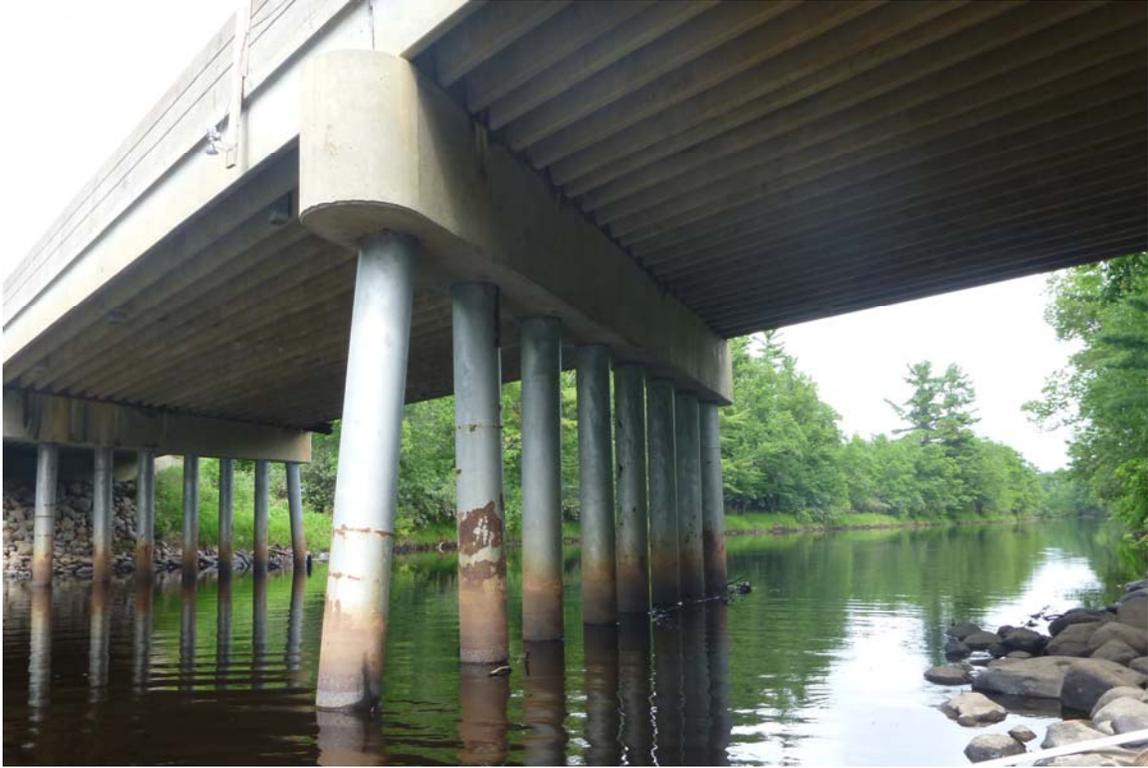
- (A) A light accumulation of timber debris consisting of branches of 3 inches in diameter and less was found around the perimeter of Pier 1, extending up to 5 feet off all faces.

Photograph 1. View of Pier 1, Looking East.

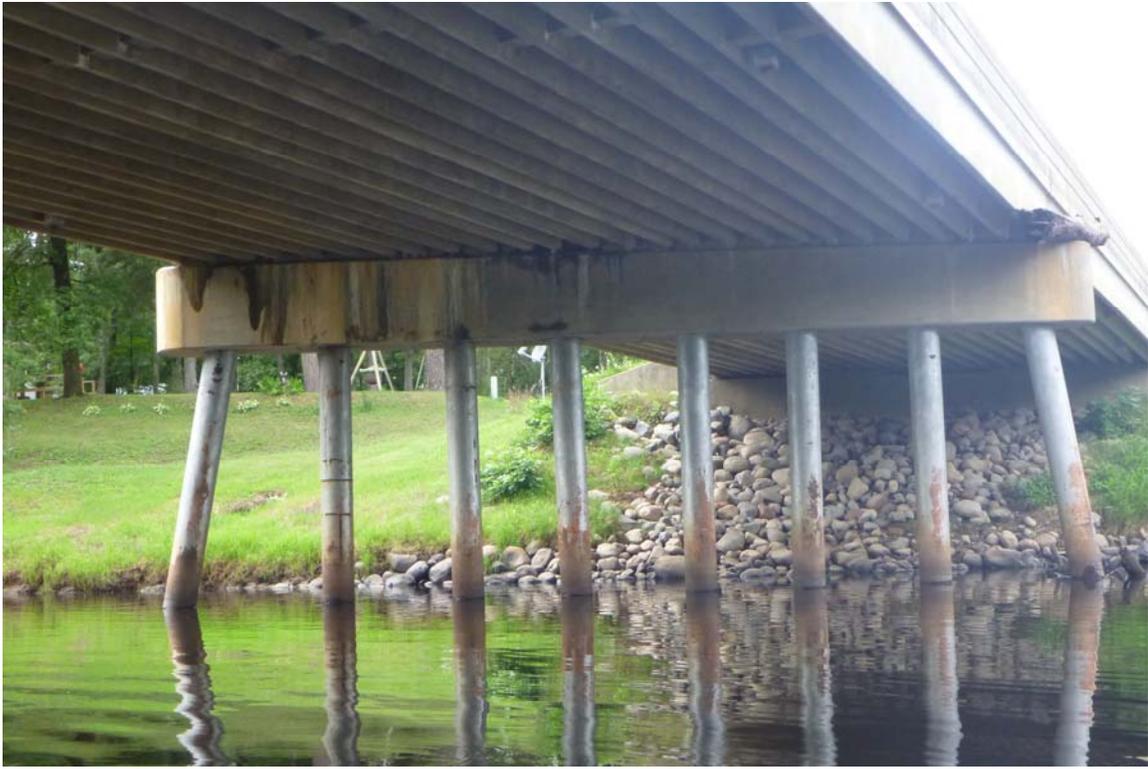
- (B) A moderate accumulation of timber debris consisting of logs and branches 12 inches in diameter and less was observed at the upstream nose of Pier 2, extending from the channel bottom to 2 feet above the waterline.

Photograph 2. View of Pier 2, Looking North.

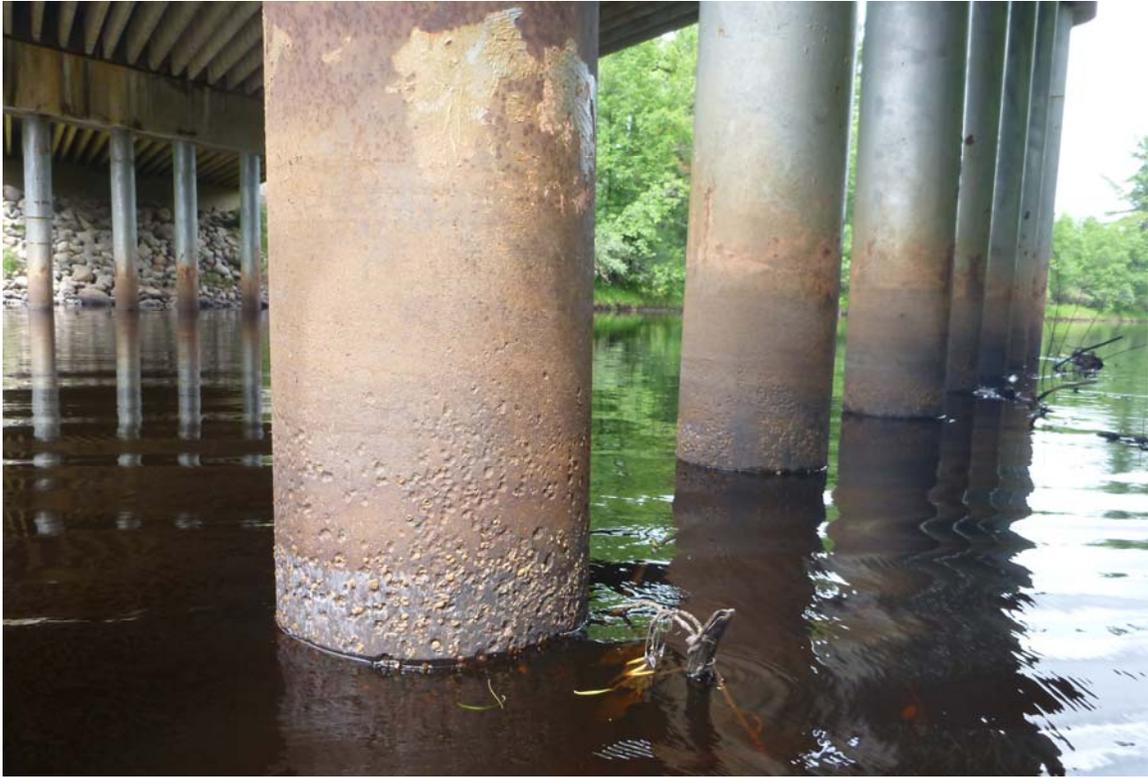
- (C) The channel bottom material consisted of silty sand allowing 6 inches of probe rod penetration.
- (D) The steel piles exhibited a band of surface pitting of 1/4 inch diameter and 1/8 inch penetration from 1 foot above to 2 feet below the waterline.

Photograph 3. View of typical Steel Pitting at Pier 1, Looking Southeast.

- (A) Monitor the extent of surface corrosion during future underwater inspections.
- (B) Monitor the timber debris accumulation at the piers, during future inspections, and if found to be increasing to a more detrimental extent, removal operations may become warranted at that time.
- (C) Reinspect the submerged substructure units at the normal maximum recommended (NBIS) interval of sixty (60) months.

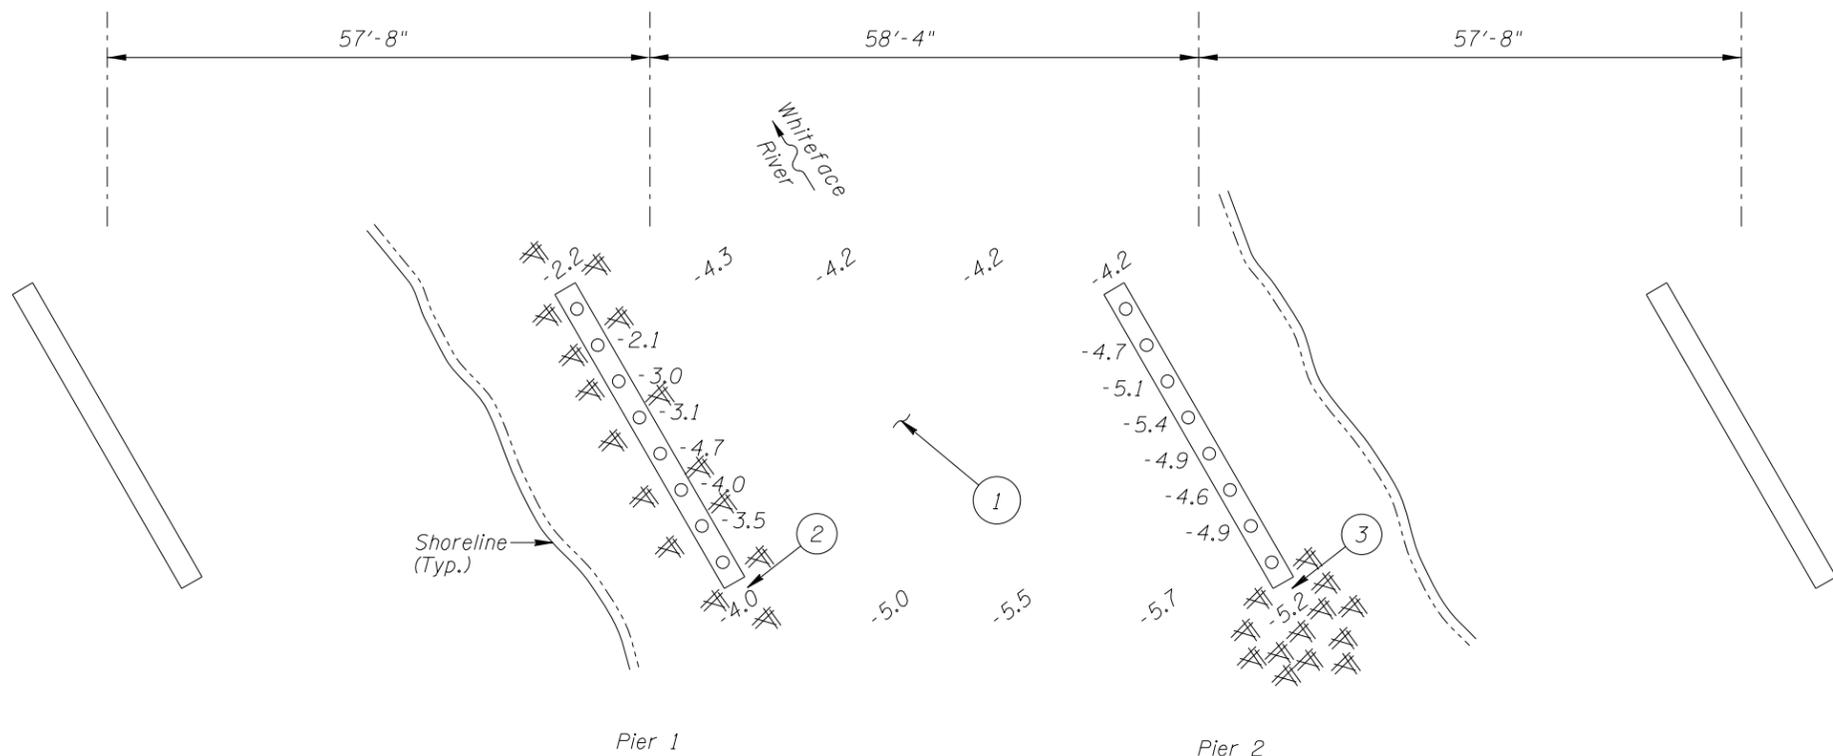
SOUNDING PLAN

- ① The channel bottom material consisted of sandy silt allowing up to 6 inches of probe rod penetration.
- ② A light accumulation of timber debris, consisting of branches 3" inch dia. and smaller, was observed around the perimeter of Pier 1 extending 5 feet off all faces and from the channel bottom to the waterline.
- ③ A moderate accumulation of timber debris, consisting of logs and branches 12" inch dia. and smaller, was observed around the upstream nose of Pier 2 extending from the channel bottom to 2 feet above the waterline.
- ④ The steel piles typically exhibited pitting 1/4 inch dia. with up to 1/8 inch penetration observed from 1 foot above to 2 feet below the waterline.
- ⑤ The steel piles from 1 foot above the waterline to the cap exhibited coating failure on approximately 25% of the surface area. Surface corrosion was present with no appreciable loss of section.
