UNDERWATER BRIDGE INSPECTION REPORT

STRUCTURE NO. 69534

CSAH 48

CLOQUET RIVER

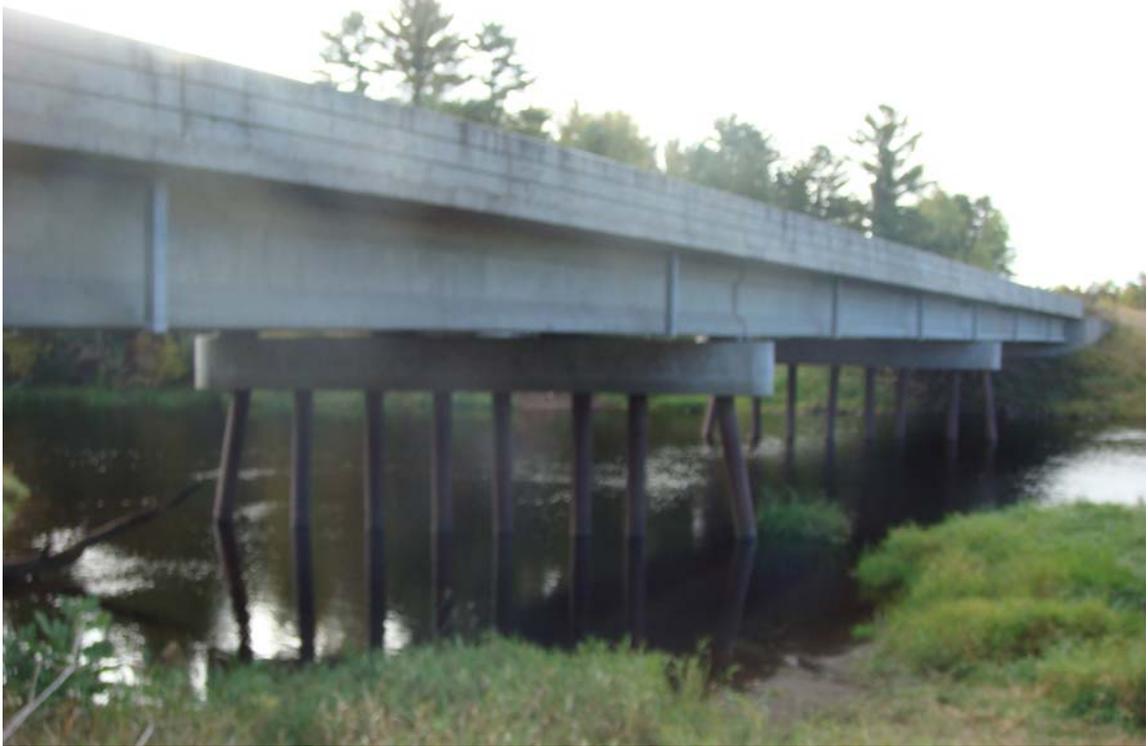
Photograph 1. Overall View of Structure, Looking Southeast

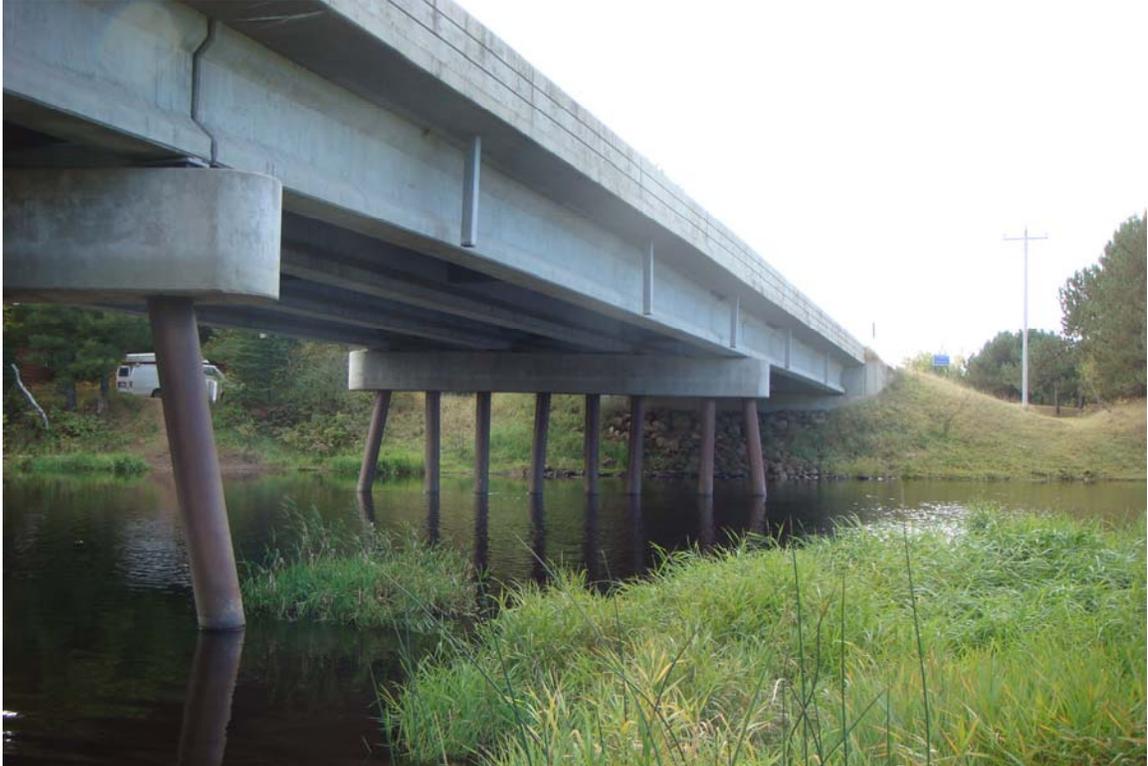
- (A) The channel bottom material around Bent 1 typically consisted of cobbles and gravel with a maximum probe rod penetration of 4 inches.
- (B) The channel bottom material around Bent 2 typically consisted of sand and gravel with a maximum probe rod penetration of 2 inches.
- (C) The steel piles of Bent 1 exhibited rust nodules, up to 1/2 inch diameter with up to 1/32 inch deep pitting, on approximately 30 percent of the pile surface area extending from the channel bottom to 1 foot below the waterline.
- (D) The steel piles of Bent 2 were in good condition with no appreciable coating loss or corrosion.

Photograph 2. View of the Bent 1, Looking Southeast.

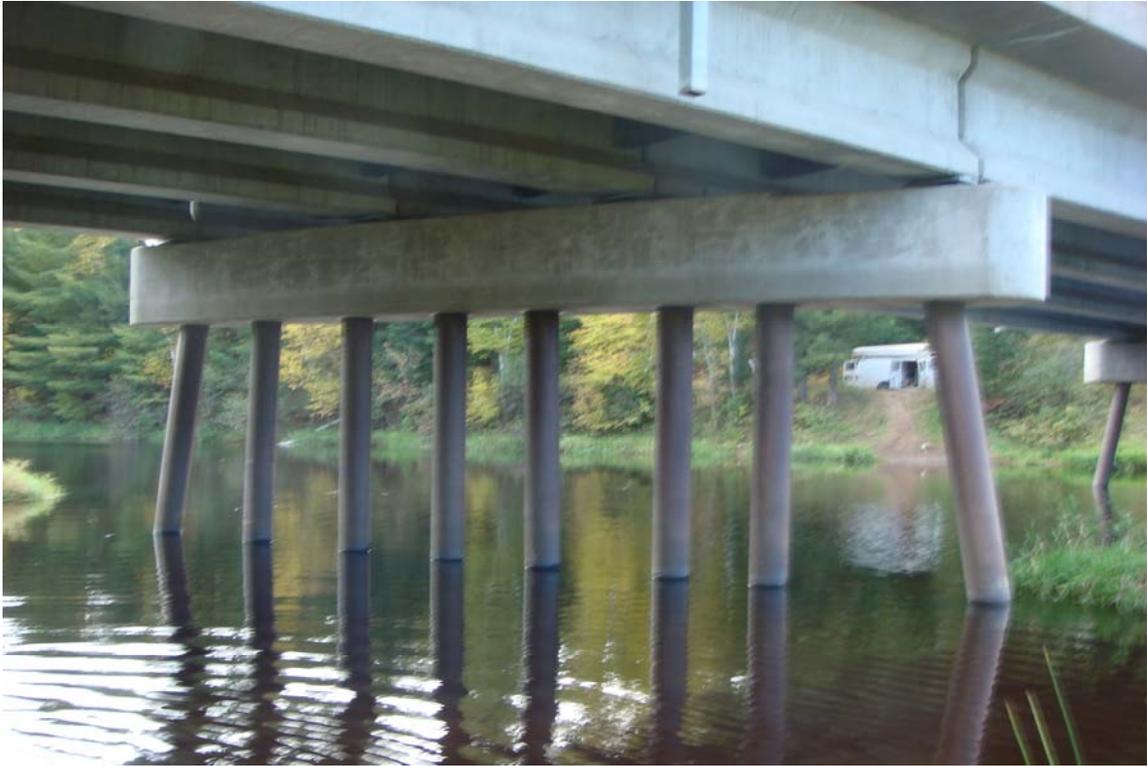
Photograph 3. View of Bent 2, Looking Southeast.

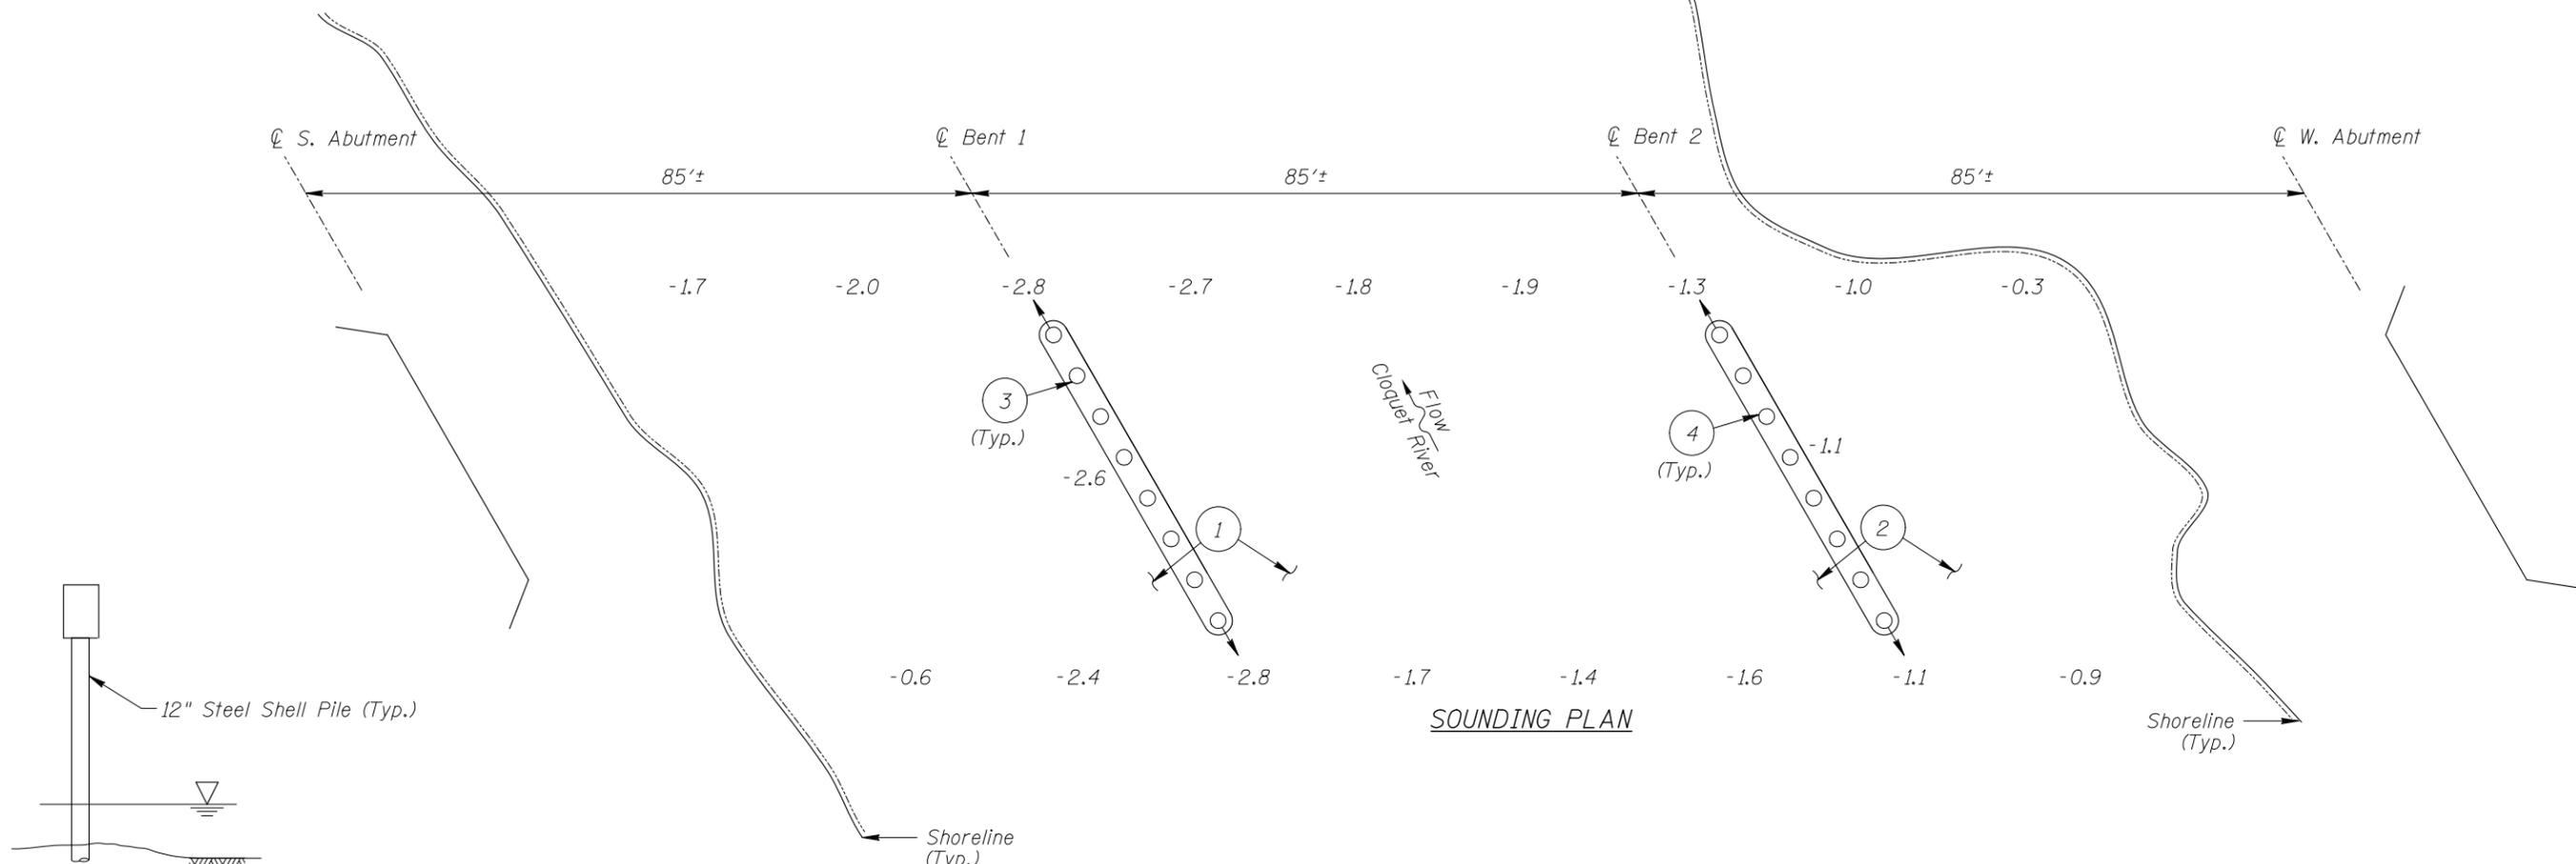
TYPICAL END VIEW OF BENT

- 1 The channel bottom material around Bent 1 typically consisted of cobbles and gravel with a maximum probe rod penetration of 4 inches.
- 2 The channel bottom material around Bent 2 typically consisted of sand and gravel with a maximum probe rod penetration of 2 inches.
- 3 The steel piles of Bent 1 exhibited rust nodules, up to 1/2 inch diameter with up to 1/32 inch deep pitting, on approximately 30 percent of the pile surface area extending from the channel bottom to 1 foot below the waterline.
- 4 The steel piles of Bent 2 were in good condition with no appreciable coating loss or corrosion.
