UNDERWATER BRIDGE INSPECTION REPORT

STRUCTURE NO. 69539
CR NO. 156
OVER THE
ST. LOUIS RIVER
DISTRICT 1 - ST. LOUIS COUNTY

JULY 25, 2012

MINNESOTA DEPARTMENT OF TRANSPORTATION
UNDERWATER BRIDGE INSPECTION

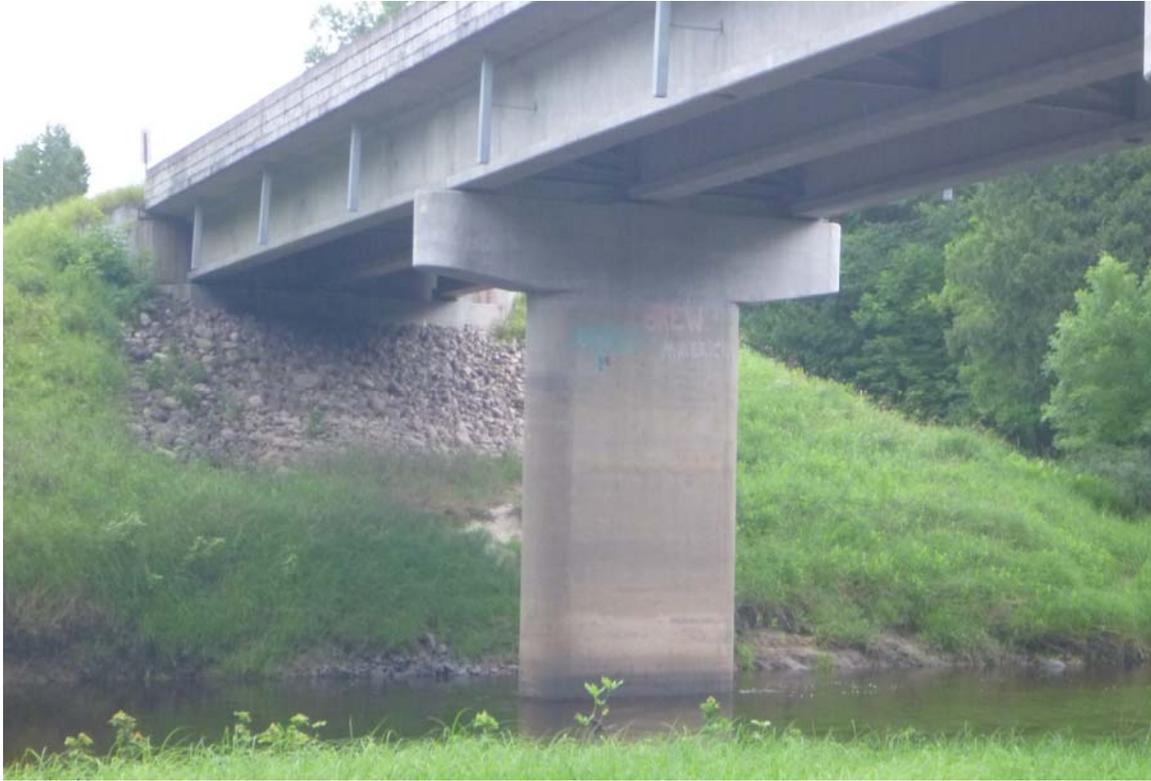
Photograph 3. View of Pier 3, Looking East.

The substructure unit inspected at Bridge No. 69539, Pier 3, was found to be in good condition with light concrete scaling present near the waterline. The channel bottom appeared to be stable with no evidence of significant scour. The substructure condition and channel bottom profile were comparable to the finding of the pervious underwater inspection.

- (A) Light scaling was observed from 1 foot below to 2 feet above the waterline with typical penetrations of 1/8 inch and a maximum penetration of 1/4 inch.

- (A) Reinspect the submerged substructure units at the normal maximum recommended (NBIS) interval of sixty (60) months.

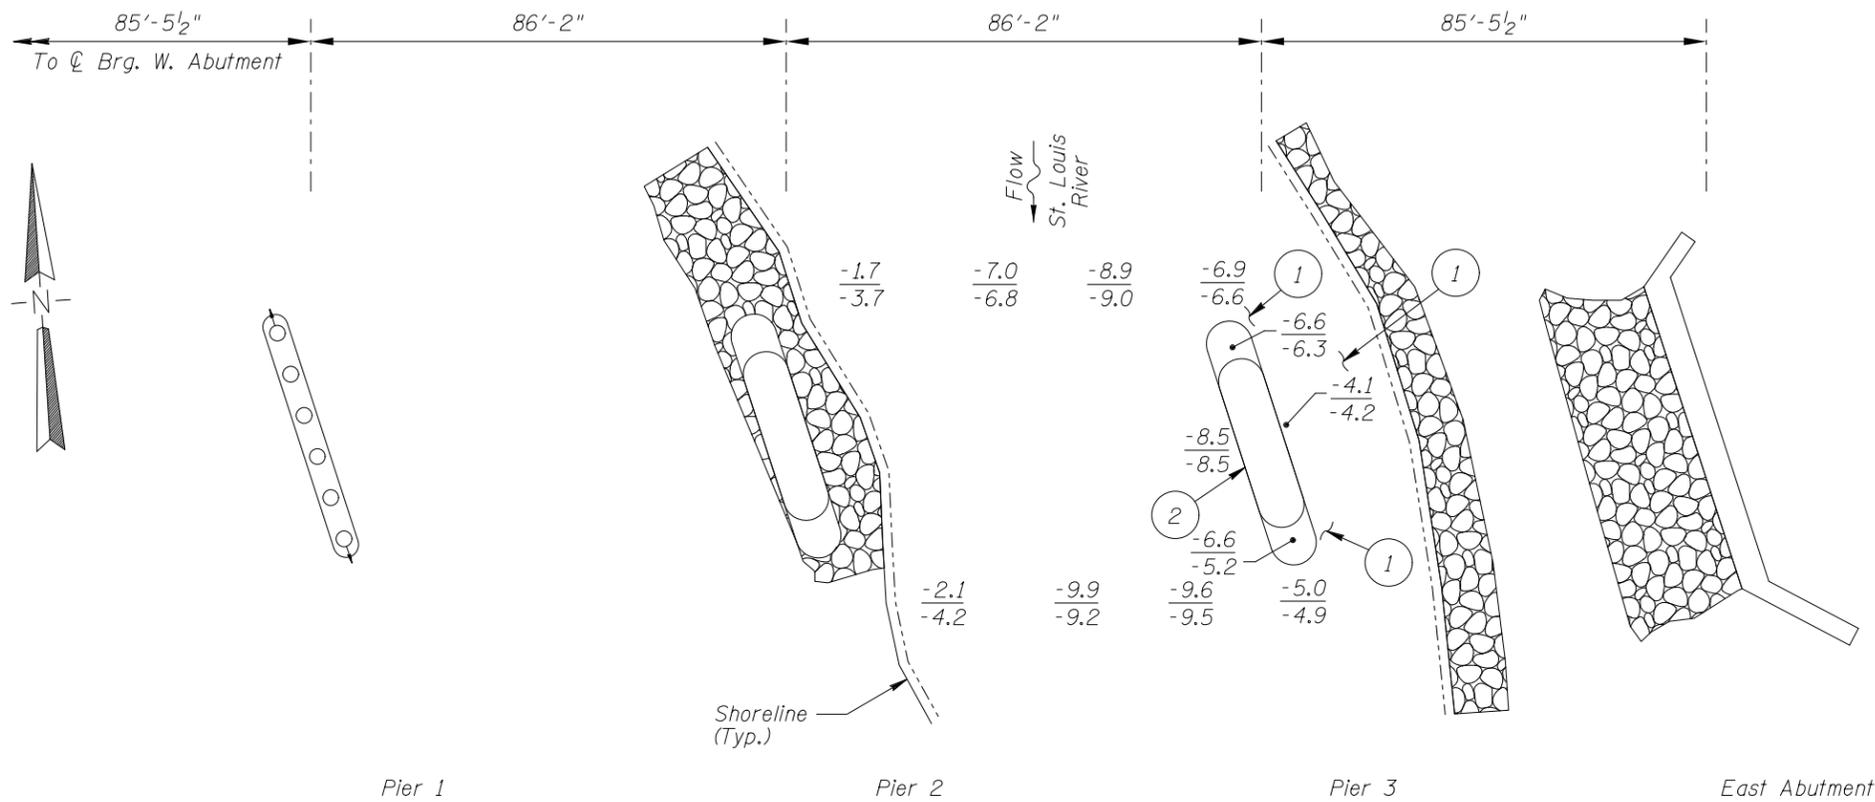
INSPECTION AND SOUNDING PLAN

- 1 The channel bottom consisted of 1-foot-diameter riprap with no probe rod penetration around Pier 3.
- 2 Light scaling was observed from 1 foot below the waterline to 2 feet above the waterline with typical penetrations of 1/8 inch and up to 1/4 inch maximum penetrations.
