UNDERWATER BRIDGE INSPECTION REPORT

STRUCTURE NO. 69541

ST LOUIS RIVER

JOB NO. 2107

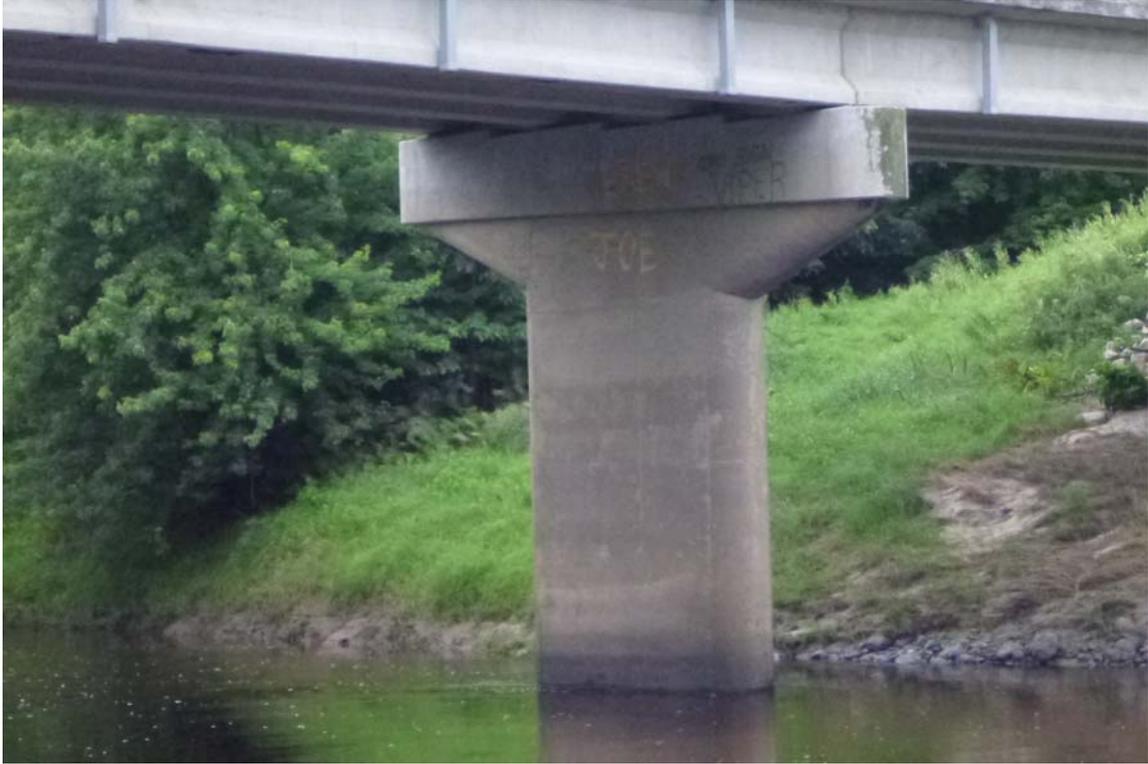
The substructure units inspected below water at Bridge No. 69541, Piers 1 and 2, were in good condition with no defects of structural significance. Light scaling was observed from 2 feet above the water line to the channel bottom, with a maximum of 1/8 inch penetration. The channel bottom appeared stable and well established.

Photograph 1. View of Pier 1, Looking Southwest.

- (A) Reinspect the submerged substructure units at the normal maximum recommended (NBIS) interval of sixty (60) months.

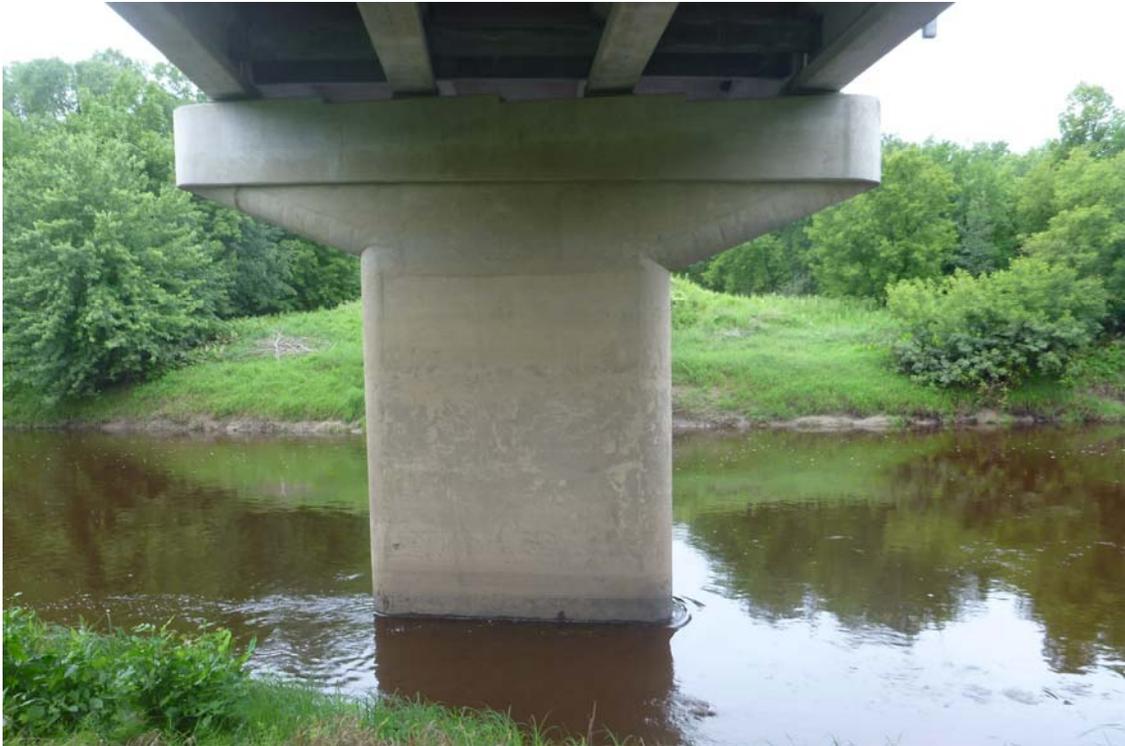
Photograph 2. View of Pier 2, Looking West.

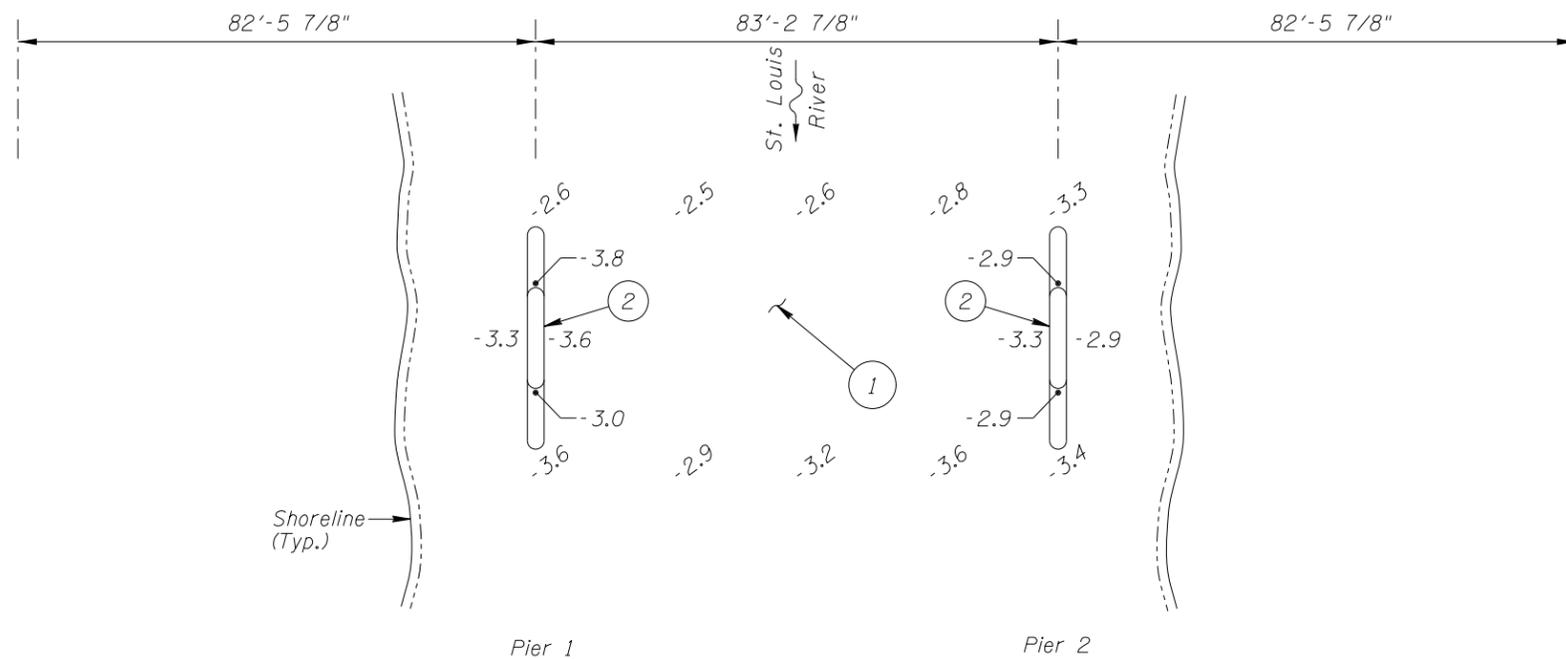
Date: JULY 2012
 Scale: NTS
 Figure No.: 1

- (1) The channel bottom material consisted of sand and gravel with random pieces of riprap 6 to 8 inch and smaller, allowing up to 3 inches of probe rod penetration.
- (2) Light concrete scaling, with up to 1/8 inch penetration was observed from 2 feet above waterline to channel bottom.
