UNDERWATER BRIDGE INSPECTION REPORT

STRUCTURE NO. 69559

CR 927

WEST SWAN RIVER

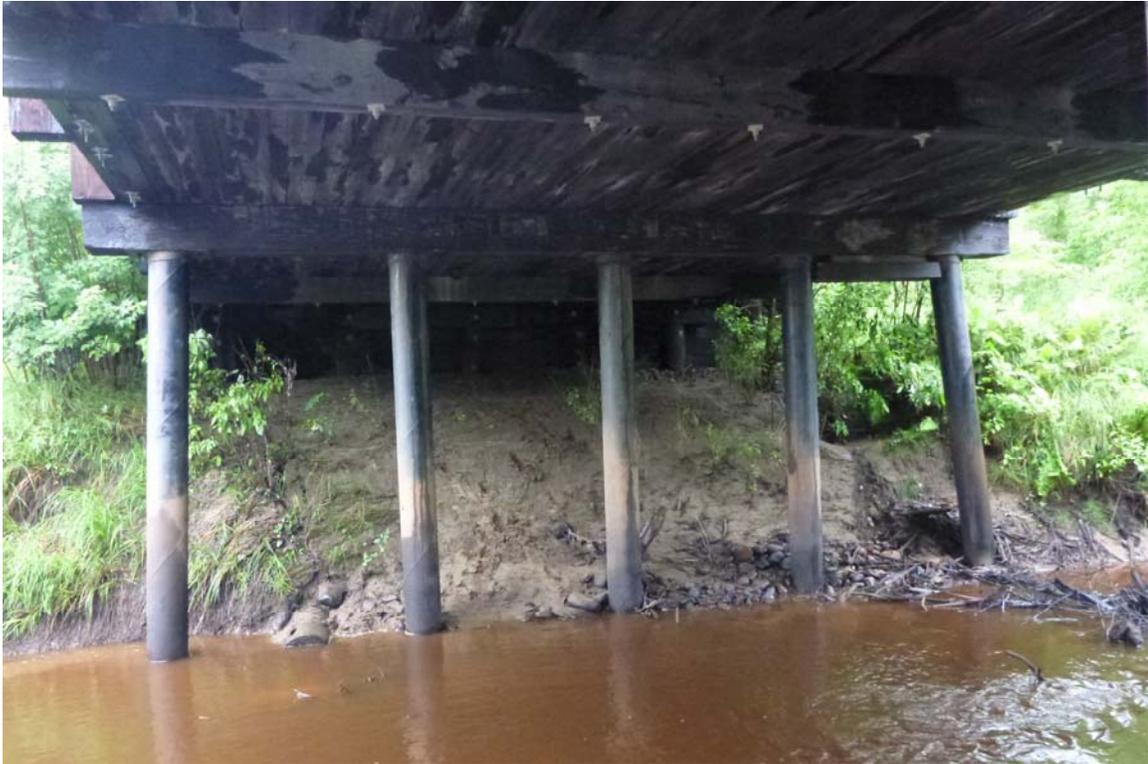
- (A) The steel pipe piles were in good condition with no measurable corrosion or section noted.

Photograph 1. View of Pier 1, Looking West.

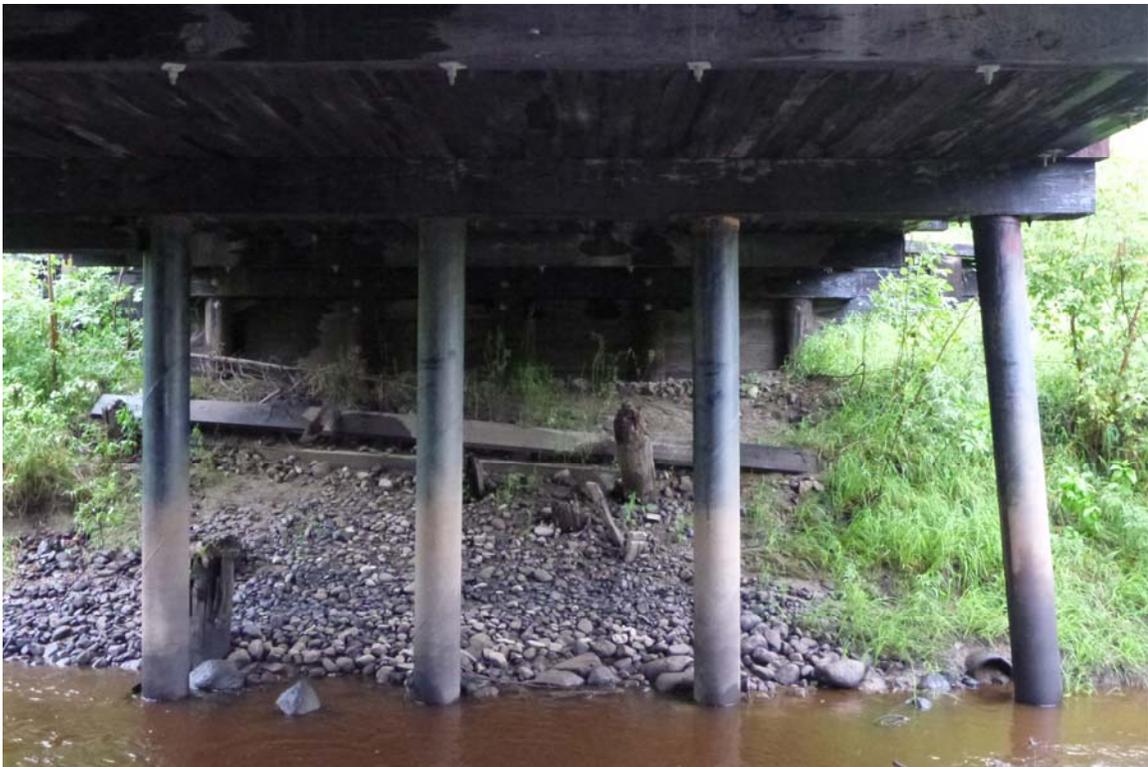
Photograph 2. View of Pier 2, Looking East.

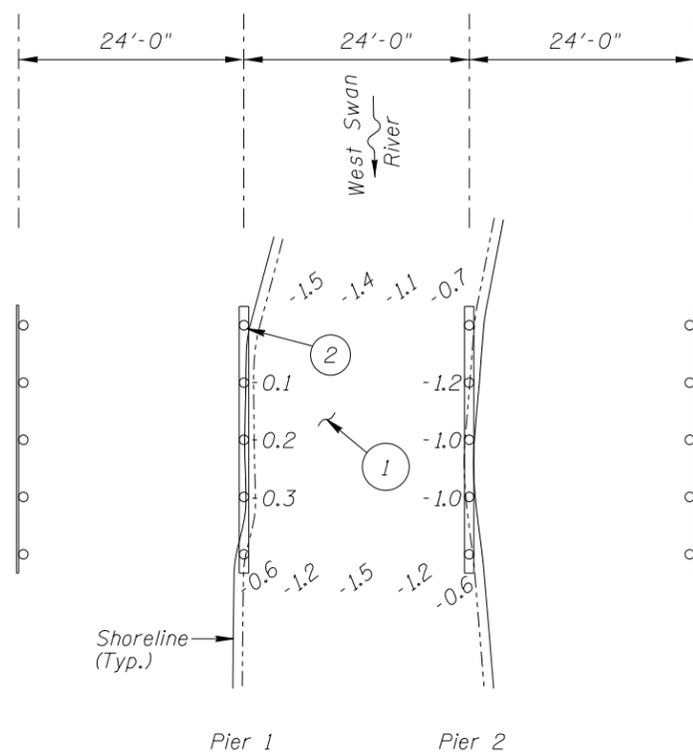
SOUNDING PLAN

- ① The channel bottom material consisted of silty clay allowing up to 2 feet of probe rod penetration.
- ② Steel pipe piles were in good condition with no notable corrosion or section loss noted.
