UNDERWATER BRIDGE INSPECTION REPORT

STRUCTURE NO. 69580

ST. LOUIS RIVER

MINNESOTA DEPARTMENT OF TRANSPORTATION
UNDERWATER BRIDGE INSPECTION

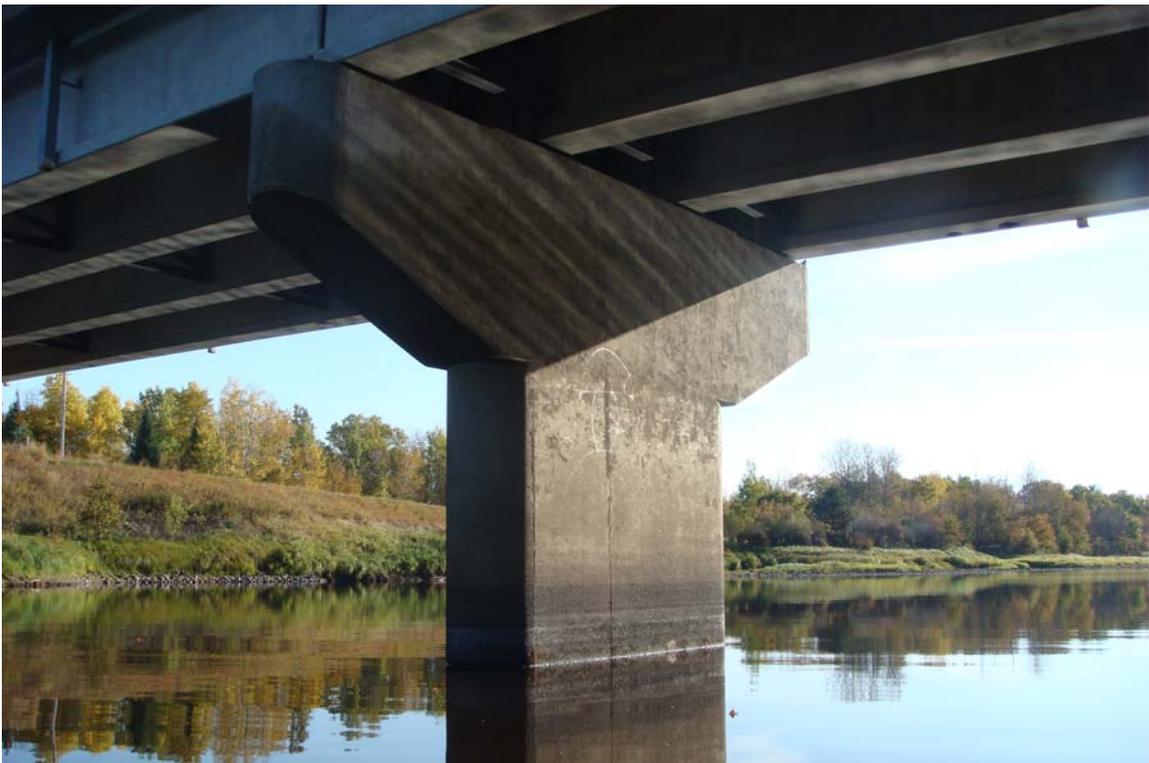
Photograph 2. View of Pier 1, Looking Northeast.

- (A) The concrete at both piers exhibited light scaling with 1/8 inch typical penetration and 1/4 inch maximum in a band around the pier extending from 1 foot below to 4 feet above the waterline.

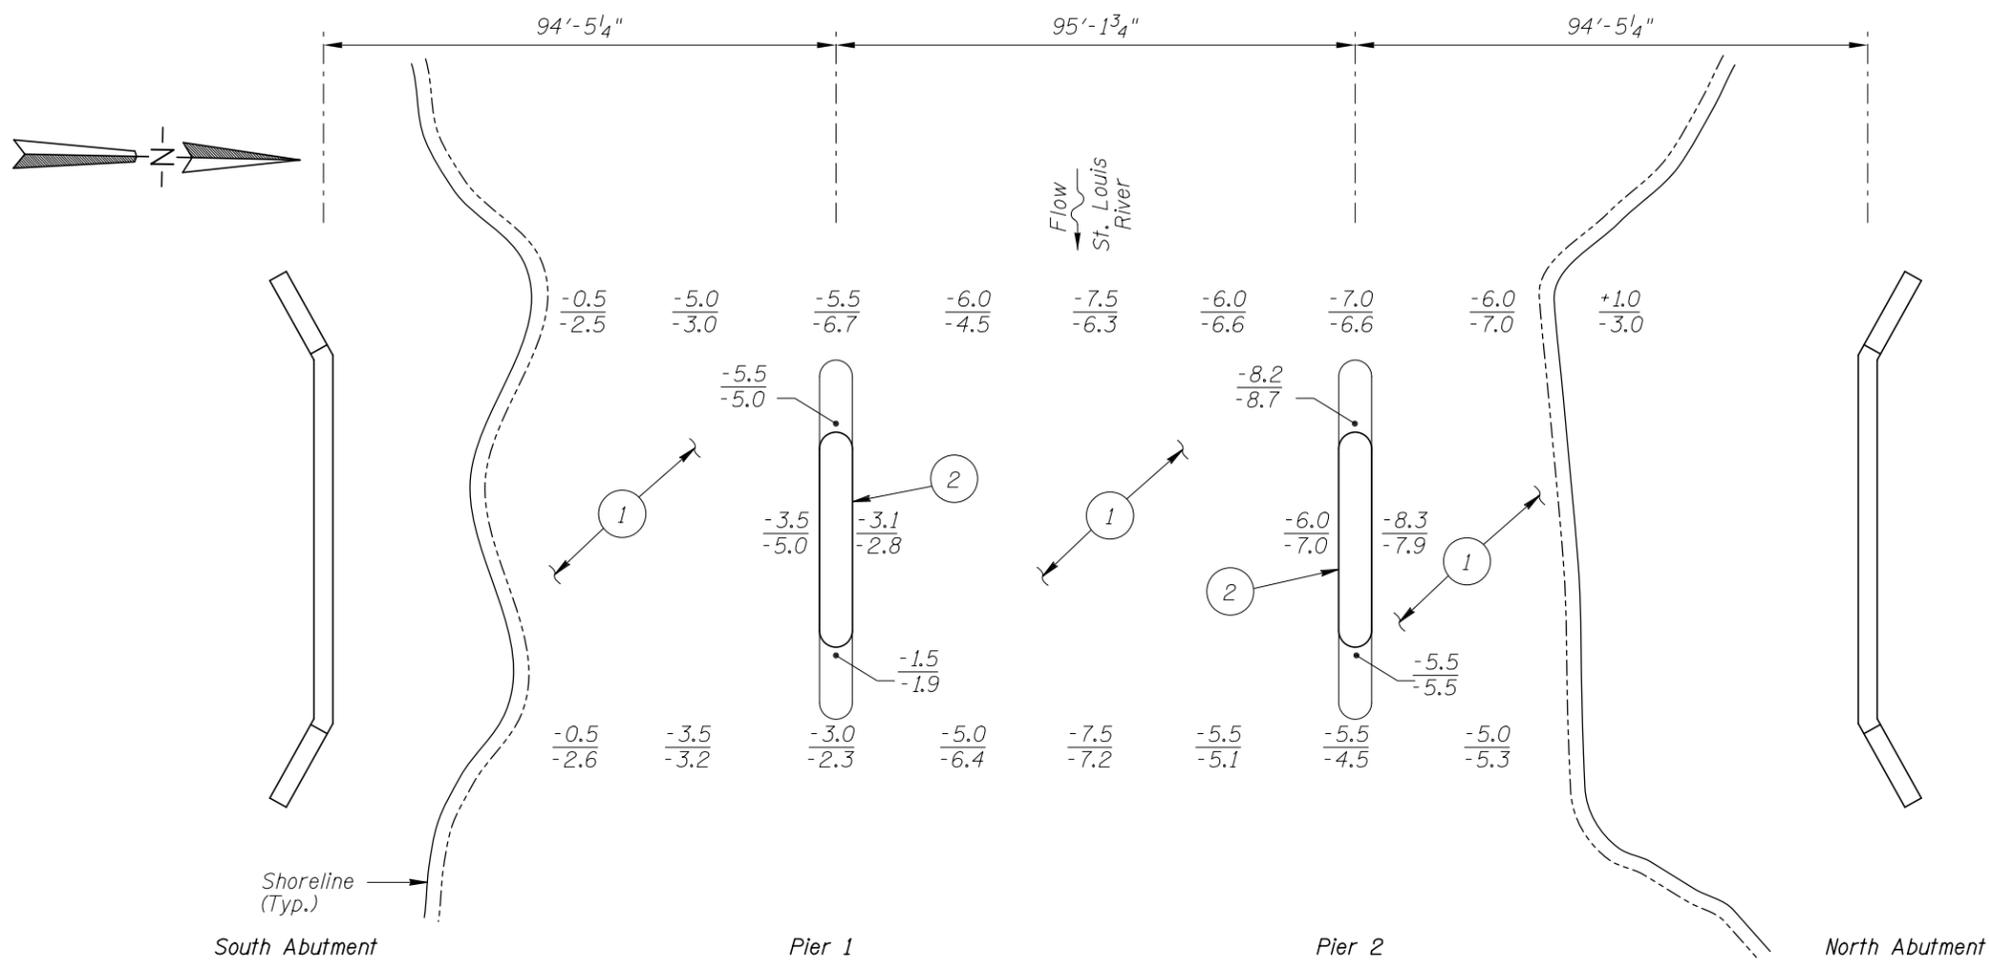
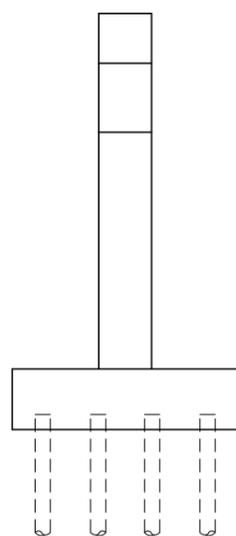
SOUNDING PLAN

- 1 The channel bottom material consisted of 1-foot-diameter and smaller riprap and cobbles with no probe rod penetration.
- 2 The concrete at both piers exhibited light scaling from 3 to 4 feet above the waterline to 1 foot below the waterline with a typical penetration of 1/8 inch and maximum penetration of 1/4 inch.
