UNDERWATER BRIDGE INSPECTION REPORT

STRUCTURE NO. 69594

CSAH 48

FISH LAKE

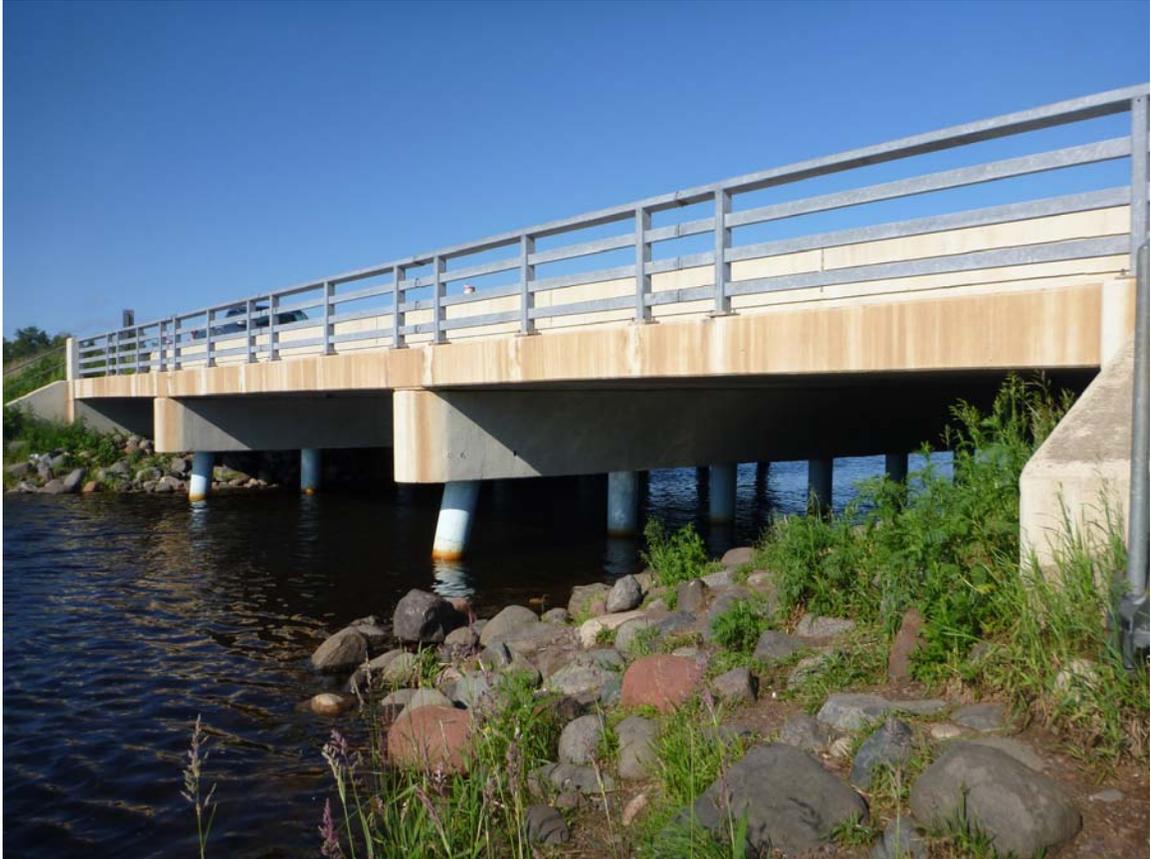
Photograph 1. View of West Fascia, Looking Northeast.

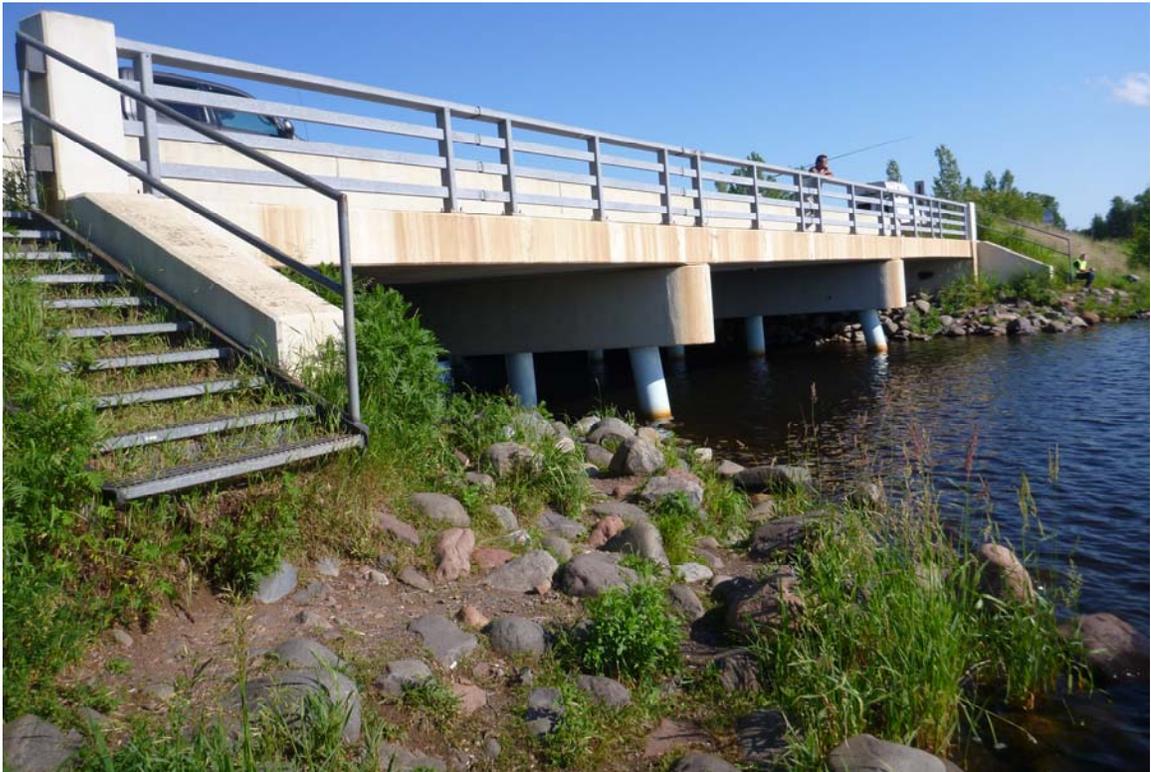
Photograph 2. View of East Fascia, Looking Northwest.

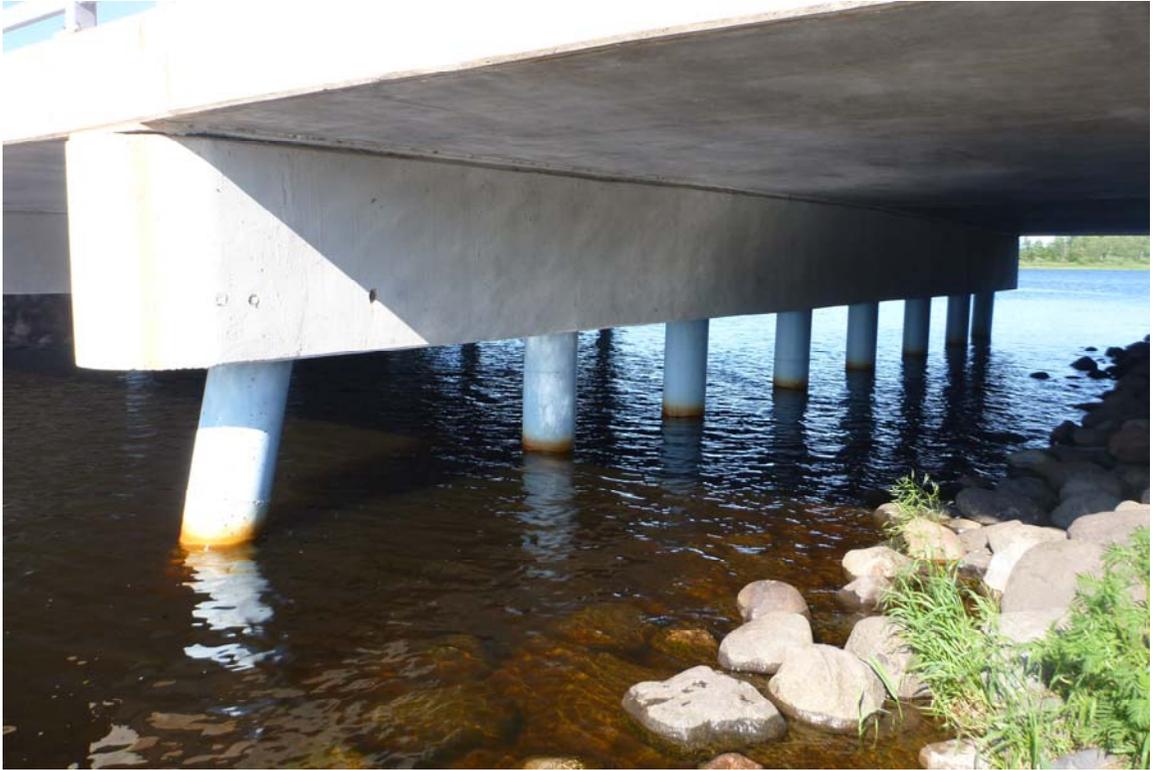
Photograph 3. View of Bent 1, Looking Northeast.

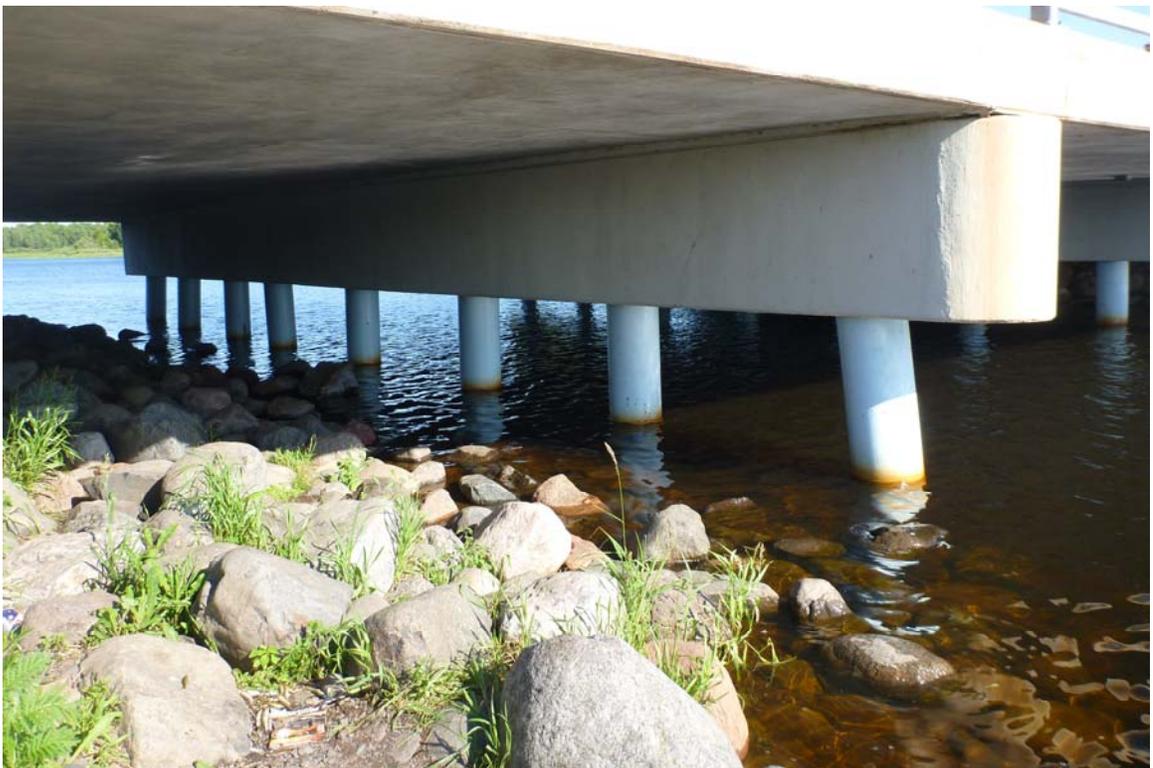
Photograph 4. View of Bent 2, Looking Southeast.

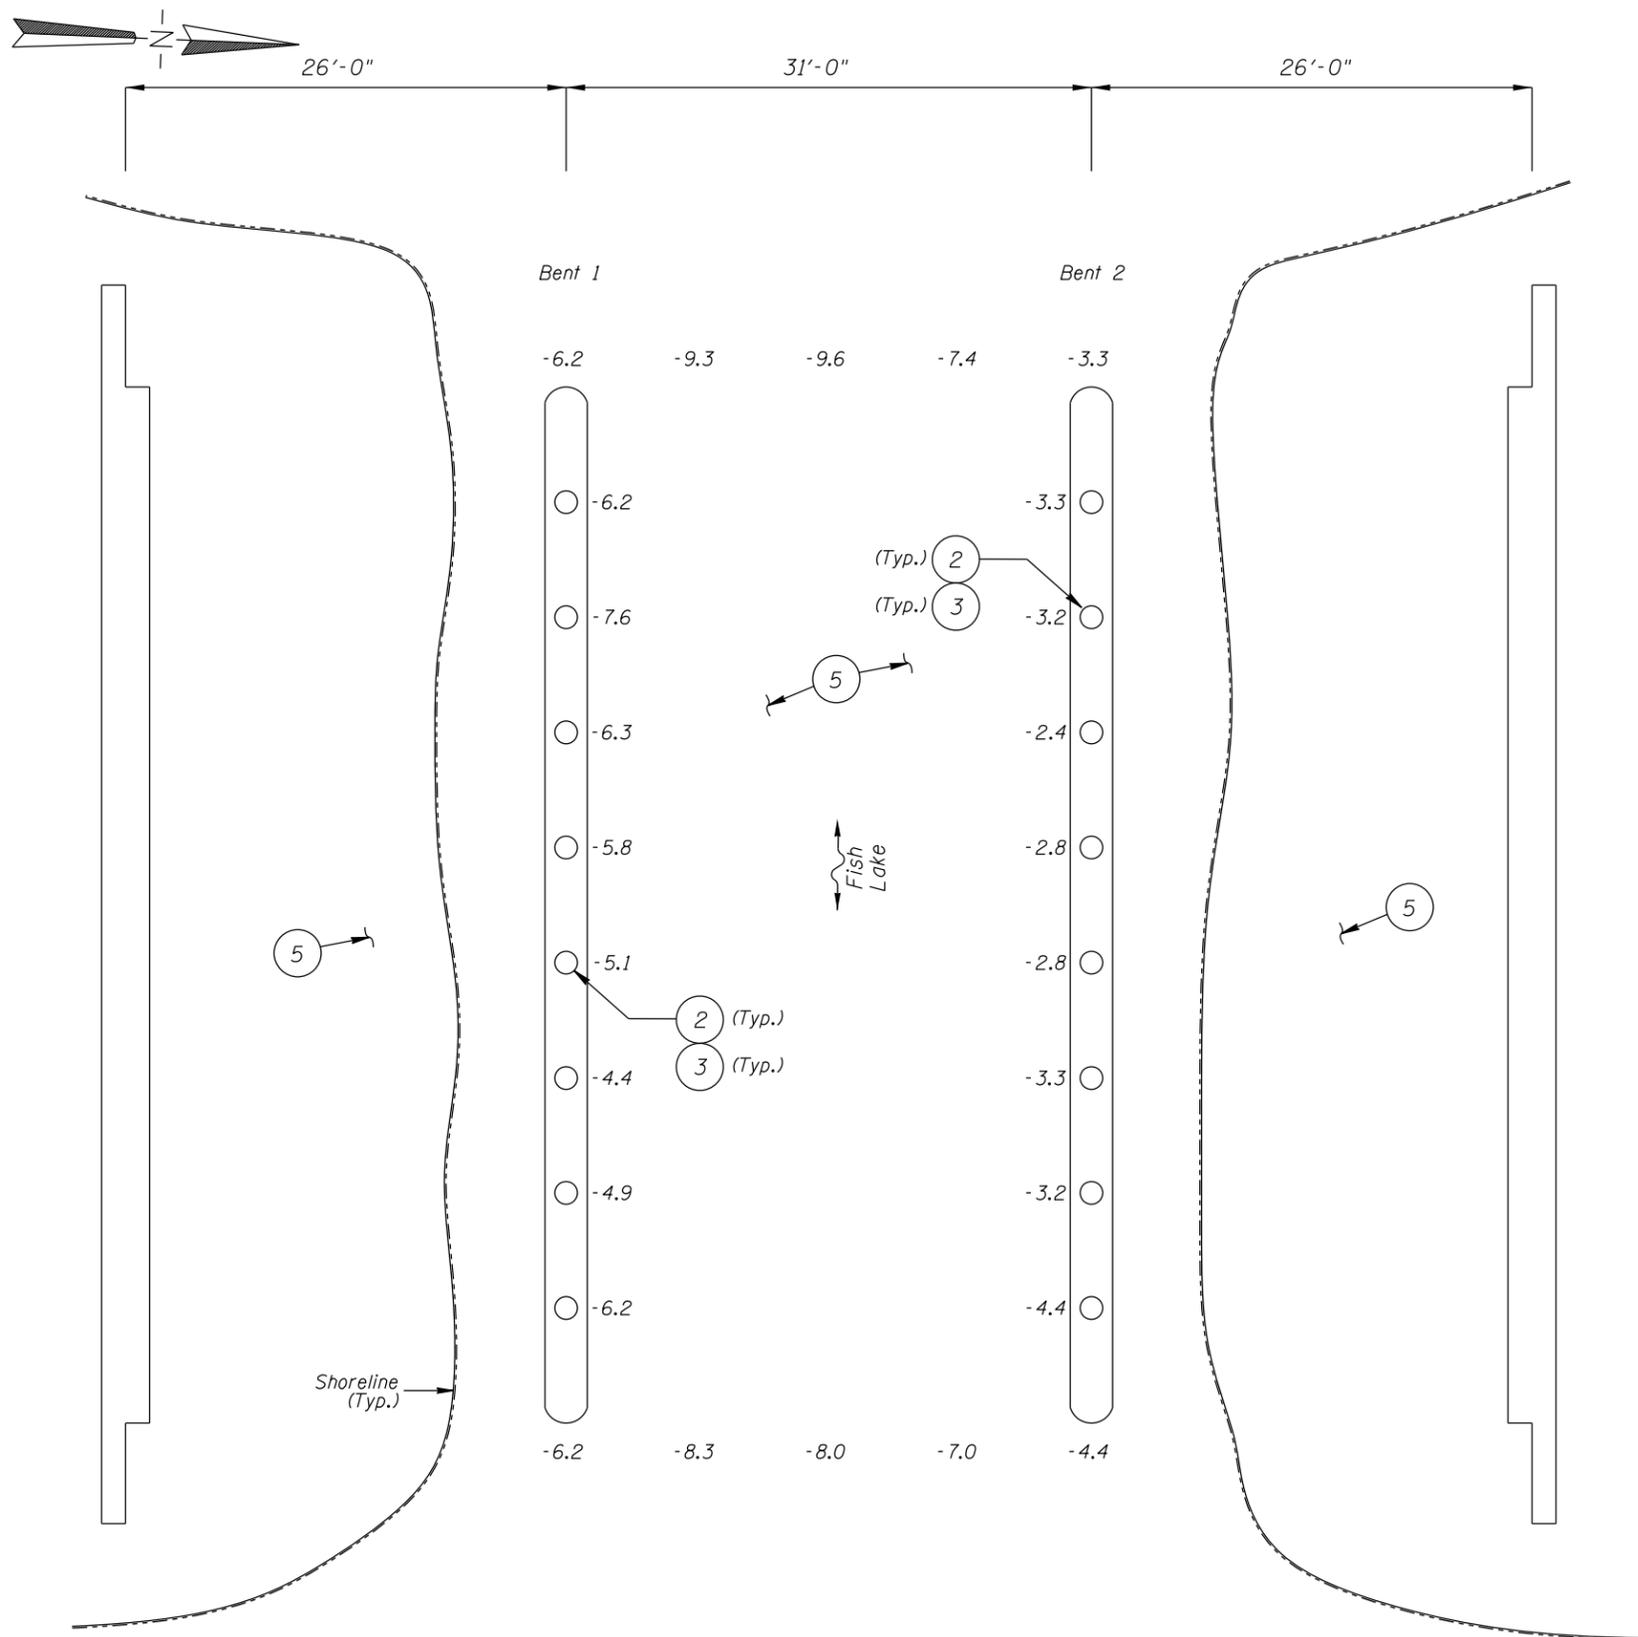
- ① Channel material as well as the shorelines consisted of up to 2 foot diameter riprap.
- ② All piles typically exhibited minor corrosion, consisting of 1/4 inch diameter rust nodules with minimal pitting, extending from 1 to 3 feet below the waterline. Nodular corrosion was present on approximately 20 percent of the surface within the specified location.
- ③ Coating loss was observed on approximately 50 percent of the surface area from 1 foot below the waterline to the channel bottom.
