UNDERWATER BRIDGE INSPECTION REPORT

STRUCTURE NO. 69602

CR 694

CLOQUET RIVER

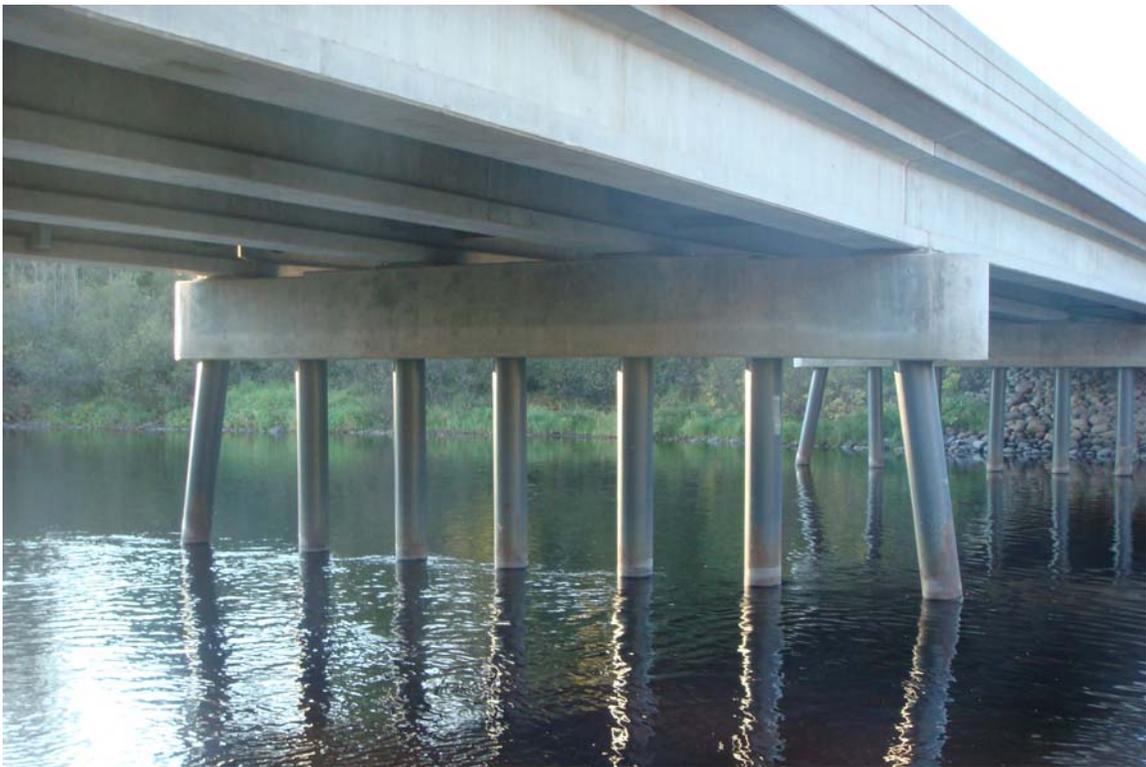
Photograph 2. View of the Bent 1, Looking Northwest.

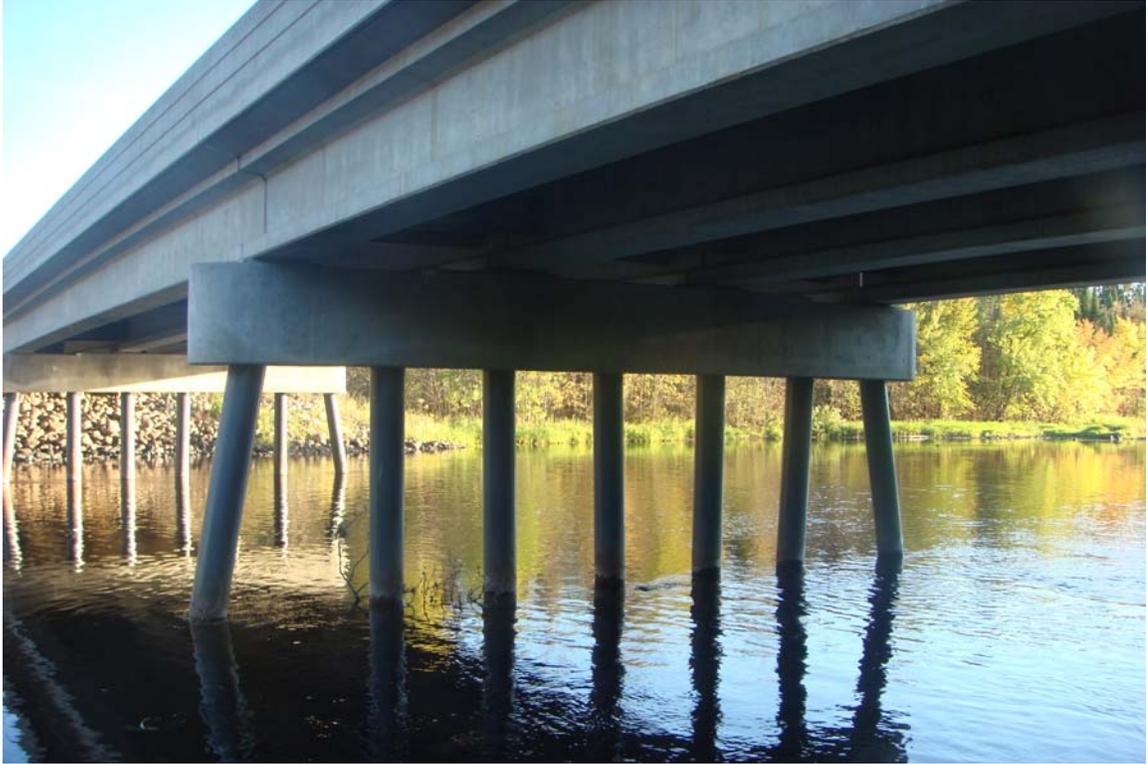
Photograph 3. View of Bent 2, Looking Southwest.

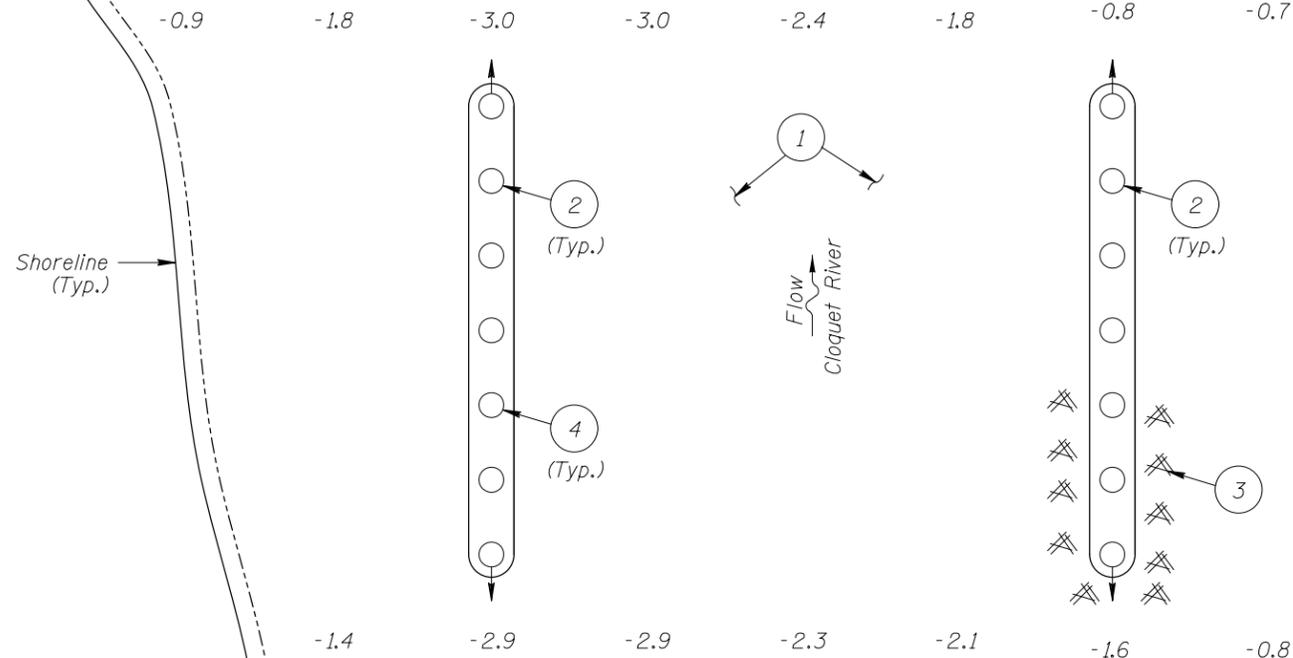
SOUNDING PLAN

- ① The channel bottom material typically consisted of 8 inch diameter and smaller stones and cobbles allowing no probe rod penetration.
- ② The piles of Bents 1 and 2 exhibited coating loss on approximately 90 percent of their surface area extending from the channel bottom to 2 feet above the waterline with light corrosion extending from the waterline to 1 foot above the waterline.
- ③ The piles of Bent 1 exhibited rust nodules, up to 1/4 inch in diameter, covering approximately 20 percent of the pile surface area extending from the channel bottom to 1 foot below the waterline. The nodules typically have negligible pitting of the steel associated with them.
- ④ A light accumulation of 2 inch diameter and smaller timber debris was observed around the upstream three piles of Bent 2.
