UNDERWATER BRIDGE INSPECTION REPORT

STRUCTURE NO. 69609

JULY 24, 2012

MINNESOTA DEPARTMENT OF TRANSPORTATION  
UNDERWATER BRIDGE INSPECTION

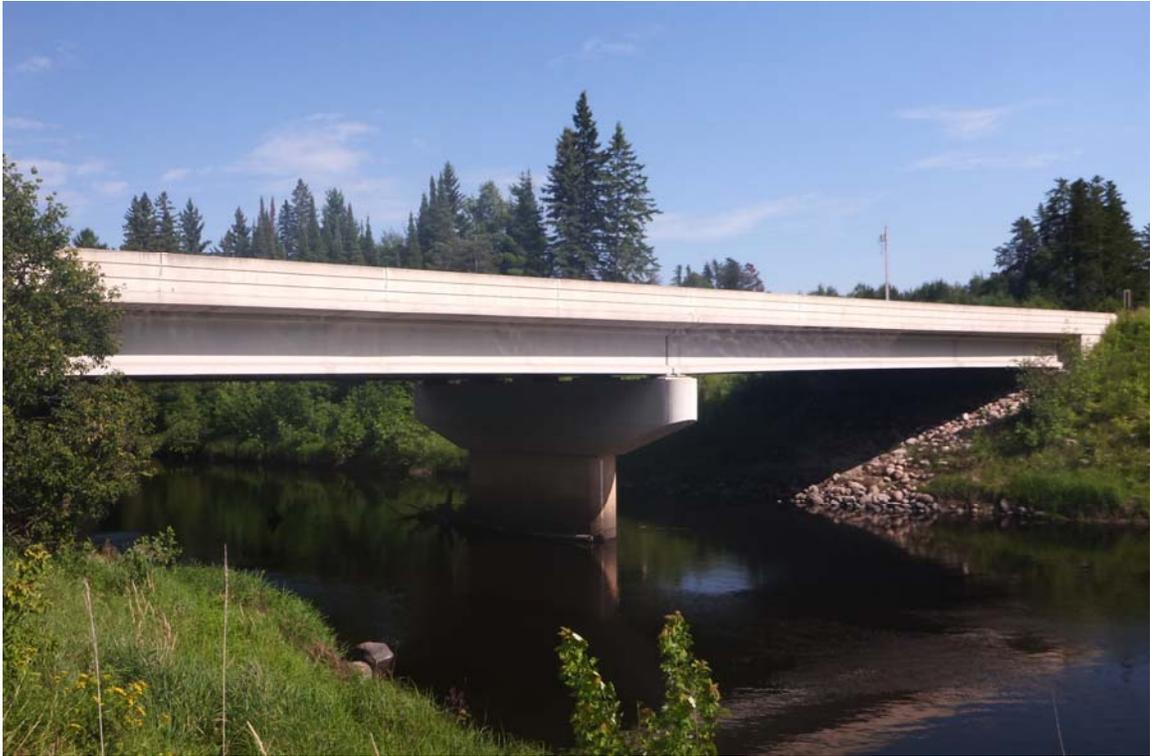
Photograph 1. View of the Downstream Fascia, Looking East.

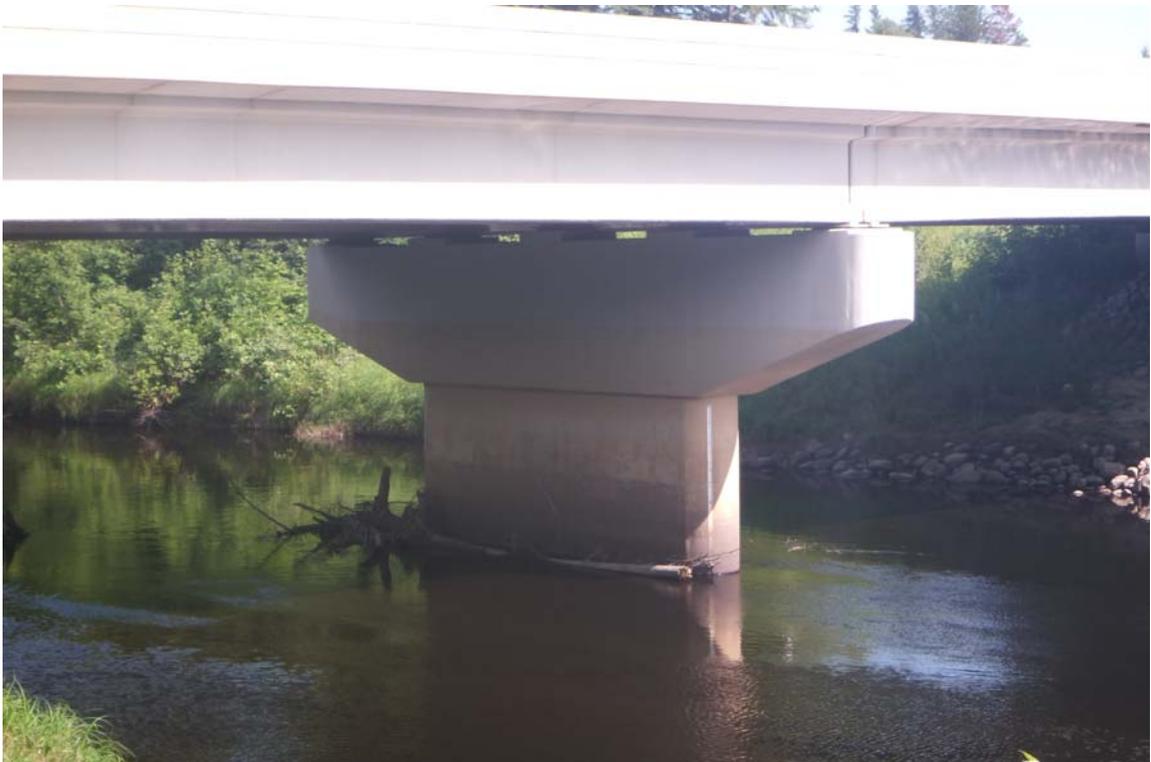
The substructure unit inspected below water at Bridge No. 69609, Pier 1, was in good condition with no defects of structural significance. Light concrete scaling was observed from 0.5 feet above to 1 foot below the waterline, with a maximum 1/4 inch penetration. Footing exposure was detected around the pier with a maximum vertical face exposure of 8 inches. Moderate timber debris accumulation was observed around Pier 1 consisting of logs and branches with up to 12 inch diameter. The debris extended from the channel bottom to 2 feet above the waterline.

Photograph 2. View of Pier 1, Looking East.

- (A) Monitor the extent of footing exposure at Pier 1 during future underwater inspections.
- (B) Monitor the timber debris accumulation at Pier 1, during future inspections, and if found to be increasing to a more detrimental extent, removal operations may become warranted at that time.
- (C) Reinspect the submerged substructure units at the normal maximum recommended (NBIS) interval of sixty (60) months.

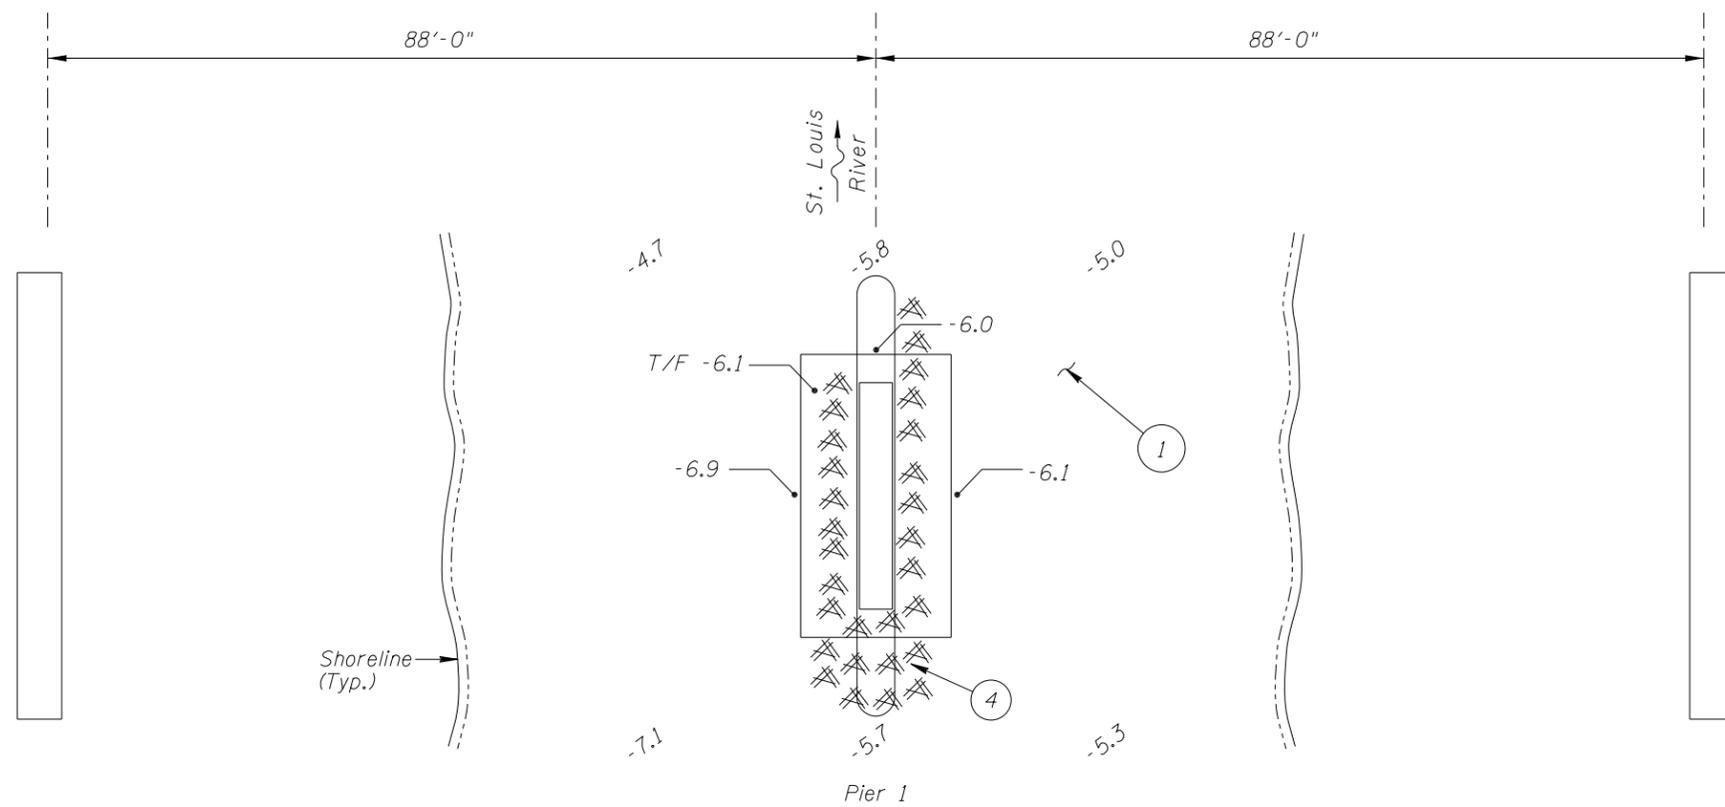
INSPECTION AND SOUNDING PLAN

- ① The channel bottom material consisted of gravel and sand with random pieces of riprap 12 inch diameter and smaller, allowing up to 3 inches of probe rod penetration.
- ② Light concrete scaling, with 1/8 inch typical penetration and 1/4 inch maximum, was observed on Pier 1 from 6 inch above to 1 foot below the waterline.
- ③ The top of footing was exposed along both faces of the pier with a maximum vertical exposure of 8 inches on the south face.
- ④ A moderate accumulation of timber debris, consisting of logs and branches 12 inch diameter and smaller around the perimeter of the pier, extending 10 feet upstream off the upstream nose and 3 feet off of the north and south faces. The debris extended from the channel bottom to 2 feet above the waterline.
