UNDERWATER BRIDGE INSPECTION REPORT

STRUCTURE NO. 69623

ST. LOUIS RIVER

JOB NO. 2107

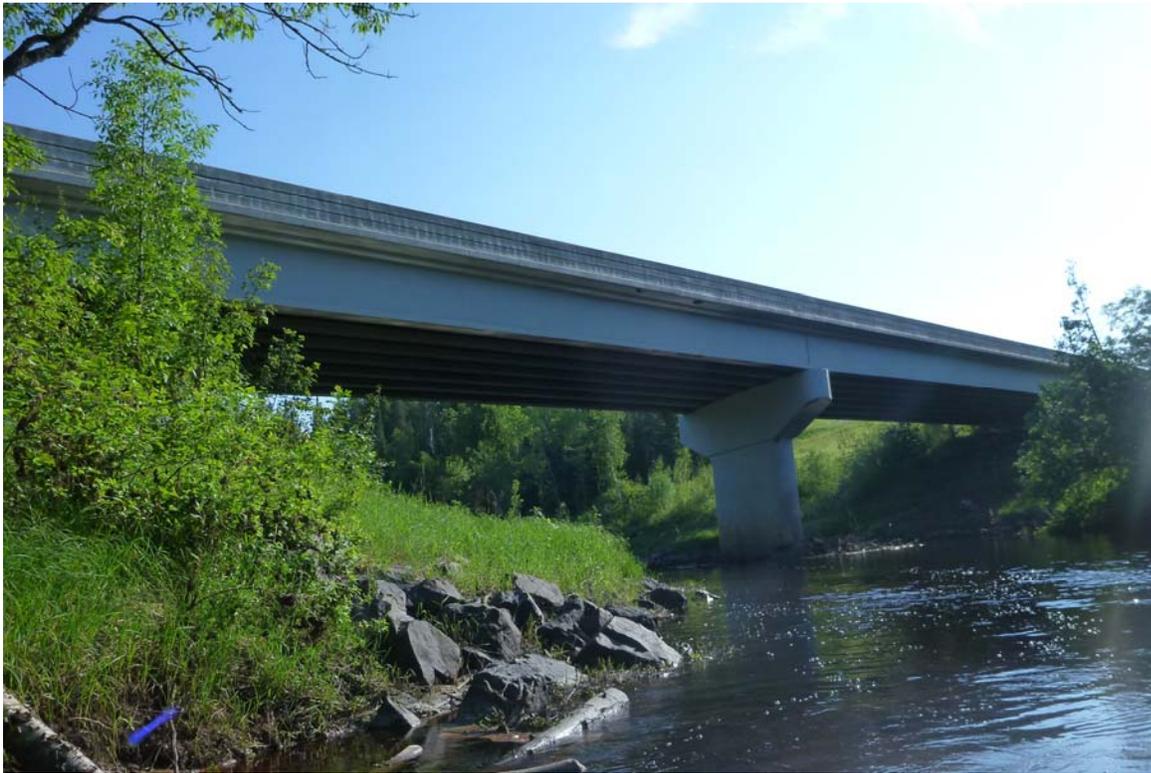
Photograph 1. Overall View of Structure, Looking Southwest.

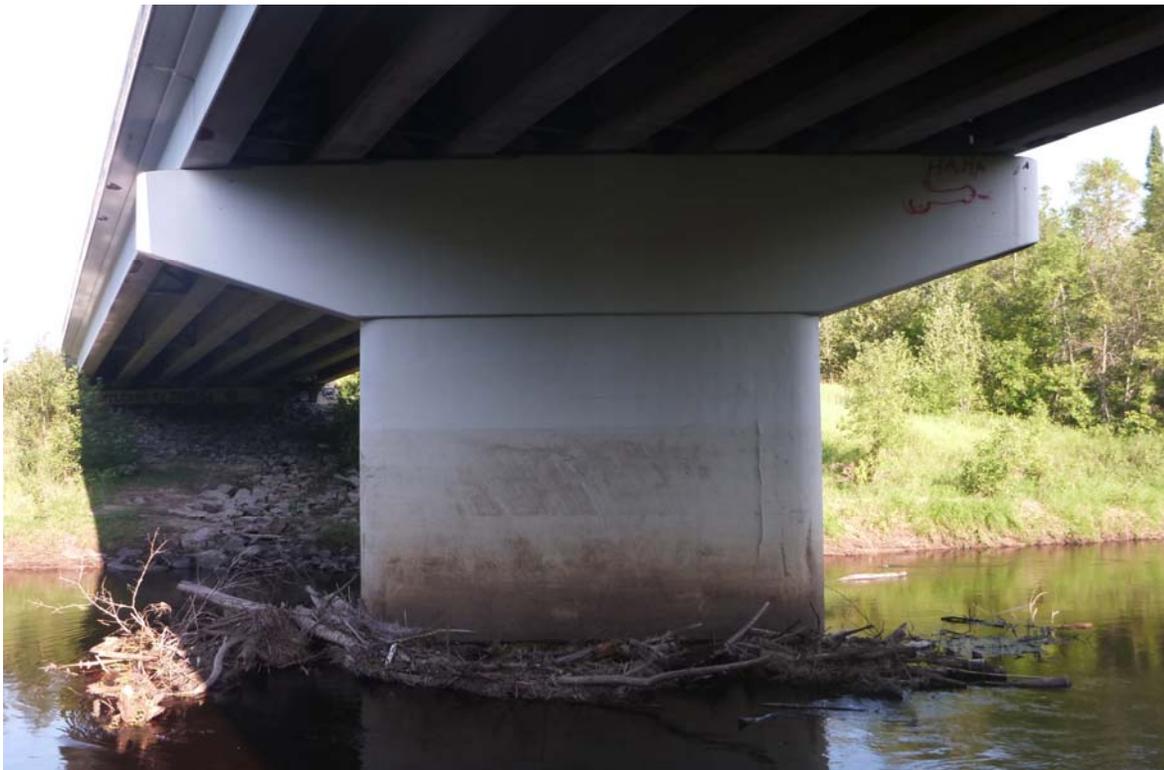
- (A) The concrete of Pier 1 was smooth and sound with no notable deterioration.
- (B) A heavy accumulation of timber debris consisting of logs and branches up to 12 inches in diameter was observed at the upstream nose of Pier 1. The accumulation extended approximately 20 off the upstream nose and along both faces of the pier.
- (C) A band of light scaling was observed around the entire perimeter of Pier 1 extending from 0.5 feet below to 2 feet below the waterline, with 1/8 inch maximum penetrations.

Photograph 2. View of Pier 1 and Drift Accumulation, Looking Southeast.

- (A) Remove the heavy accumulation of timber debris at the upstream nose and along the faces of Pier 1 to alleviate scour influence at the pier and to minimize any further accumulation.

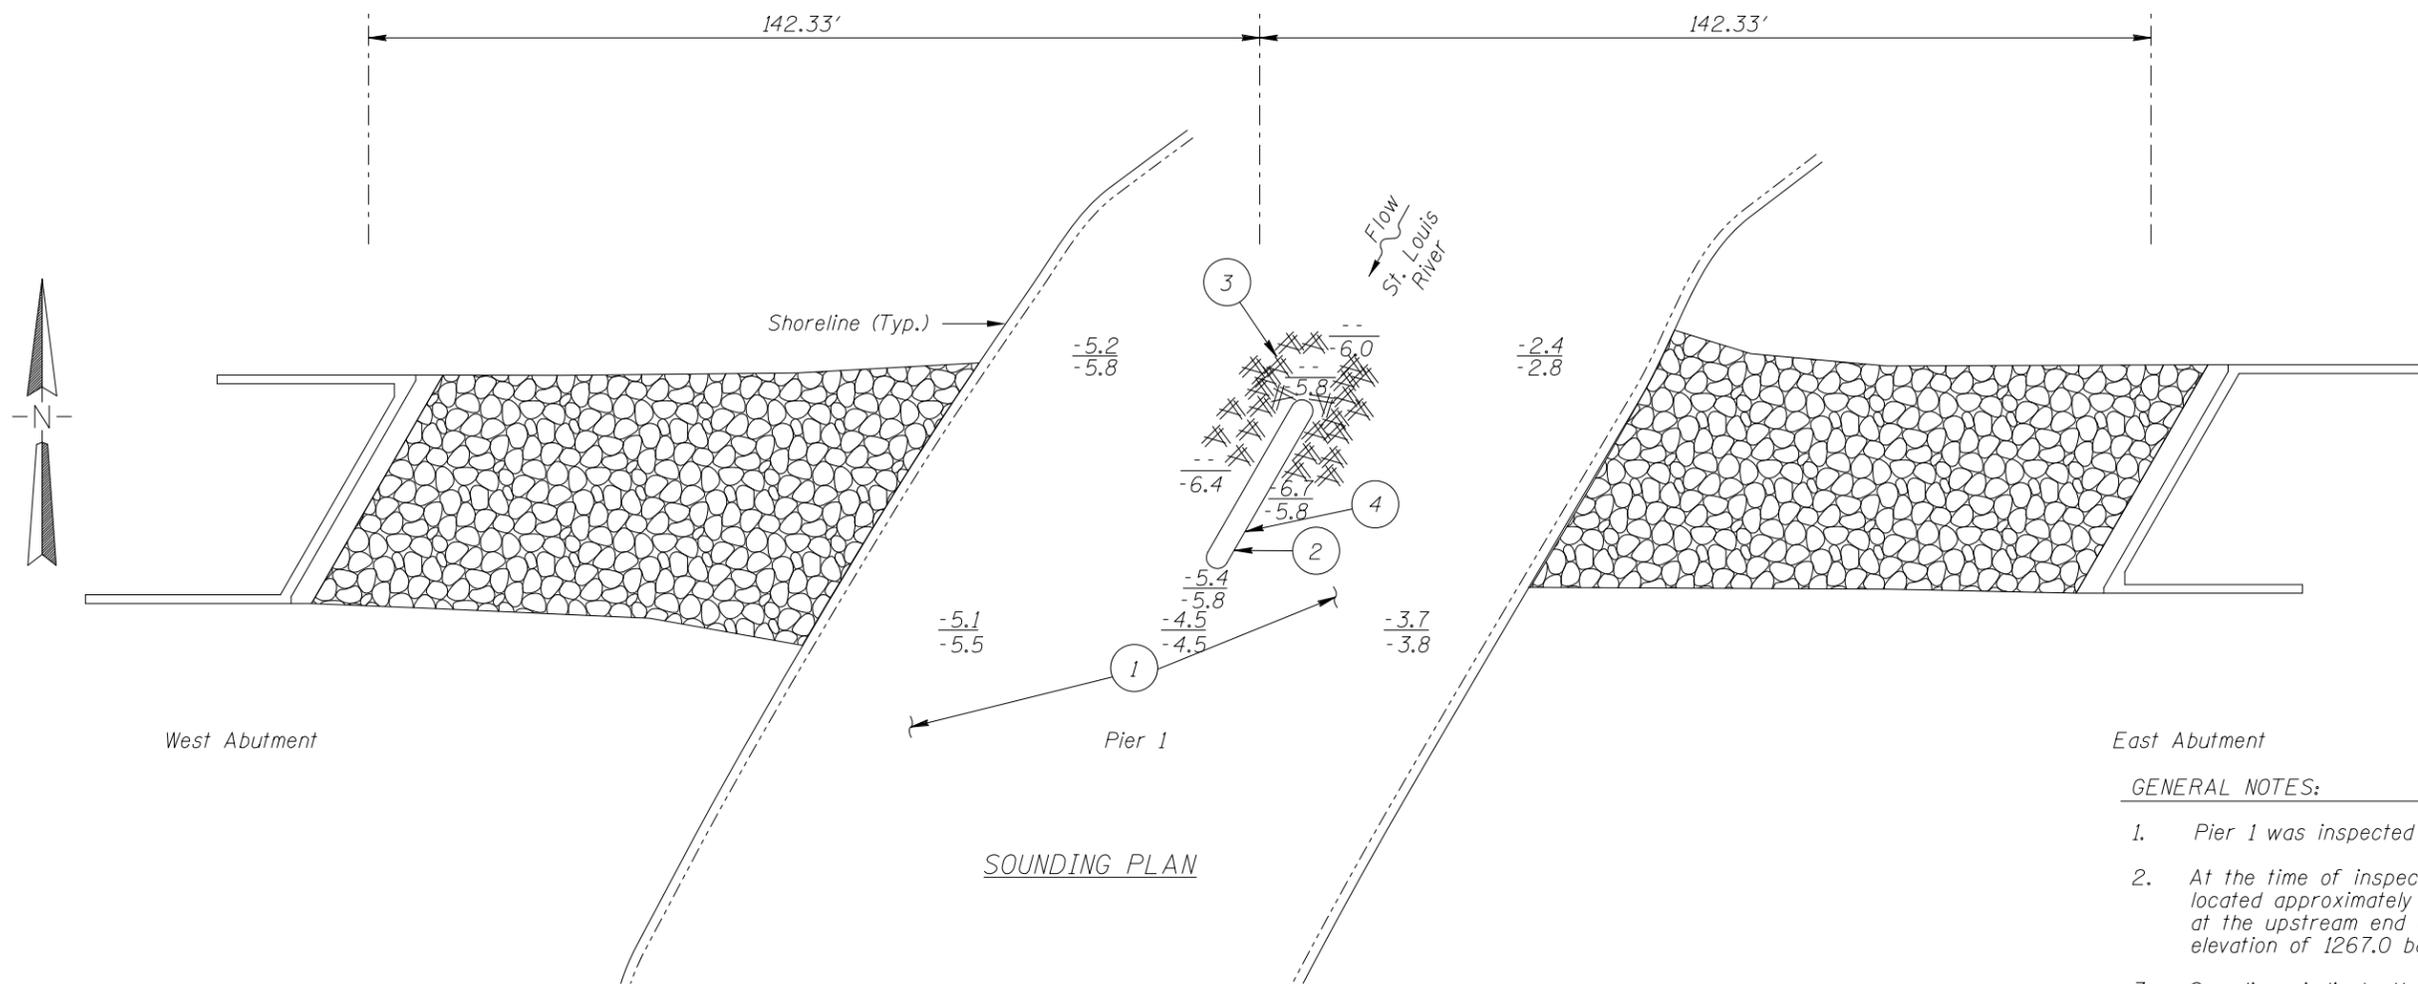
SOUNDING PLAN

1. The channel bottom consisted of soft silt with 1.5 to 2 feet of probe rod penetration and riprap at the upstream nose of Pier 1.
2. The concrete of Pier 1 was smooth and sound.
3. A heavy accumulation of timber debris consisting of logs and branches up to 12 inch in diameter was observed around the upstream half of Pier 1 extending from the channel bottom to 4 feet above the waterline. The accumulation extended approximately 20 feet off the pier nose and faces.
4. Light scaling was observed around entire pier from 0.5 foot below to 2 feet below the waterline with 1/8 inch maximum penetration.
