UNDERWATER BRIDGE INSPECTION REPORT

STRUCTURE NO. 69624

CSAH 29

ST LOUIS RIVER

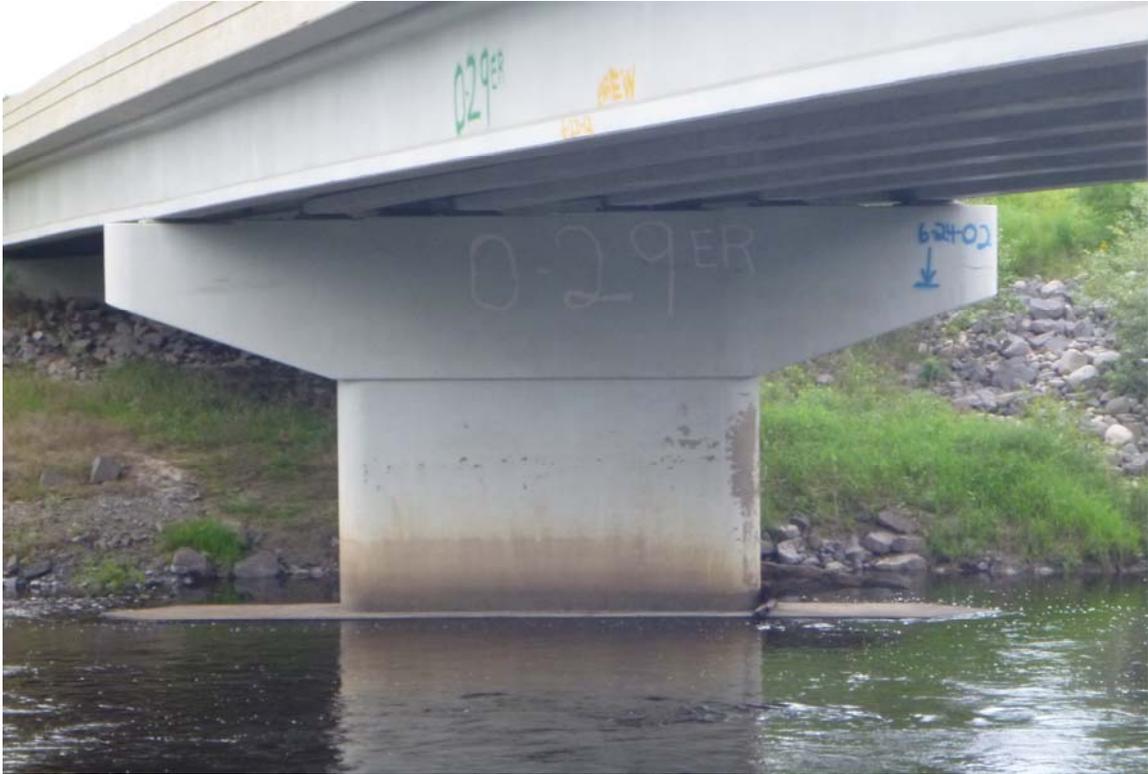
Photograph 1. View of Pier 1, Looking West.

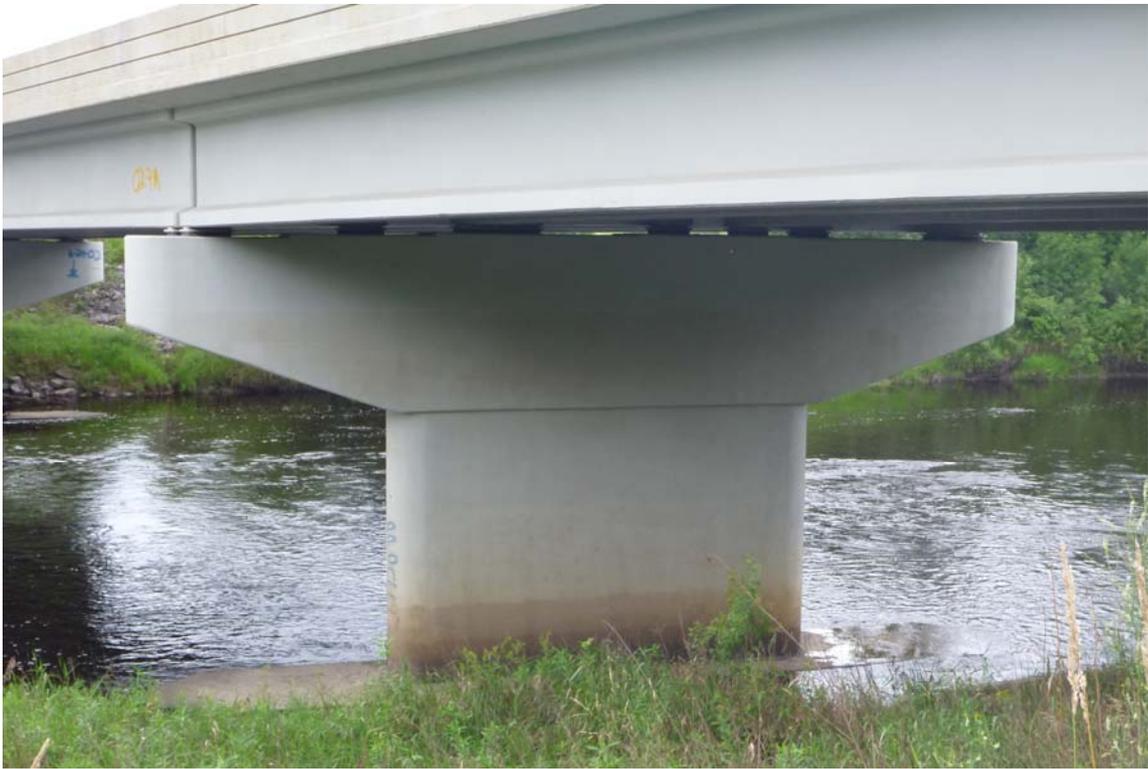
Photograph 2. View of Pier 2, Looking West.

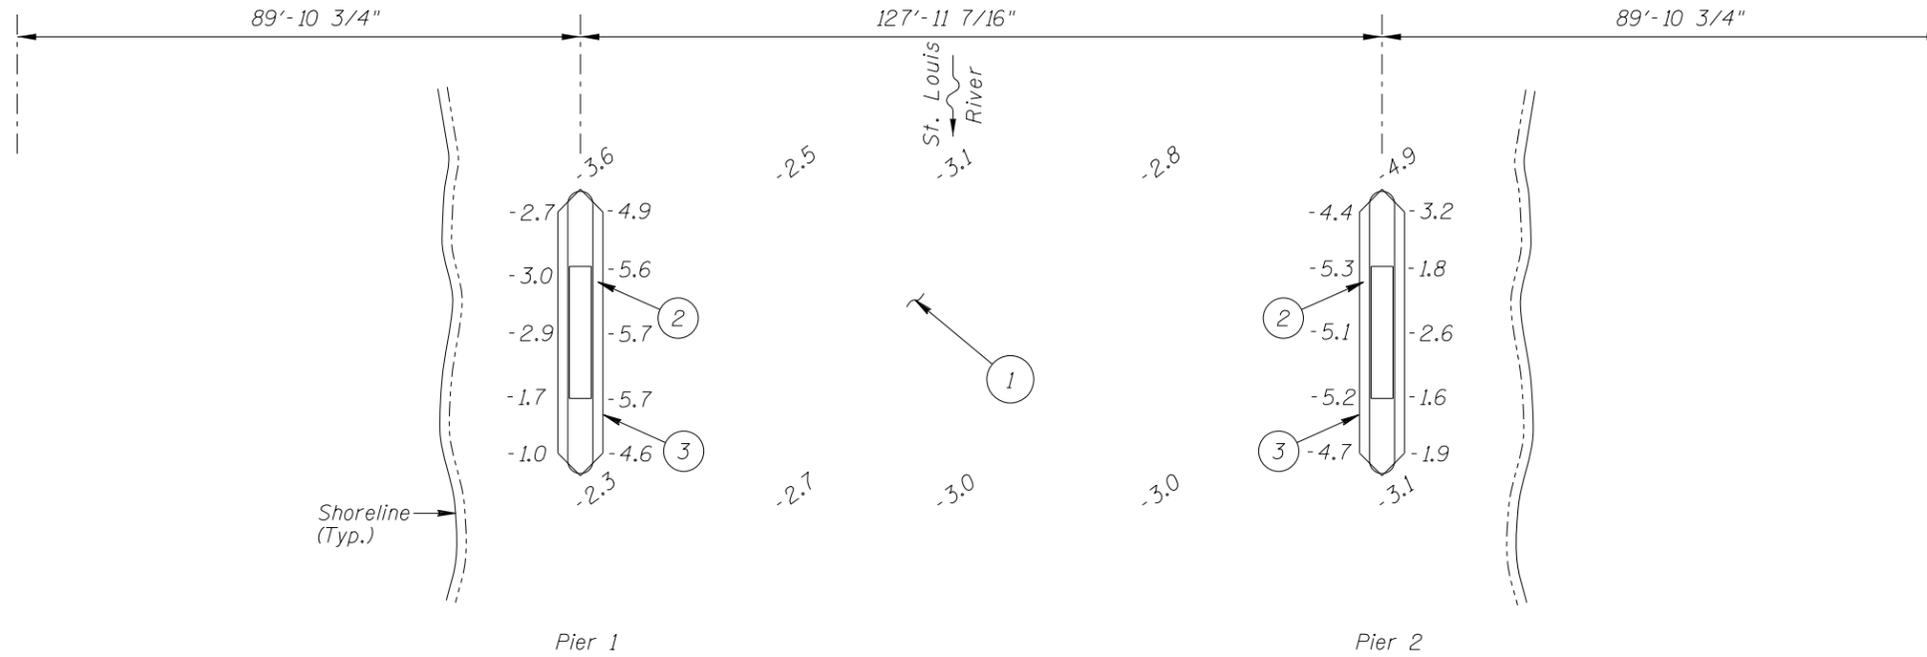
INSPECTION AND SOUNDING PLAN

- ① The channel bottom consisted of sand with random pieces of riprap 24 inch diameter and smaller, allowing up to 6 inches of probe rod penetration.
- ② Concrete surfaces were typically smooth and sound
- ③ The footing was partially exposed with up to 5.7 feet of vertical exposure.

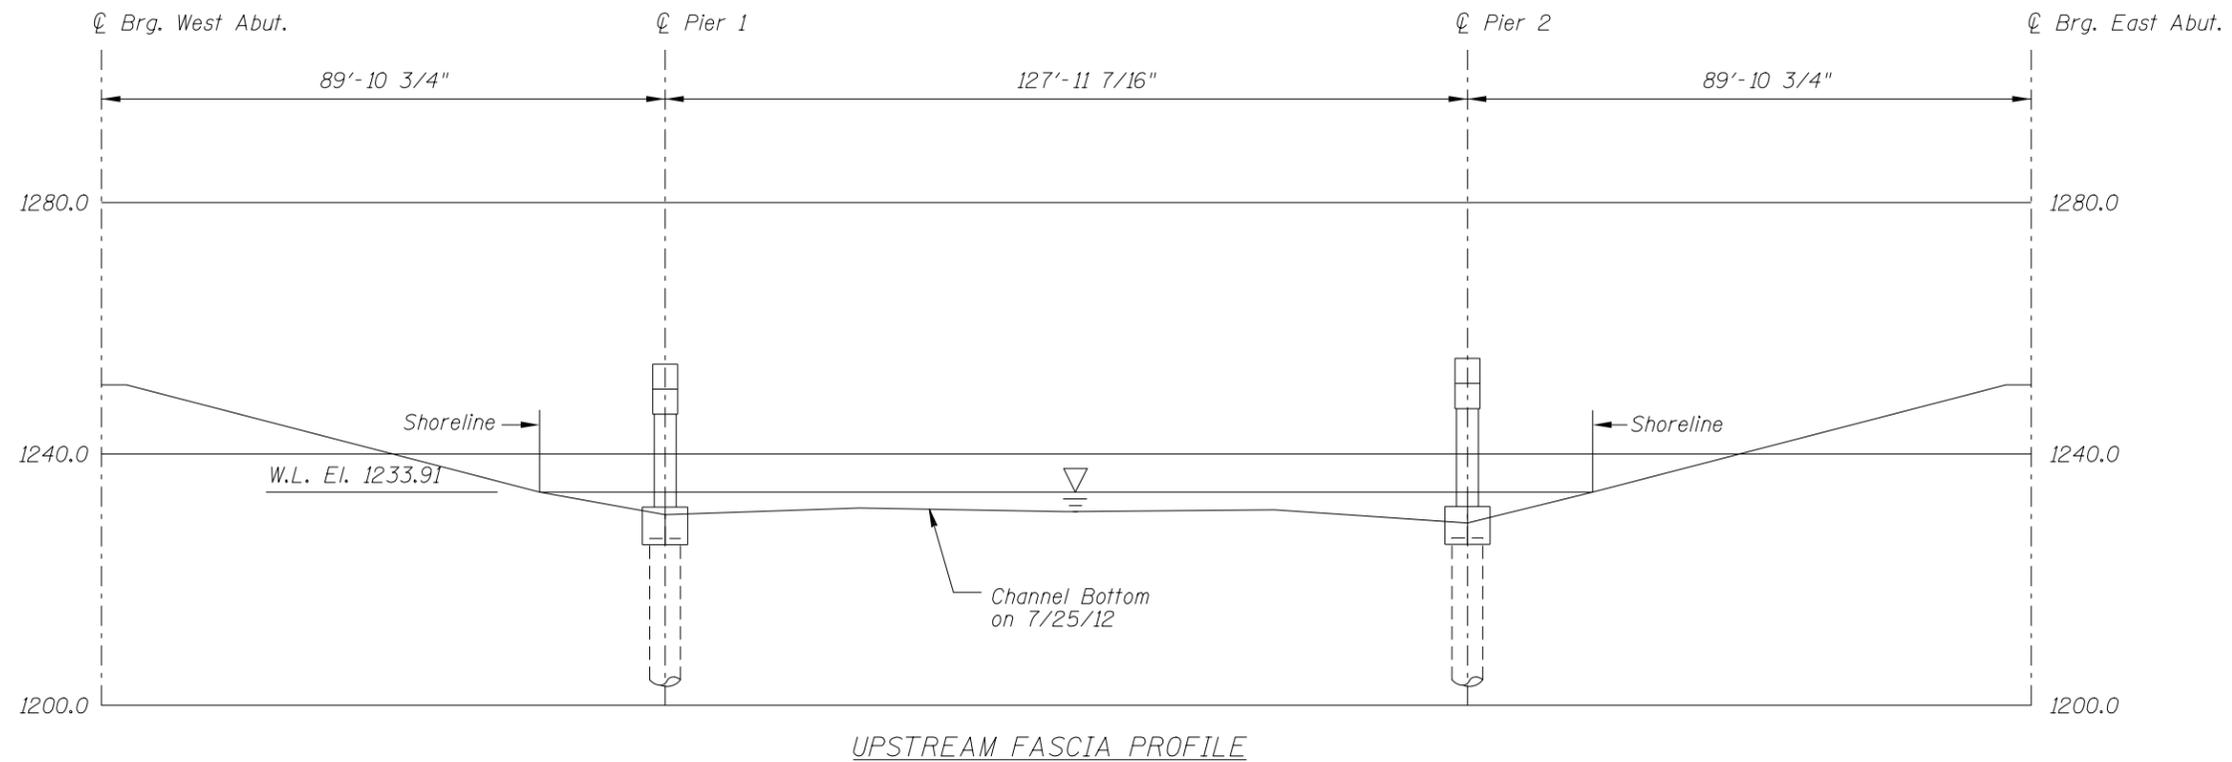
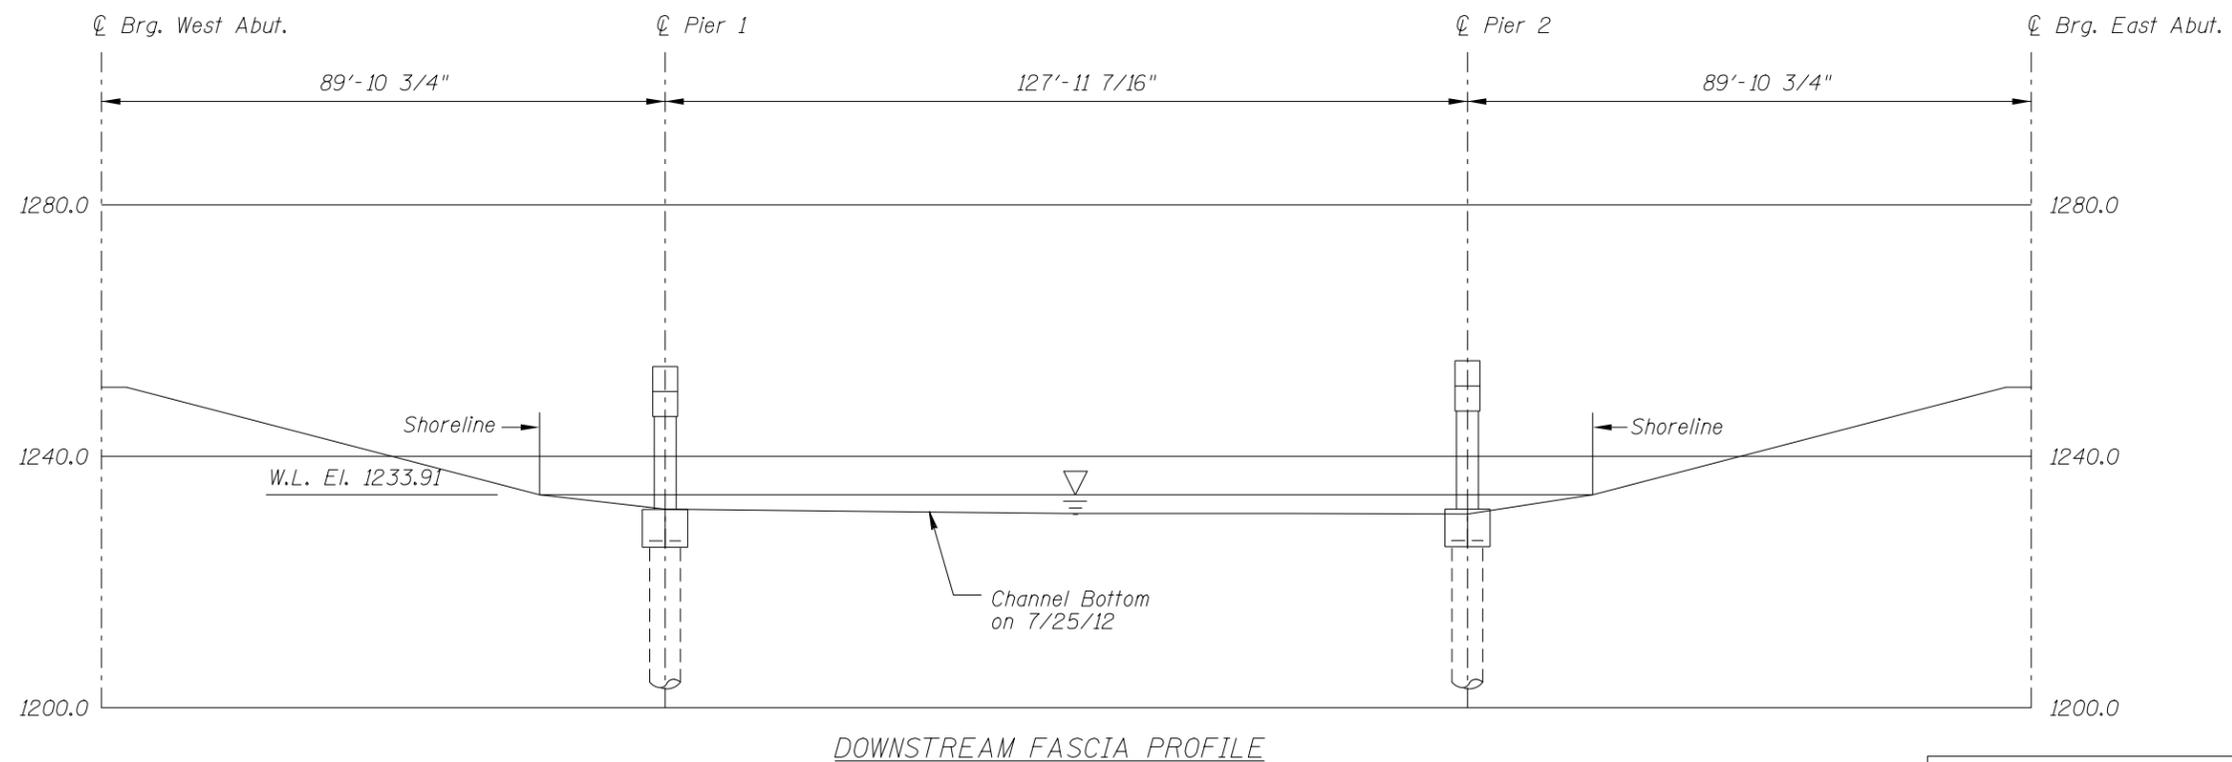
**UPSTREAM AND DOWNSTREAM  
FASCIA PROFILES**

REMARKS: Overall, Piers 1 and 2 were in good condition with no defects of structural significance. The footings were both exposed with up to 5.7 feet over vertical exposure. The channel bottom appeared stable and well established.

- (A) Monitor footing exposure at both piers during future inspections.
- (B) Reinspect the submerged substructure units at the normal maximum recommended (NBIS) interval of sixty (60) months.
