UNDERWATER BRIDGE INSPECTION REPORT

STRUCTURE NO. 69634

ST LOUIS RIVER

JULY 24, 2012

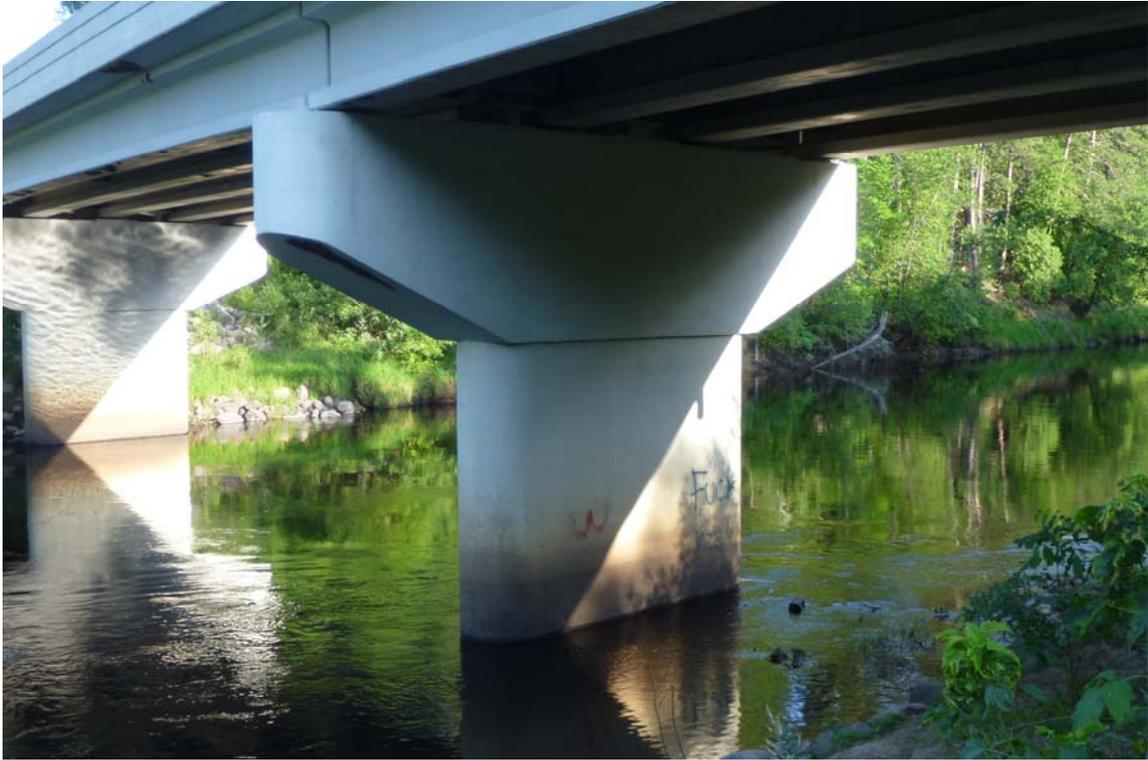
The substructure units inspected below water at Bridge No. 69634, Pier 1 and Pier 2, were in very good condition with no defects of structural significance. The concrete surfaces of the piers were smooth and sound.

Photograph 1. View of Pier 1, Looking East.

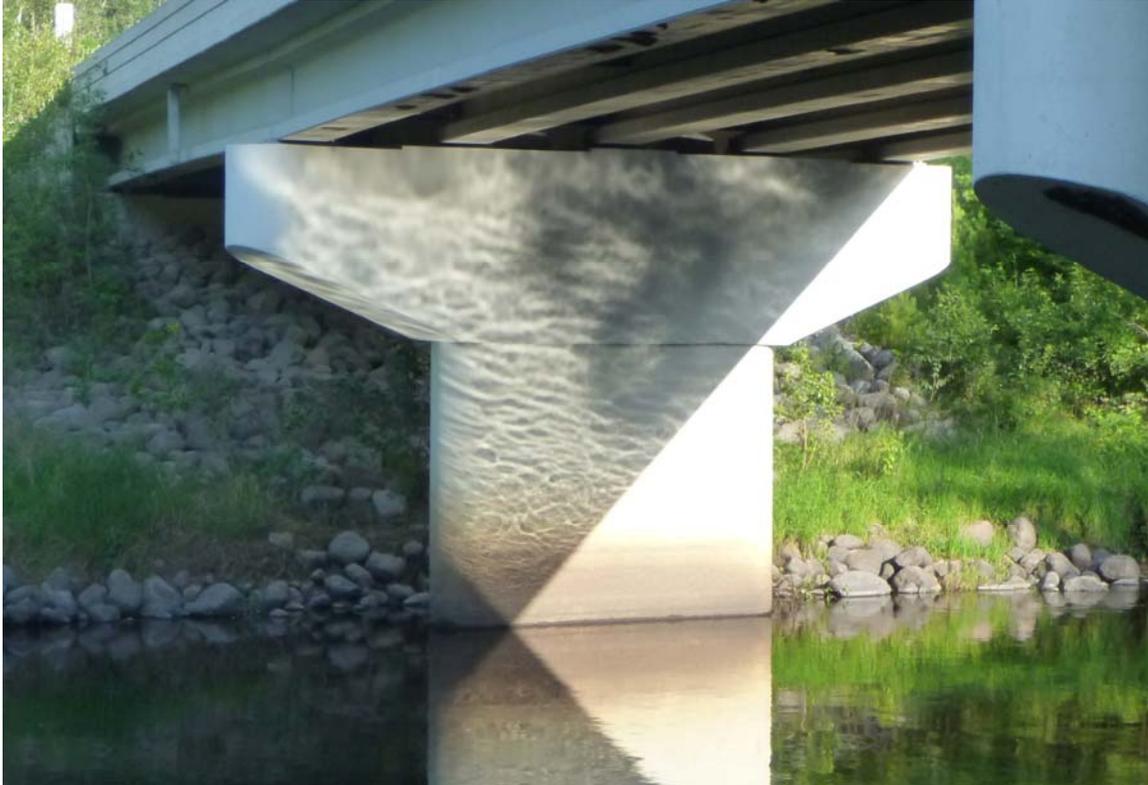
Photograph 2. View of Pier 2, Looking East.

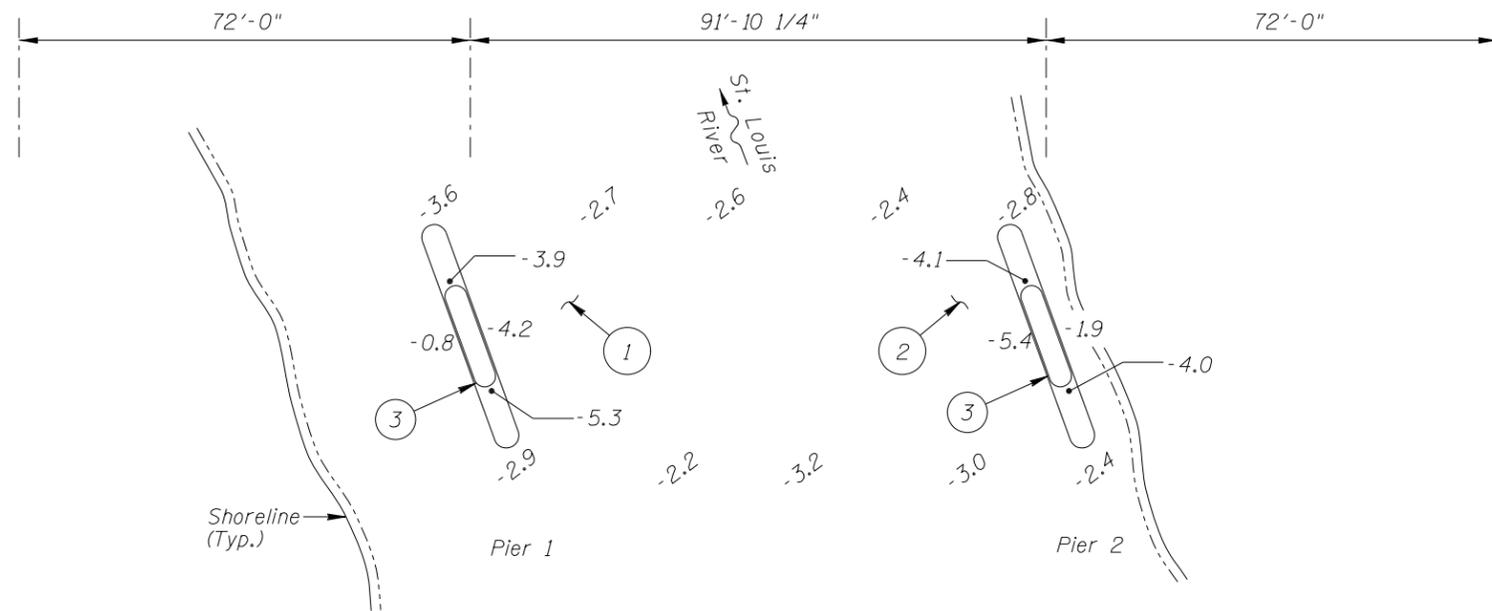
INSPECTION AND SOUNDING PLAN

- ① The channel bottom consisted of silty sand allowing up to 6 inches of probe rod penetration.
- ② The channel bottom consisted of firm silty clay allowing up to 1 inches of probe rod penetration.
- ③ The concrete surfaces of both piers were smooth and sound.

- (A) Reinspect the submerged substructure units at the normal maximum recommended (NBIS) interval of sixty (60) months.
