UNDERWATER BRIDGE INSPECTION REPORT

STRUCTURE NO. 69J24

CSAH 108

FLINT CREEK

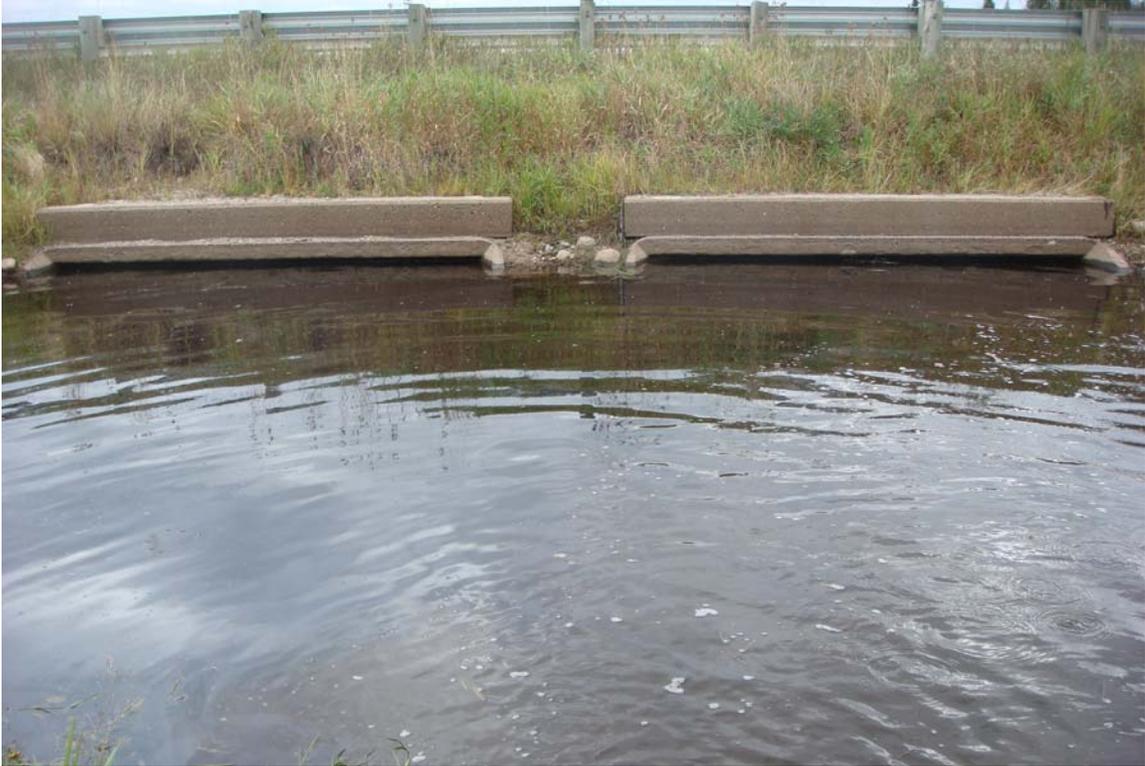
Photograph 1. Overall View of Structure, Looking East.

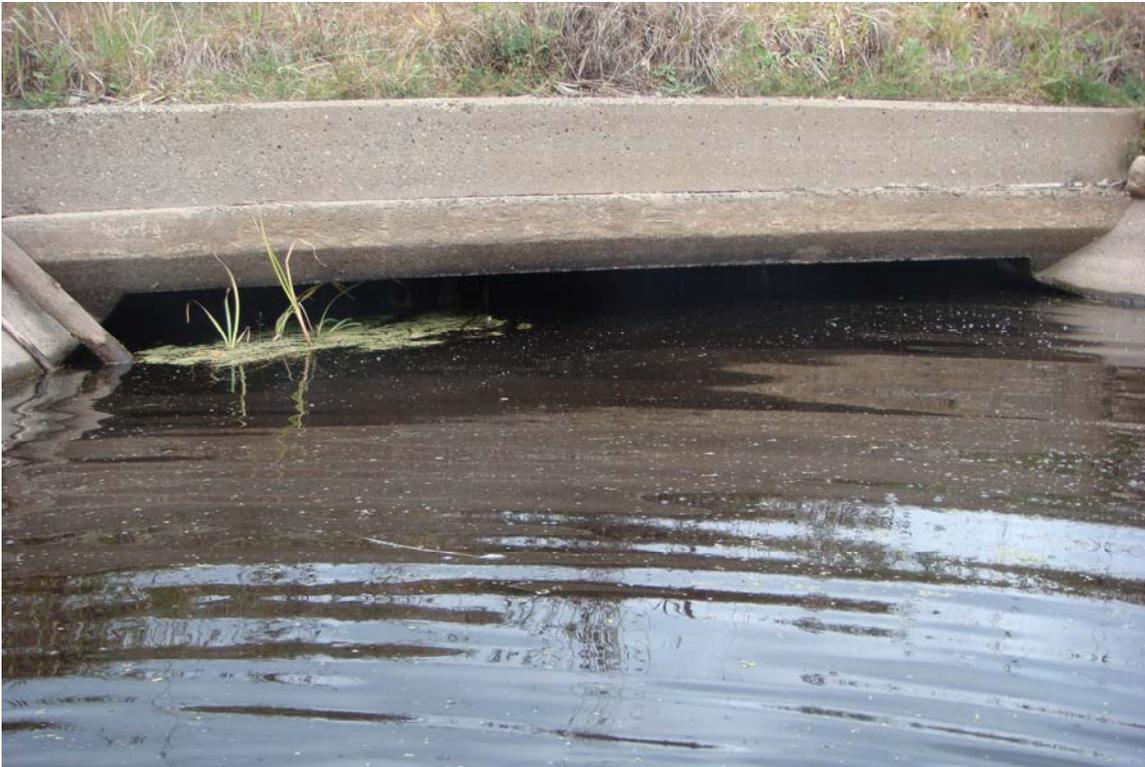
Photograph 2. View of the North Culvert, Looking West.

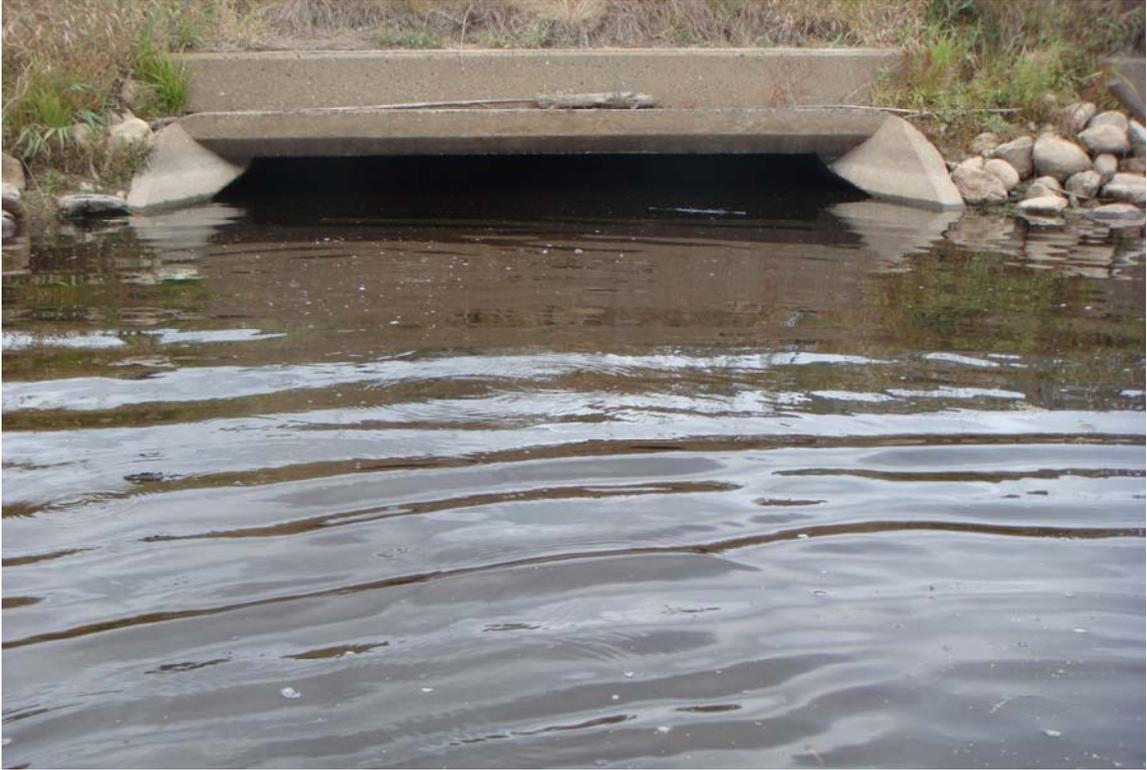
Photograph 3. View South Culvert, Looking West.

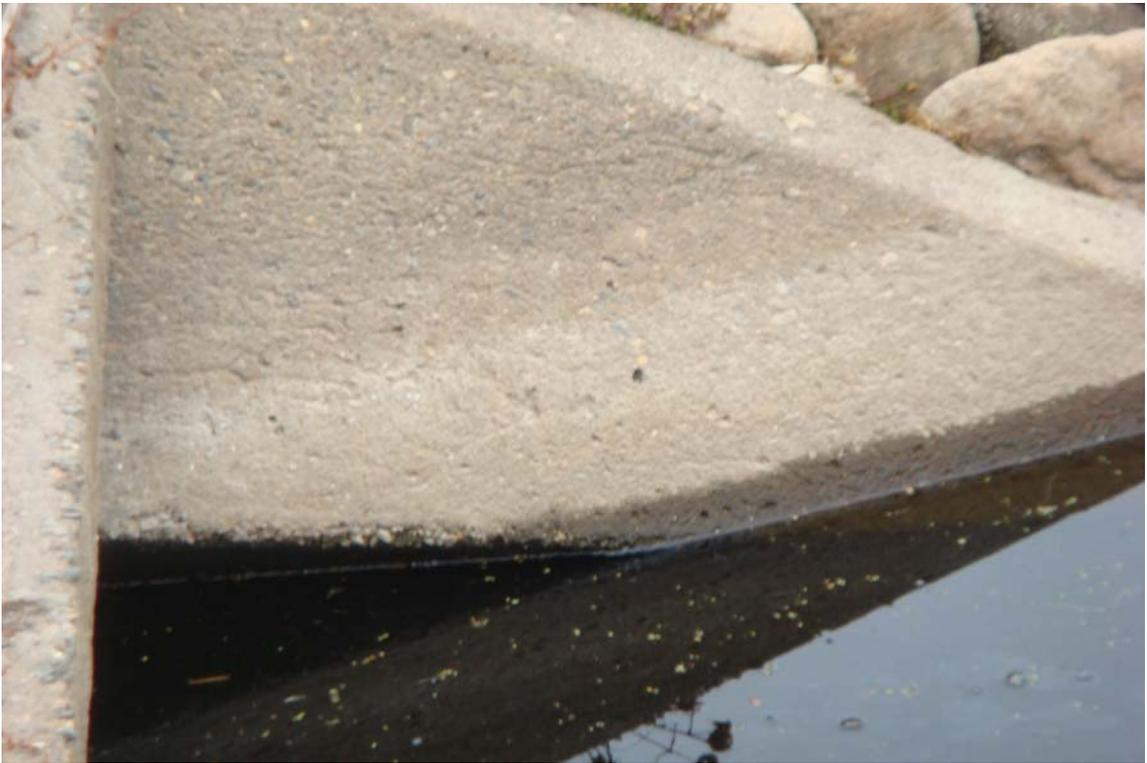
- (A) The channel bottom material typically consisted of silt with a maximum probe rod penetration of 2 feet.
- (B) The concrete of both culverts was typically sound with light scaling with a maximum penetration of 1/16 inch.
- (C) The concrete floor was exposed and free of debris throughout the length of both culverts.
- (D) The aprons of both culverts were covered by a layer of silt at the east and west openings from approximately the headwall to the apron toe. The silt layer was typically 0.8 feet and 1 foot thick at the east and west openings respectively.
- (E) Several joints along both culverts had a 1/2 inch wide gap between box segments. A lap joint was visible through the gap, but there was no surrounding embankment exposed.

Photograph 4. View of the Typical Concrete Condition at the Waterline, Looking North.

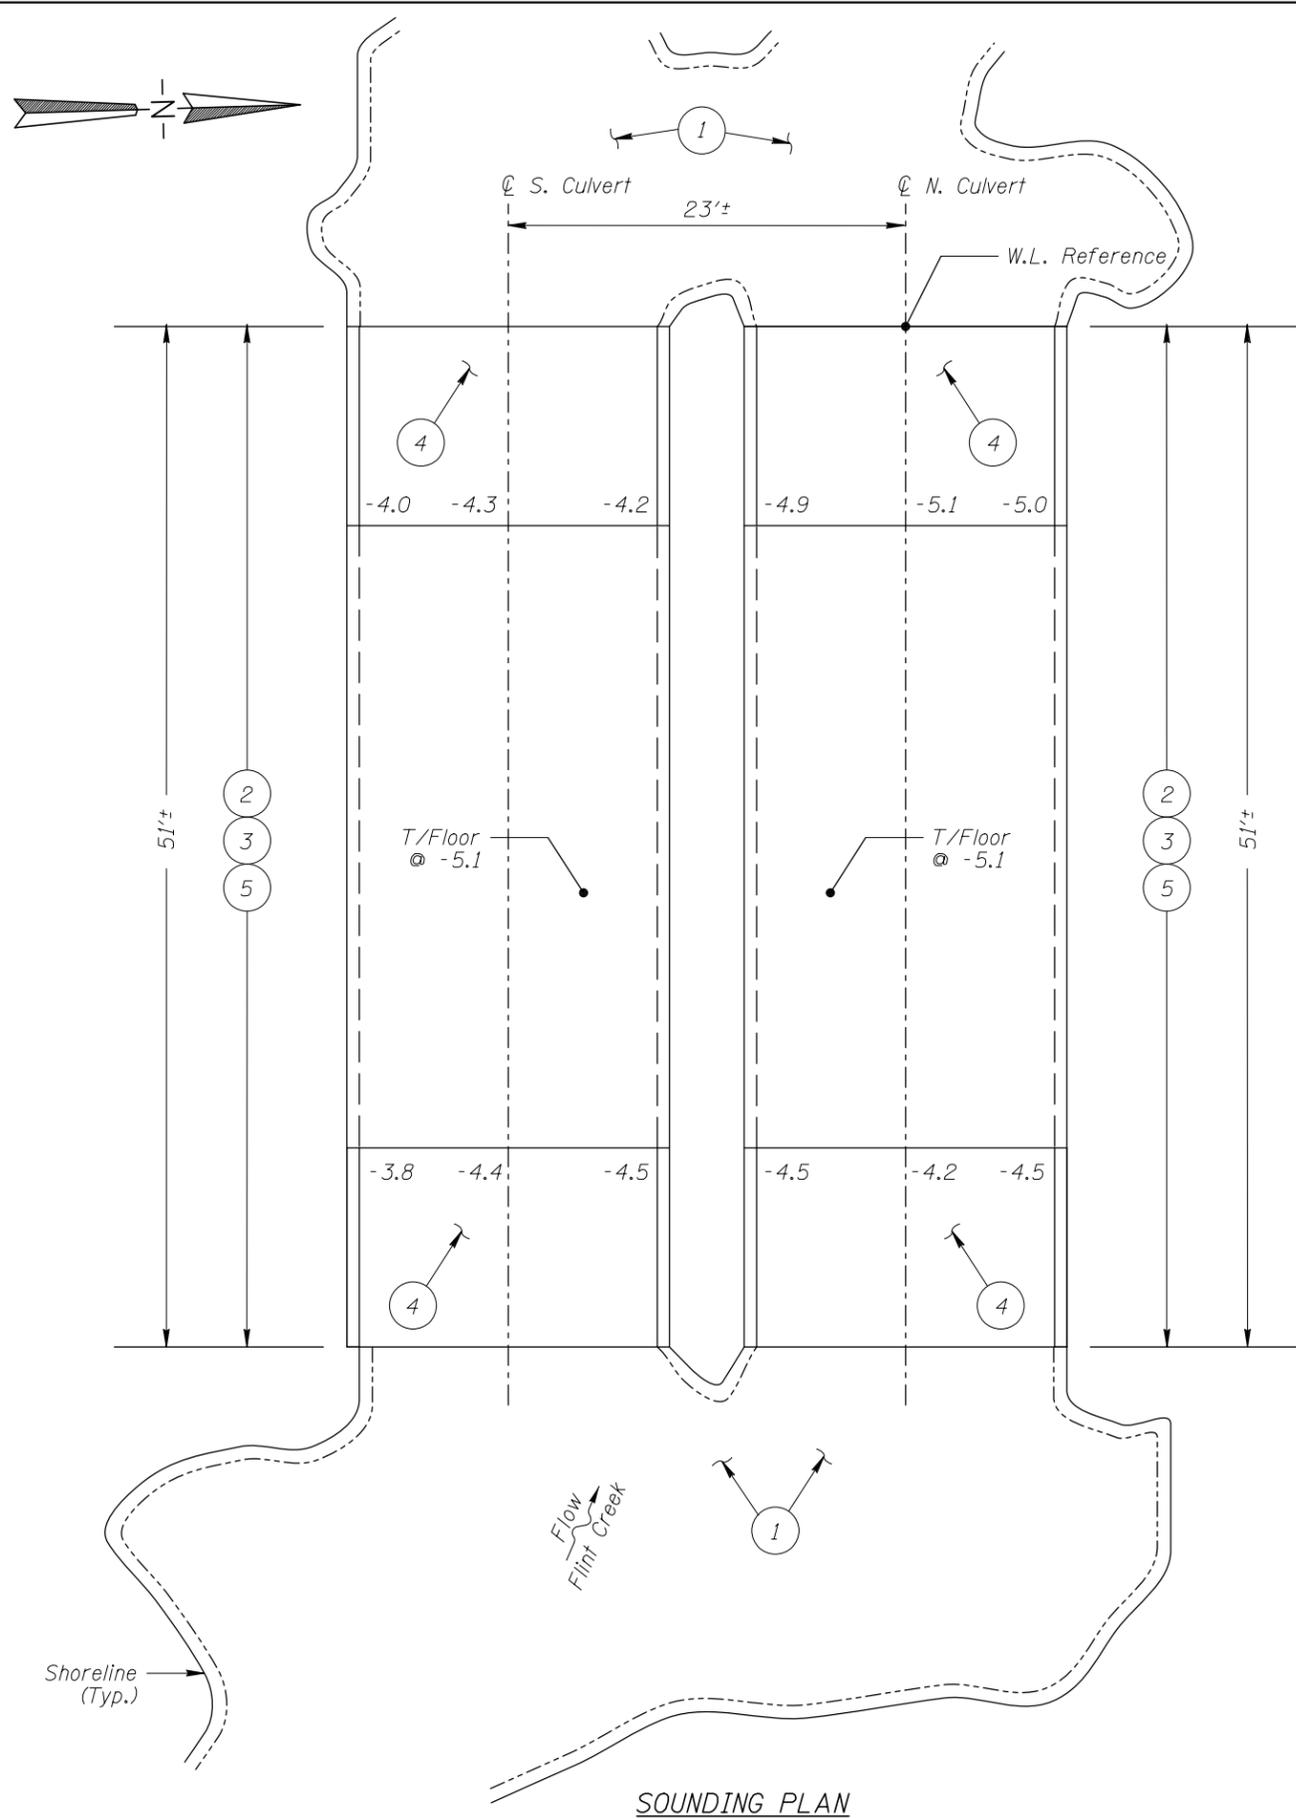
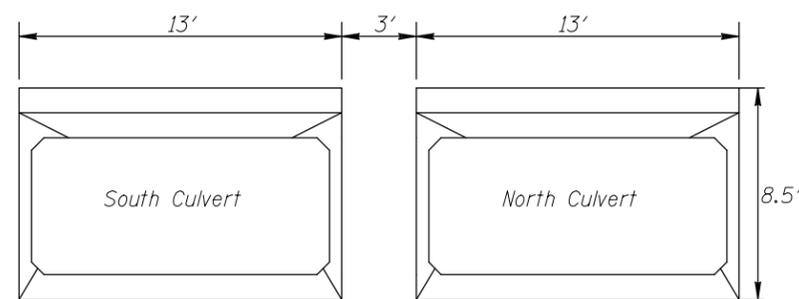
SOUNDING PLAN

- ① The channel bottom material typically consisted of silt with a maximum probe rod penetration of 2 feet.
- ② The concrete of both culverts was typically sound with light scaling with a maximum penetration of 1/16 inch.
- ③ The concrete floor was exposed throughout the length of both culverts.
- ④ The aprons of both culverts were covered by a layer of silt at the east and west openings from approximately the headwall to the apron toe. The silt layer was typically 0.8 feet and 1 foot thick at the east and west openings respectively.
- ⑤ Several joints along both culverts had a 1/2 inch wide gap between box segments. A lap joint was visible through the gap.
