UNDERWATER BRIDGE INSPECTION REPORT

STRUCTURE NO. 7003

BIG FORK RIVER

AUGUST 14, 2012

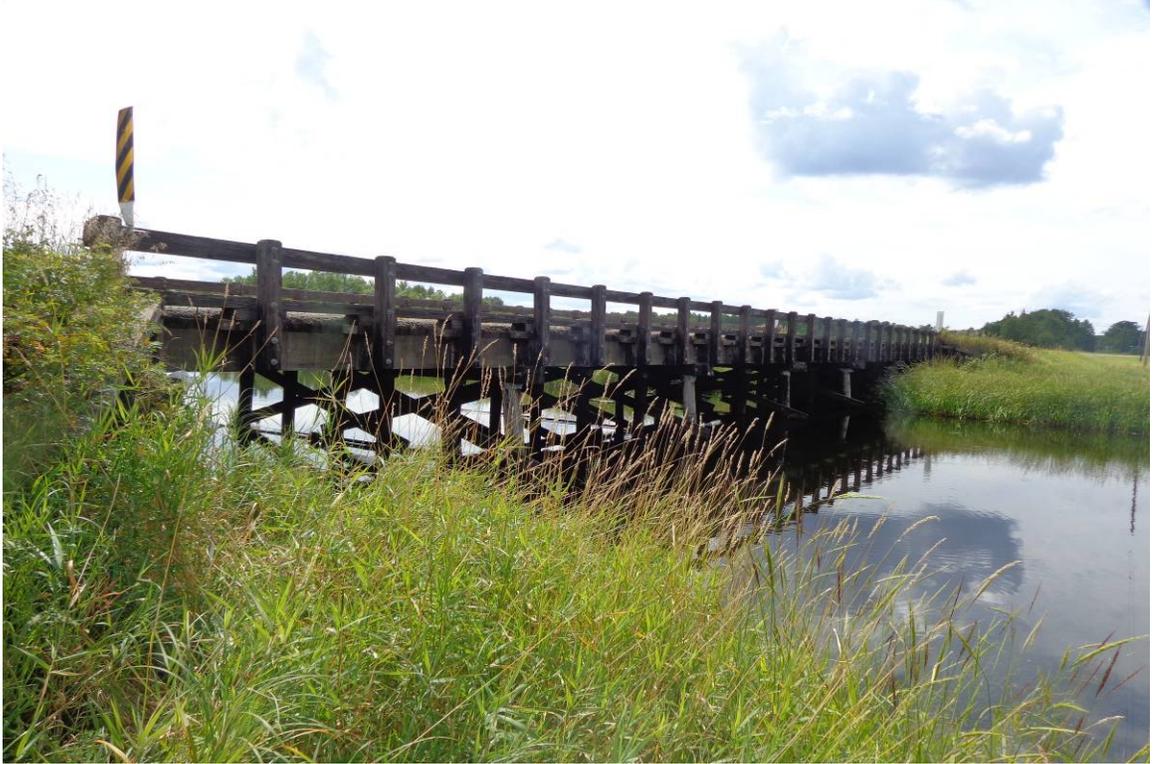
Photograph 1. Overall View of the Structure, Looking Southwest.

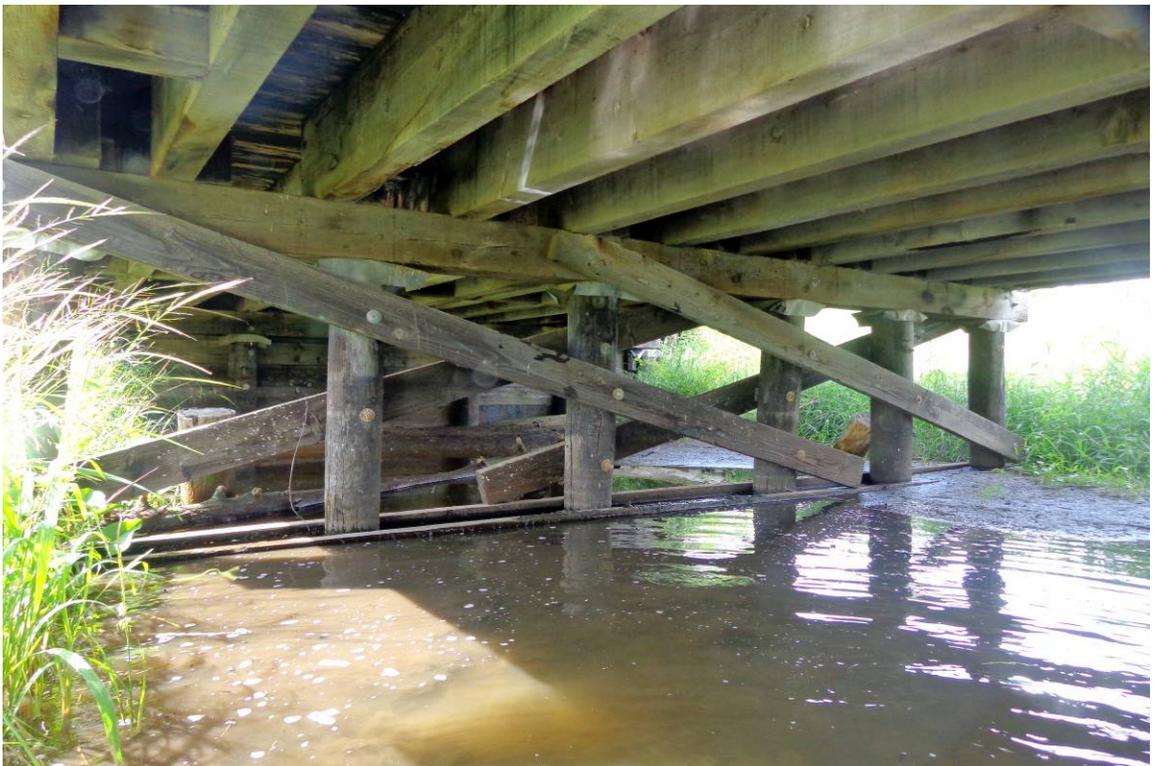
Photograph 2. View of Pier 1, Looking Northwest.

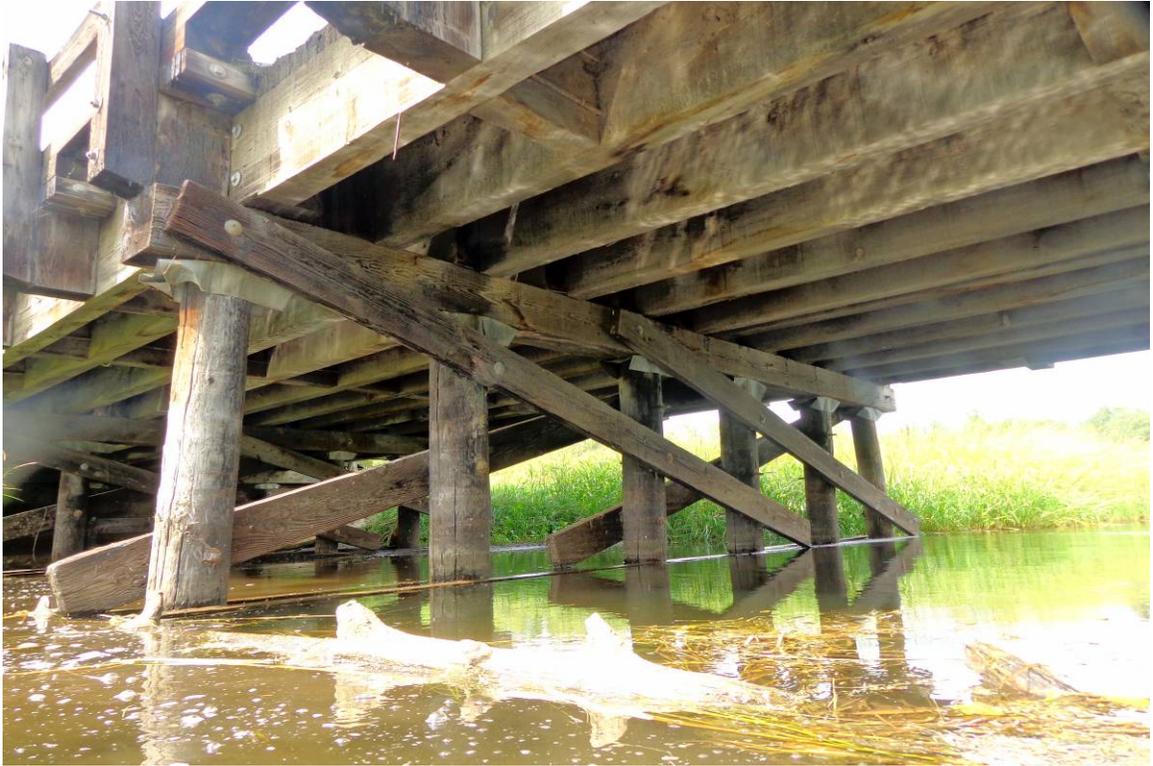
Photograph 3. View of Pier 2, Looking Northwest.

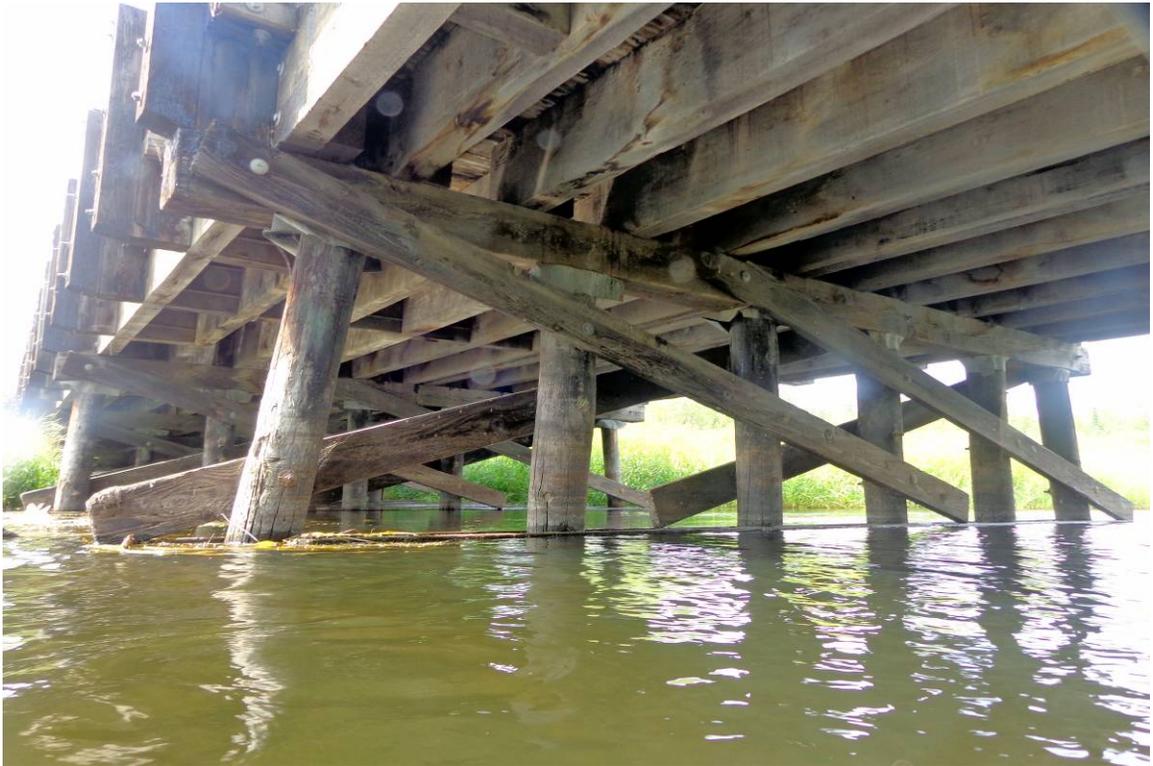
Photograph 4. View of Pier 3, Looking Northwest.

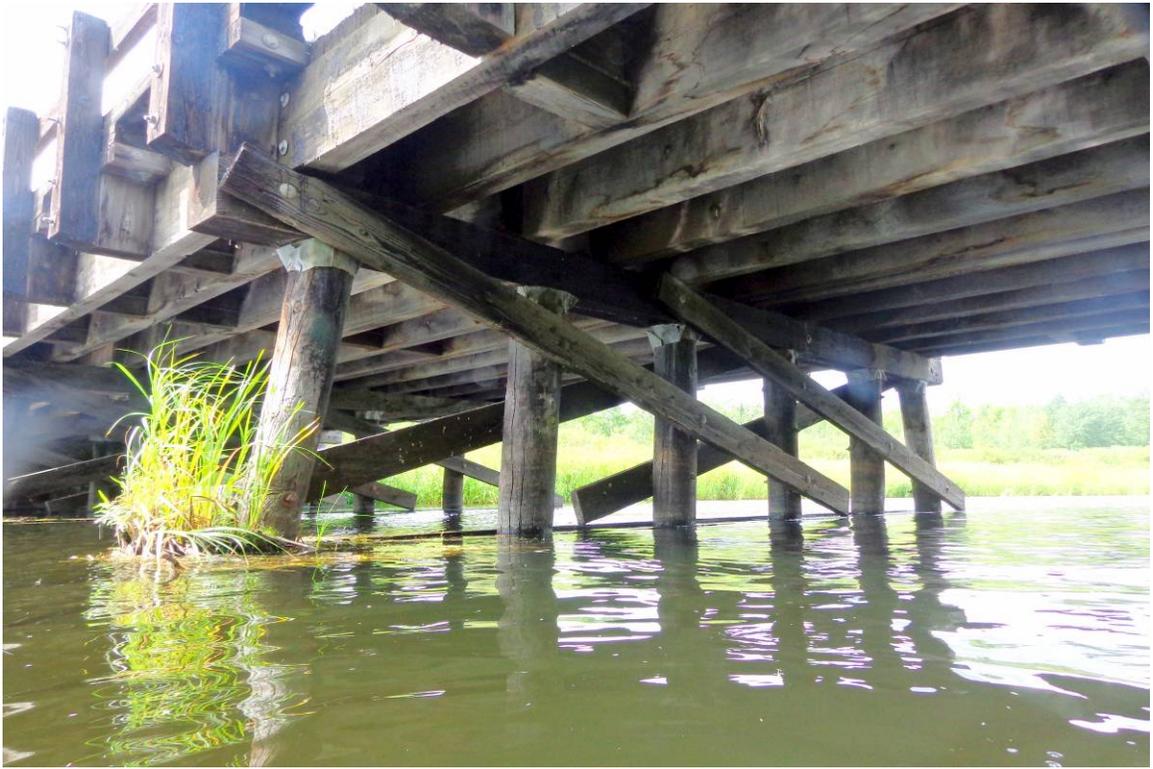
Photograph 5. View of Pier 4, Looking Northwest.

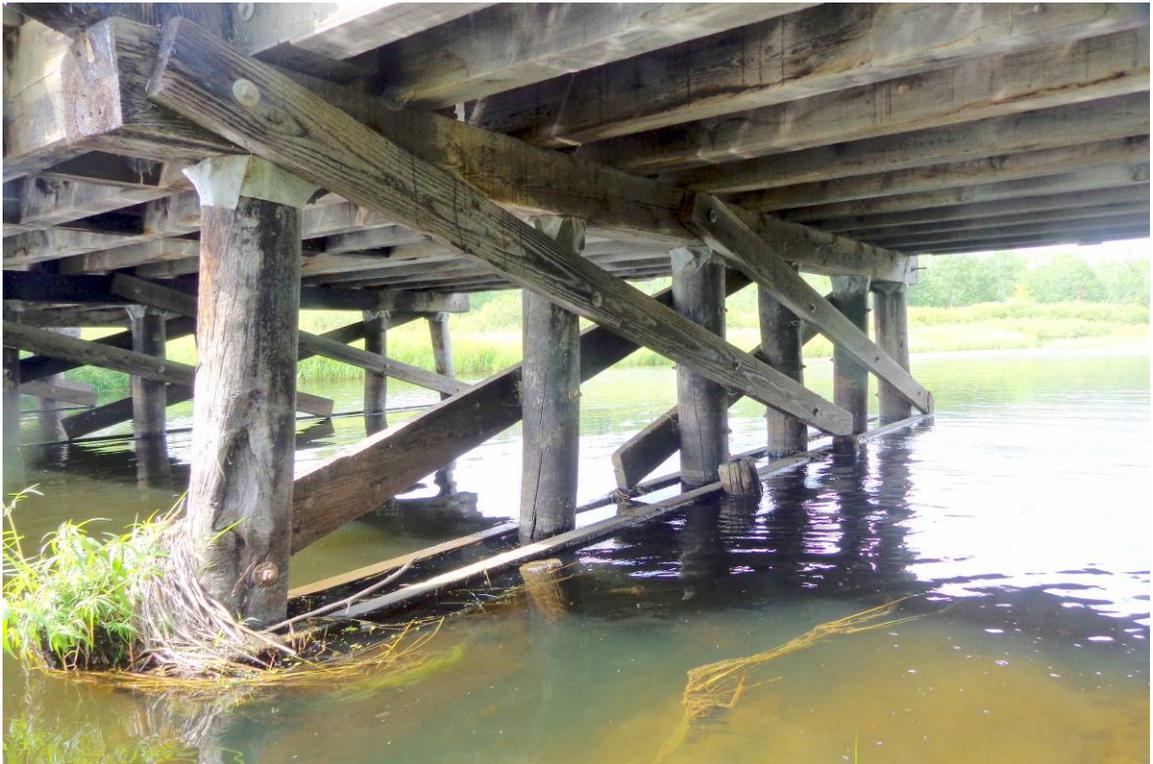
Photograph 6. View of Pier 5, Looking Northwest.

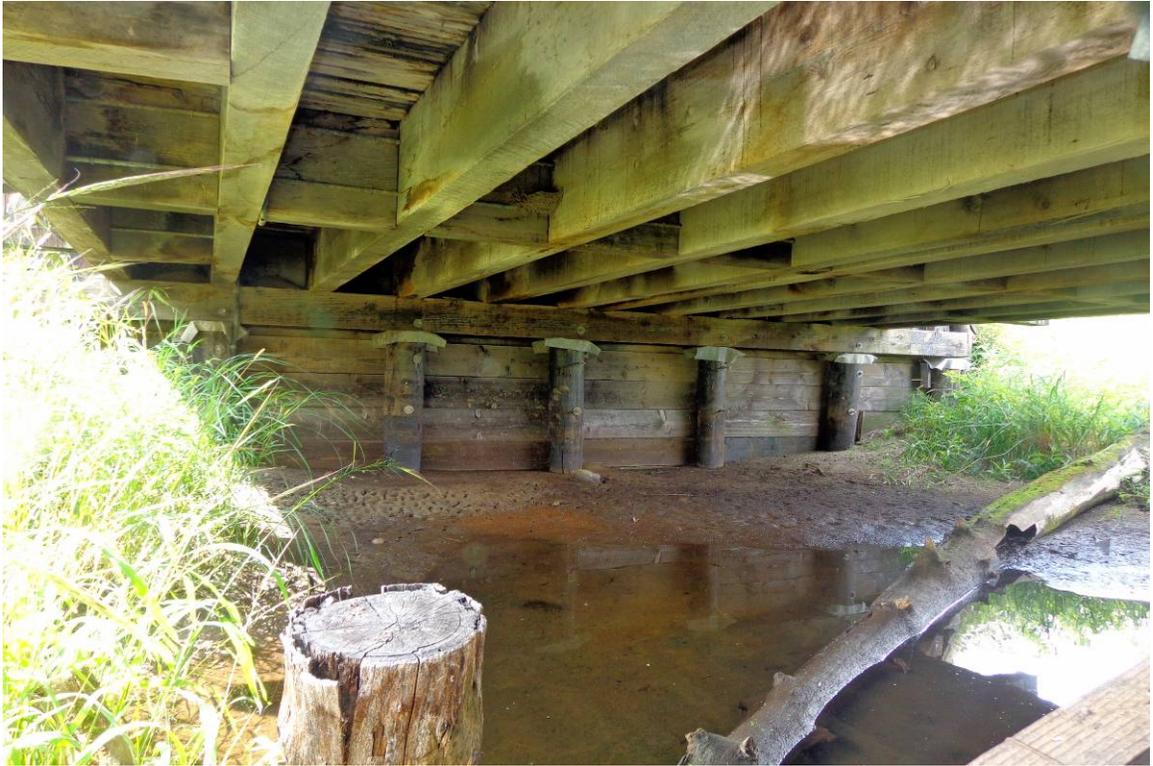
Photograph 7. View of West Abutment, Looking Northwest.

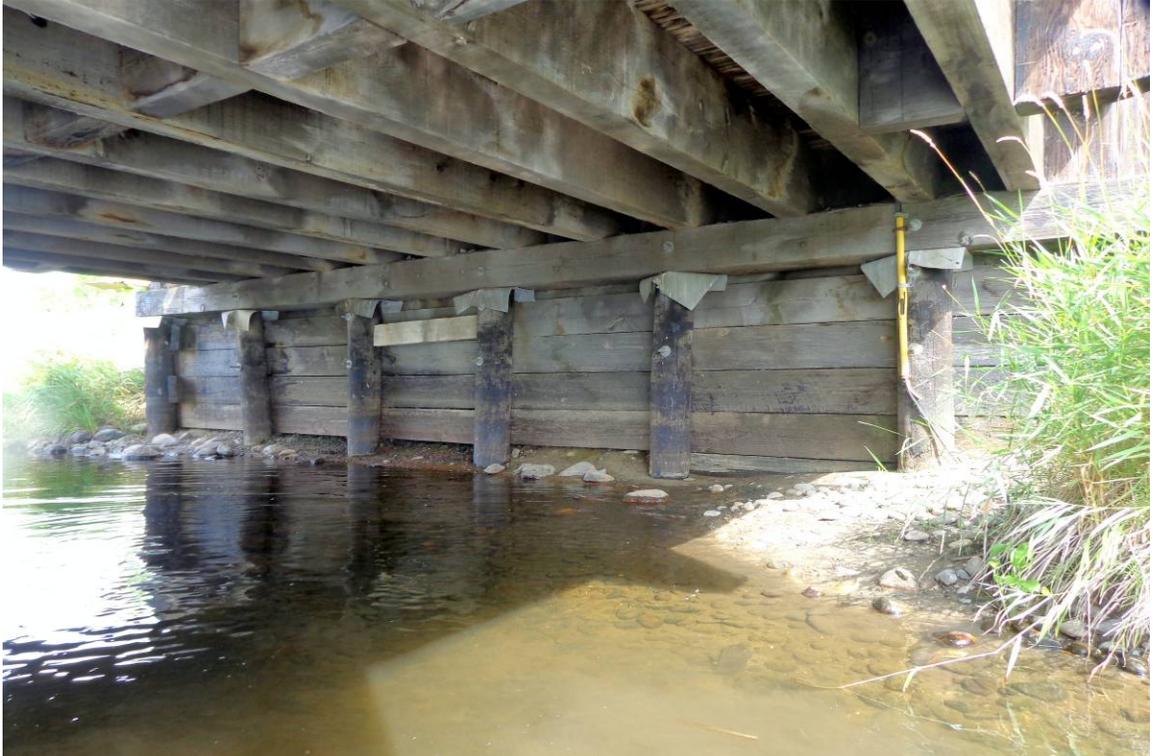
Photograph 8. View of East Abutment, Looking Northeast.

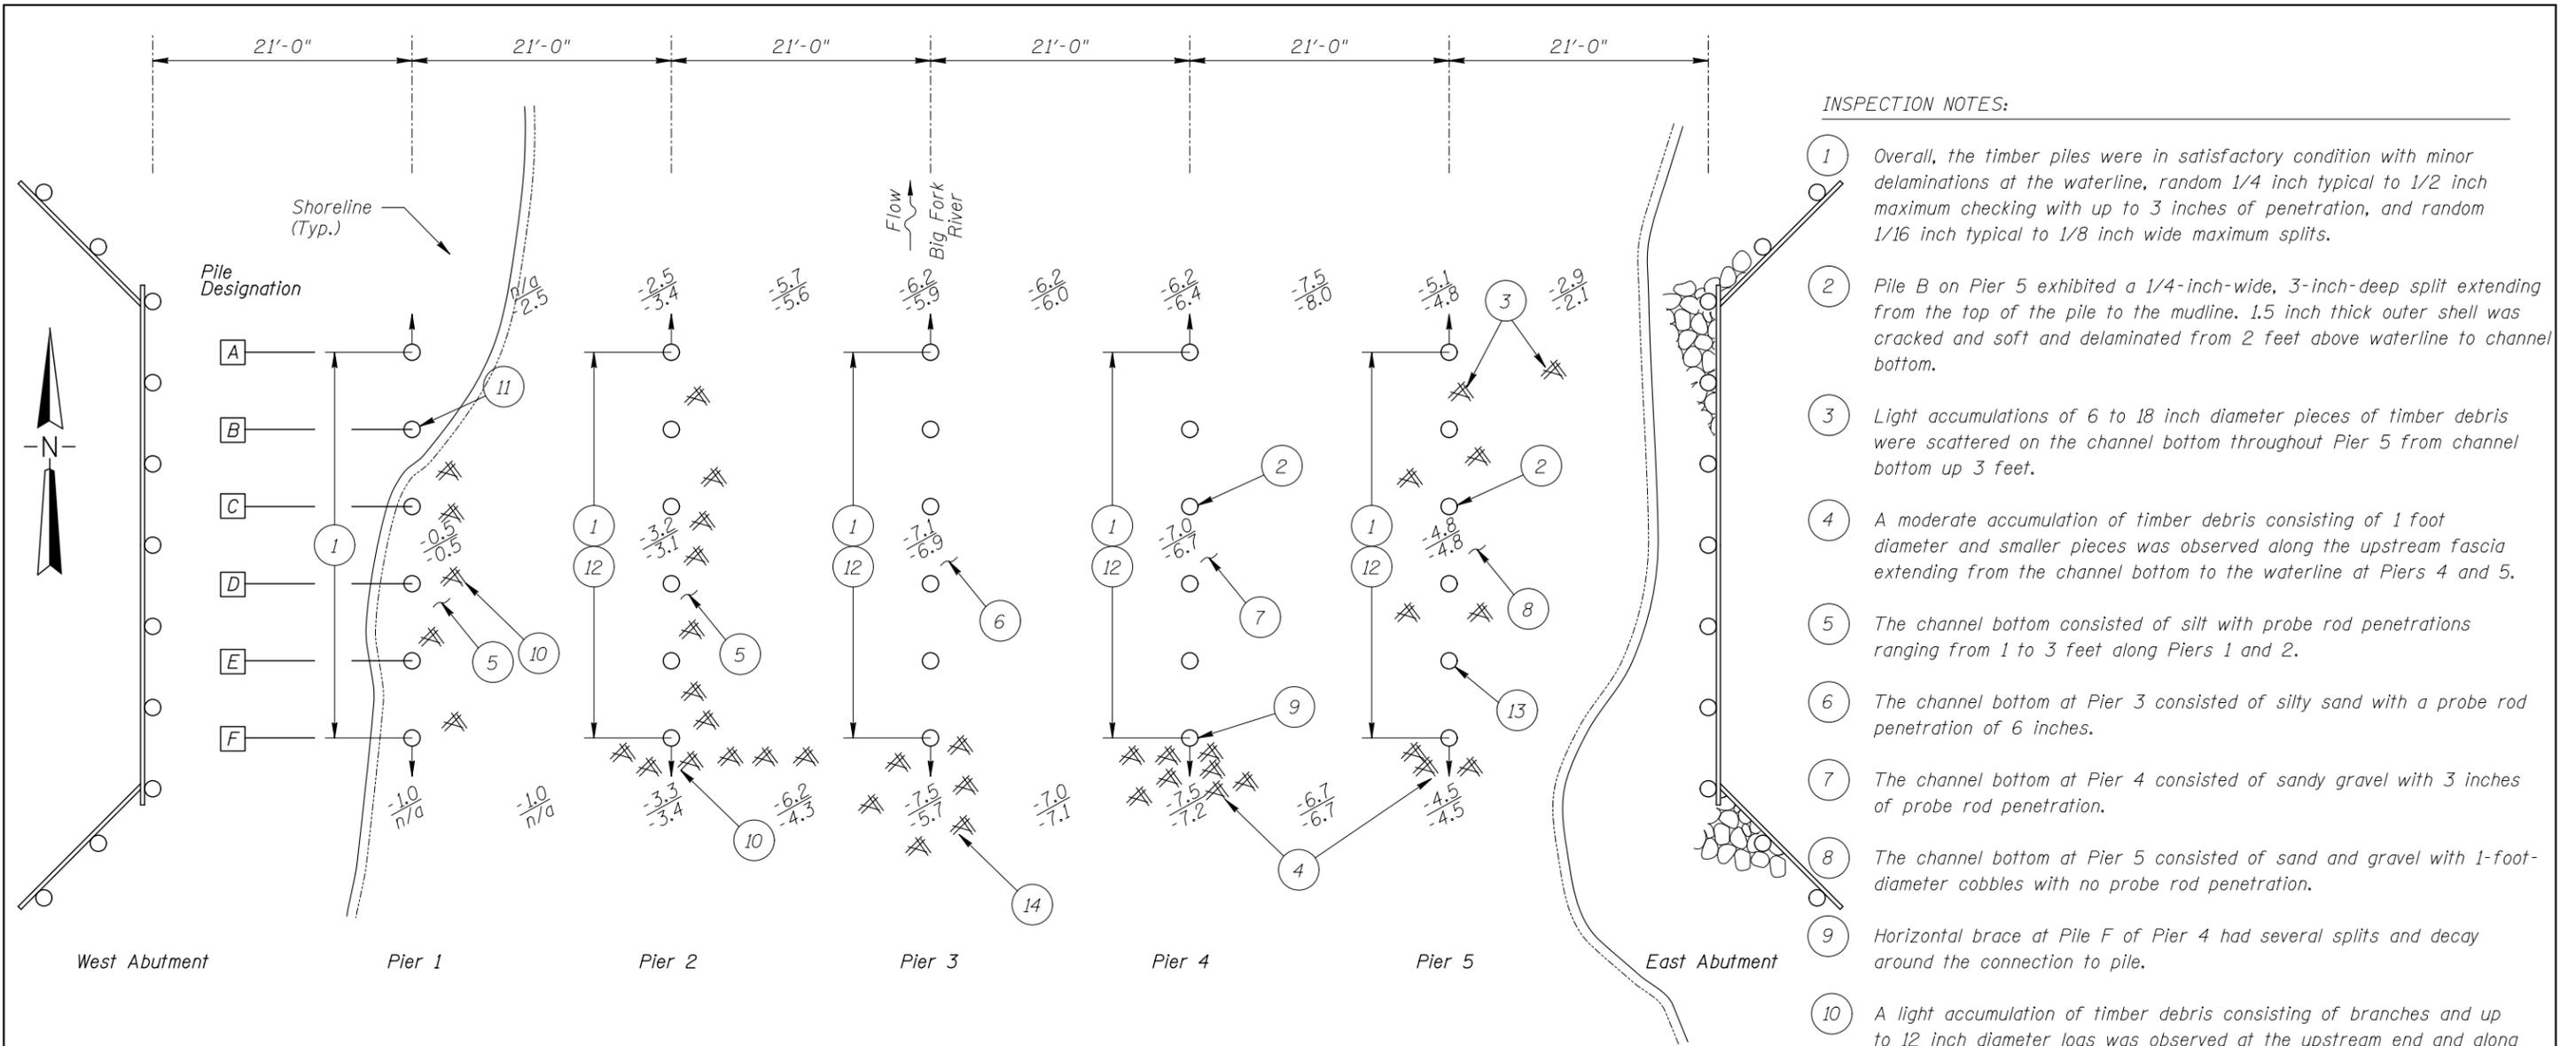
MINNESOTA DEPARTMENT OF TRANSPORTATION UNDERWATER BRIDGE INSPECTION		
STRUCTURE NO. 7003 OVER THE BIG FORK RIVER DISTRICT 1, ITASCA COUNTY		
INSPECTION AND SOUNDING PLAN		
Drawn By: JTF	COLLINS ENGINEERS	Date: AUGUST 2012
Checked By: DGS		Scale: NTS
Code: 52217003		Figure No.: 1

- 1 Overall, the timber piles were in satisfactory condition with minor delaminations at the waterline, random 1/4 inch typical to 1/2 inch maximum checking with up to 3 inches of penetration, and random 1/16 inch typical to 1/8 inch wide maximum splits.

- 2 Pile B on Pier 5 exhibited a 1/4-inch-wide, 3-inch-deep split extending from the top of the pile to the mudline. 1.5 inch thick outer shell was cracked and soft and delaminated from 2 feet above waterline to channel bottom.

- 3 Light accumulations of 6 to 18 inch diameter pieces of timber debris were scattered on the channel bottom throughout Pier 5 from channel bottom up 3 feet.

- 4 A moderate accumulation of timber debris consisting of 1 foot diameter and smaller pieces was observed along the upstream fascia extending from the channel bottom to the waterline at Piers 4 and 5.

- 5 The channel bottom consisted of silt with probe rod penetrations ranging from 1 to 3 feet along Piers 1 and 2.
- 6 The channel bottom at Pier 3 consisted of silty sand with a probe rod penetration of 6 inches.

- 7 The channel bottom at Pier 4 consisted of sandy gravel with 3 inches of probe rod penetration.
- 8 The channel bottom at Pier 5 consisted of sand and gravel with 1-foot-diameter cobbles with no probe rod penetration.

- 9 Horizontal brace at Pile F of Pier 4 had several splits and decay around the connection to pile.
- 10 A light accumulation of timber debris consisting of branches and up to 12 inch diameter logs was observed at the upstream end and along the east faces of Piers 1 and 2.

- 11 Pile B on Pier 1 was 50% broken and missing (loss of section) at horizontal connection.
- 12 The braces exhibited section loss at the ends and minor splitting. Except where noted, the connections were in good condition.

- 13 Pile E on Pier 5 exhibited a 1/4 inch to 1/2 inch wide split from 2 feet above to 1 foot below the waterline on the north face.
- 14 Moderate accumulation of timber debris consisting of 6 inch to 18 inch diameter branches, extending from the channel bottom to the waterline, was observed around the upstream end of Pier 3.
