UNDERWATER BRIDGE INSPECTION REPORT

STRUCTURE NO. 7065

GARDEN LAKE

MINNESOTA DEPARTMENT OF TRANSPORTATION
UNDERWATER BRIDGE INSPECTION

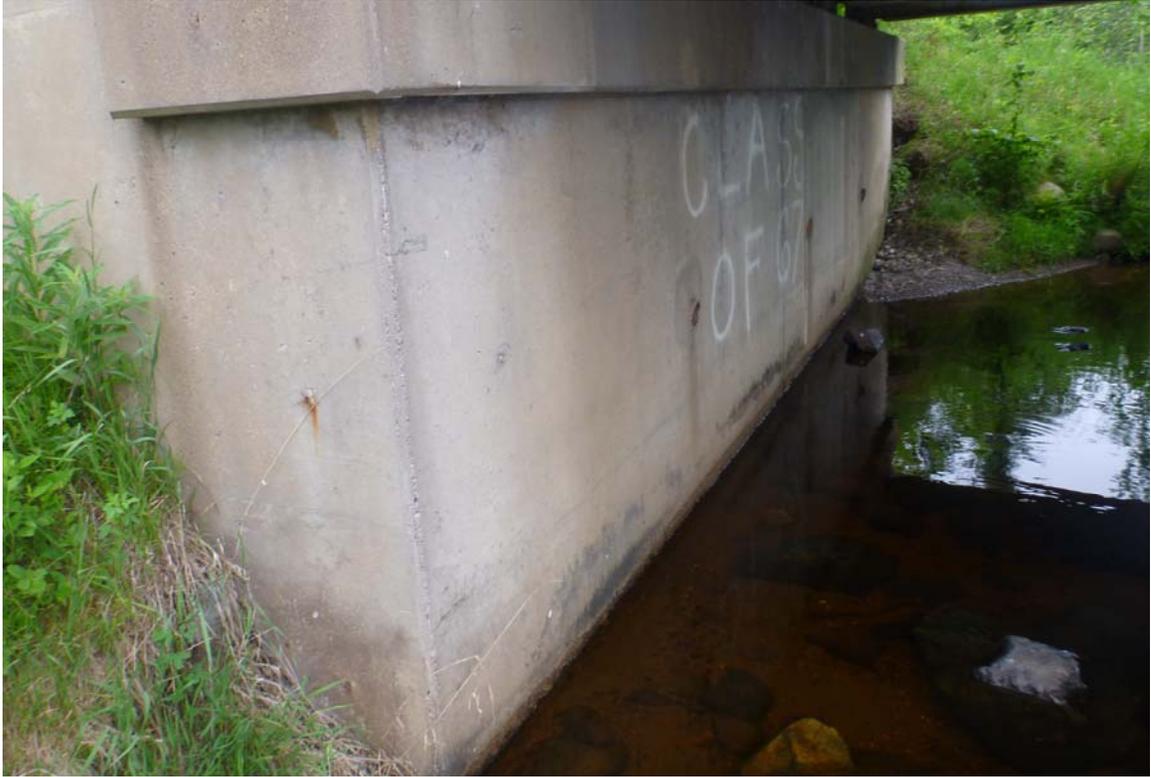
Photograph 3. View of the West Abutment, Looking Northwest.

9. 1/4" to 1/2" deep scaling was observed at the West and East abutments extending from the waterline to the channel bottom.

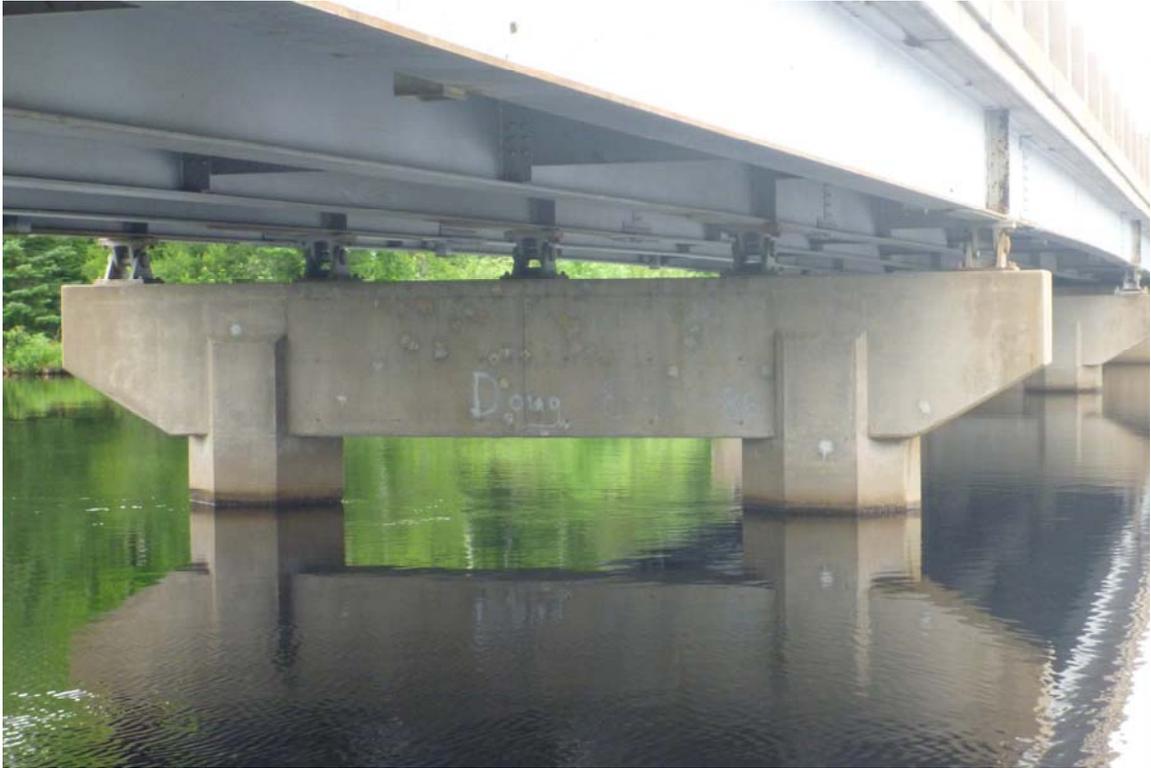
- (A) An area of minor section loss, 12 inches high by 6 inches wide with 2 inches of penetration, was located on the upstream nose of the downstream column of Pier 1 with no exposed reinforcing steel observed.

- (F) A minor scour depression, 5 foot in radius by 1 foot deep, was observed at the upstream nose of Pier 1.

Photograph 4. View of Pier 1, Looking Northeast.

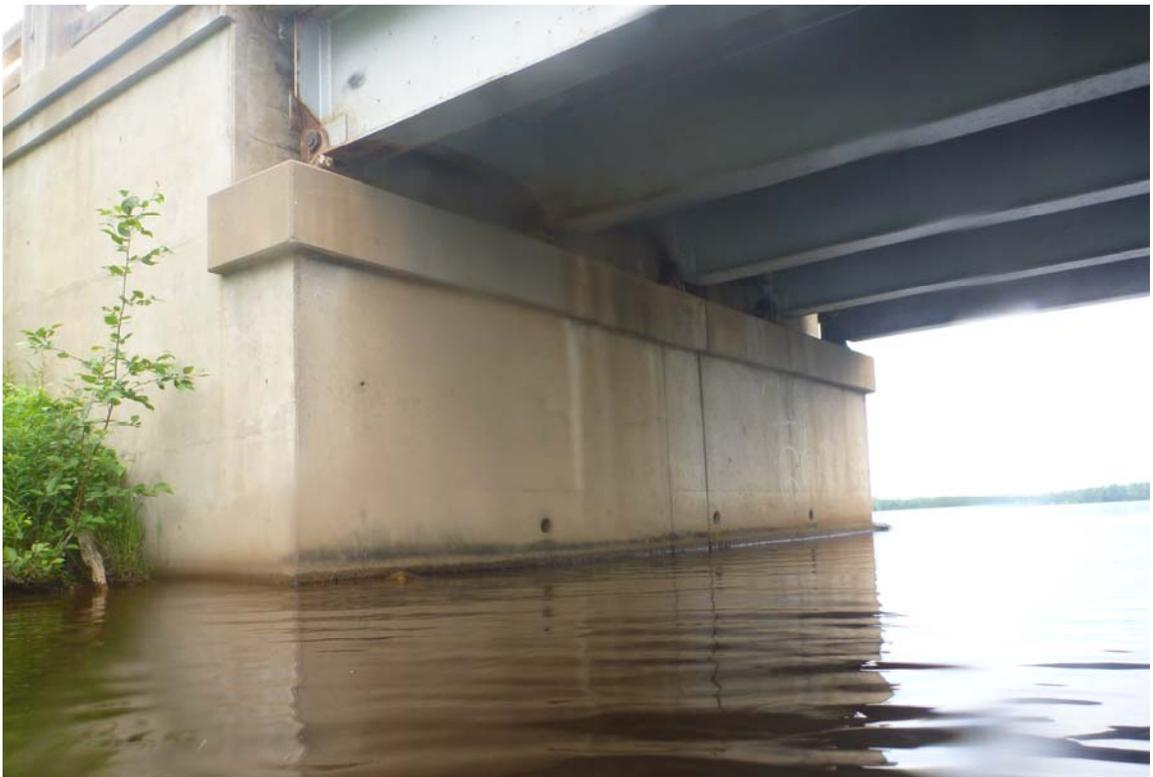
Photograph 6. View of the East Abutment, Looking Southeast.

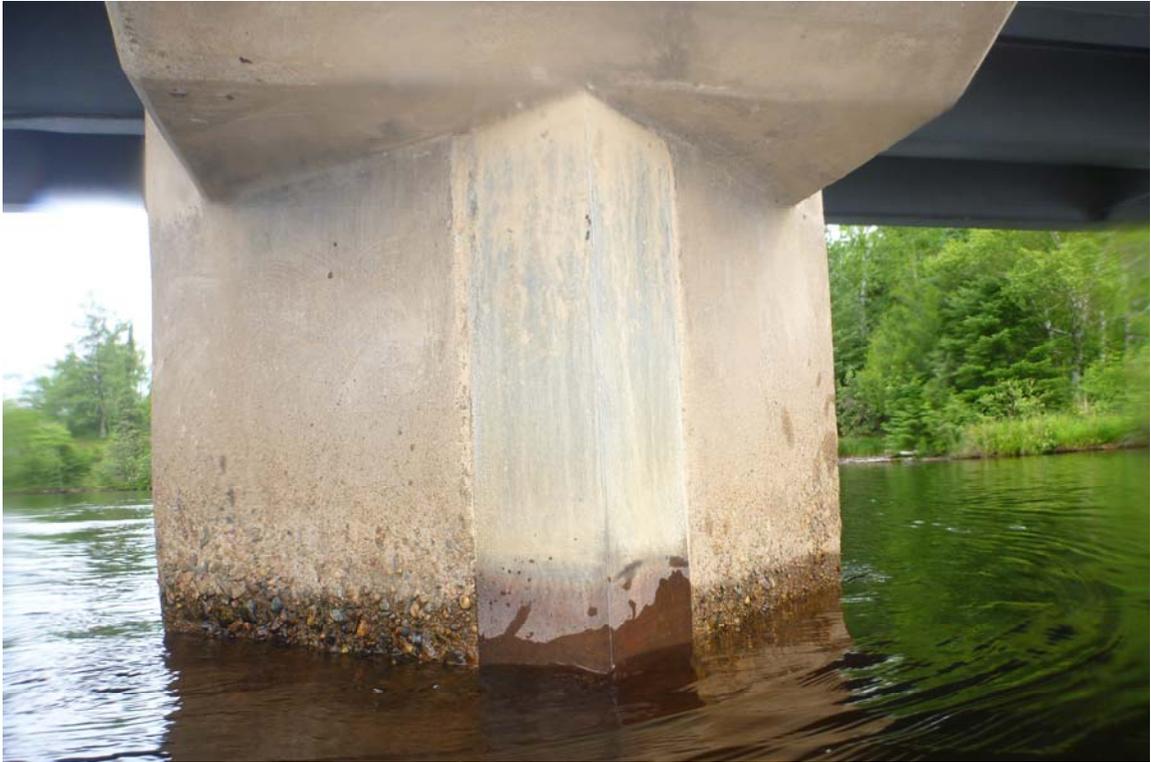
- (D) Light scaling was observed on both piers extending from 6 inches above to 3 feet below the waterline and had a maximum penetration of 1/4 inch.
- (E) Moderate scaling was observed at the West and East Abutments extending from the waterline to the channel bottom with a typical penetration of 1/2 inch.

Photograph 7. View of Typical Scaling near the Waterline at the Upstream Column of Pier 2, Looking North.

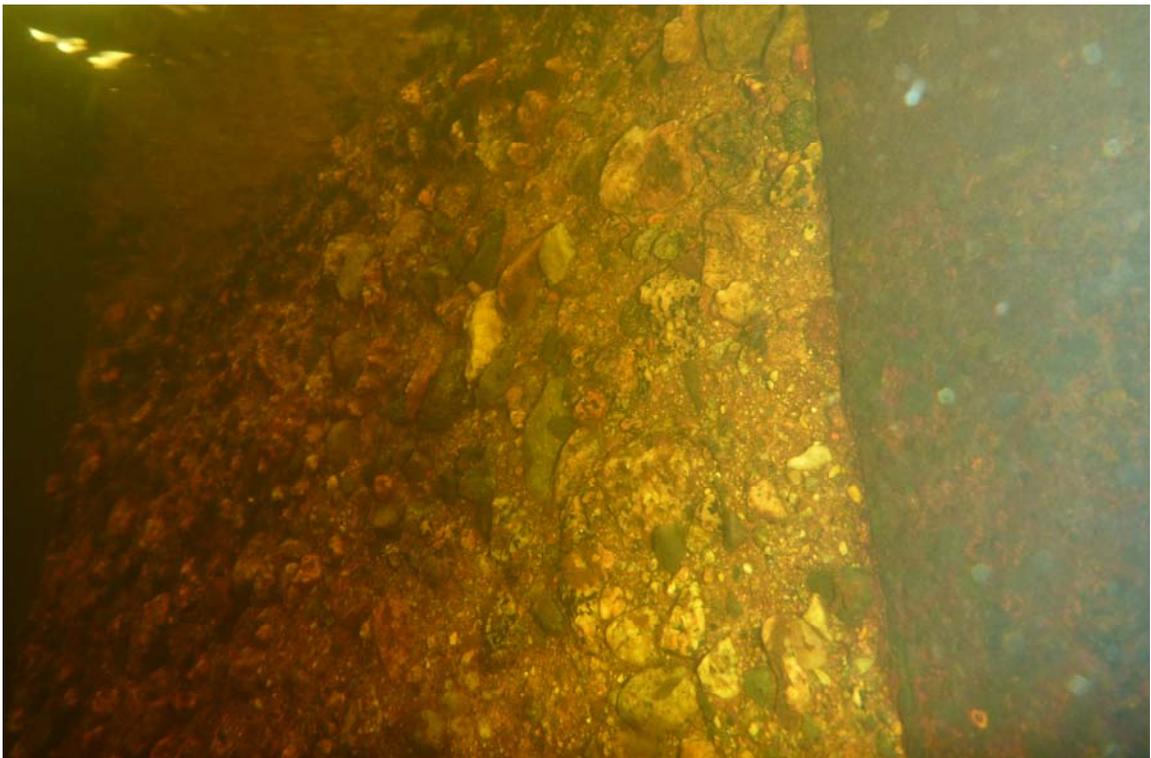
Photograph 8. View of Typical Scaling Below Water at the Upstream Column of Pier 2, Looking Northeast.

5. The concrete surfaces on both piers from 6 inches above to 3 feet below the waterline exhibited up to a 1/4 inch deep scaling with exposed aggregate.

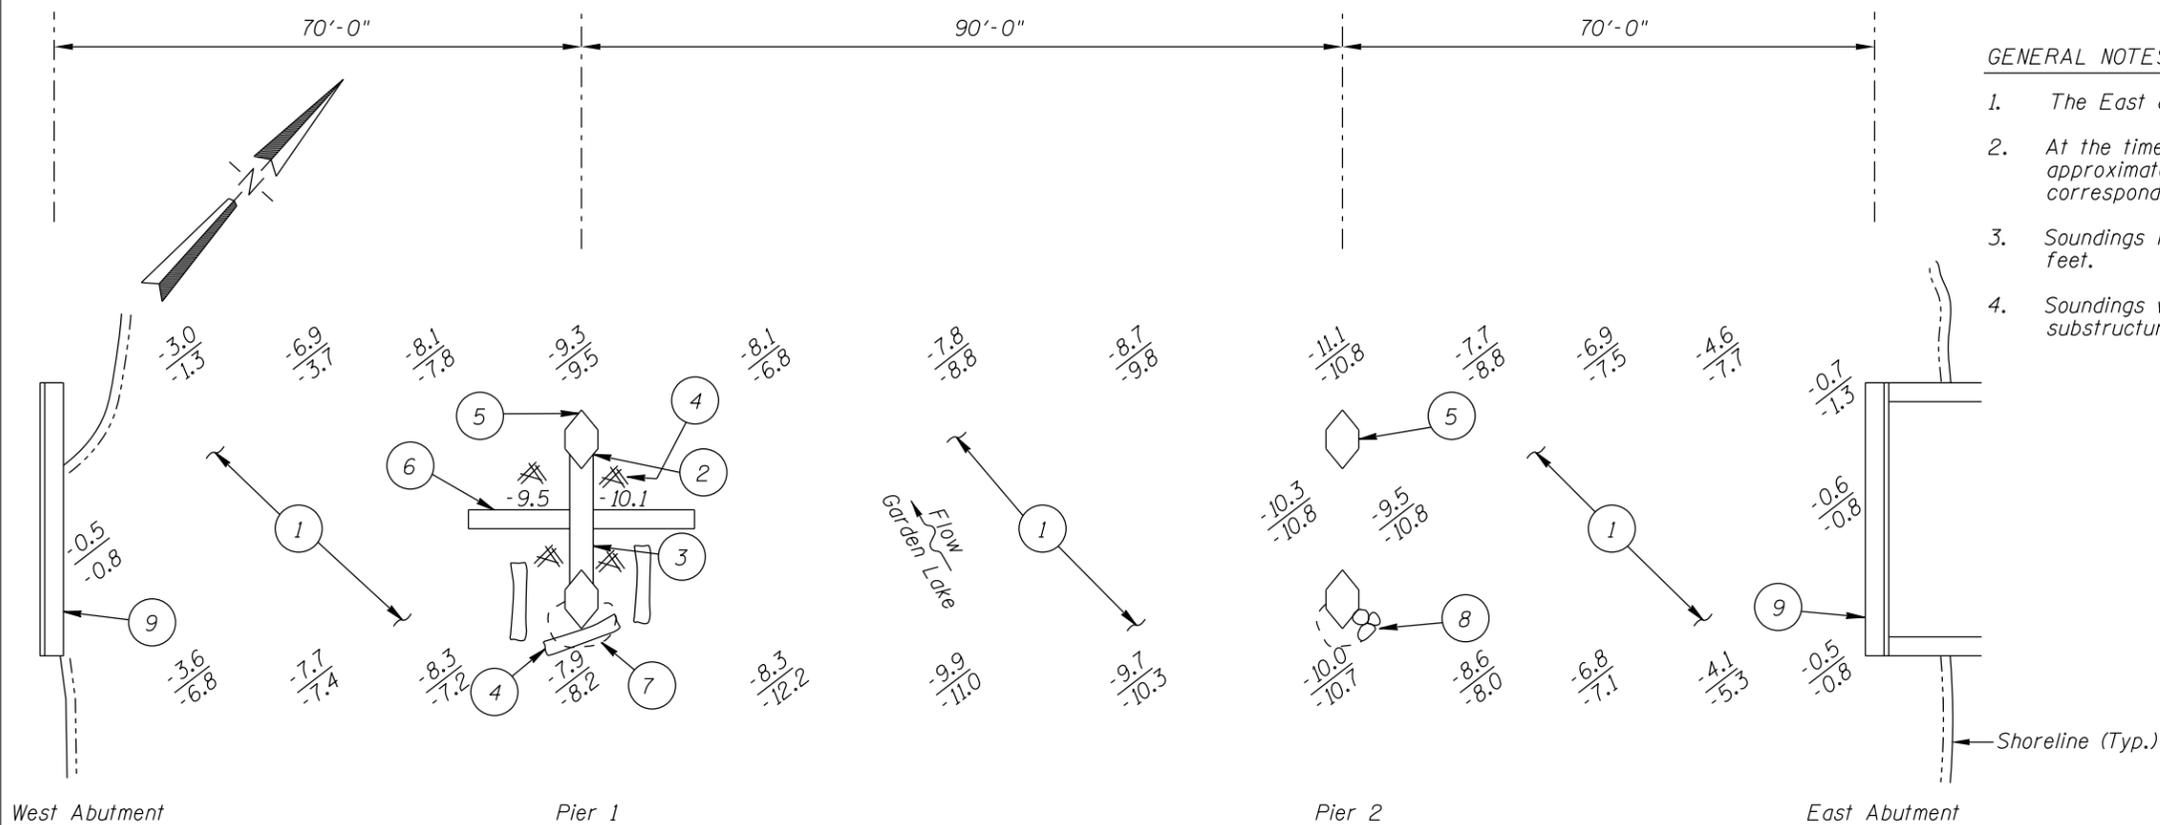
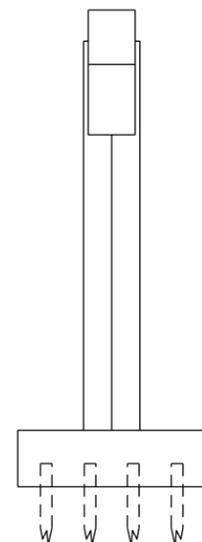
INSPECTION AND SOUNDING PLAN

1. The channel bottom material consisted of sandy gravel allowing 2 inches of probe rod penetration with scattered 1- to 3-foot-diameter riprap and 6-inch-diameter cobbles.

2. Section loss, approximately 12 inches high by 6 inches wide, with 2 inches maximum penetration was observed at the upstream nose of the downstream column of Pier 1. No exposed reinforcing steel was present.

3. The top of a horizontal strut was observed approximately 5.5 feet below the waterline. The channel bottom was generally flush with the bottom of horizontal strut on both the east and west side of the pier.

4. Several scattered 1-foot-diameter logs were observed on the channel bottom around the pier, with one extending across the upstream nose of the pier. Other 6 inch diameter and smaller drift was also scattered around the pier.

6. At approximately 8 feet below the waterline at the center of the horizontal strut of Pier 1, a steel I-beam was observed extending out 5 feet on each side of the strut.

7. A minor scour depression, 5 feet in radius by 1 foot deep, was observed at the upstream column of Pier 1.
8. Heavy concentration of up to 4 foot diameter riprap was observed at the easterly side of the upstream column of Pier 2. On the westerly side, there was smaller riprap and a slight 1 foot deep scour depression.
