UNDERWATER BRIDGE INSPECTION REPORT

STRUCTURE NO. 7111

BIG FORK RIVER

AUGUST 14, 2012

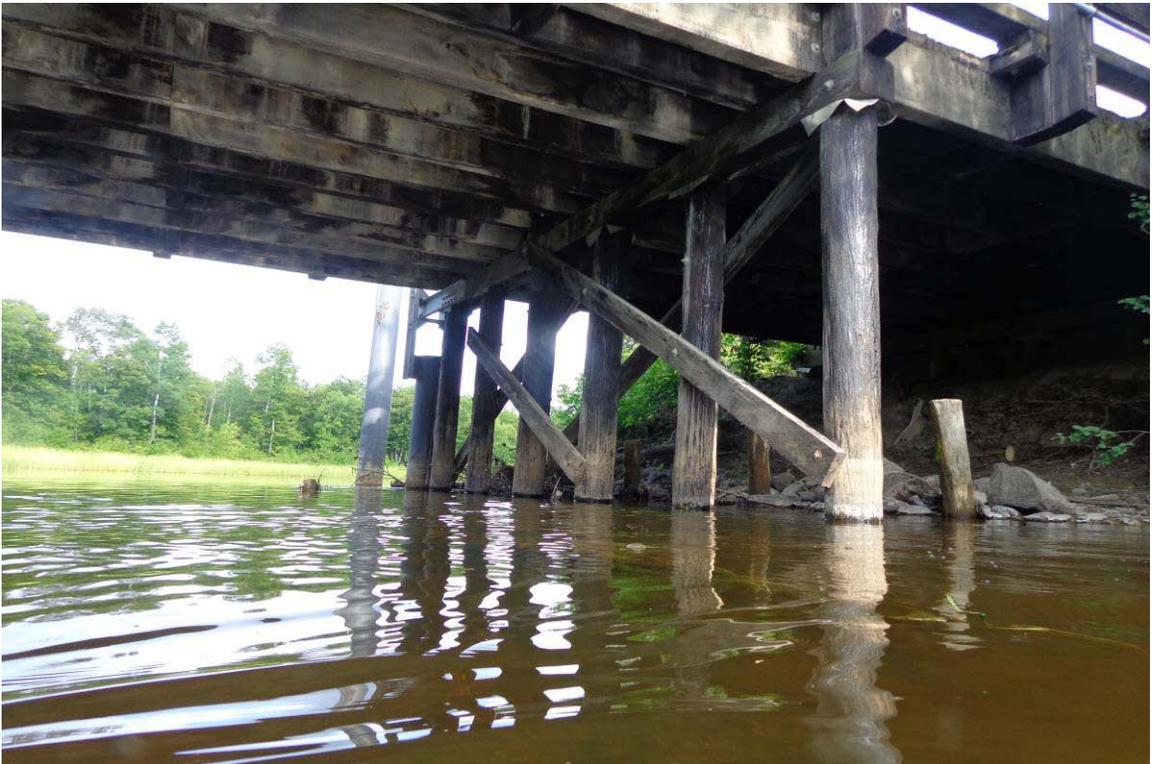
Photograph 2. View of Pier 1, Looking Southeast.

- 5 The F Pile at Piers 1 and 4 have been supplemented with concrete filled steel piles that were connected to the upstream end of the existing timber pier caps with steel braces.

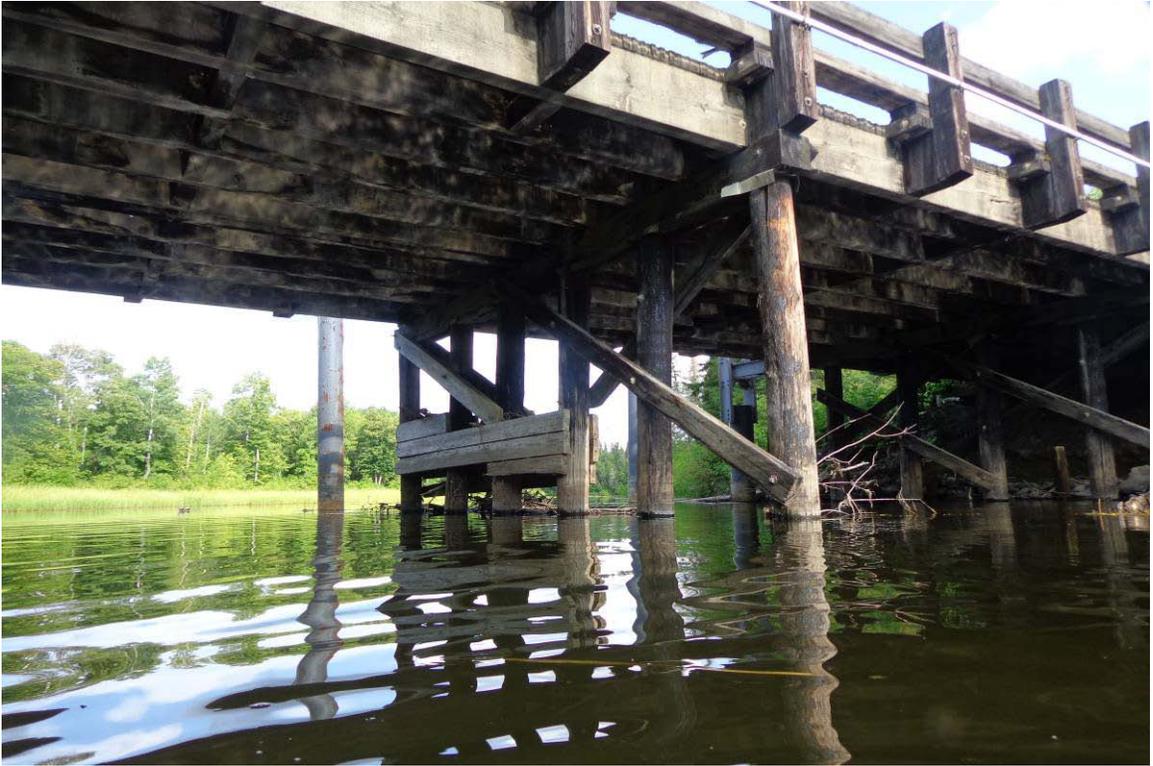
Photograph 3. View of Pier 2, Looking Southeast.

- 7 Pile F at Pier 2 has been displaced approximately 1.5 inches westward under the cap with some related damage present at the pile top due to timber drift and high water.

- 10 Both shorelines under the bridge consisted of bare slope with heavy erosion and 6 foot high vertical cut slopes.
- 11 Pile E at Pier 2 was crushed and failed from 3 feet above waterline to 1 foot below the waterline.

- 12 The horizontal timber planking between Piles E and F at Pier 2 exhibited heavy impact damage from debris and ice.
- 13 The bottom horizontal timber planking on the north face of Pier 2 was missing from Pile C to Pile F. The rest of the timber planking on the north face of Pier 2 exhibited heavy damage due to drift and ice flows.

- (D) The stability and load carrying capacity of Pier 2 should be examined based on the damaged pile, and if found to be insufficient, it may be necessary to supplement the pile with some means of carrying load for the pier. If Pier 2 still has sufficient capacity/stability, given the significantly cracked pile, then future inspections should particularly monitor that pile and pier for any further distress.

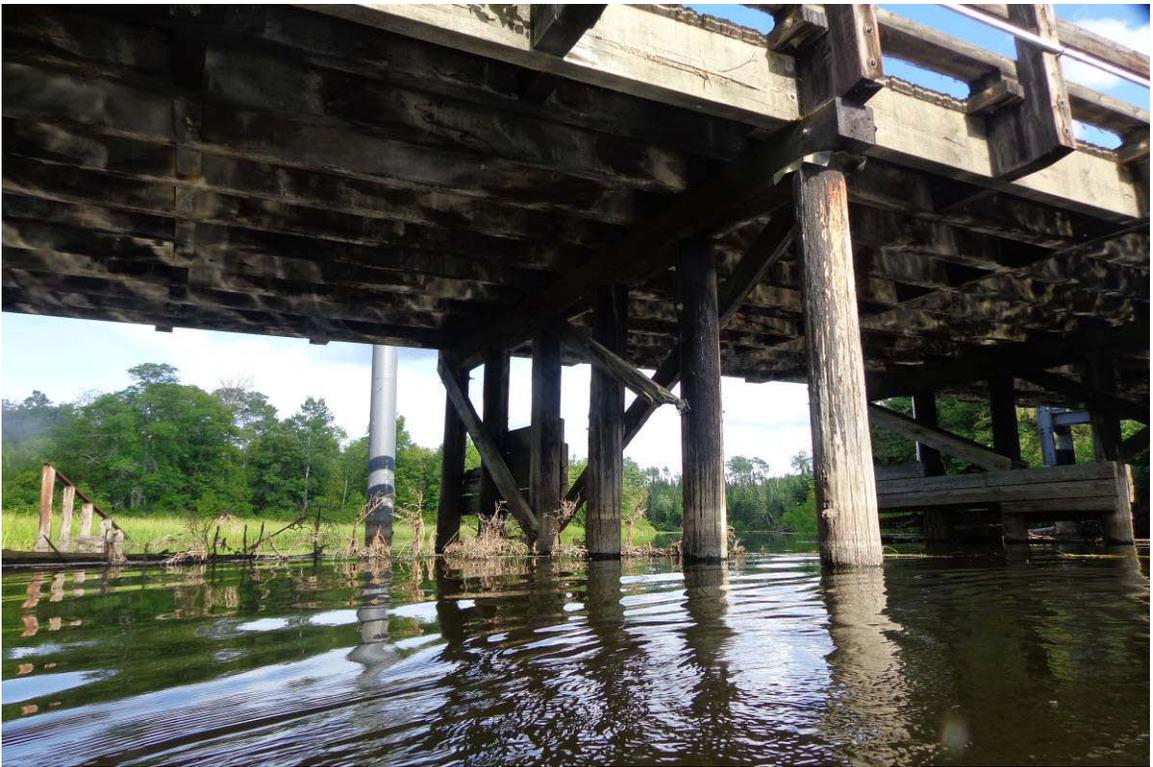
Photograph 4. View of Pier 3, Looking Southeast.

- 14 The timber cross bracing was broken off on the north face of Pier 3 at Pile E.
- 15 The horizontal timber planking on the south face of Pier 3 was missing at Piles D, E, and F from the waterline up 2 feet.

- 16 Moderate timber debris was observed along the north face and at the upstream pile of Pier 3. The debris extended from the channel bottom to the waterline and consisted of 18 inch diameter and smaller timber pieces.

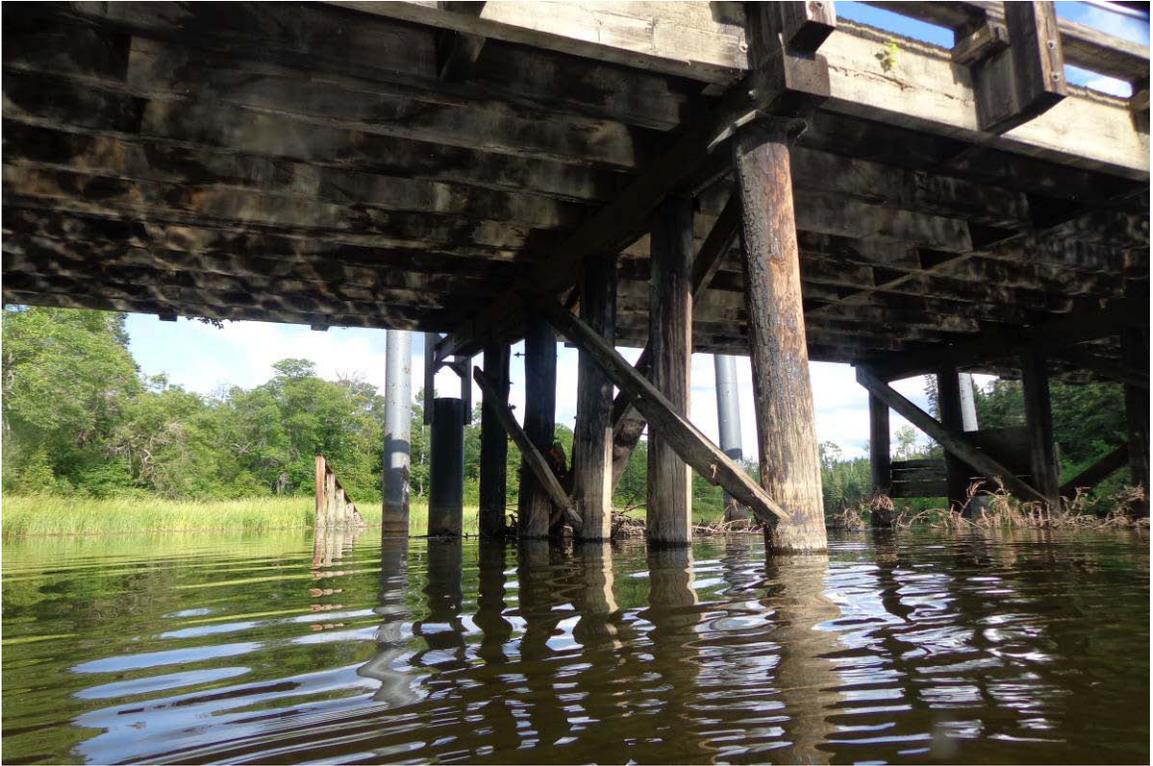
Photograph 5. View of Pier 4, Looking Southeast.

- 6 The timber Pile F at Pier 4 has been displaced and was positioned at an incline towards the downstream fascia with the top of the pile about 4 feet above the waterline.

- 9 The timber cross bracing on both the north and south faces had a split extending from Pile A to Pile C at Pier 4. The split extended through the connection at Pile A and approximately 3 feet of the timber bracing under the split was broken away and failed.

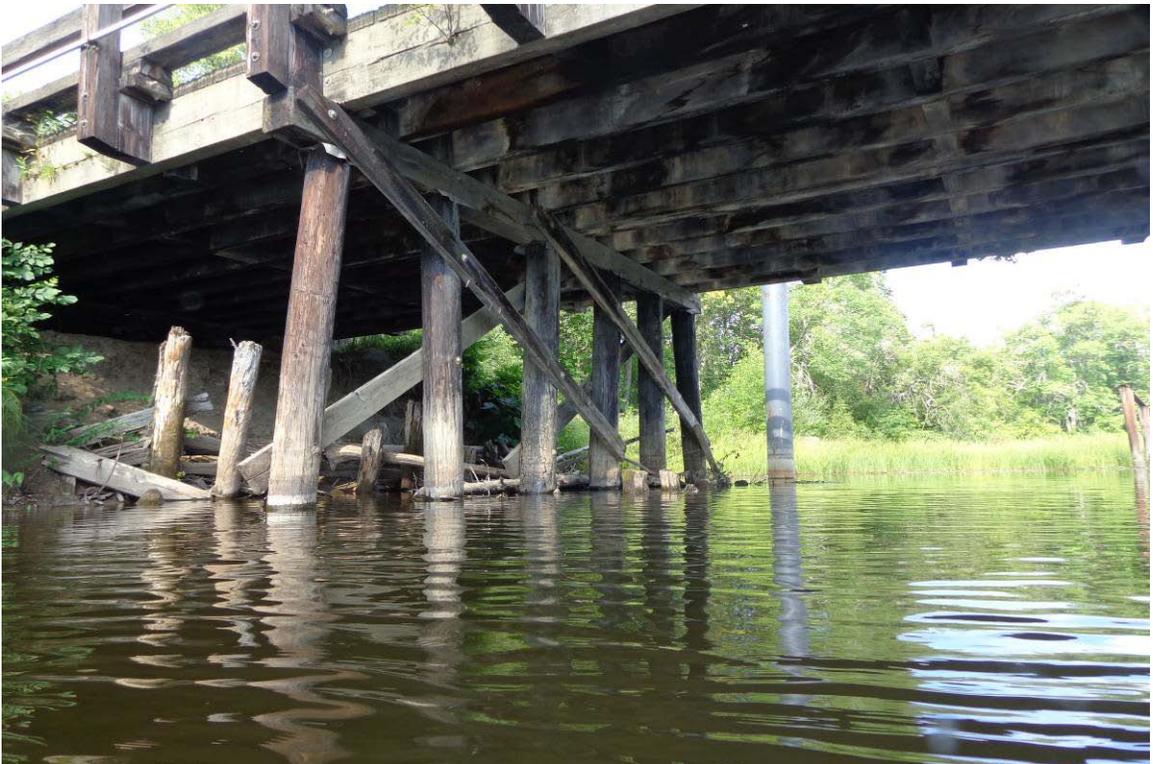
Photograph 6. View of Pier 5, Looking Northeast.

- 17 Moderate to heavy timber debris consisting of 6 inch diameter and smaller logs and branches was observed at Piers 4 and 5, extending from the waterline to the channel bottom.

- 22 The timber cross bracing exhibited a 3-foot-long by 1/4-inch wide split through the connection at Pile A of Pier 5.
- 23 The cross bracing on the south face of Pier 5 at Pile F was crushed and failed.
