UNDERWATER BRIDGE INSPECTION REPORT

STRUCTURE NO. 7182

WHITEFACE RIVER

JULY 24, 2012

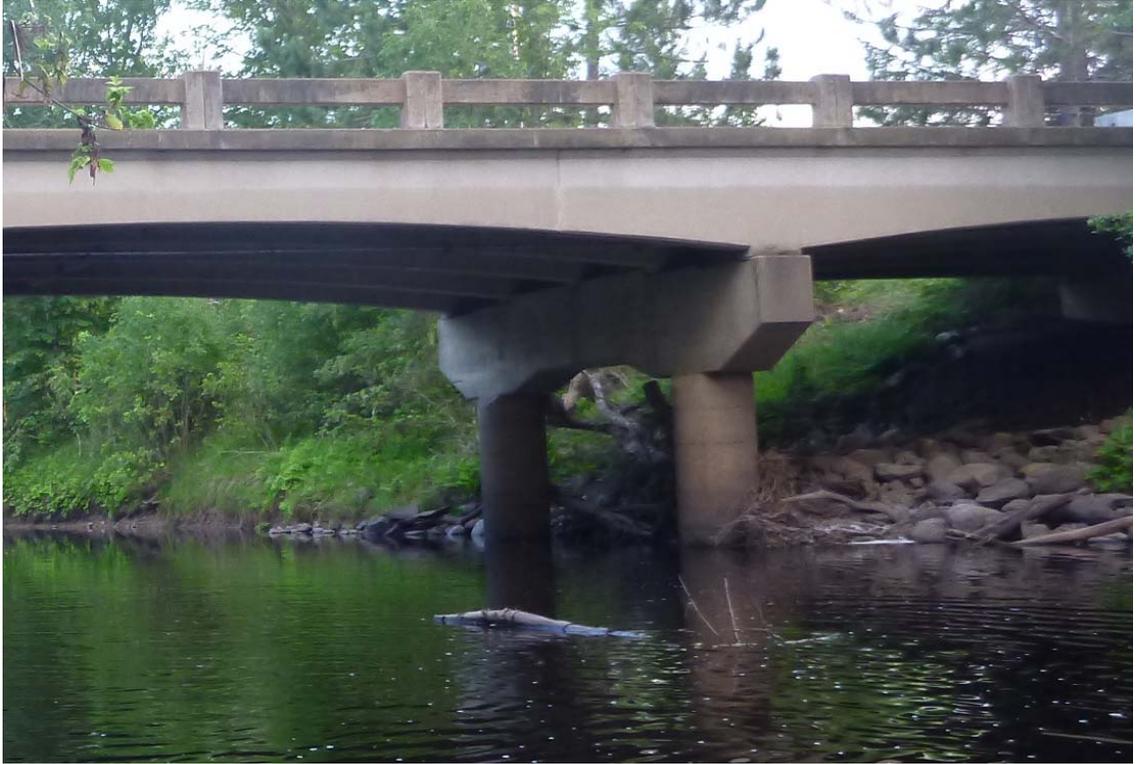
Photograph 1. View of Pier 1, Looking Southwest.

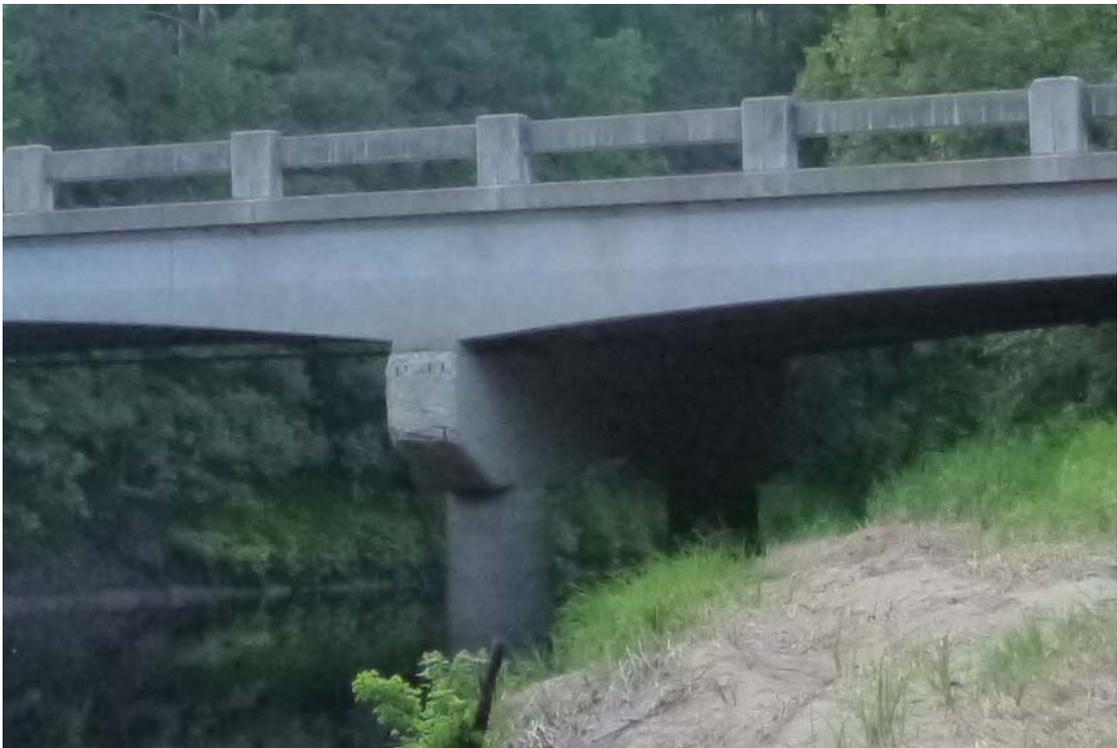
Photograph 2. View of Pier 2, Looking Northwest.

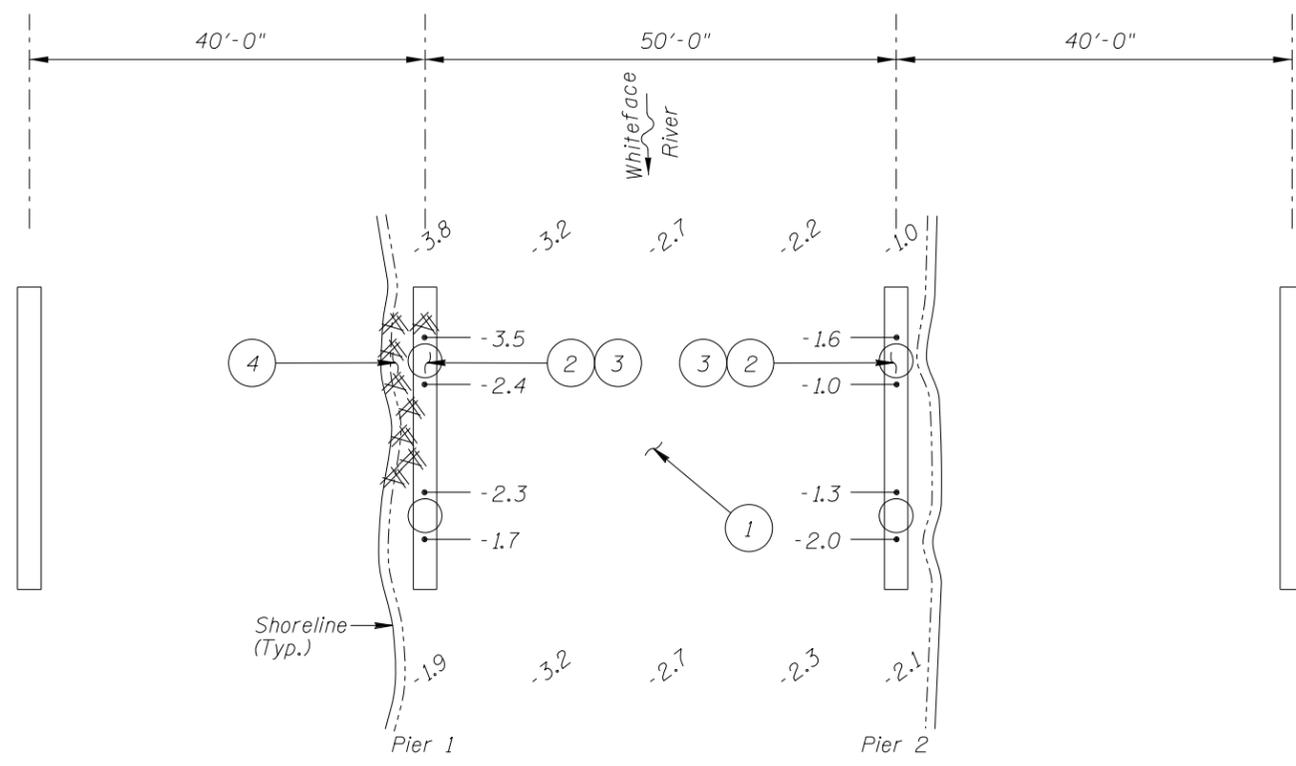
INSPECTION AND SOUNDING PLAN

- ① The channel bottom consisted of sand and scattered riprap 12 inch diameter and smaller.
- ② Light concrete scaling, with up to 1/8 inch penetration was observed from 4 feet above waterline to channel bottom.
- ③ Heavy concrete scaling, with 1/2 inch typical and 1 inch maximum penetration was observed from 1 foot above waterline to 1 foot below waterline.
- ④ A moderate accumulation of timber debris, consisting of logs and branches 12" inch dia. and smaller, was observed around the upstream column of Pier 1 extending along the west side of the pier and up to 5 feet off the pier, from the channel bottom to 5 feet above the waterline.
