UNDERWATER BRIDGE INSPECTION REPORT

STRUCTURE NO. 7183

CSAH 100

ST. LOUIS RIVER

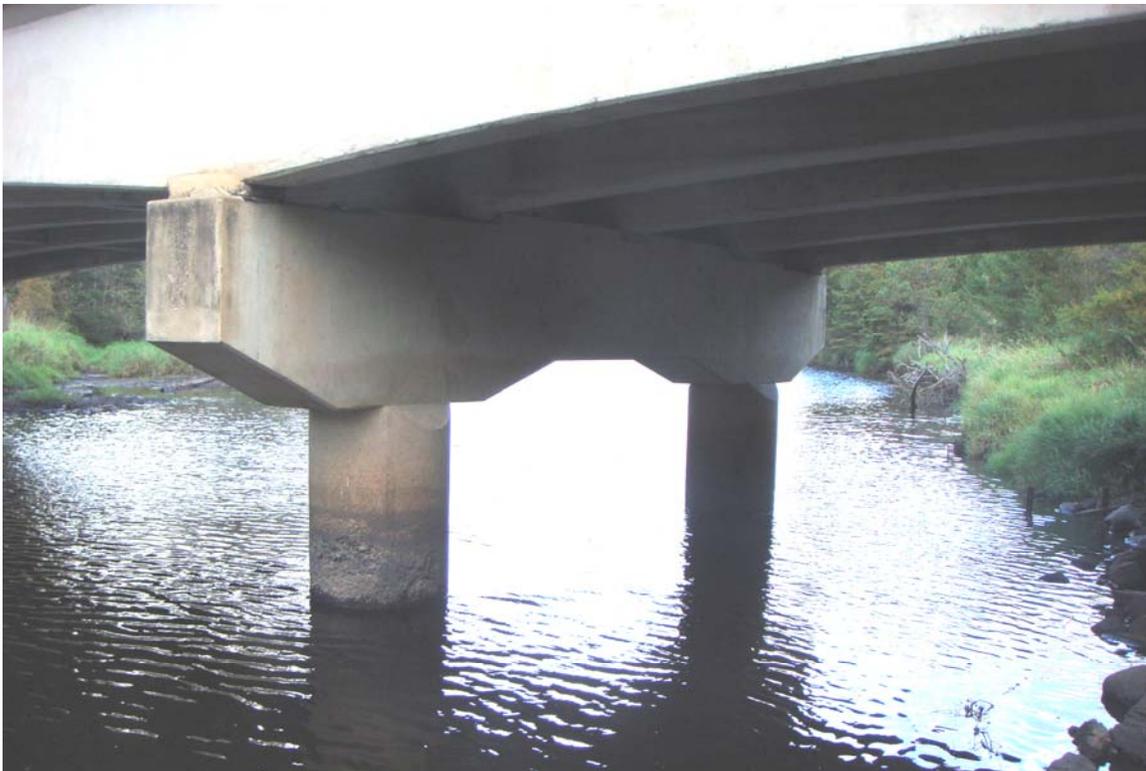
Photograph 2. View of Pier 1, Looking Northeast.

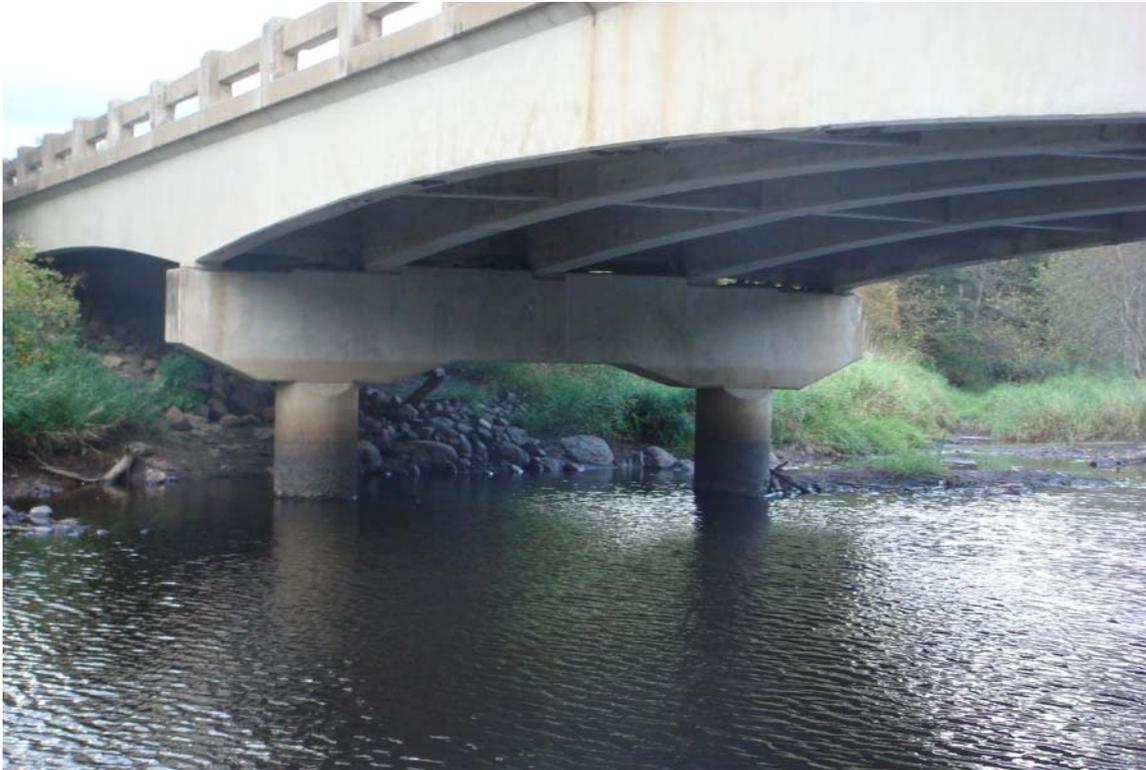
- (C) A scour depression measuring 5 feet in radius with a depth of 2 feet was observed at the upstream and downstream columns of Pier 2.
- (D) A light to moderate accumulation of 6 inch diameter and smaller timber debris was observed at the upstream column of Pier 2. The debris extended from the channel bottom up 3 feet.

Photograph 3. View of Pier 2, Looking Northeast.

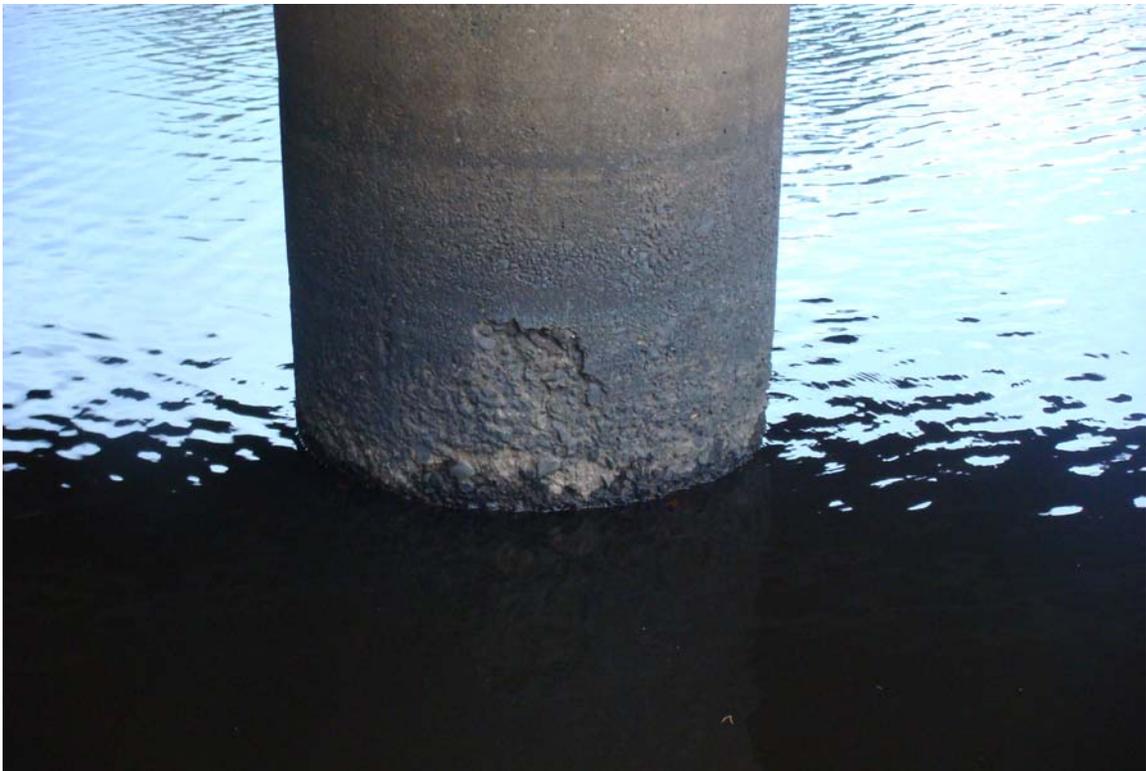
- (A) Moderate scaling with some aggregate exposure from 4 feet above the waterline to 1.5 feet below the waterline with typical penetrations of 1/8 to 1/4 inch and up to 1 inch maximum penetration was present at the all columns of Piers 1 and 2. The scaling was heaviest from 1 foot below to 1.5 feet above the waterline on the south face of all columns, the west face of the downstream column of Pier 2 and the east face of the upstream columns of Piers 1 and 2

Photograph 4. View of Typical Scaling at the Waterline at the Downstream Column of Pier 2, Looking East.

- (A) Due to the current section loss and the apparent progression of concrete deterioration since the previous inspection, consideration could be given to repairing the concrete defects at the columns of Piers 1 and 2. Until the repairs are implemented, the defected areas should be monitored during future underwater inspections for any progression of section loss and/or exposure of reinforcing steel.

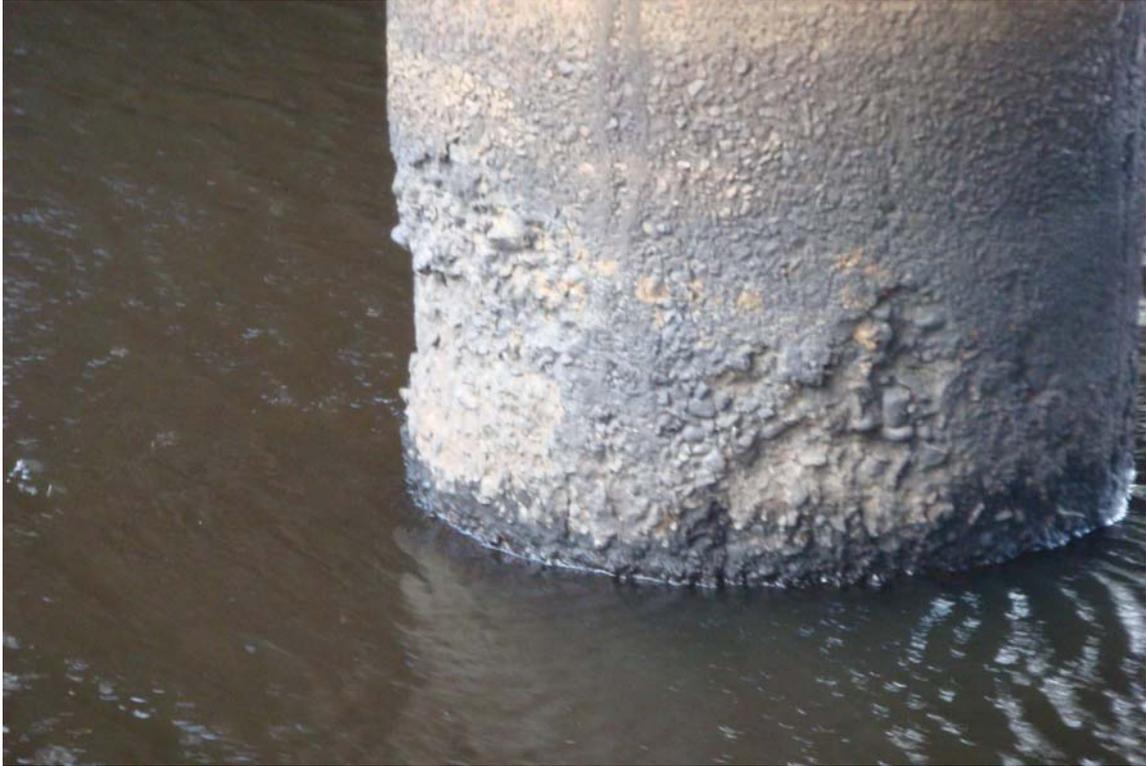
- (B) An area of section loss, 2-foot-high by 2.5-feet-wide, was observed 0.5 feet below to 1.5 feet above the waterline with a maximum penetration of 2.5 inches on the downstream column of Pier 1. The concrete substrate within the area of section loss was typically flakey and unsound.

Photograph 5. View of Heavier Scaling at the Downstream Column of Pier 1, Looking North.

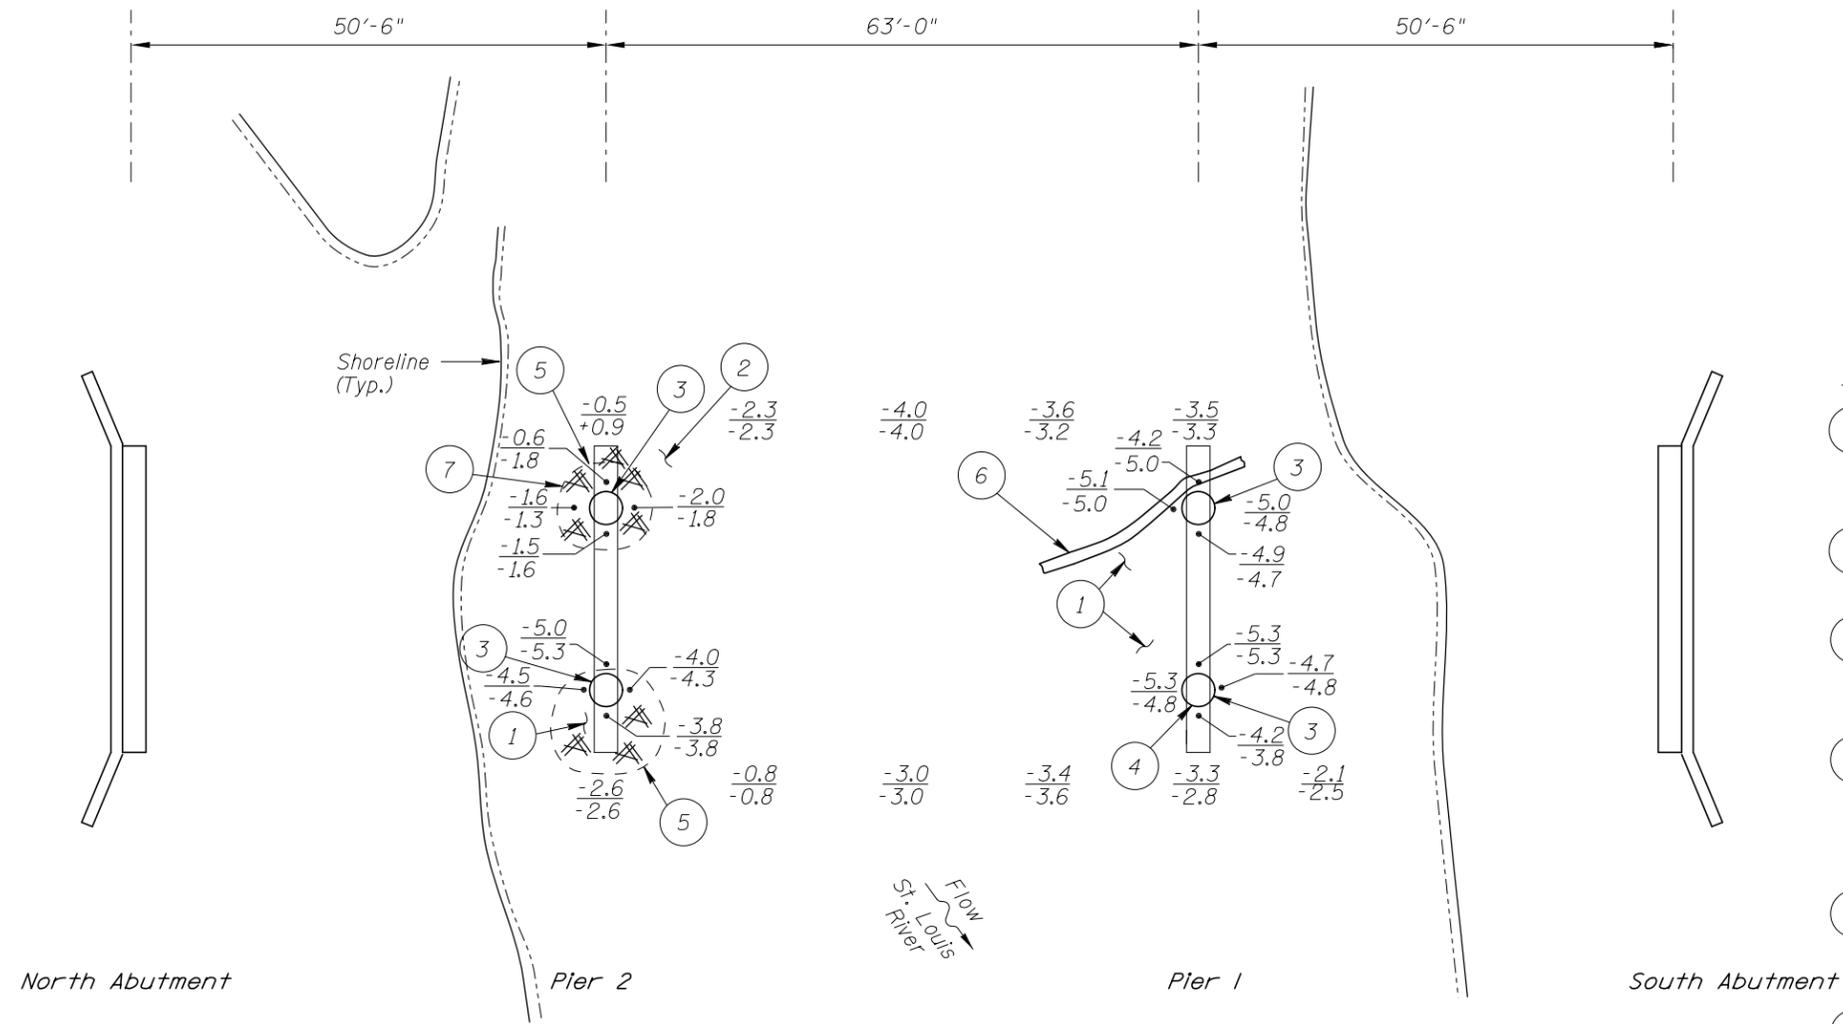
SOUNDING PLAN

- 1 The channel bottom consisted of sand and gravel with 6 inch-diameter and smaller cobbles and random 1-foot-diameter riprap and a maximum probe rod penetration of 1 inch.

- 2 The channel bottom consisted of soft silt and organic material with typical 1.5 feet of probe rod penetration at the upstream column of Pier 2.
- 3 Moderate scaling with some aggregate exposure from 4 feet above the waterline to 1.5 feet below the waterline with typical penetrations of 1/8 to 1/4 inch and up to 1 inch maximum was observed around all columns of both piers.

- 4 An area of heavy scaling/section loss was observed around the downstream column of Pier 1, 2-foot-high by 2.5-foot-wide at 0.5 feet below to 1.5 feet above the waterline with a maximum penetration of 2.5 inches. The concrete within the heavy scaling was flakey and unsound.

- 5 A scour depression, 5 feet in radius with a depth of 2 feet, was observed at the upstream and downstream column of Pier 2. The accumulation of timber debris was observed within the depression.

- 6 6-to 12-inch-diameter log was observed from the channel bottom to the waterline along Pier 1 as shown.
- 7 A light to moderate accumulation of 6-inch-diameter and smaller timber debris was at the upstream end of Pier 2. Accumulations extended from the channel bottom up 3 feet.
