UNDERWATER BRIDGE INSPECTION REPORT

STRUCTURE NO. 7185

CSAH 5

STURGEON RIVER

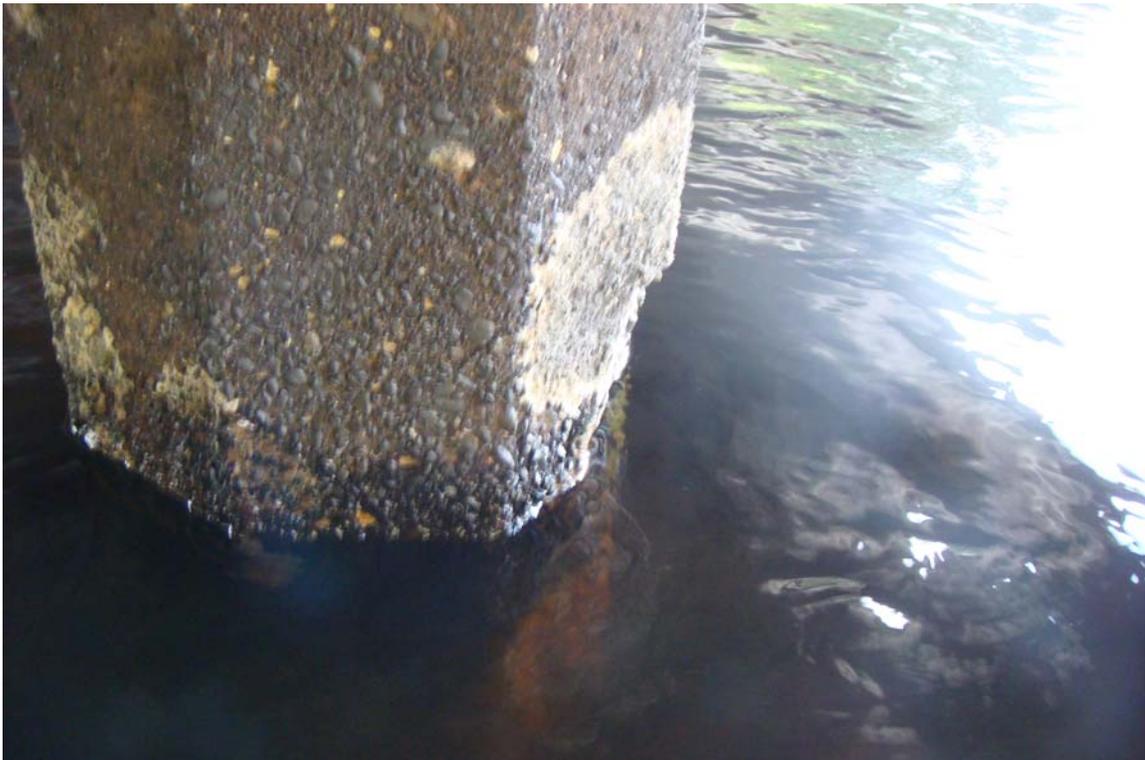
- (C) An area of section loss was observed on the north side of Pile E at Bent 2, extending from 6 inches above to 6 inches below the waterline. The deterioration measured 6 inches wide with a maximum penetration of 1 inch. No reinforcing steel was exposed.

Photograph 4. View Typical Concrete Condition at the Waterline and Section Loss on Pile C of Bent 2, Looking West.

- 3 An area of section loss was observed on the north side of Pile E at Bent 2, extending from 6 inches above to 6 inches below the waterline. The deterioration measured 6 inches wide with a maximum penetration of 1 inch. No reinforcing steel was exposed.

- (B) The scaling and section loss observed at Piles C and D, respectively, are not a structural concern at this time given their size compared to the overall pile size, and as a result, no repairs are recommended. These areas should be monitored during future inspections for increasing extent or severity. If the extent is observed to be increasing or reinforcing steel becomes exposed, it may be necessary to repair the areas at that time.

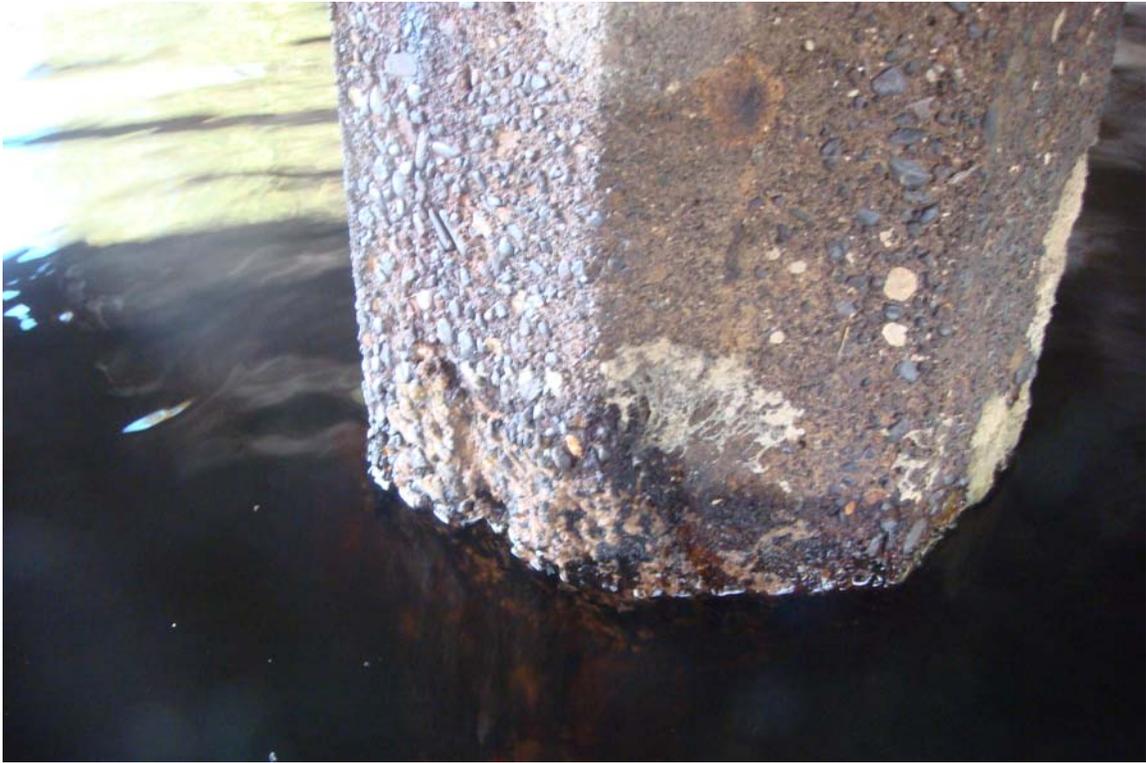
- (D) An area of heavier scaling was observed on the west face of Pile D at Bent 2. The scaling extended from 6 inches above the waterline to the channel bottom and had a maximum penetration of 1 inch.

Photograph 5. View of Heavy Scaling on Pile D of Bent 2, Looking East.

- 4 A area of heavier scaling was observed on the west face of Pile D at Bent 2. The scaling extended from 6 inches above the waterline to the channel bottom and had a maximum penetration of 1 inch.

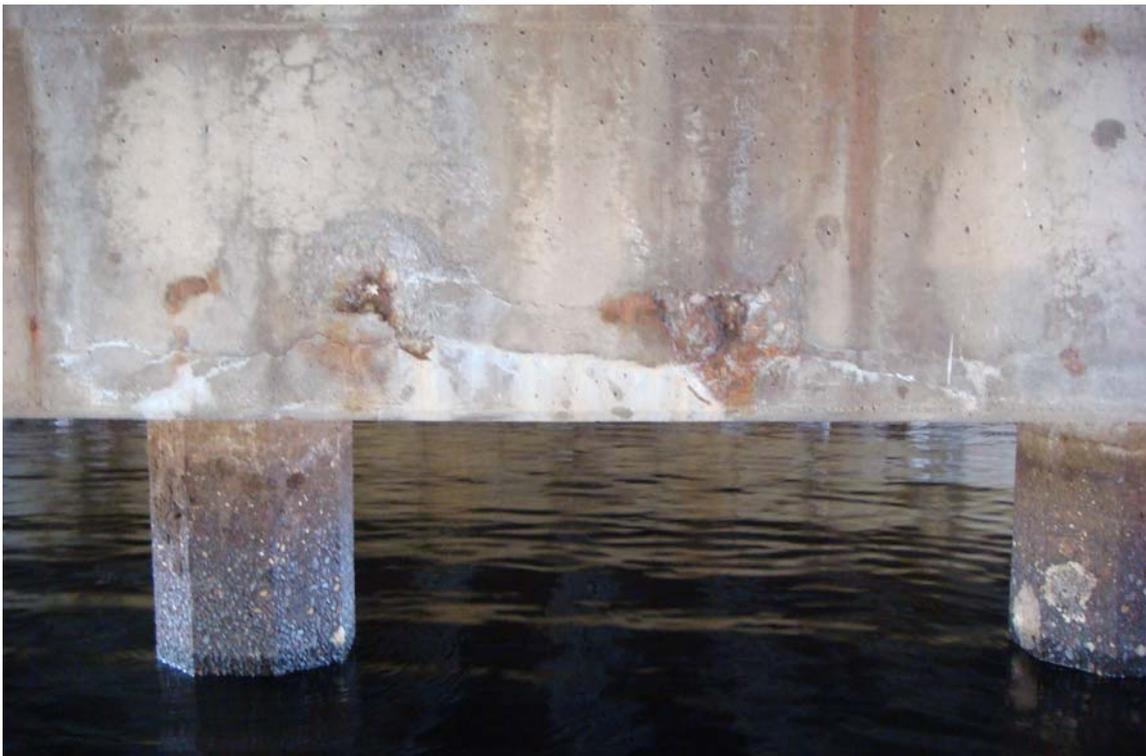
- (E) A 4 foot wide by 1 foot high area of spalling and impending spalling was observed on the east face of the Bent 1 pile cap above Piles C and D. The area had a maximum penetration of 1 inch with exposed reinforcing steel. The exposed steel exhibited less than 10 percent loss of section.

Photograph 6. View of Spall and Impending Spall on the Bent 1 Pile Cap, Looking West.

- 5 A 4 foot wide by 1 foot high area of spalling and impending spalling was observed on the east face of the Bent 1 pile cap above Piles C and D. The area had a maximum penetration of 1 inch with exposed reinforcing steel. The exposed steel exhibited less than 10 percent loss of section.

- (A) The spalled area with exposed reinforcing steel is not a structural concerns at this time; however, it should be repaired to prevent further deterioration. The repair should include removal of concrete to a minimum of 1 inch behind the reinforcing steel, cleaning and replacing reinforcing steel as required, and placing concrete designed to provide high durability with low permeability.

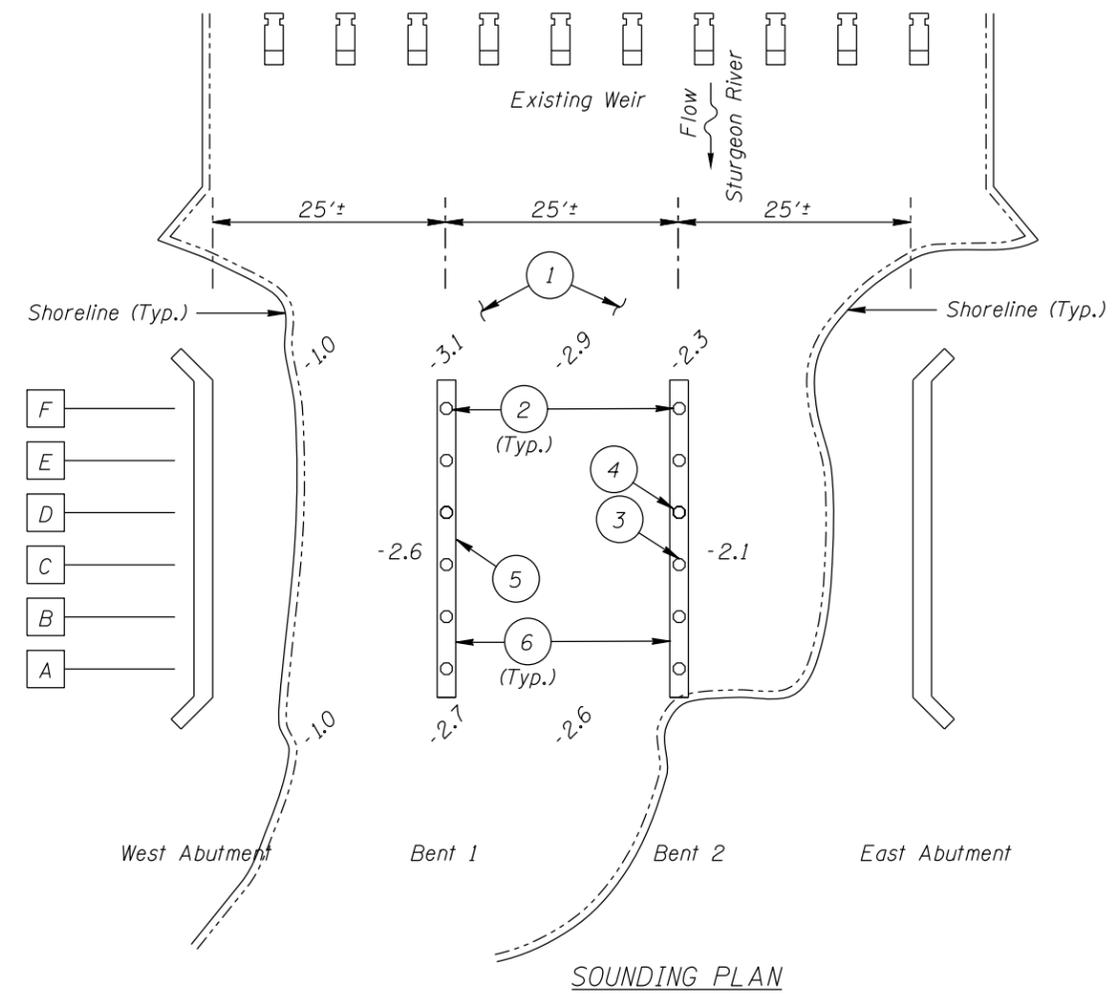
SOUNDING PLAN

- 1 The channel bottom material consisted of rocks, up to 2 feet in diameter, and areas of sand infill with a maximum probe rod penetration of 6 inches.

- 2 The concrete piles were typically sound with moderate scaling extending from 1 foot above the waterline to the channel bottom. The scaling typically had a penetration of 1/4 inch.

- 6 The concrete pier cap at Bents 1 and 2 exhibited random hairline cracks with efflorescence and random areas of rust staining.
