UNDERWATER BRIDGE INSPECTION REPORT

STRUCTURE NO. 7221

VERMILLION RIVER

JUNE 22, 2012

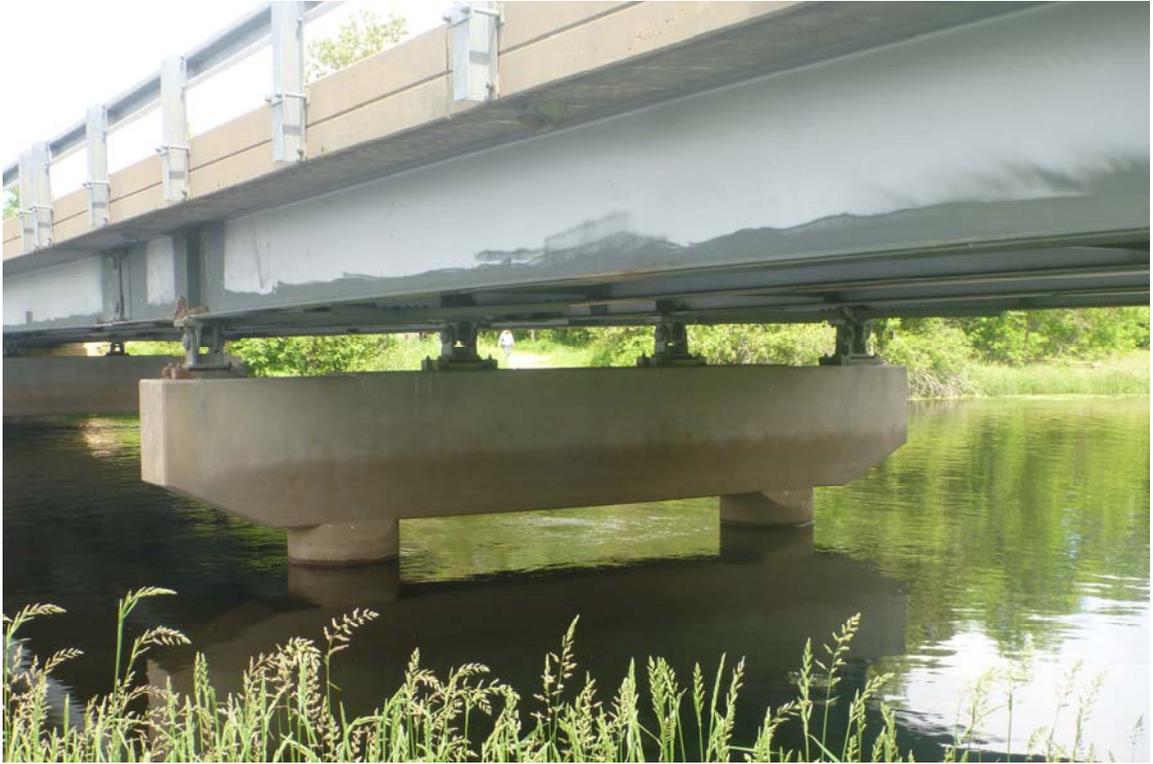
Photograph 3. View of Pier 1, Looking Northeast.

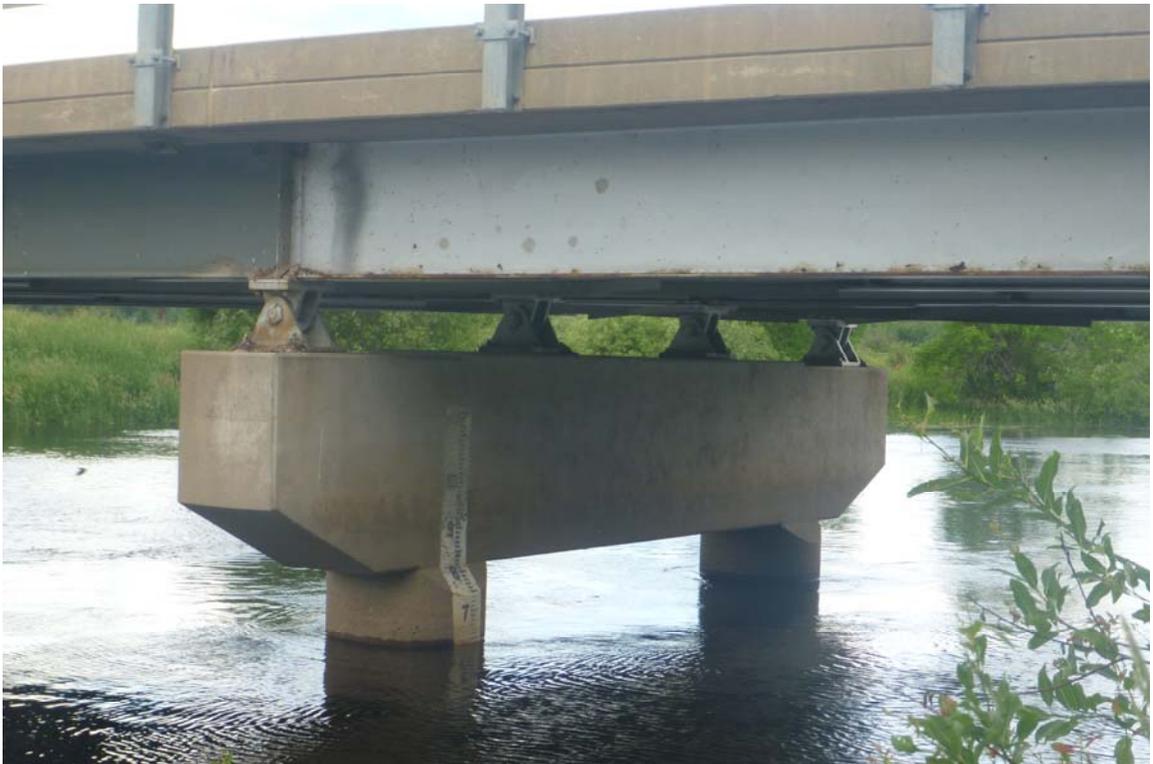
Photograph 4. View of Pier 2, Looking Southwest.

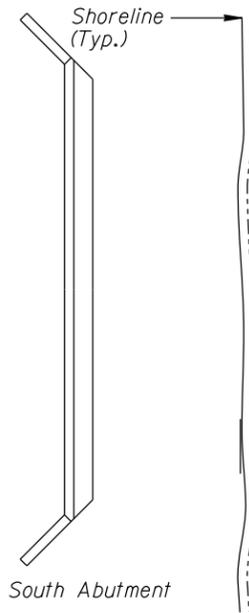
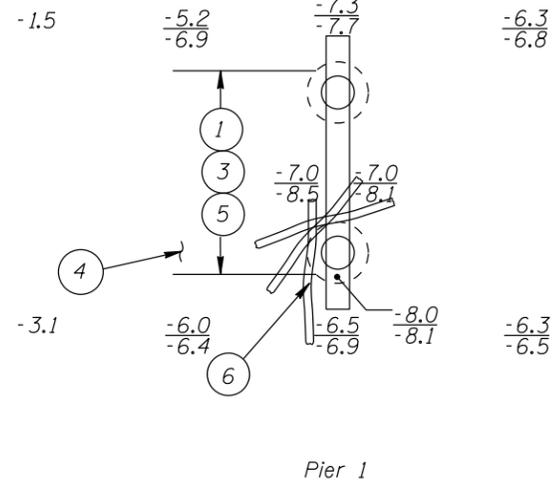
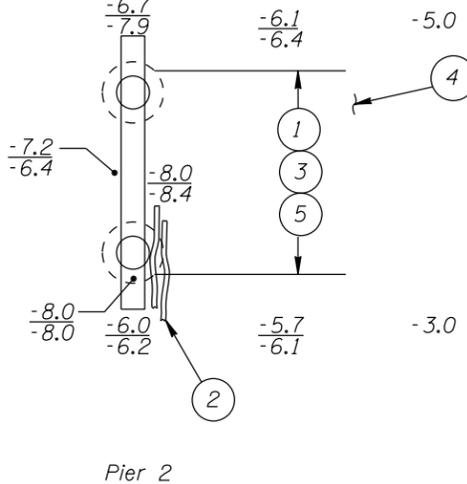
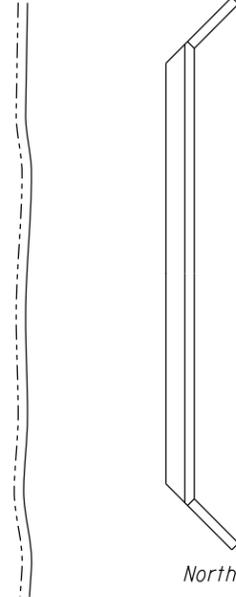
SOUNDING PLAN

- 1 Overall, the concrete was sound with no significant deterioration present.
- 2 A light accumulation of timber debris, consisting of two 6 inch diameter logs (approx. 10 feet long each), was located on the channel bottom across the upstream column of Pier 2.

- 3 Scaling was observed 3 feet below the waterline to channel bottom with a 1/2 inch maximum penetration (1/4 inch typical) at upstream and downstream columns of Piers 1 & 2.

- 4 Channel bottom material consisted of scattered rocks 2 feet in diameter and smaller, sandy silt, and gravel with up to 6 inches of probe rod penetration.

- 5 Scour depression 6 feet in radius, 2 feet deep was observed at upstream column of Piers 1 & 2. Also, scour depression 6 feet in radius, 1 foot deep was observed at downstream column of Piers 1 & 2.

- 6 A light accumulation of timber debris, consisting of three 8 inch diameter logs (approx. 15 feet long each), was located on the channel bottom across the upstream column of Pier 1.
