UNDERWATER BRIDGE INSPECTION REPORT

STRUCTURE NO. 7678

CSAH 22

SAND RIVER

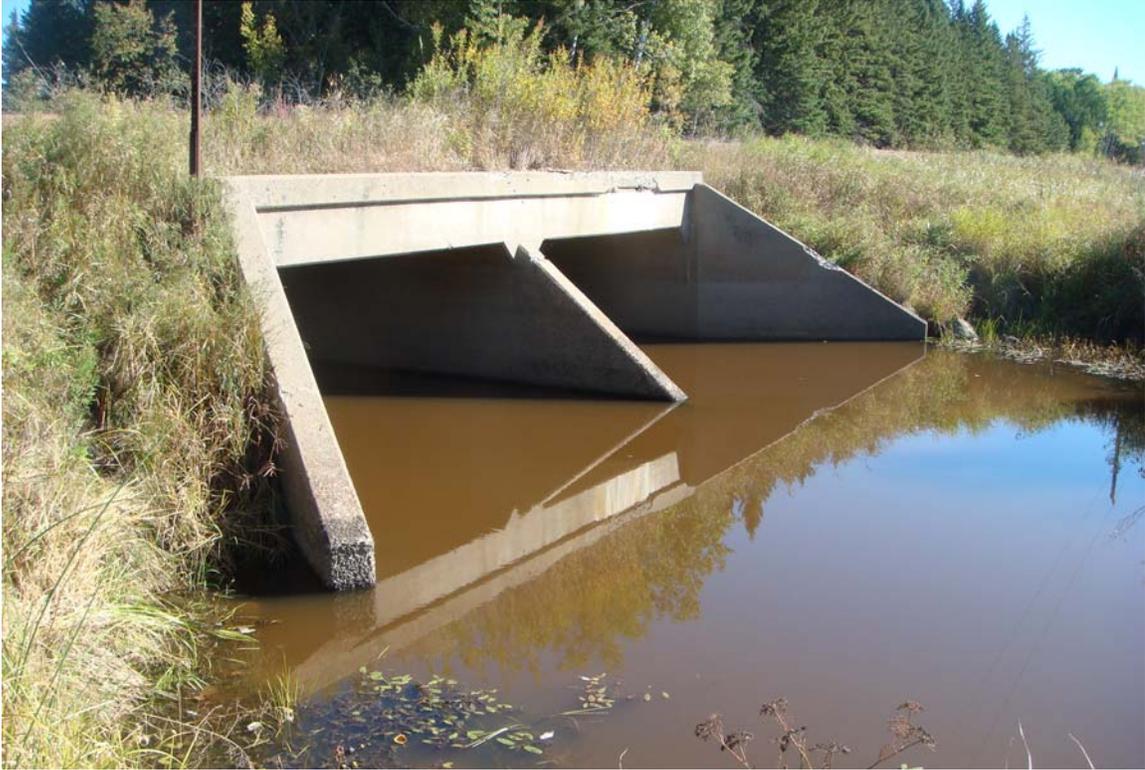
Photograph 1. Overall View of the South Headwall, Looking Northeast.

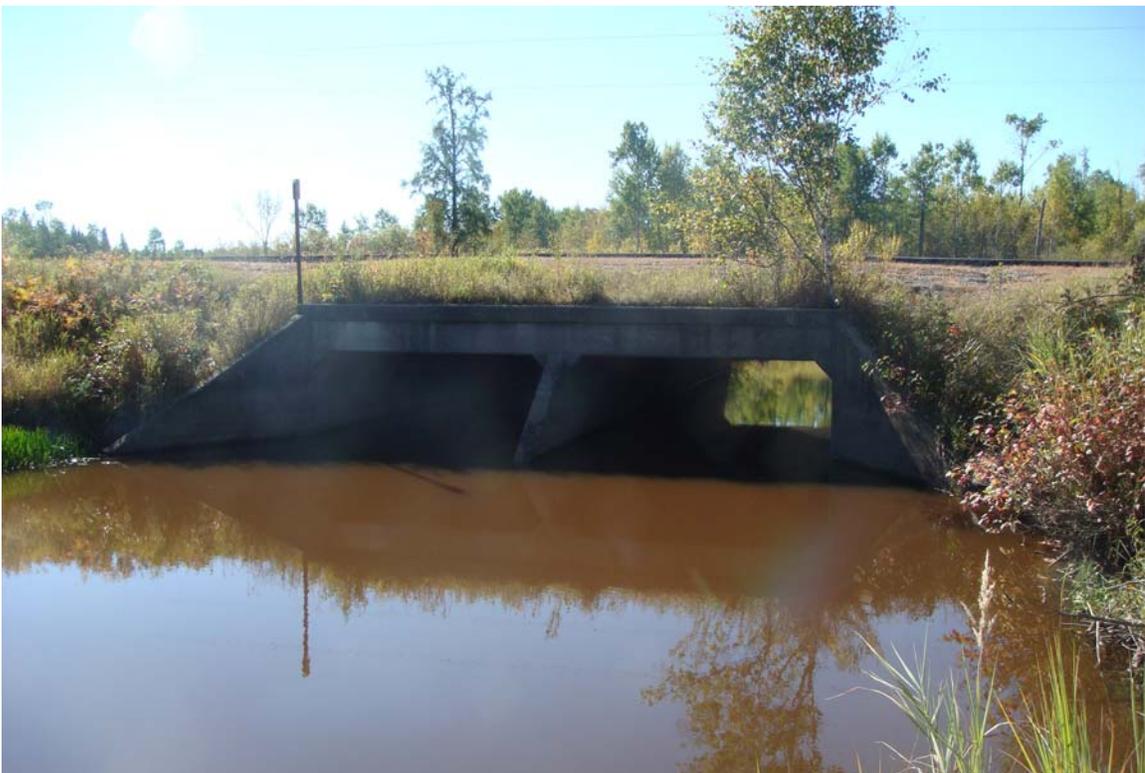
Photograph 2. Overall View of the North Headwall, Looking South.

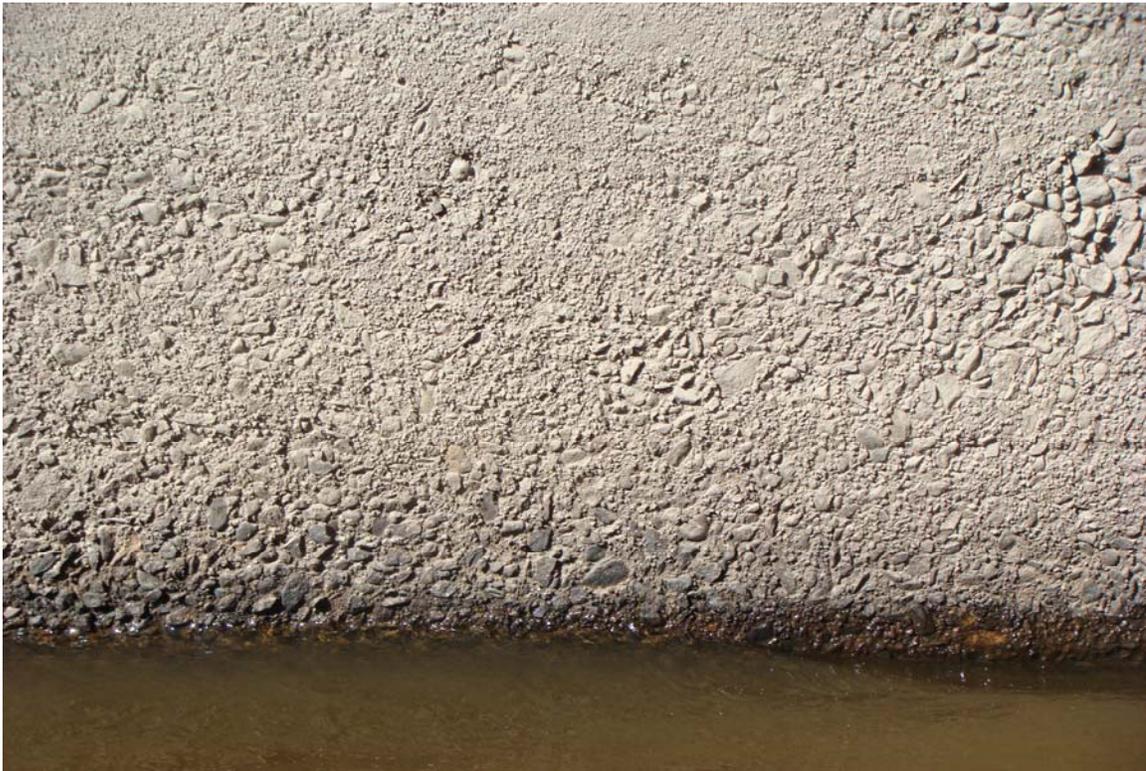
Photograph 3. Typical Concrete Condition at the Waterline, Looking West.

- 2 A band of light scaling and random areas of poor concrete consolidation were observed on the culvert floor, ceiling and walls extending from the floor to 2 feet above the waterline. The scaling had a maximum penetration of 1/4 inch and the poor concrete consolidation had a maximum penetration of 1.5 inches.

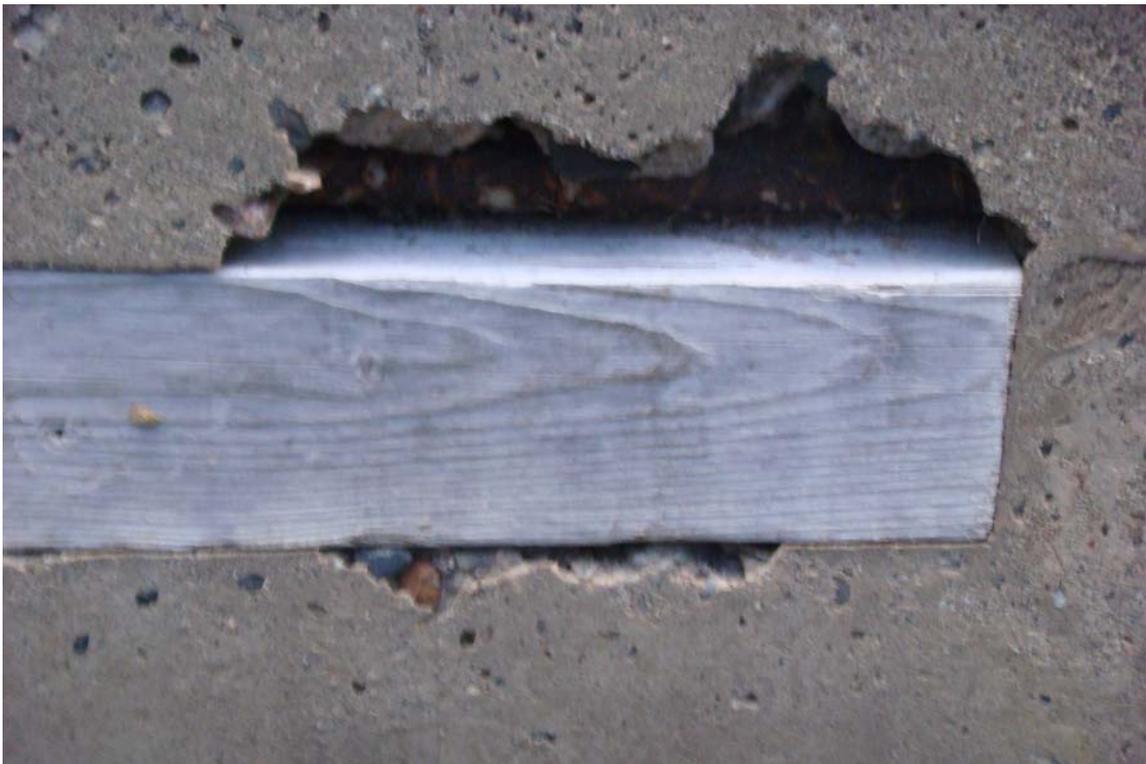
Photograph 4. View Concrete Section Loss and Left-in-Plane Form Board, Looking up.

- 3 An area of concrete section loss and residual 2"x4" form work was observed in the ceiling of Box 2, 1 foot from the north opening. The area of section loss measured 6 inches long by 3 inches wide with a maximum penetration of 1.5 inches and one exposed reinforcing bar exhibiting less than 5 percent loss of section.

- (A) The areas of concrete section loss and spalling with exposed reinforcing steel are not structural concerns at this time; however, it should be repaired to prevent further deterioration. The repairs should include removal of concrete to a minimum of 1 inch behind the reinforcing steel, cleaning and replacing reinforcing steel as required, and placing concrete designed to provide high durability with low permeability.

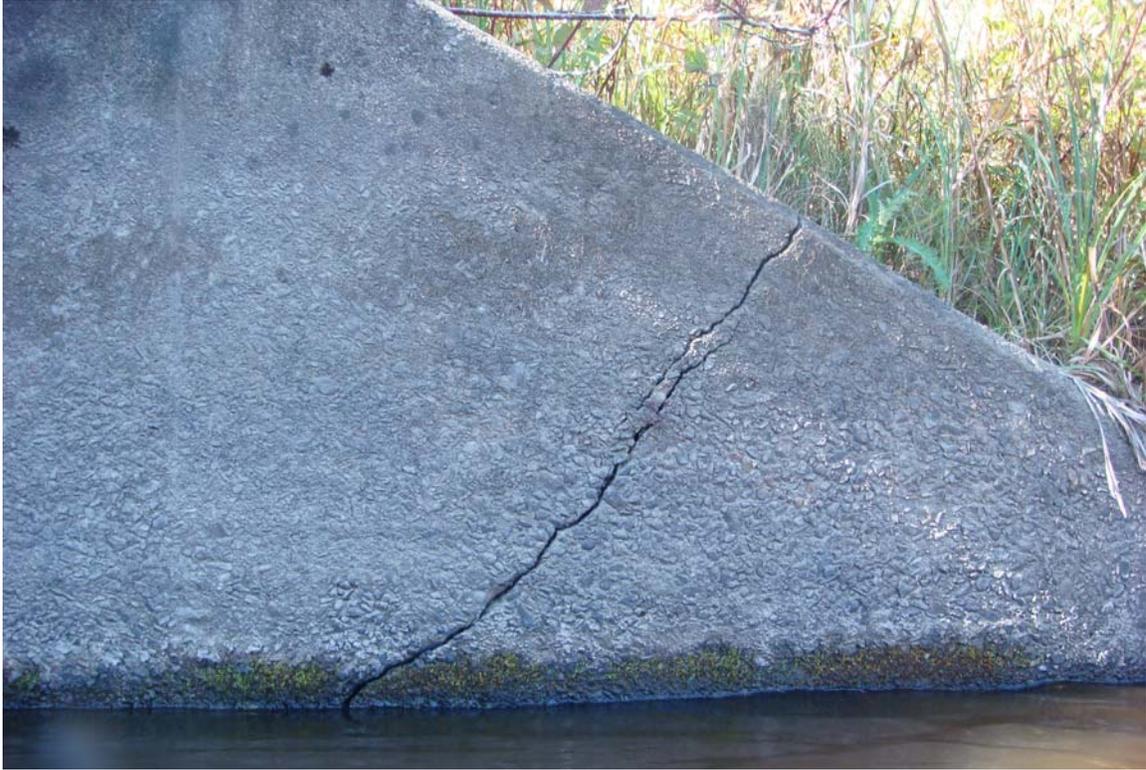
- (F) A diagonal crack, up to 1/4 inch wide, was observed on the southeast and northwest wingwalls extending from the apron to the top of the wingwall.

Photograph 5. View Diagonal Crack on Northwest Wingwall, Looking West.

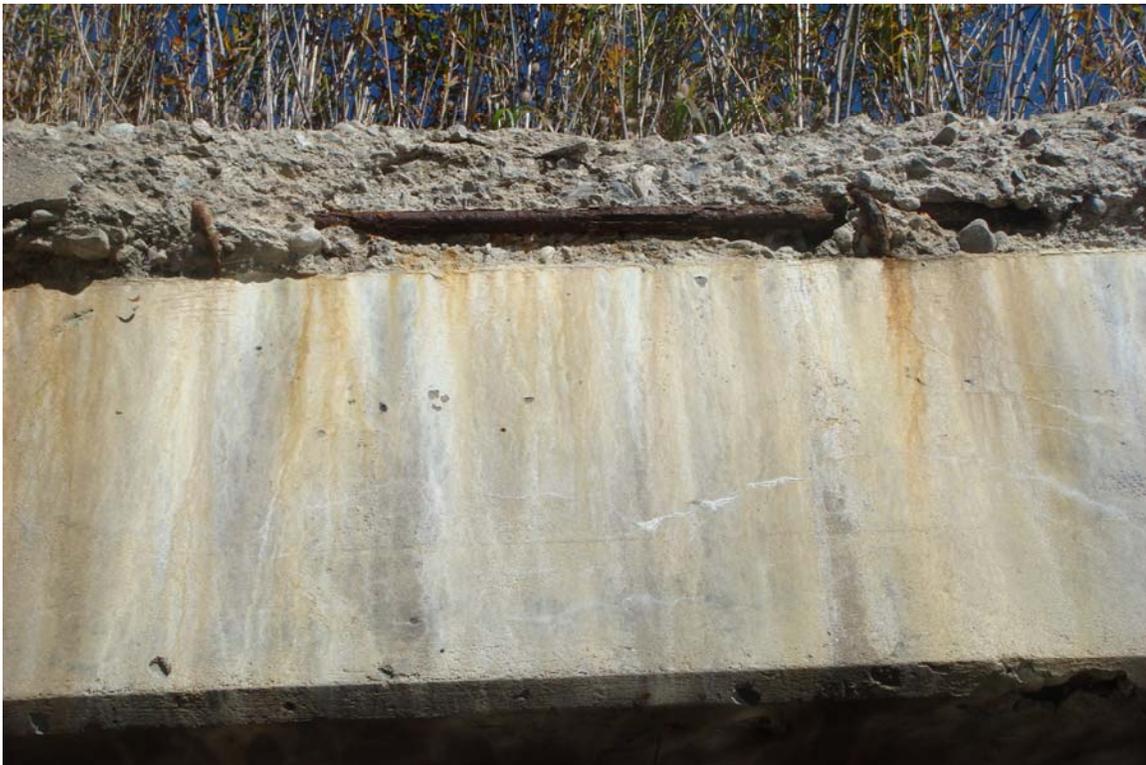
- (G) A spall was observed on the south headwall above Box 2. The spall measured 15 feet long by 1 foot high with a maximum penetration of 3 inches. Several reinforcing bars were exposed exhibiting less than 10 percent loss of section.

Photograph 6. View of Concrete Section Loss and Exposed Reinforcing Bars on the South Headwall, Looking North.

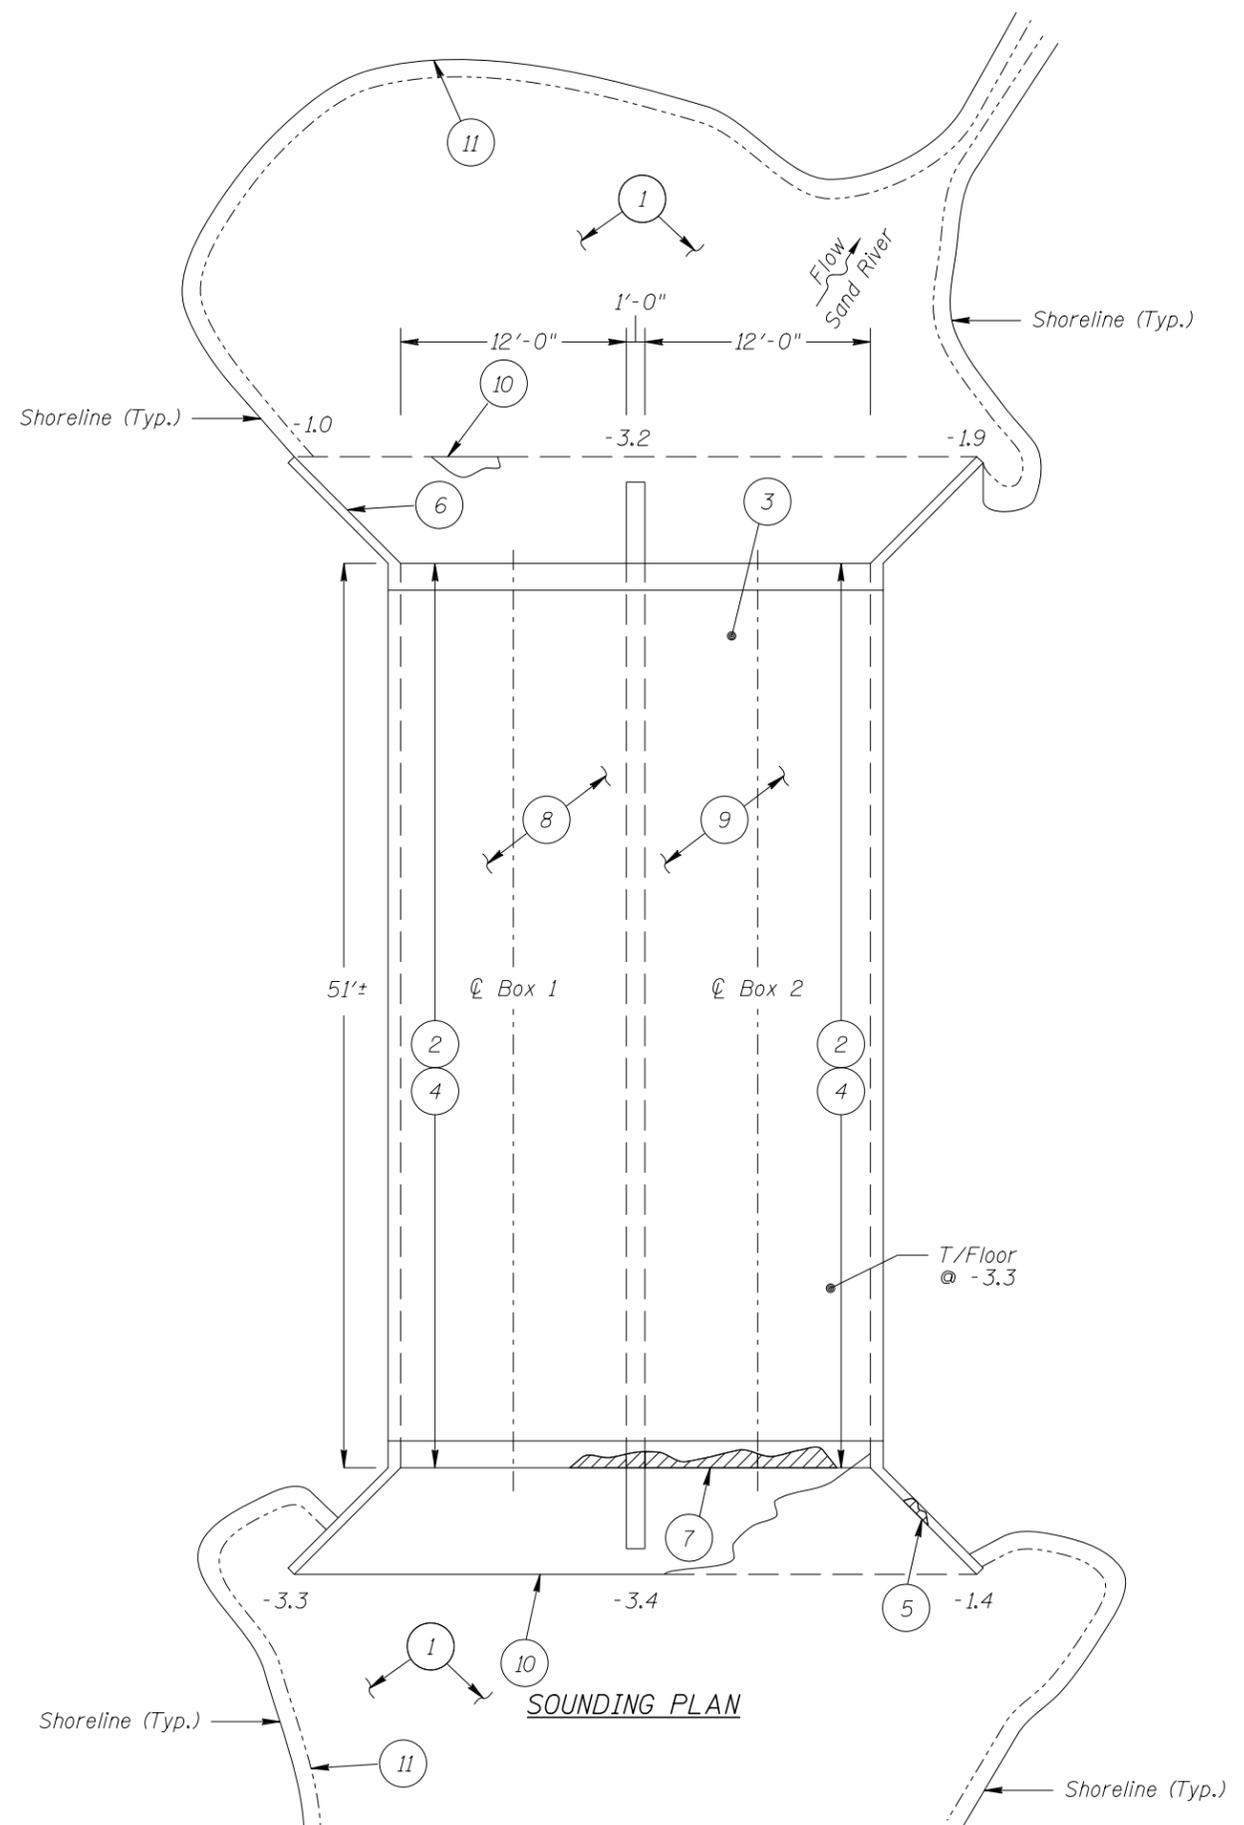
- 1 The channel bottom material upstream and downstream of the culvert apron consisted of rocks, cobbles and silt with a maximum probe rod penetration of 6 inches.

- 4 Areas of concrete section loss and poor concrete consolidation were observed along the horizontal construction joints of all the top haunches of both Box 1 and 2. The areas had a maximum penetration of 3/4 inch.

- 5 An area of concrete section loss was observed on the top of the southeast wingwall. The area measured 15 inches wide by 6 inches high with a maximum penetration of 2 inches. No reinforcing steel was observed.

- 6 A diagonal crack, up to 1/4 inch wide, was observed on the southeast and northwest wingwalls extending from the apron to the top of the wingwall.
- 7 A spall was observed on the south headwall above Box 2. The spall measured 15 feet long by 1 foot high with a maximum penetration of 3 inches. Several reinforcing bars were exposed exhibiting less than 10 percent loss of section.

- 8 The Box 1 culvert floor was covered with a 2 inch thick layer of silt from the culvert midpoint to the downstream opening.
- 9 The Box 2 culvert floor was covered with a 5 inch thick layer of silt from the upstream quarter point to the downstream opening.

- 10 The apron toe was exposed at the downstream midpoint of Box 1 with a maximum vertical exposure of 6 inches and the upstream opening of Box 1 with a maximum vertical exposure of 1 inch. No undermining was observed at the upstream or downstream aprons.

- 11 The upstream and downstream banks exhibited minor erosion.
