UNDERWATER BRIDGE INSPECTION REPORT

STRUCTURE NO. 7685

CSAH 24

HAWKINSON CREEK

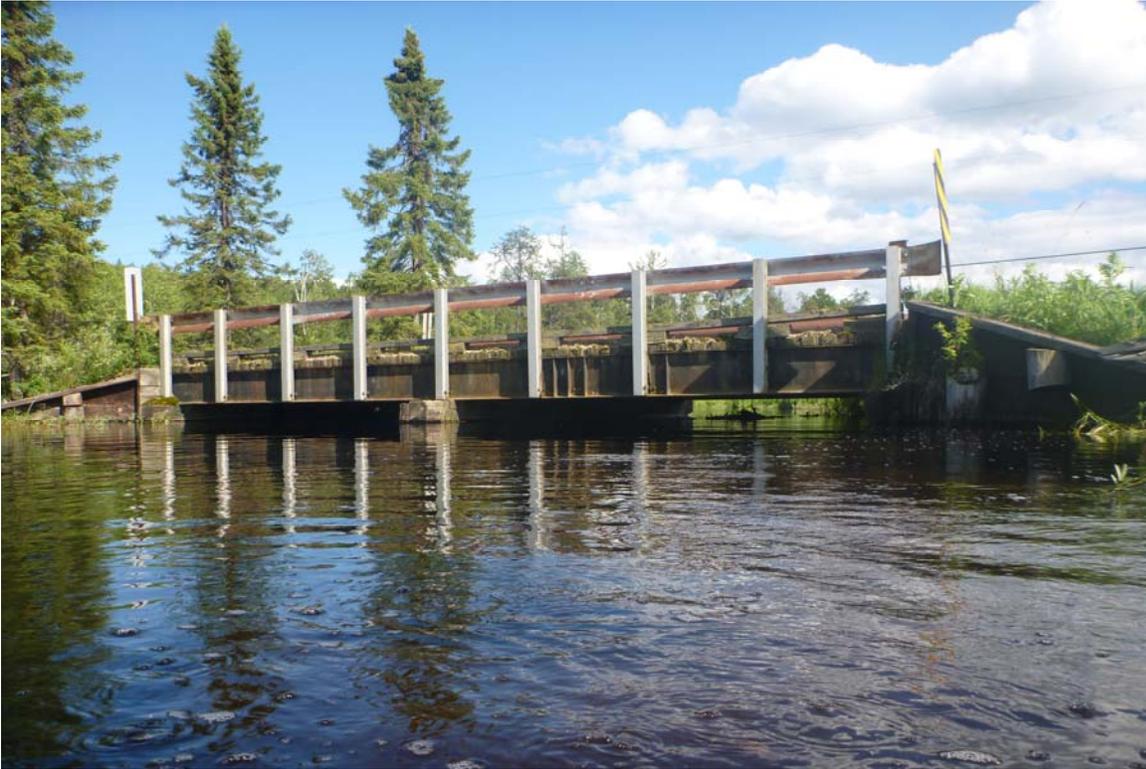
Photograph 1. View of the Upstream Fascia, Looking Southeast.

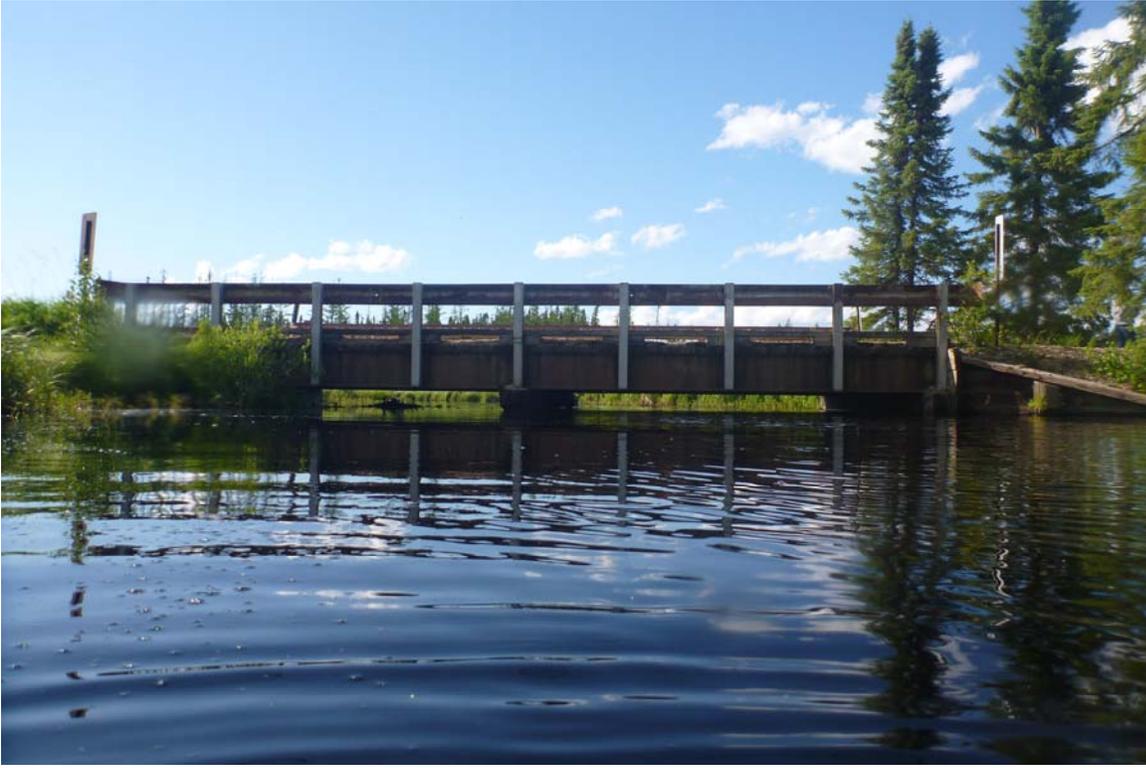
Photograph 2. View of the Downstream Fascia, Looking North.

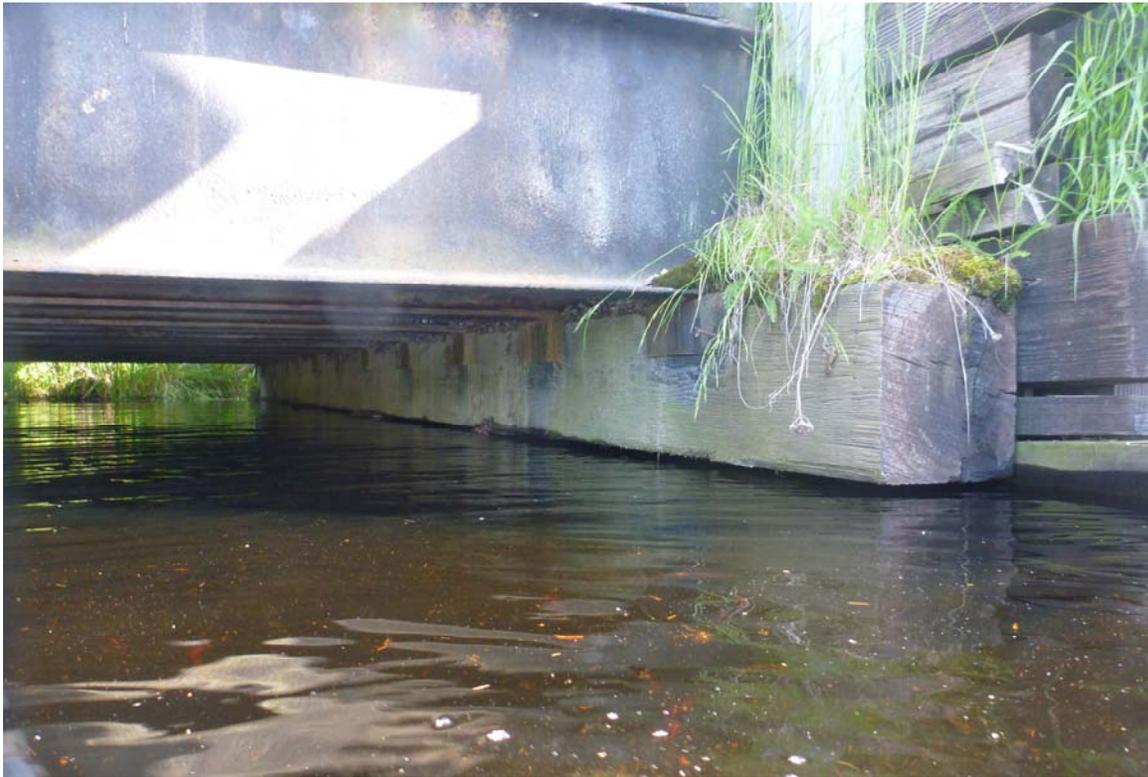
Photograph 3. View of the West Abutment, Looking Southwest.

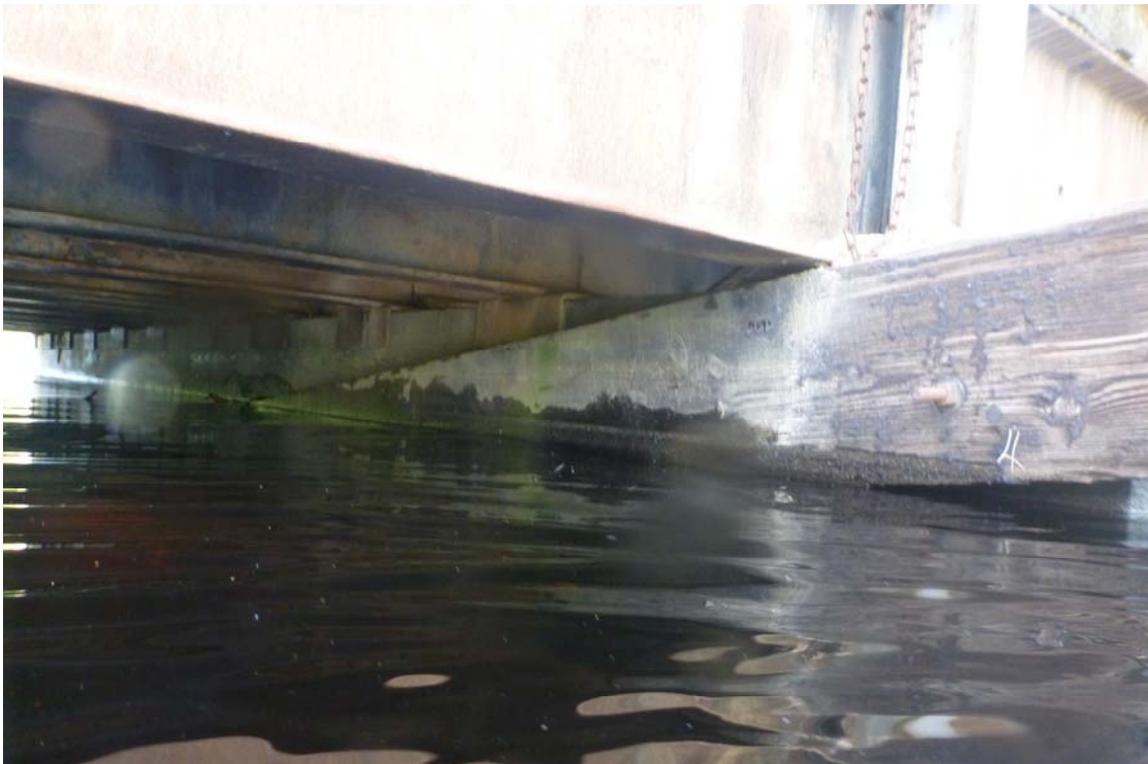
Photograph 4. View of Bent 1, Looking Northeast.

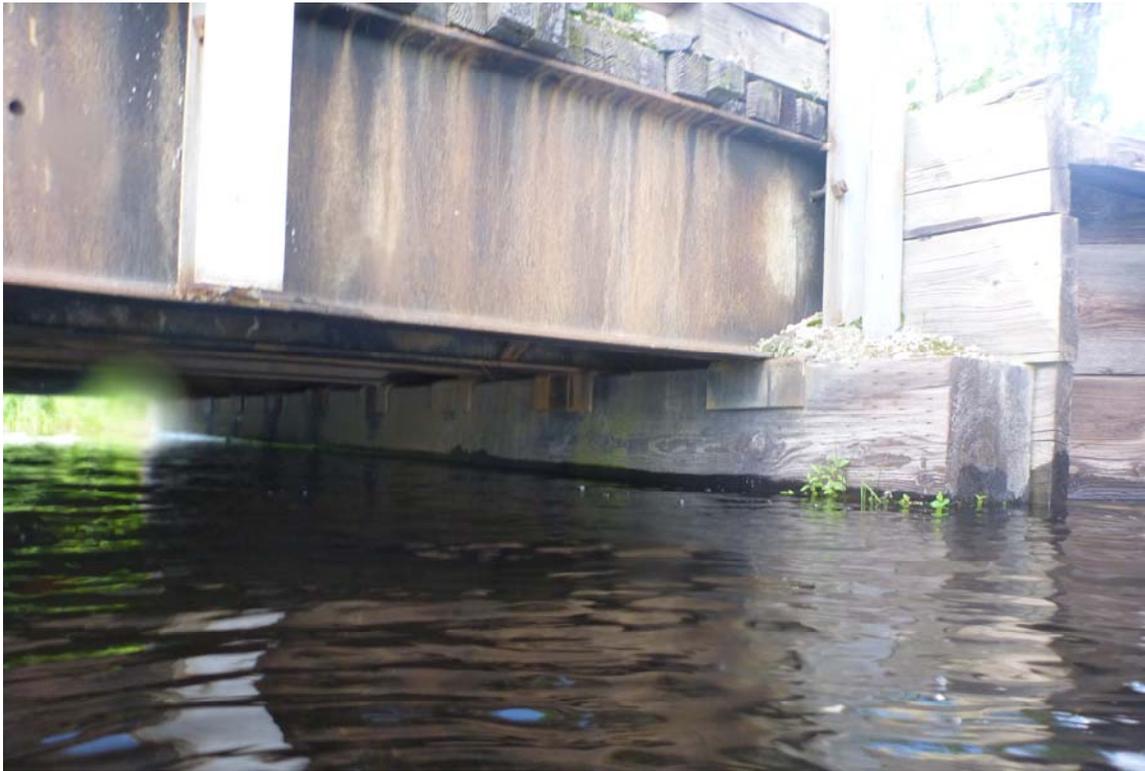
Photograph 5. View of the East Abutment, Looking Northeast.

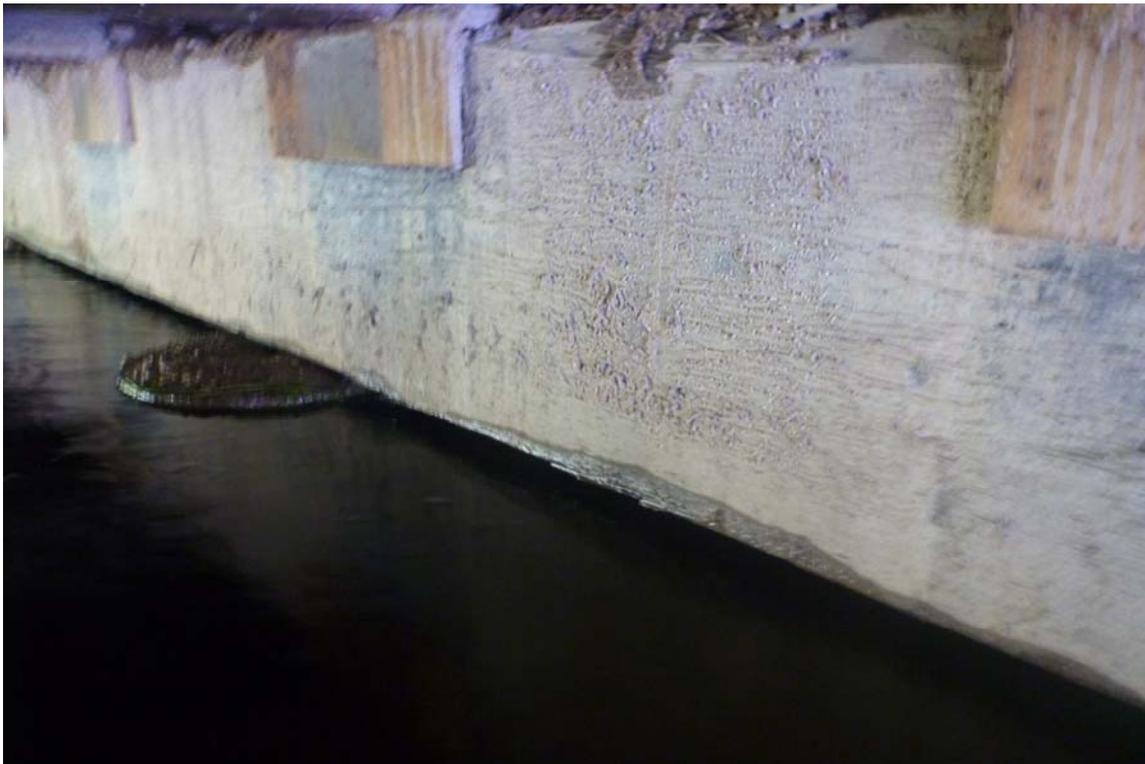
- (A) All the timber piles were in good condition with only minor checking. There was no notable loss of section or indications of decay. The timber typically allowed a awl penetration of 1/8 inch.
- (B) Only half of the pile cap was bearing on Piles C, D, and E of the West Abutment. The pile cap was not properly seated on Piles C, D, and E of the West Abutment.
- (C) A split 5 feet long by 1 inch wide was observed on the cross-brace at Pile A of Bent 1. Due to the split, the Pile A to cross-brace connection was compromised.
- (D) A light accumulation of branchy debris and soft silty infill was observed on the west side along the downstream half of Bent 1. The channel bottom depth in this area ranged from 1 to 2 feet deep.
- (E) The channel bottom material consisted of sandy silt typically allowing 6 inches of probe rod penetration.

Photograph 6. View of Partial Pile Cap Bearing on Pile D of the West Abutment, Looking Southwest.

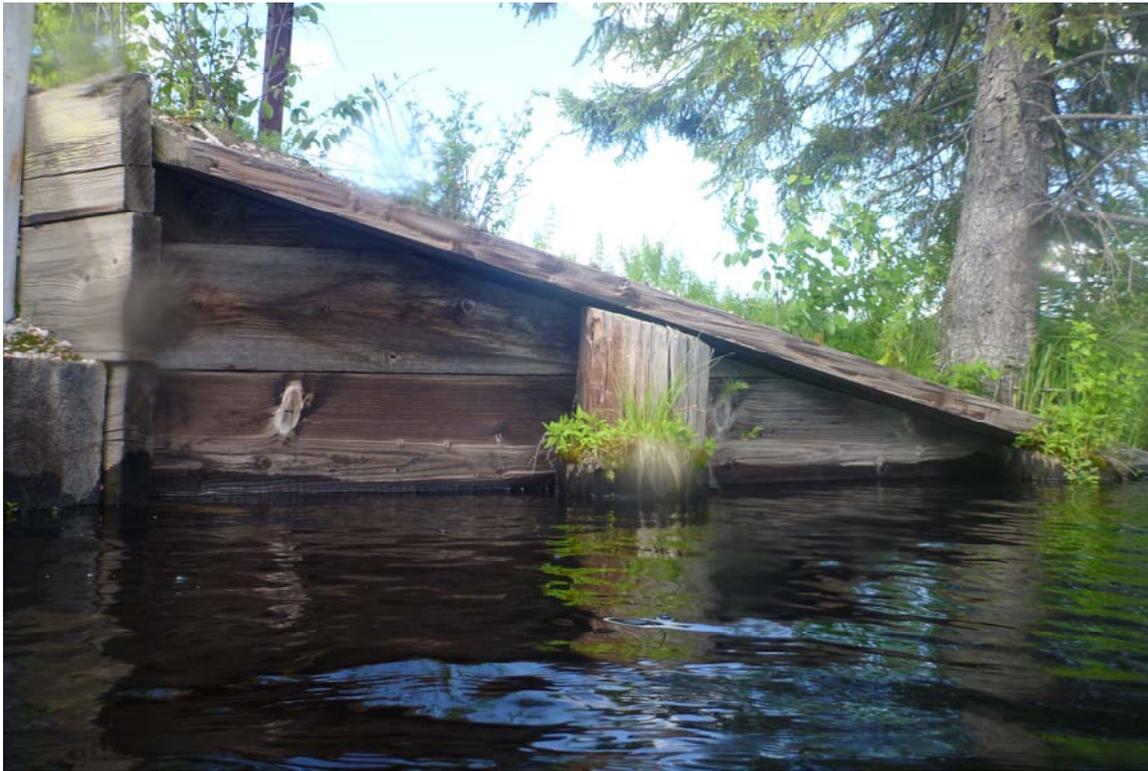
Photograph 7. View of the Typical Condition of the Wingwalls at the Downstream side of the East Abutment, Looking Northeast.

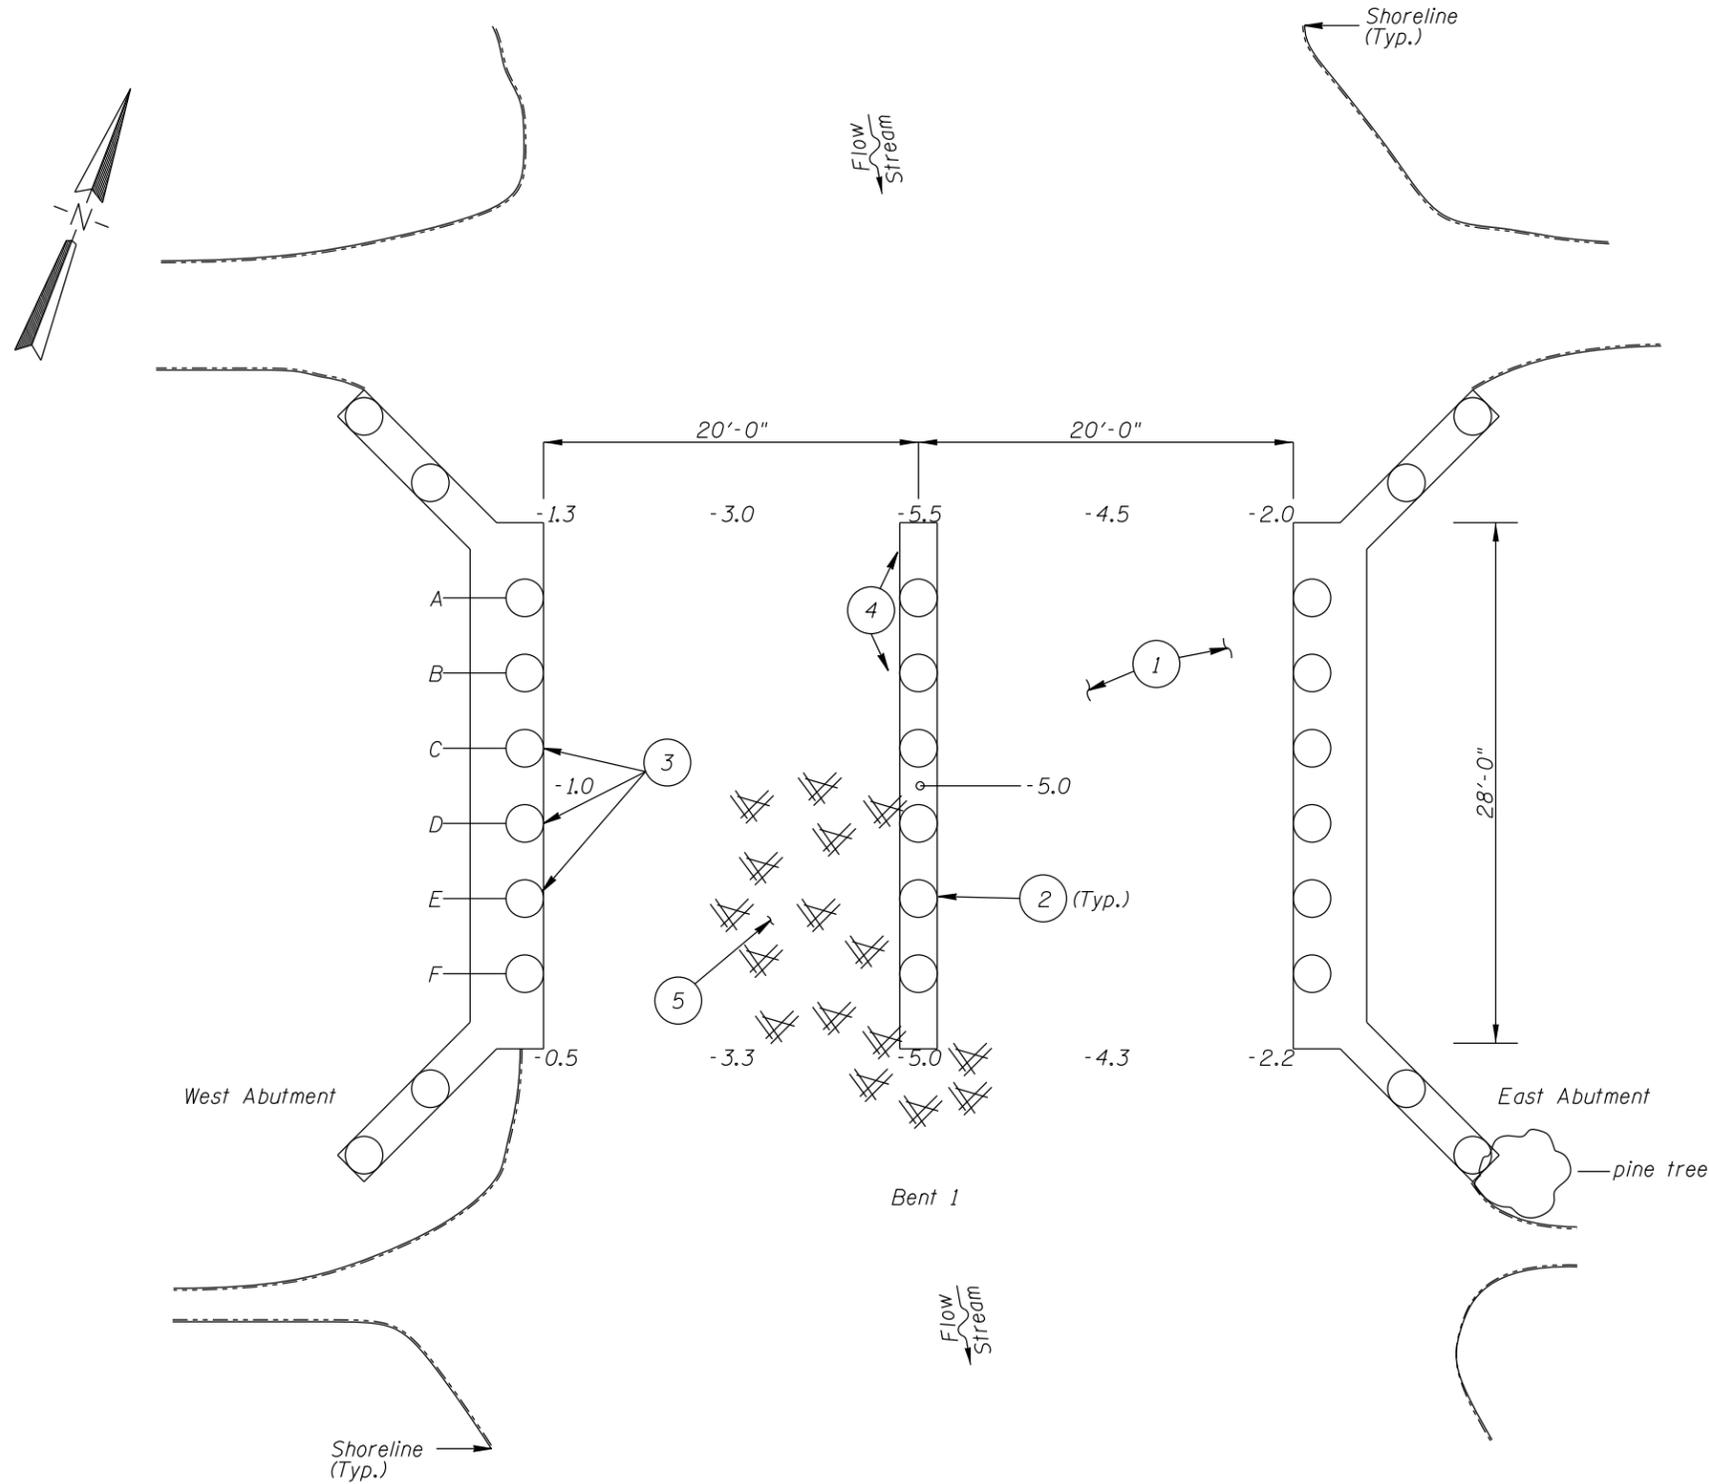
INSPECTION AND SOUNDING PLAN

- 1 The channel bottom material consisted of sandy silt typically allowing 6 inches of probe rod penetration.
- 2 All the timber piles were in good condition with only minor checking. There was no notable loss of section or indications of decay. The timber typically allowed a awl penetration of 1/8 inch.
- 3 Only half of the pile cap was bearing on Piles C, D, and E of the West Abutment. The pile cap was not properly seated on Piles C, D, and E of the West Abutment.
- 4 A split 5 feet long by 1 inch wide was observed on the cross-brace at Pile A of Bent 1. Due to the split, the Pile A to cross-brace connection was compromised.
- 5 A light accumulation of branchy debris and soft silty infill was observed on the west side along the downstream half of Bent 1. The channel bottom depth in this area ranged from 1 to 2 feet deep.
