UNDERWATER BRIDGE INSPECTION REPORT

STRUCTURE NO. 7771  
CSAH NO. 110  
OVER THE  
CHANNEL AT WHITEWATER AND COLBY LAKES  
ST. LOUIS COUNTY

JUNE 20, 2012  
PREPARED FOR THE  
MINNESOTA DEPARTMENT OF TRANSPORTATION  
BY  
COLLINS ENGINEERS, INC.  
JOB NO. 7423

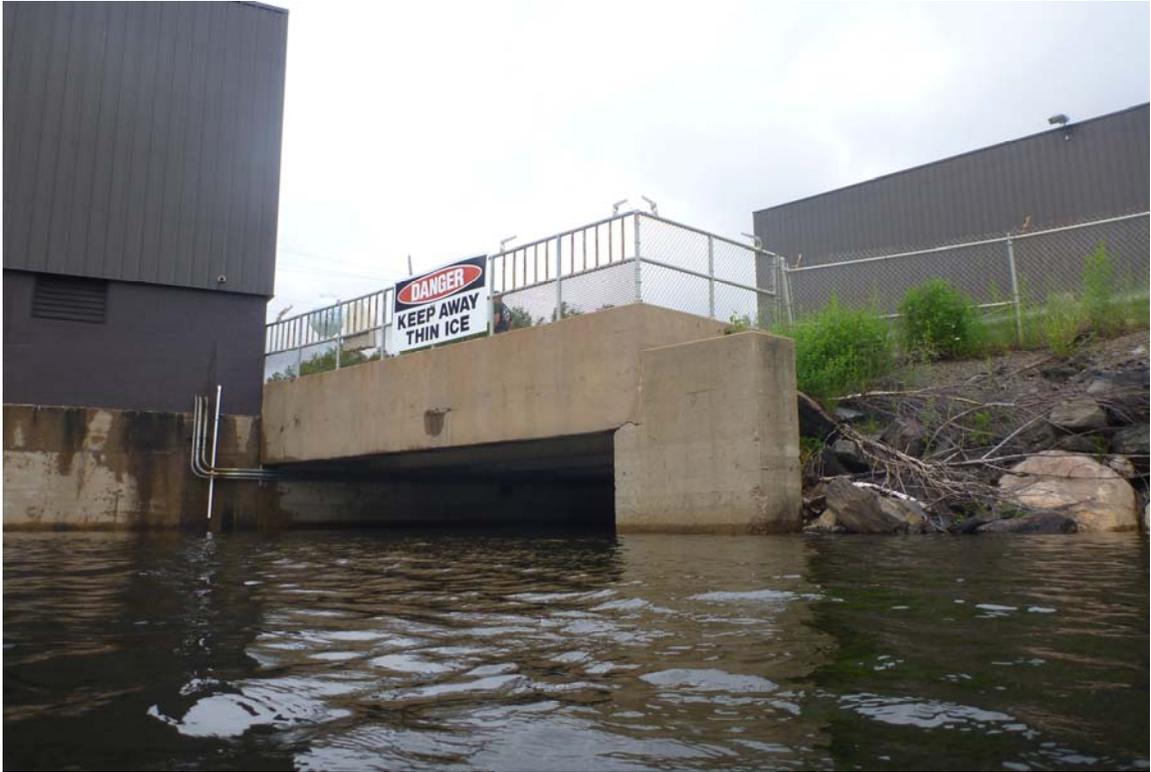
Photograph 1. Overall View of the South Fascia, Looking Northwest.

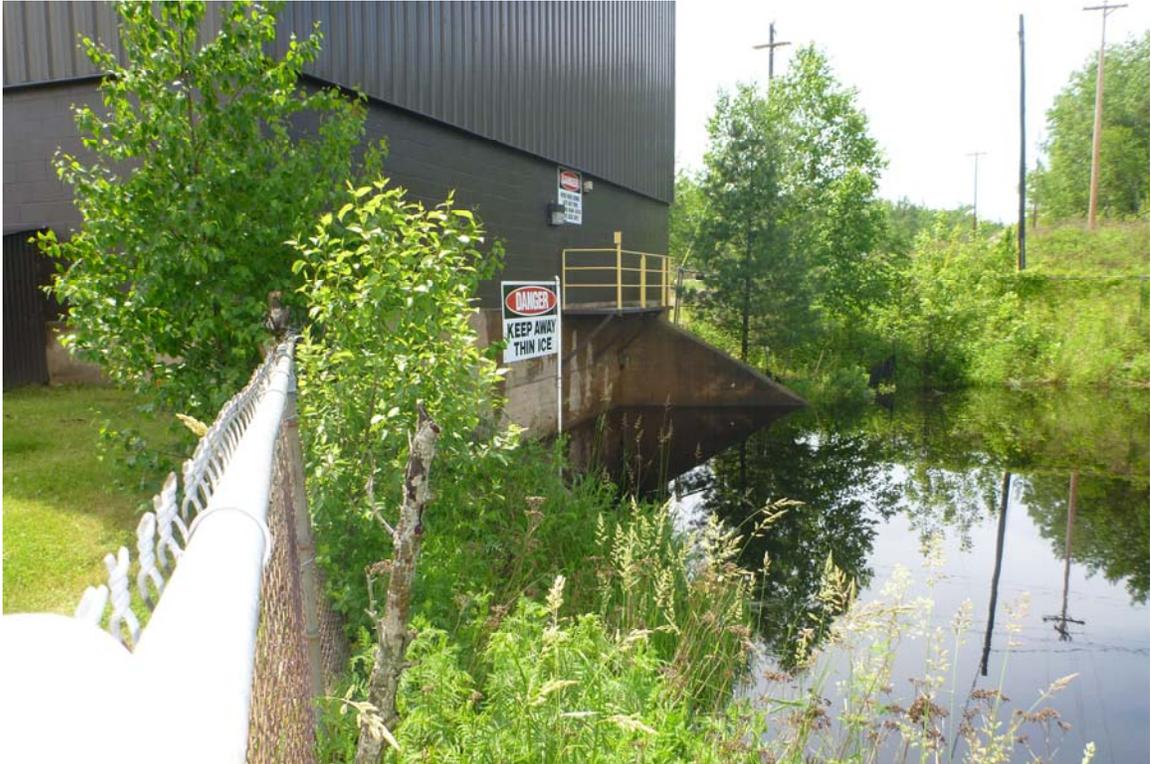
Photograph 2. Overall View of the North Fascia/Gate House, Looking West.

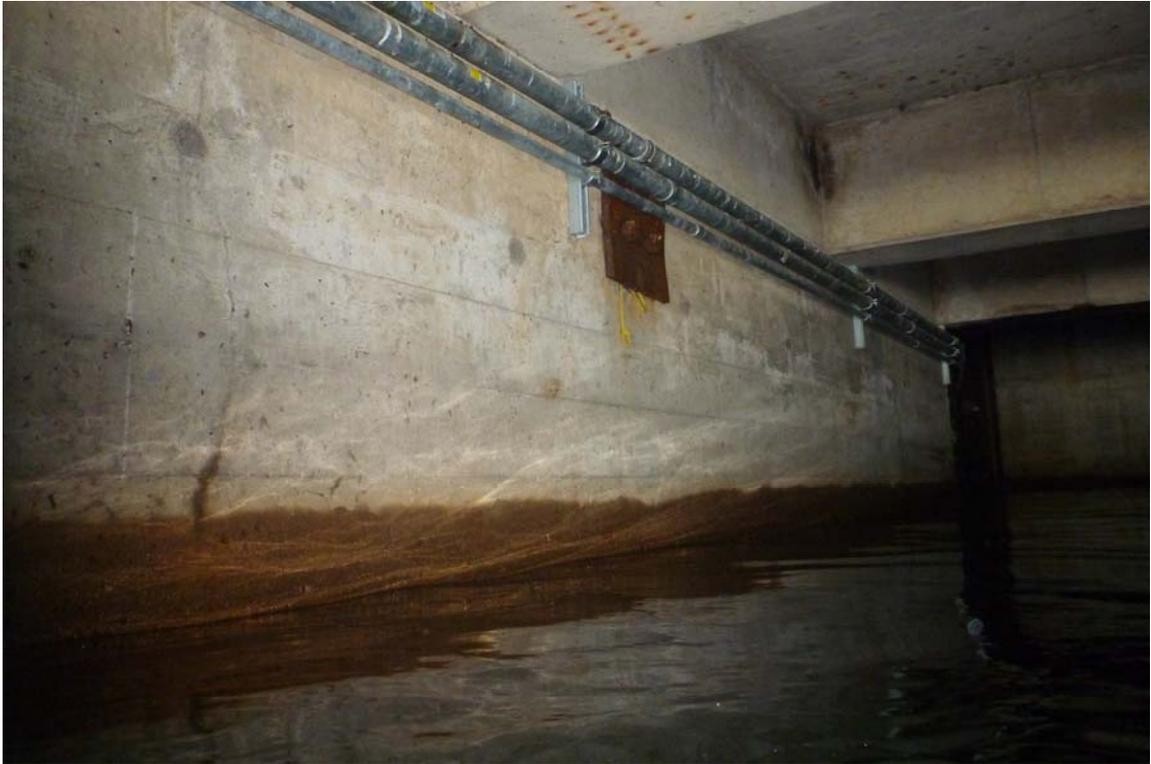
- (B) There was a vertical crack at the south end of the West Abutment, extending from under the fascia beam to 10 foot below the waterline with a maximum width of 1/8 inch. Associated areas of minor section loss, up to 1 inch wide, were observed at various locations along the crack. At the bottom of the crack, a larger area of section loss with up to 1.5 inches of penetration was present.

- (D) Random hairline map cracking with light efflorescence was observed from the waterline to 3 feet above the waterline.
- (E) Hairline to 1/16 inch wide vertical cracks with light efflorescence were observed on both abutment walls beginning at the bottom of the bridge deck and extending below water up to 5 feet below the waterline.

Photograph 3. View of Vertical Cracking on the West Abutment Above Water, Looking Northwest

- (A) Monitor the cracks in both abutment walls for any progression during future underwater inspections, which could result due to freeze and thaw action, and if found to be substantially progressing, repairs may become warranted at a later date.
- (B) Reinspect the submerged substructure units at the normal maximum recommended (NBIS) interval of sixty (60) months.

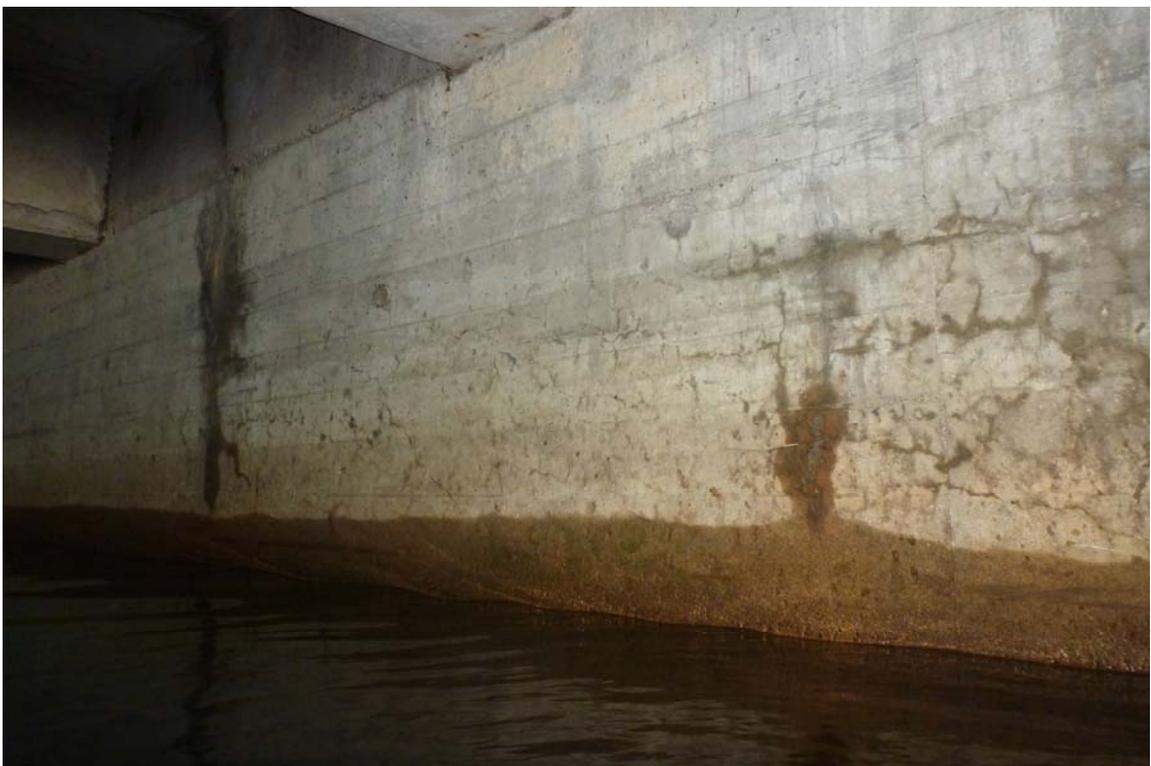
Photograph 4. View of Typical Map Cracking Above the Waterline at the East Abutment, Looking Northeast.

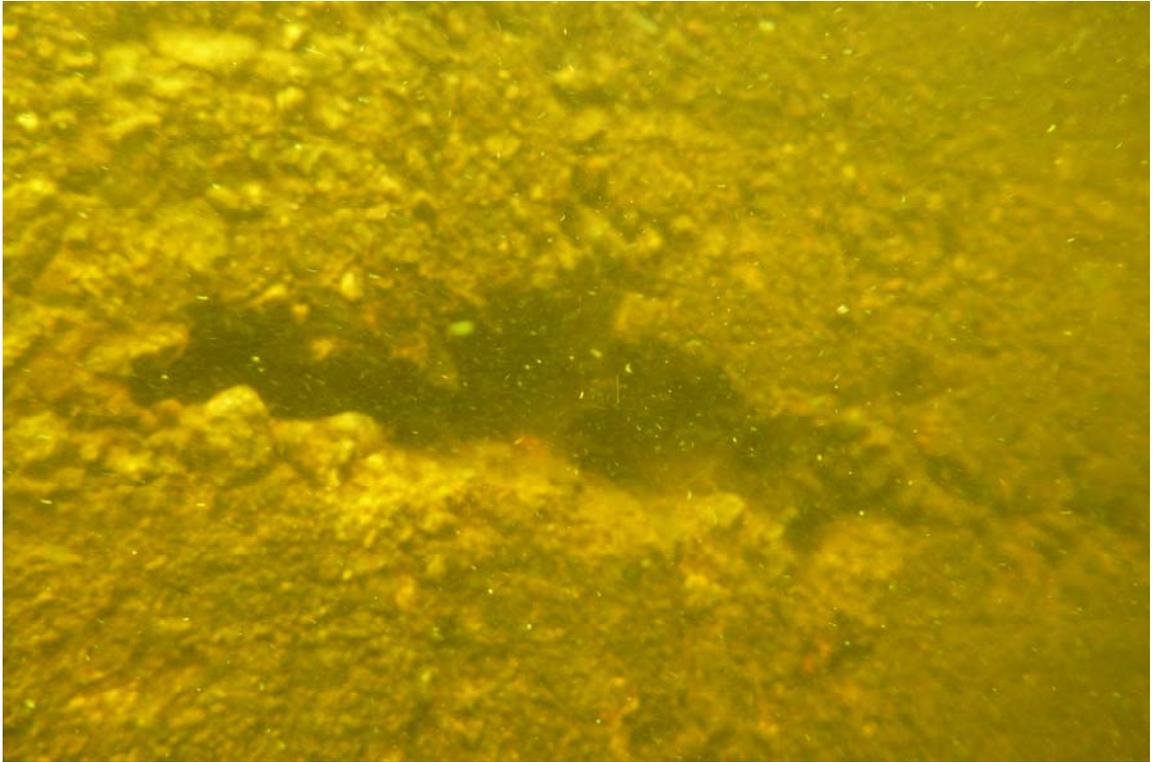
- (A) The concrete on all faces was generally smooth and sound with random small pockets of poorly consolidated concrete. On the walls there was up to 1/2 inch of section loss along various horizontal cold construction joints just below the waterline.

- (C) Random small areas of poorly consolidated concrete were observed on both abutments. There were also random, less frequent small areas of minor section loss.

Photograph 5. View of Typical Section Loss Underwater at the West Abutment, Looking West.

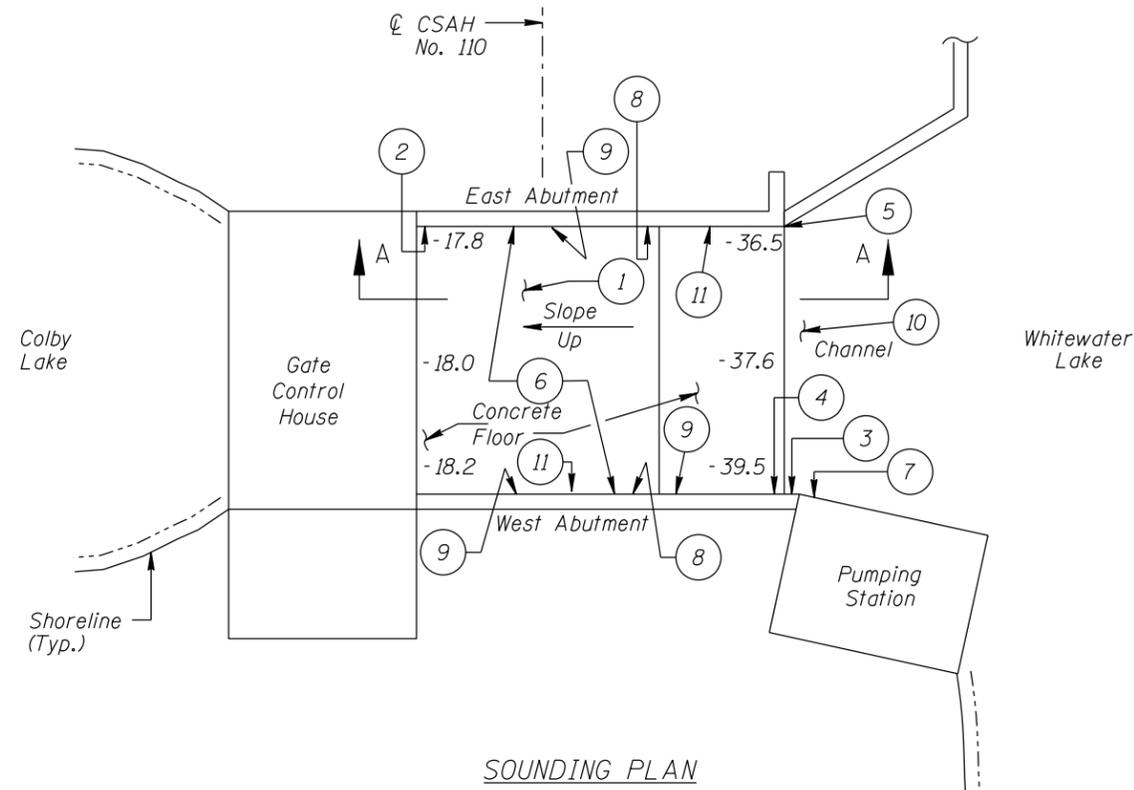
SOUNDING PLAN

- 1 The channel bottom consisted of a formed concrete slab with a light layer of silt.
- 2 At 17.5 feet below the water surface (at floor), the edge of the abutment wall along the vertical joint exhibited a 6-inch-high by 3-inch-wide area of section loss with a penetration of 2 inches.

- 3 Vertical crack, extending from under the fascia beam to 10 feet below the waterline with a maximum width of 1/8 inch and minor loss of section with surface openings of up to 1 inch wide along crack.

- 4 Area of horizontal section loss at 5 feet below the waterline, measuring 2.5 feet long by 3 inches high with a maximum penetration of 2 inches.
- 5 Section loss on corner at waterline to 3 feet below waterline, measuring 9 inches wide by 2 feet high with 2 inches of penetration.

- 6 The concrete on all faces was generally smooth and sound with random small pockets of poorly consolidated concrete. On walls, up to 1/2 inch section loss along various horizontal cold construction joints below water.

- 7 An area of horizontal section loss, 3 feet long by 2 inches high, with 3 inches of penetration, was observed on the pump station wall at 10 feet below the waterline.

- 8 Random hairline map cracking with light efflorescence was observed from around the waterline to 3 feet above the waterline.
- 9 Hairline to 1/16 inch wide vertical cracks with light efflorescence were observed on both abutment walls typically beginning at the bottom of the bridge deck and extending below water up to 5 feet below the waterline. Crack locations where as follows; at the west abutment, north and south of 3rd beam from the south, at the west abutment, between 3rd and 4th beams from the north and at the east abutment, north and south of the 5th beam from north.

- 10 Scattered riprap was observed along the south fascia.
- 11 Light scaling of concrete surfaces with from 1/8 inch to 1/4 inch penetration was observed from 1 foot above the waterline to approximately 10 feet below the waterline on both abutment walls.
