UNDERWATER BRIDGE INSPECTION REPORT

STRUCTURE NO. 7773

CSAH 116

PICKET RIVER

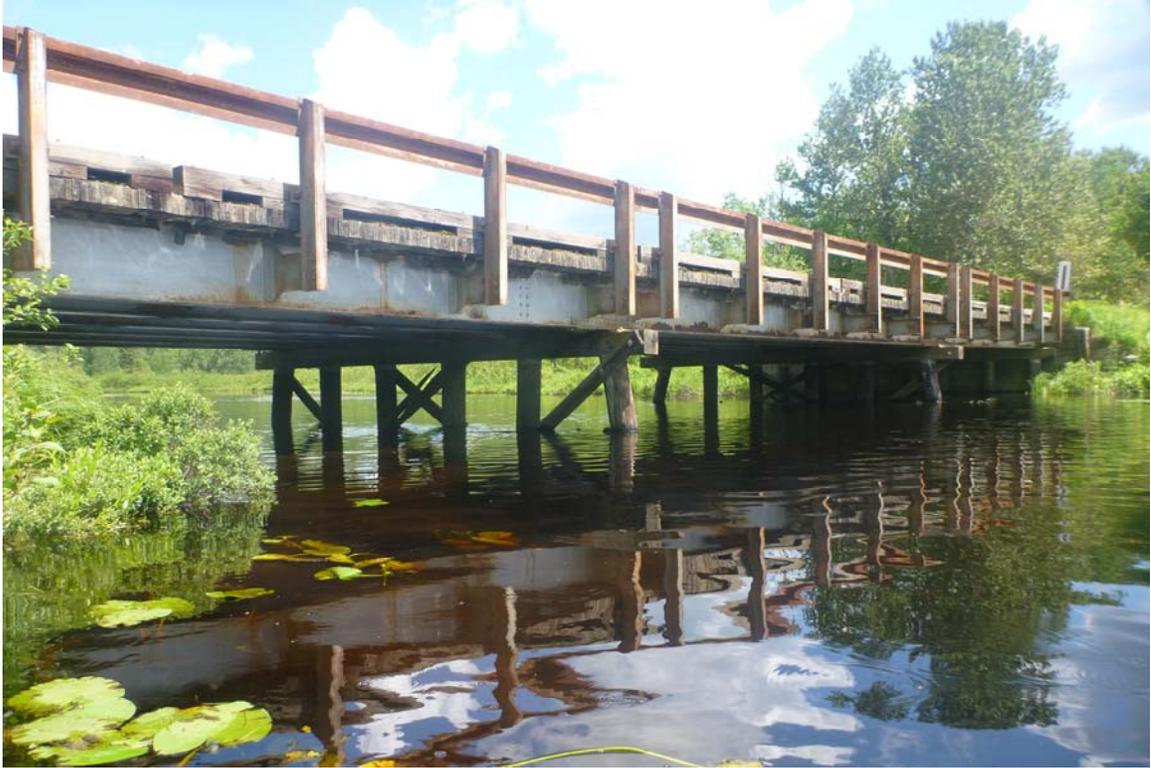
Photograph 1. View of the Upstream Fascia, Looking Northeast.

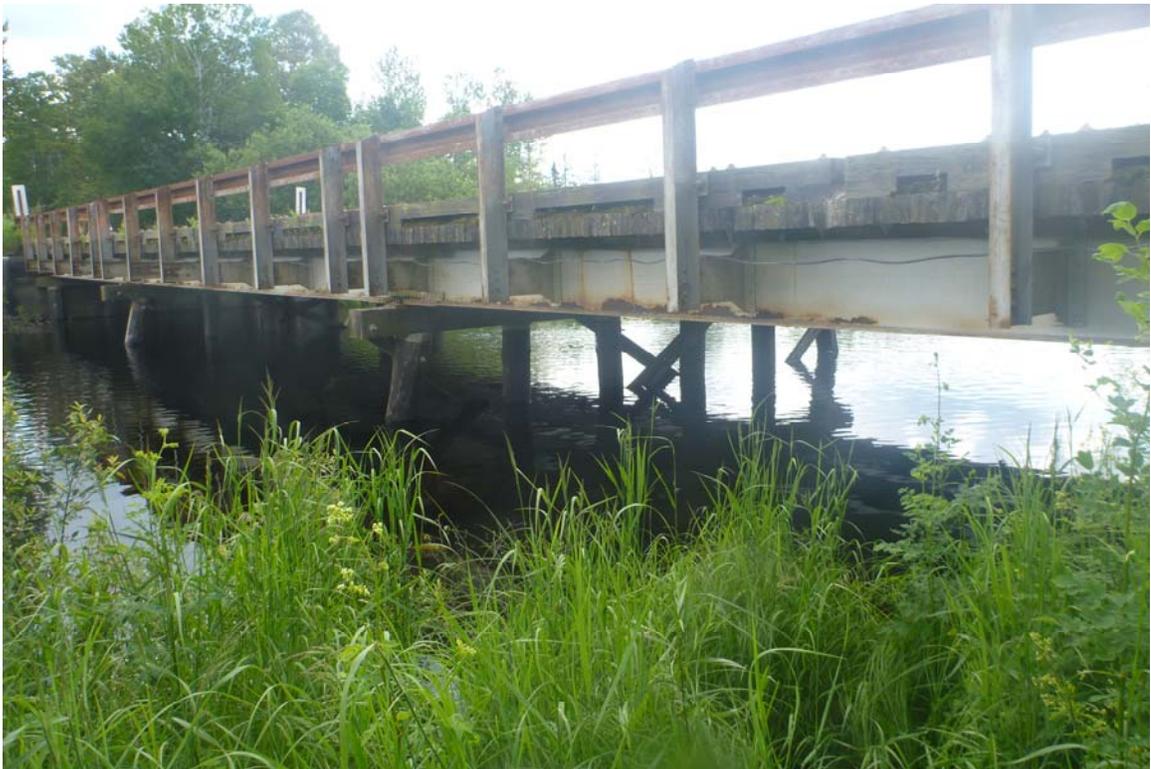
Photograph 2. View of the Downstream Fascia, Looking Southeast.

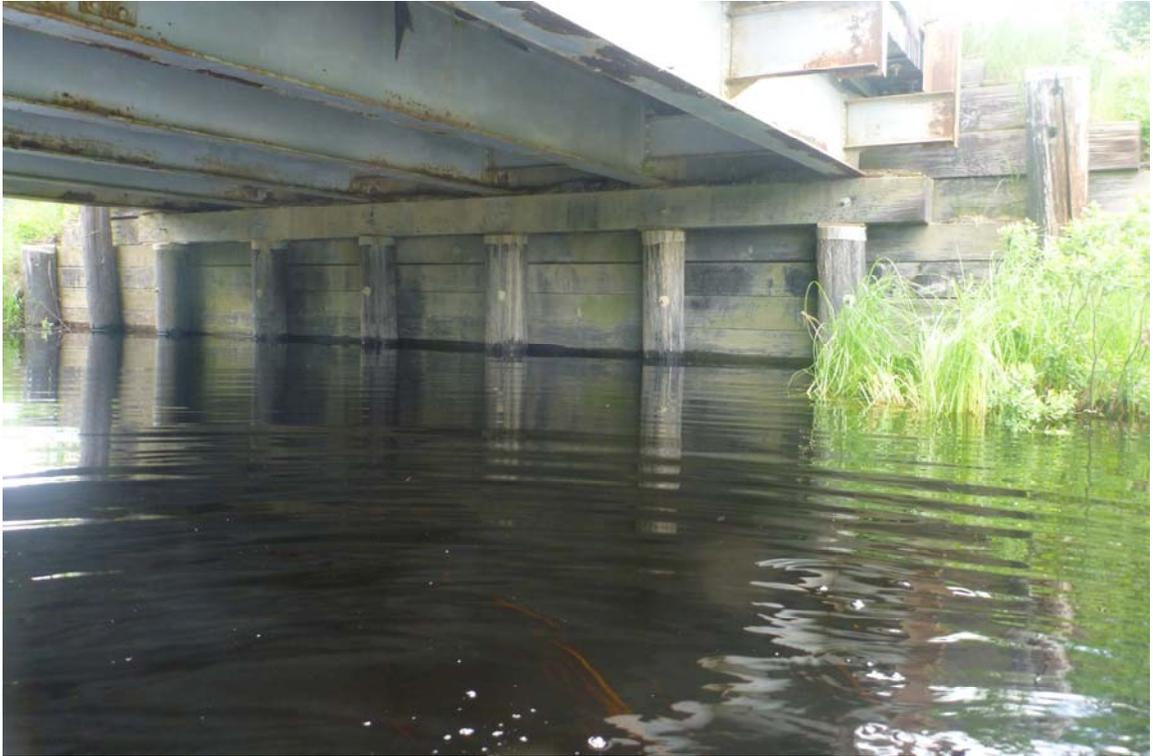
Photograph 3. View of the East Abutment, Looking Northeast.

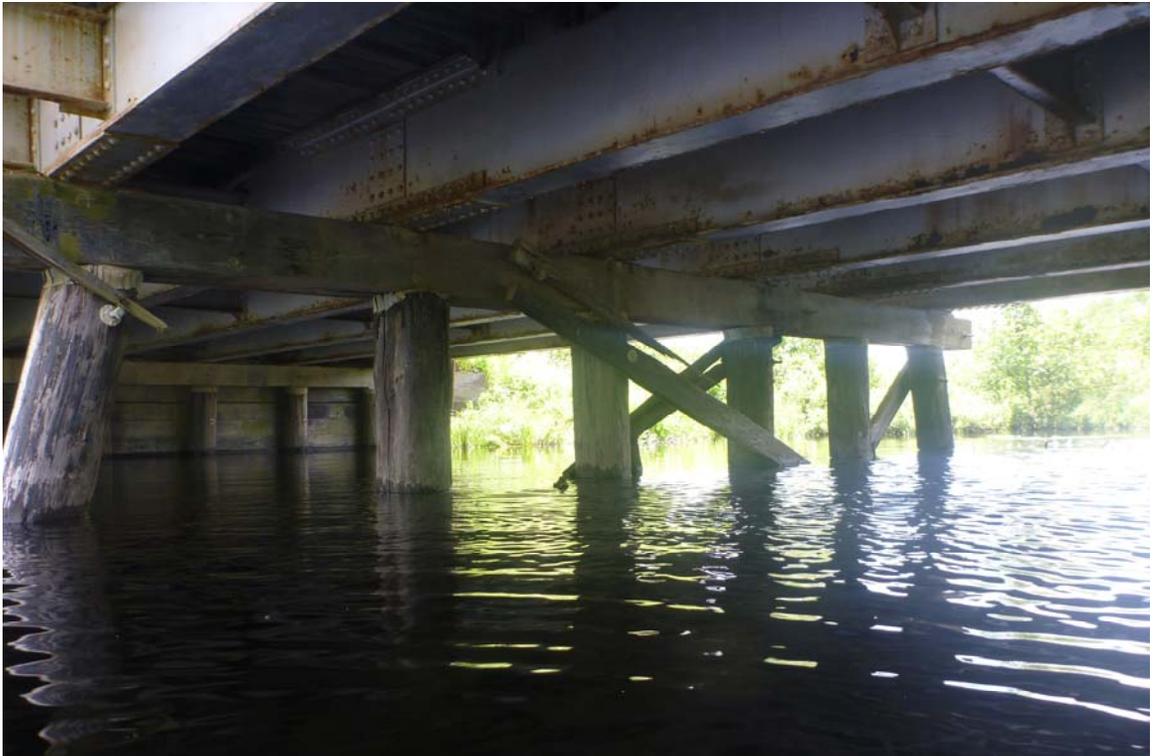
Photograph 4. View of Bent 1, Looking Southeast.

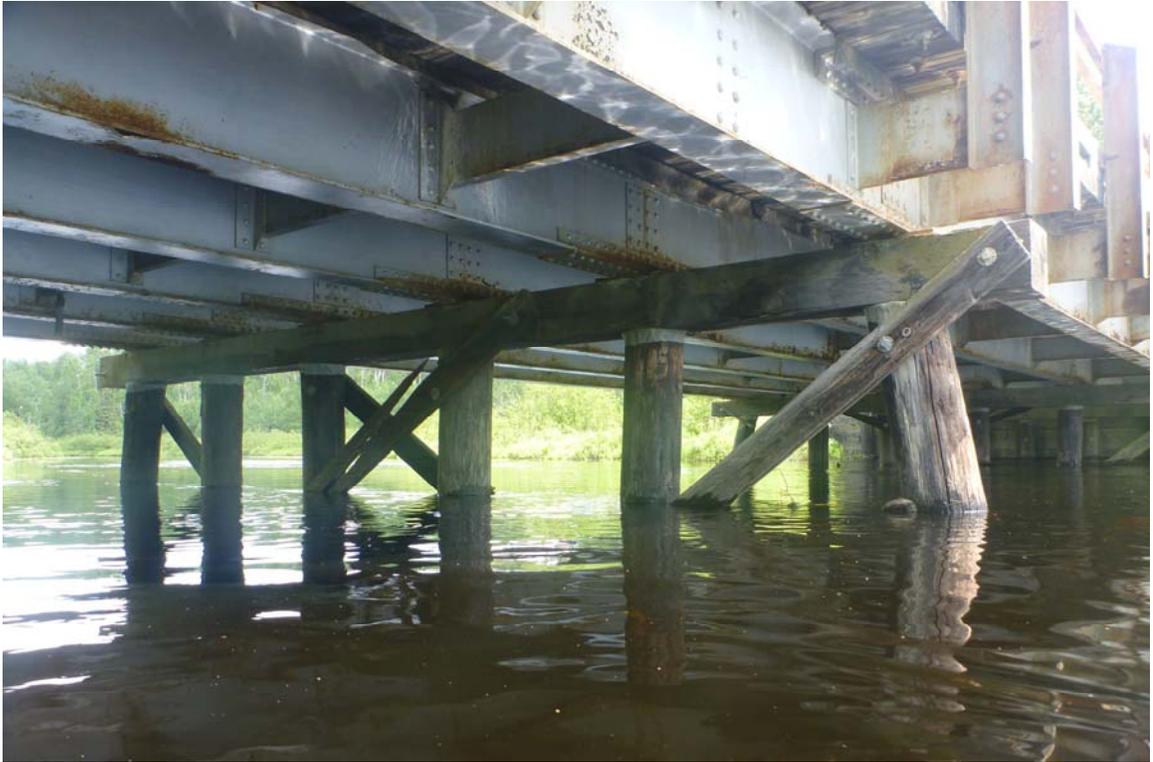
Photograph 5. View of Bent 2, Looking Northeast.

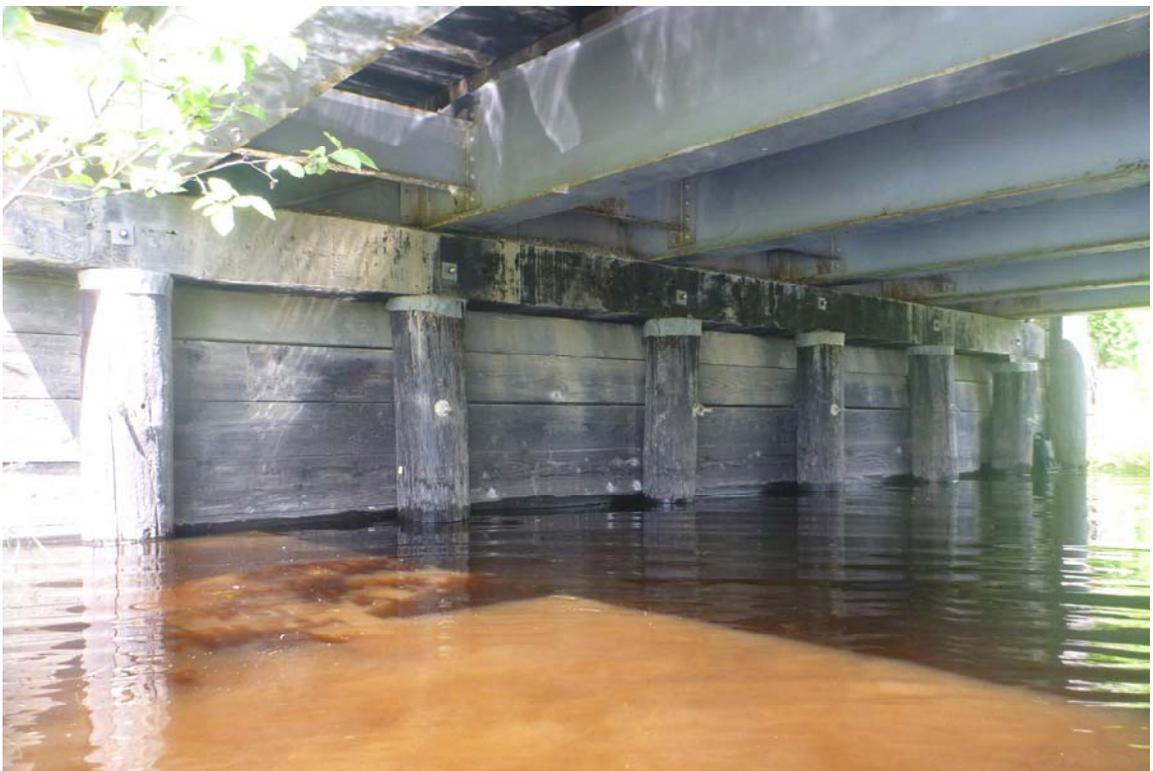
Photograph 6. View of the West Abutment, Looking Northwest.

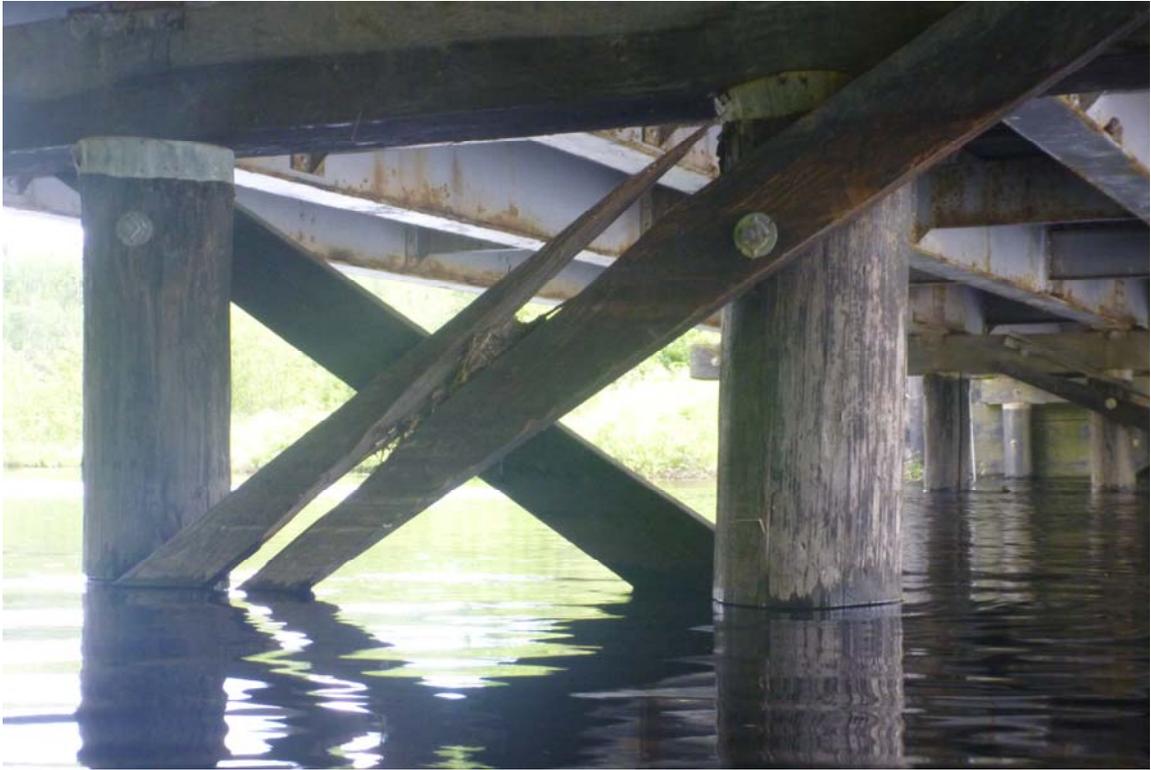
Photograph 7. View of Timber Cross-brace Condition at Bent 2, Looking Northeast.

- 8 A split in the cross-brace, measuring up to 2 inches wide, was observed on the west side of Bent 2 extending from Pile C to Pile E. The cross-brace to pile connection at Pile D was compromised.

- (A) Repair or replace the deficient timber cross-bracing particularly all the bracing at Bent 1.

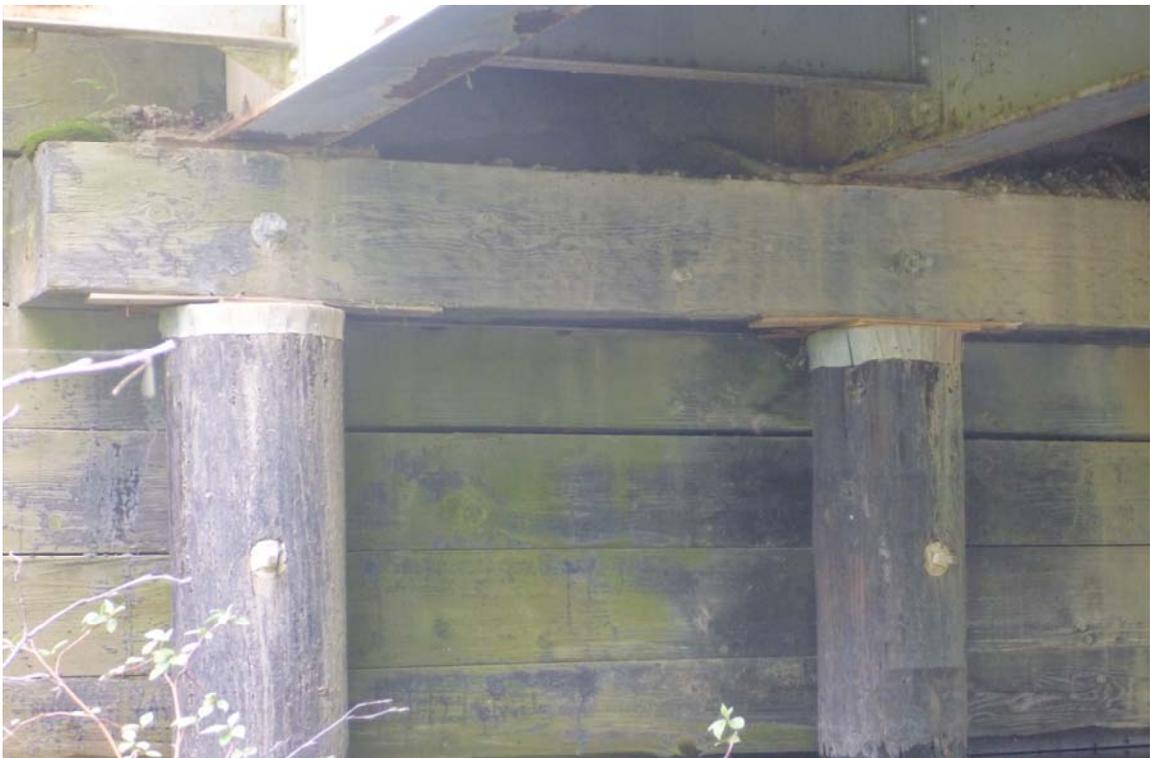
Photograph 8. View of Pile Cap and Shims at the East Abutment, Looking Southeast.

- 4 The timber pile cap at the East Abutment was bearing on shims at the top of Piles A, B, C, E, and F.
- 5 A timber cross-brace was missing on the west side of Piles D through F of Bent 1.

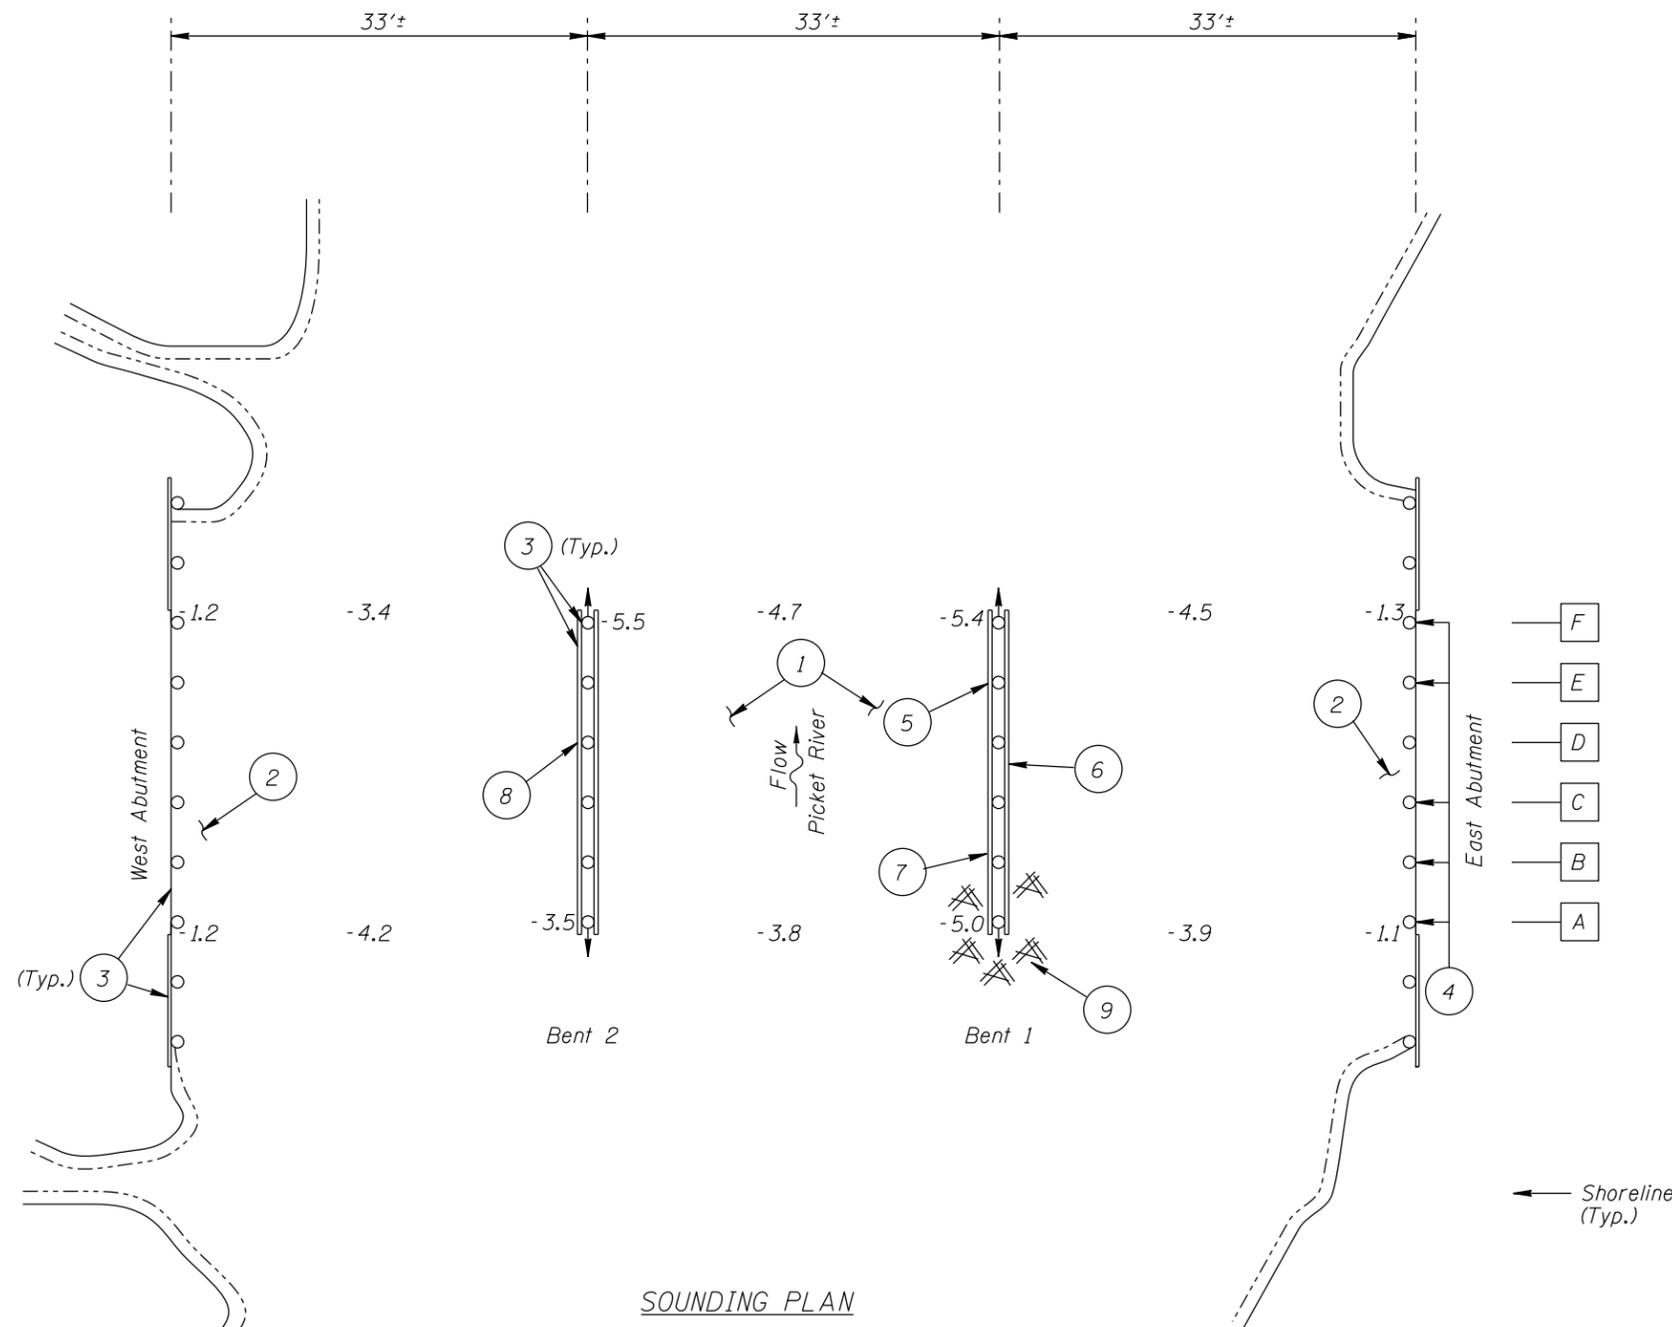
- 1 The channel bottom material typically consisted of silty sand allowing 4 inches of probe rod penetration.
- 2 The channel bottom material in the vicinity of both abutments consisted of riprap 1.5 feet in diameter and smaller.

- 3 The timber piles, cross-bracing, wingwalls, and backwall planking were generally sound allowing a typical timber awl penetration of 1/6 to 1/8 inch.

- 6 The timber cross-bracing on the east side of Piles C and D of Bent 1 exhibited heavy deterioration and splitting with up to 100 percent section loss.

- 7 A split in the cross-brace, measuring up to 4 inches wide, was observed on the west side of Bent 1 extending from Pile D to Pile A. The cross-brace to pile connection at Pile D was compromised.

- 9 A light accumulation of timber debris, consisting of 2 inch diameter and smaller branches, was observed around Pile A of Bent 1.
