UNDERWATER BRIDGE INSPECTION REPORT

STRUCTURE NO. 7787

CSAH 6

DUTCH SLOUGH

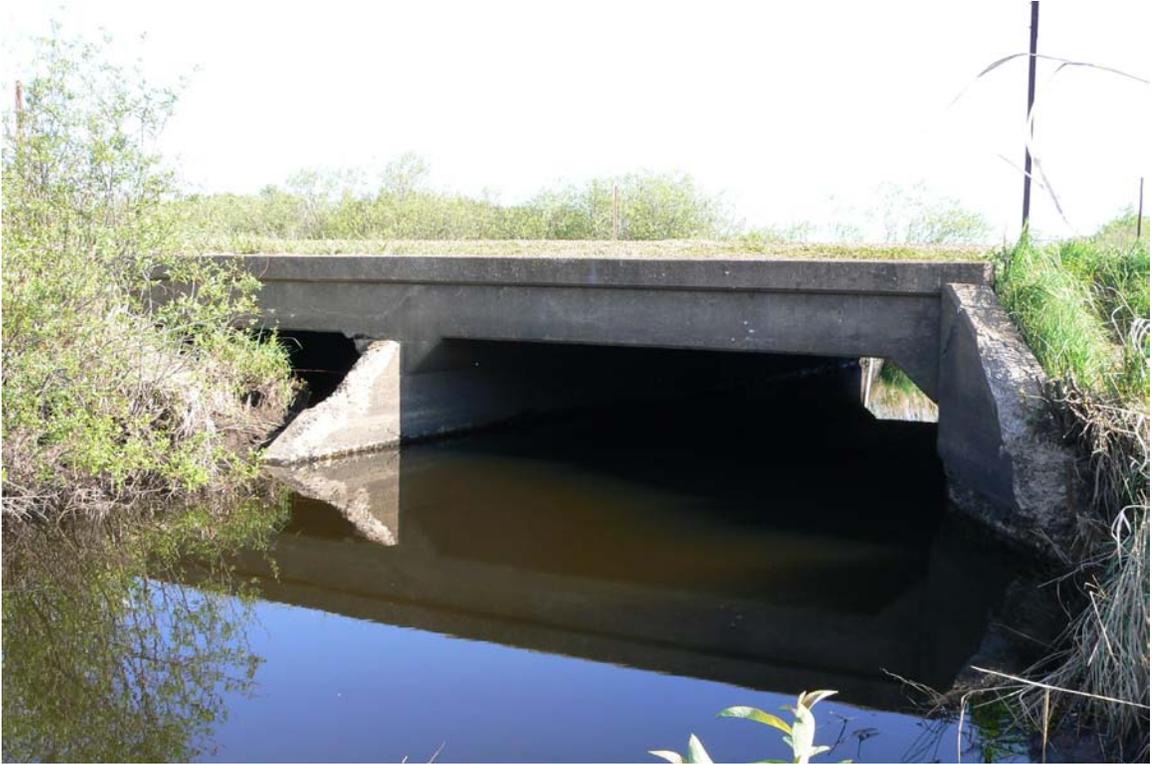
Photograph 1. View of the downstream end of the East Barrel, Looking Northwest.

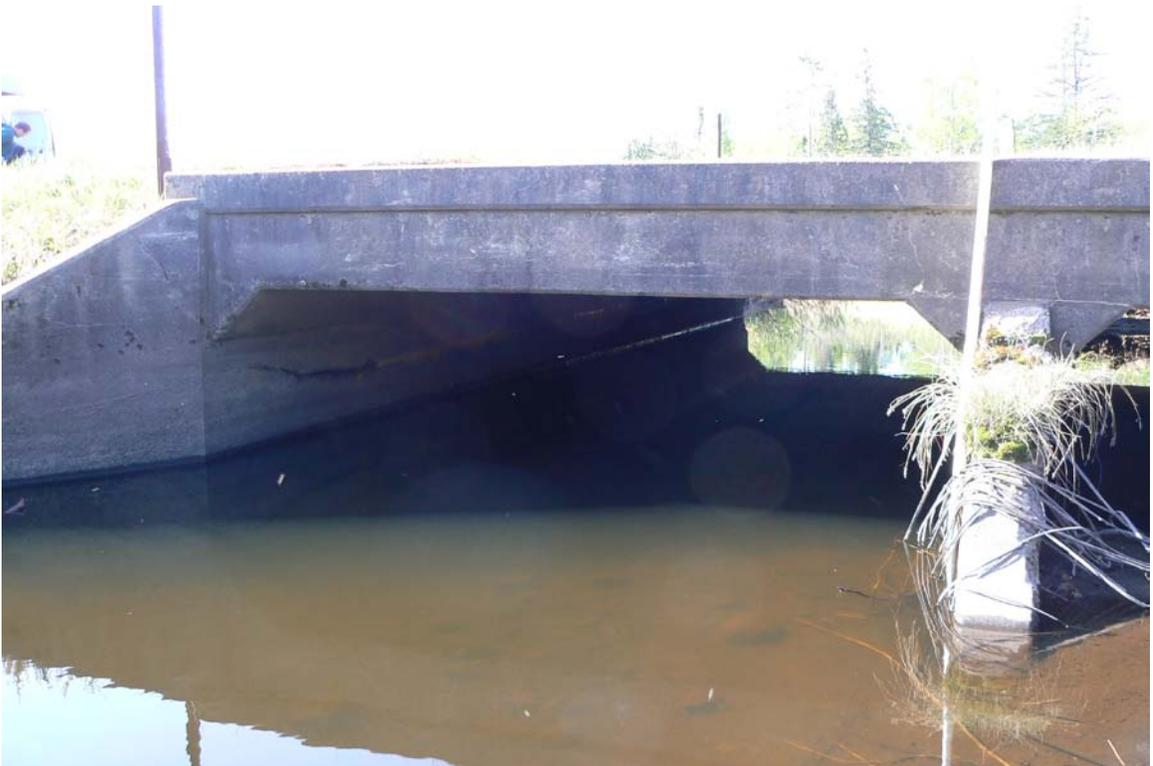
Photograph 2. View of the Upstream Face of the East Barrel, Looking South.

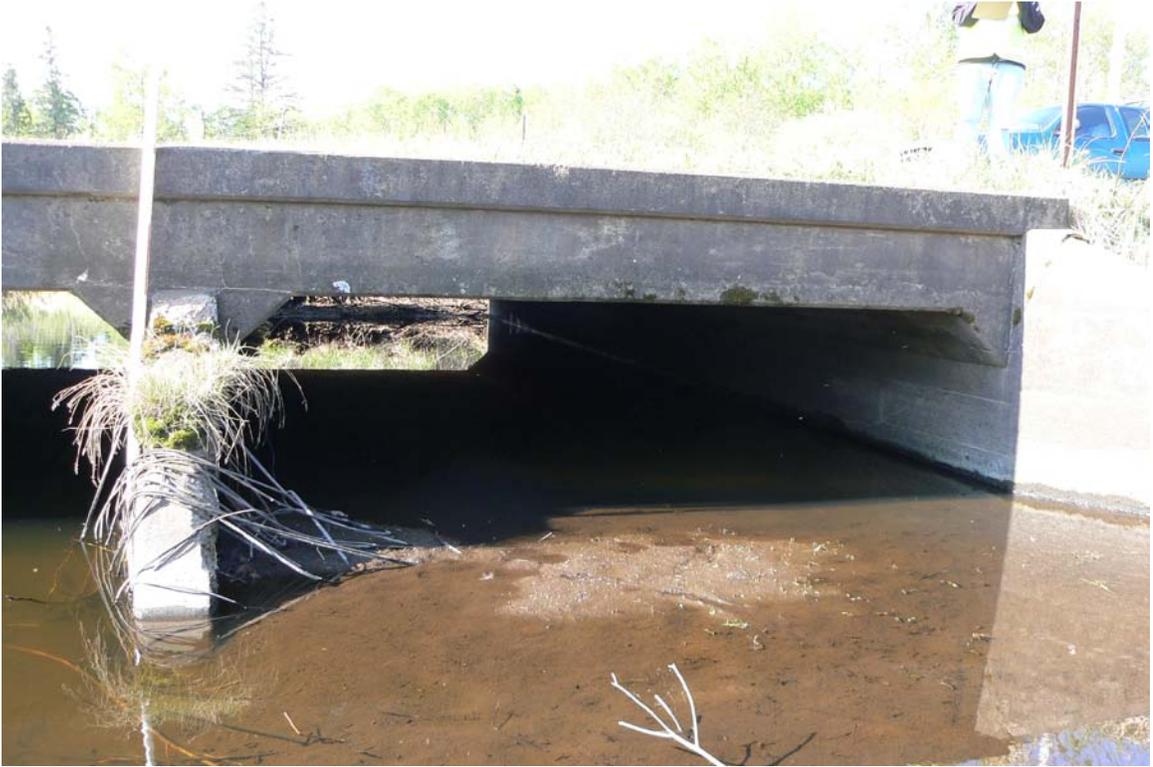
Photograph 3. View of the Upstream End of the West Barrel, Looking South.

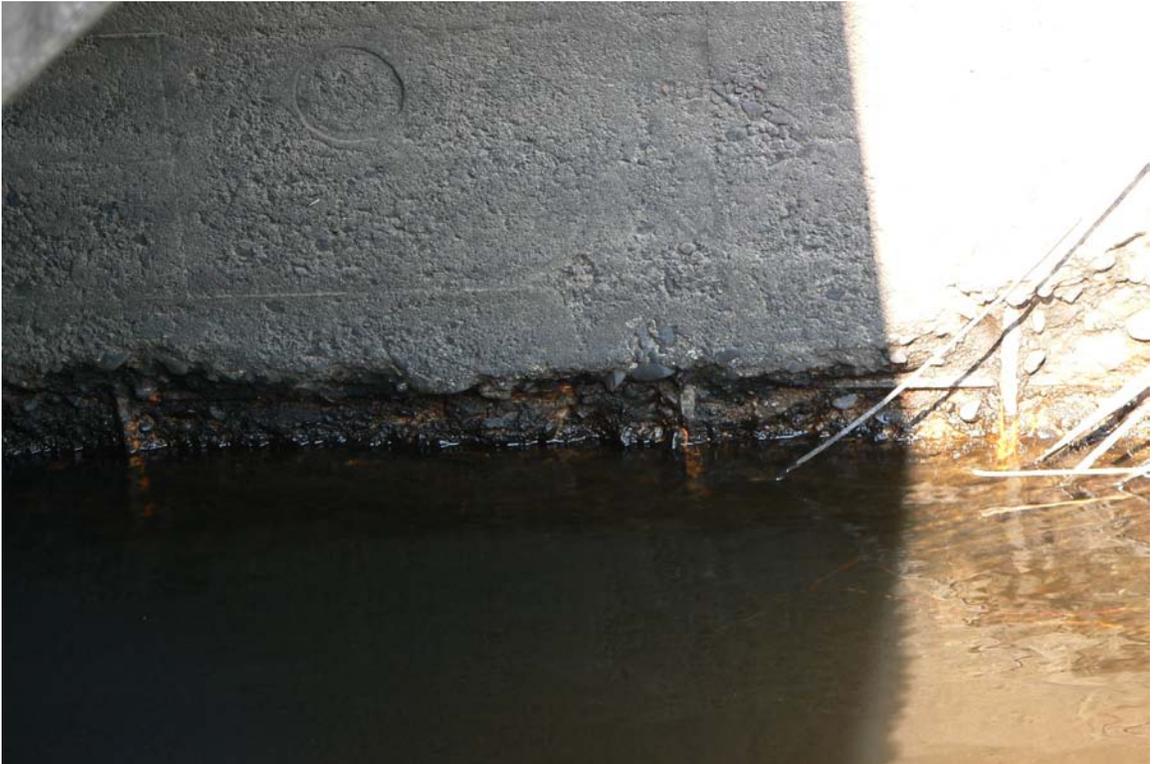
- (C) A spall with exposed reinforcing steel was observed along the length of the west wall of the East barrel extending from 1 foot below to 6 inches above the waterline with up to 3 inches of penetration. Exposed reinforcing steel exhibited 10 percent loss of section.

Photograph 4. View of Spall on East face of the Center Wall Extending the Length of the Barrel, Looking West.

- 3 Spall with exposed reinforcing steel located on the entire length of the west wall of the East barrel from the upstream to the downstream fascia extended from 1 foot below to 6 inches above the waterline with up to 3 inches of penetration. Exposed reinforcing steel exhibited 10 percent loss of section.

The spalls and associated concrete section loss are not structural concerns at this time; however, they should be repaired to prevent further deterioration. The repairs should include removal of concrete to a minimum of 1 inch behind the reinforcing steel, cleaning and replacing reinforcing steel as required, and placing concrete designed to provide high durability with low permeability.

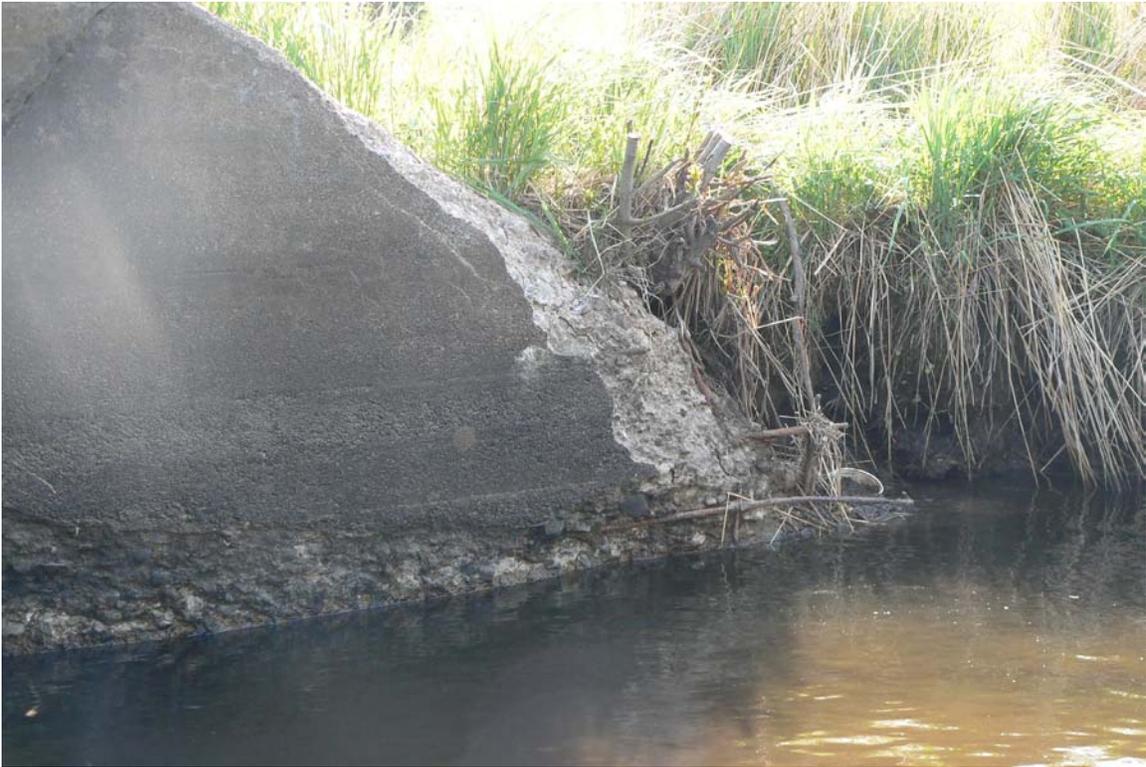
- (E) Heavy concrete section loss with exposed reinforcing steel was observed along the downstream 2 feet of the southeast wingwall.
- (F) Concrete section loss with exposed reinforcing steel was observed along the downstream end of the center wall with 2-3 inches of penetration.

Photograph 5. View of the Southeast Wingwall Spall with Exposed Reinforcing Steel, Looking East.

- 5 Heavy concrete section loss with exposed reinforcing steel located along the downstream 2 feet of the southeast wingwall.
- 6 Concrete section loss with exposed reinforcing steel located across the full width of the downstream end of the center wall with 2 to 3 inches of penetration.

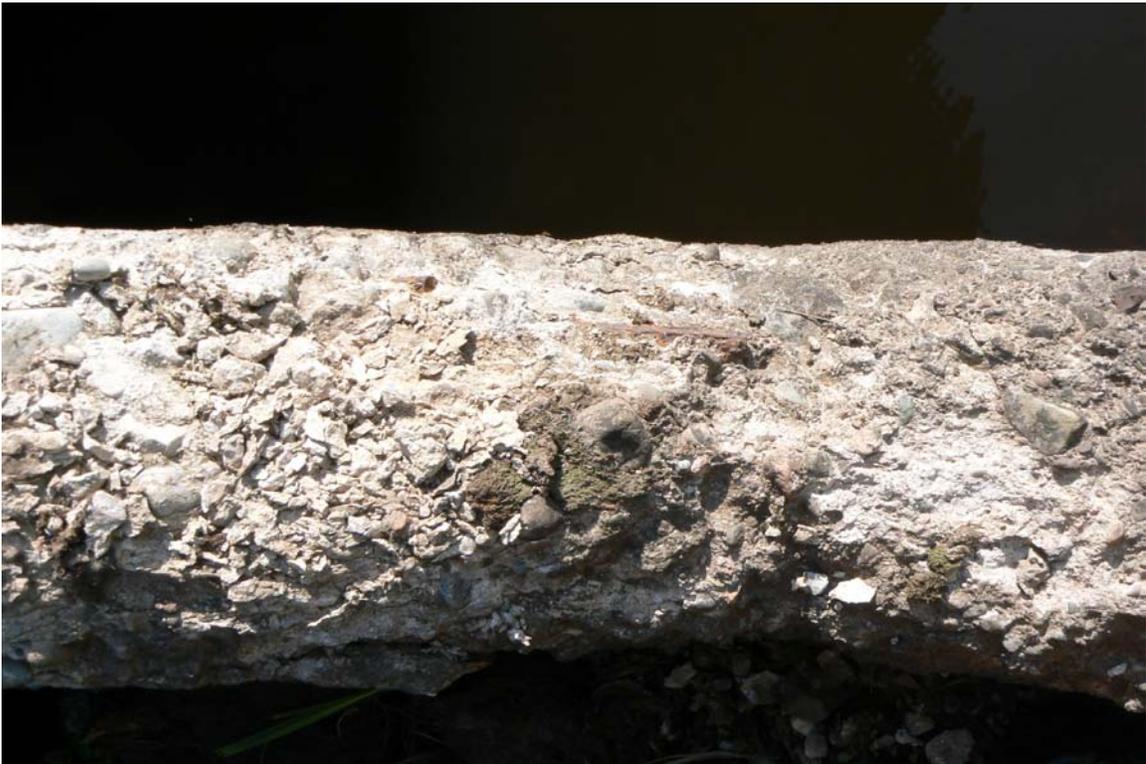
Photograph 6. View of the Section Loss along Downstream End of the Center Wall, Looking Down.

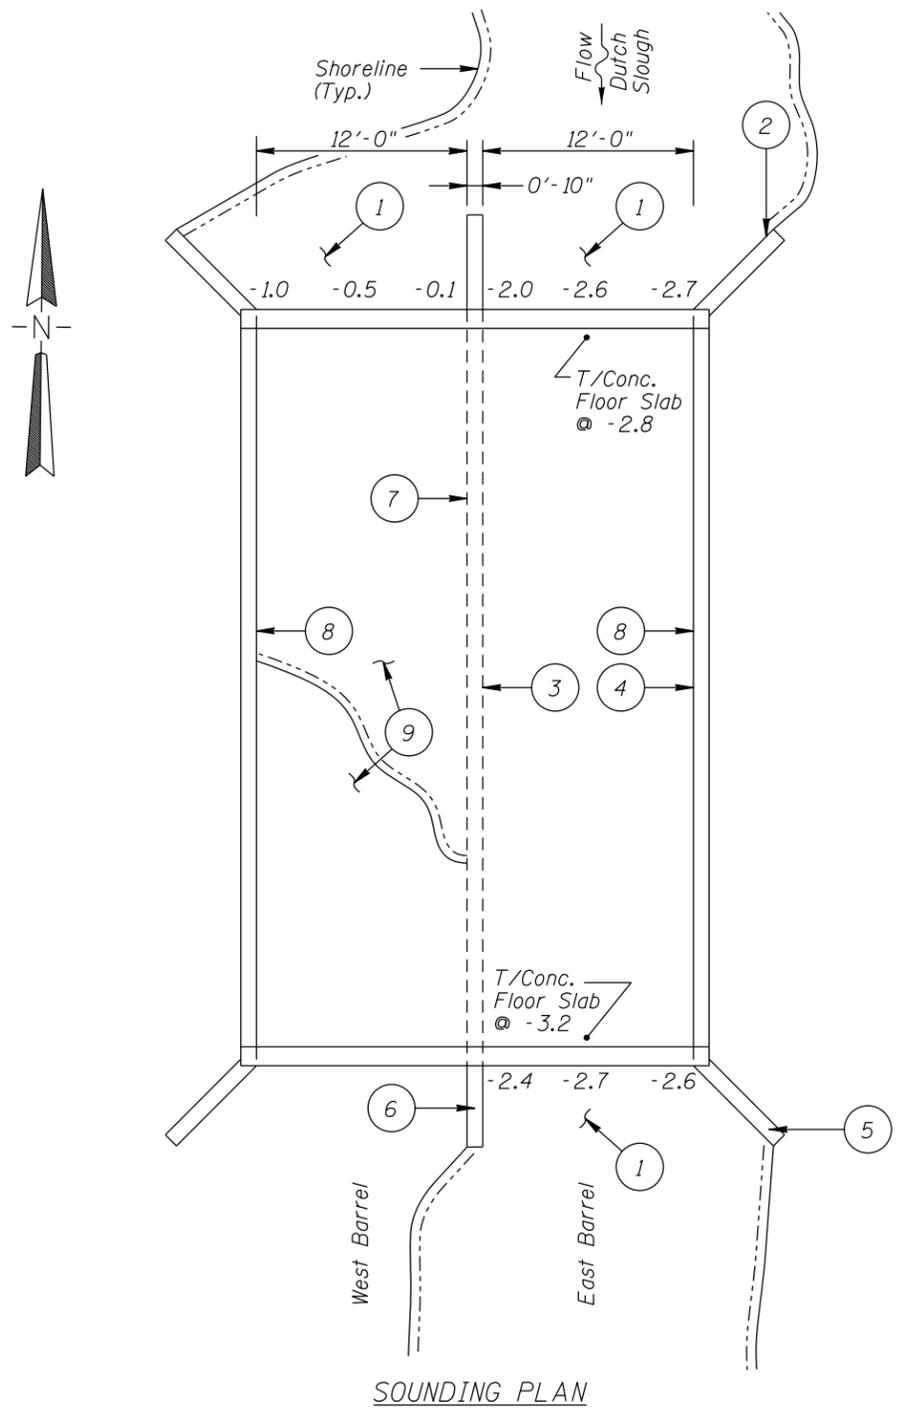
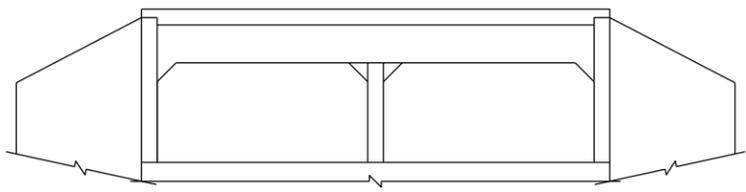
SOUNDING PLAN

- 1 Channel bottom material consisted of gravel and riprap up to 8 inches in diameter.
- 2 Two areas of minor concrete section loss located at the upstream end of the northeast wingwall measured 8 inches in diameter with 2 inches of penetration. No exposed reinforcing steel was observed.

- 4 Horizontal cold joint along the entire east wall of the East barrel located 1.5 feet above the waterline measured up to 1 inch wide with up to 1-1/2 inches of penetration.

- 7 Areas of concrete section loss located along the upstream half on the east wall of the West barrel extended from the channel bottom to 4 inches above the waterline with up to 2 inches of penetration.

- 8 Moderate scaling along the west wall of the West barrel and the east wall of the East barrel extended from the waterline to 3 inches above the waterline with typically 1 inch of penetration.

- 9 The culvert floor within the West barrel was covered with up to 4 feet thick layer of silty infill.
