UNDERWATER BRIDGE INSPECTION REPORT

STRUCTURE NO. 7819

CR 213

ST. LOUIS COUNTY

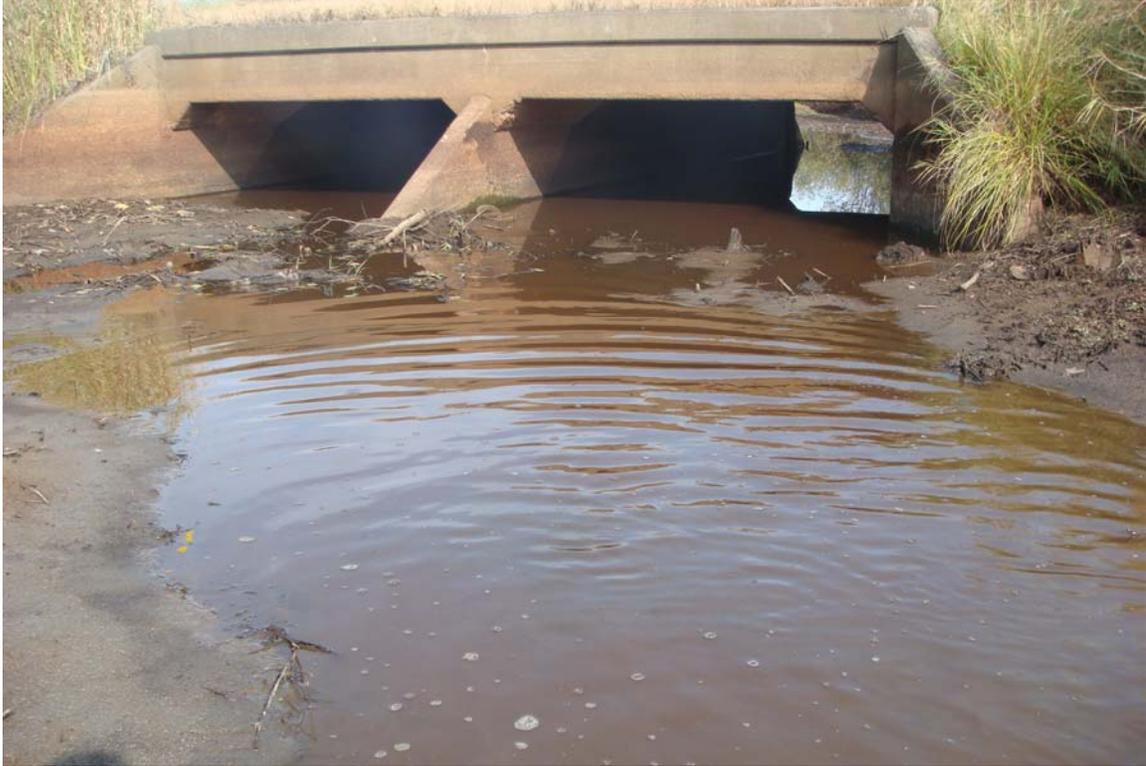
Photograph 1. Overall View of the Culvert, Looking East.

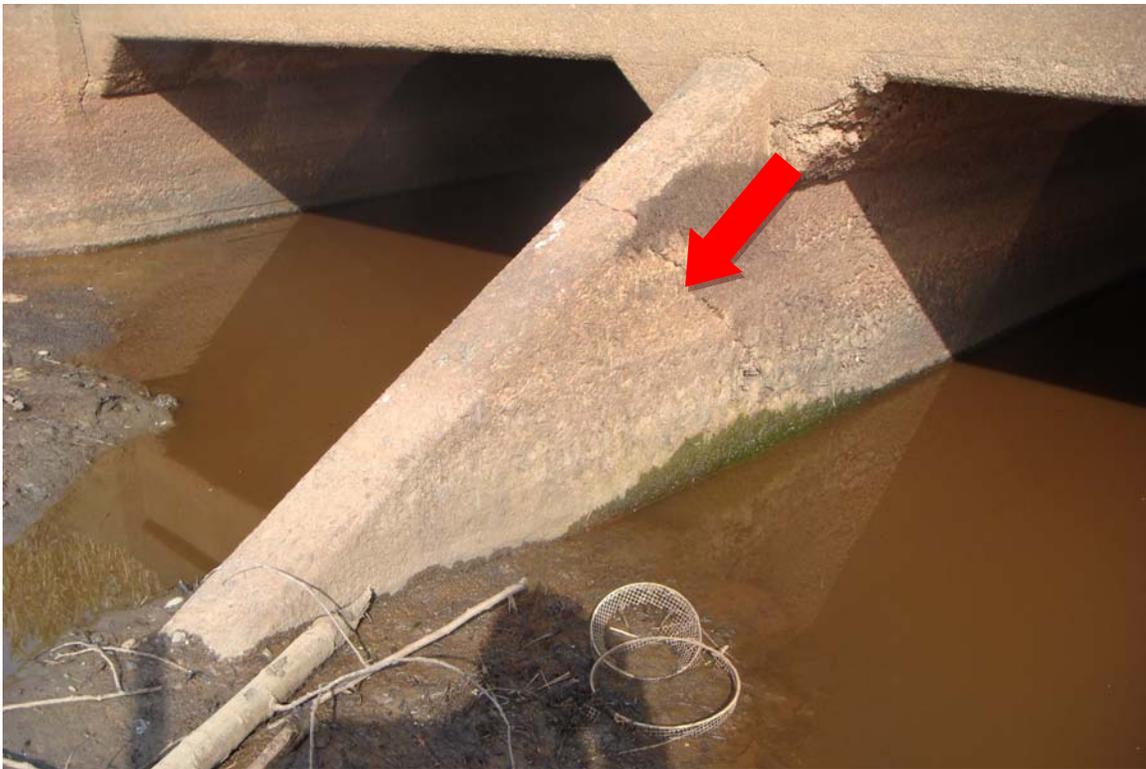
- (C) The center wall extensions at both the upstream and downstream ends of the culvert and the northwest and southeast wingwalls exhibited a diagonal crack extending from the channel bottom to the top of the wall. The cracks were typically 1/8 inch wide.

Photograph 2. View of the Typical Scaling and Concrete Condition at the Waterline and Diagonal Crack on the Upstream Center Wall Extension, Looking Northeast.

- ③ The center wall extensions at both the upstream and downstream ends of the culvert and the northwest and southeast wingwalls exhibited a diagonal crack extending from the channel bottom to the top of the wall. The cracks were typically $\frac{1}{8}$ inch wide.

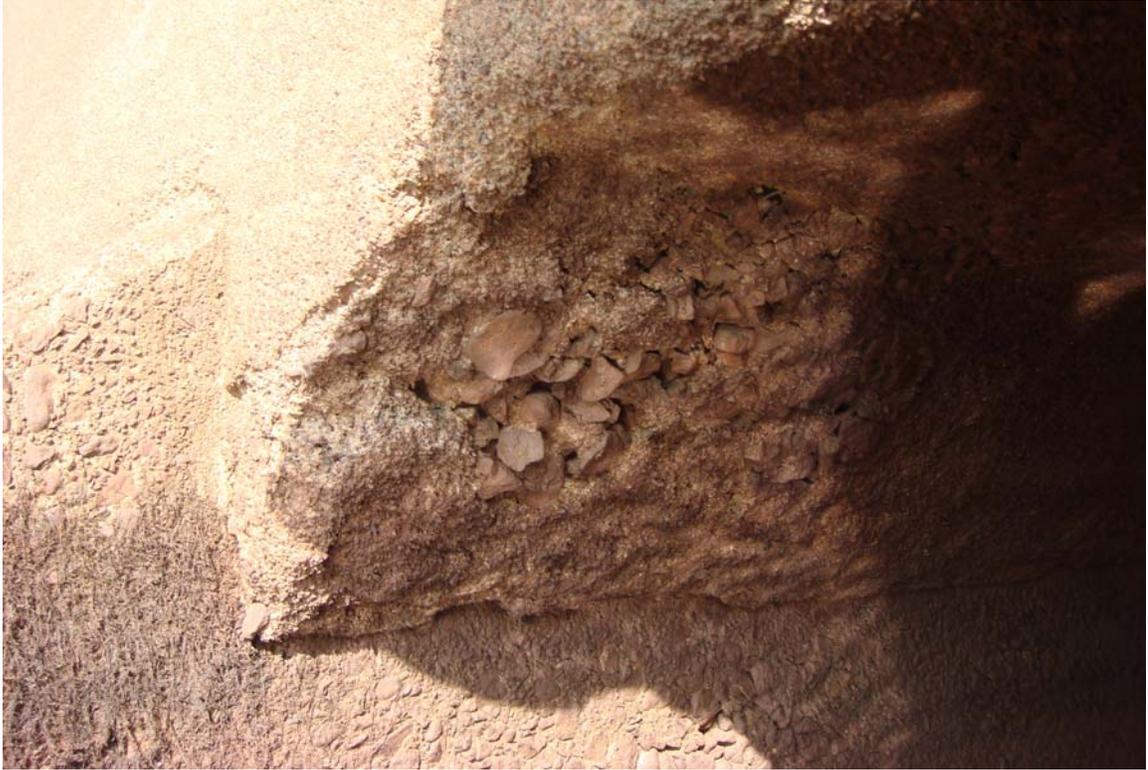
- (E) An area of heavy scaling was observed at the north wall of Box 1 near the upstream opening. The area measured 2 feet long by 8 inches high with a maximum penetration of 2 inches. No reinforcing steel was exposed.

Photograph 3. View of Heavy Scaling on the North Wall of Box 1 Near the Upstream Opening, Looking Northeast.

- ⑤ An area of heavy scaling was observed at the north wall of Box 1 near the upstream opening. The area measured 2 feet long by 8 inches high with a maximum penetration of 2 inches. No reinforcing steel was exposed.

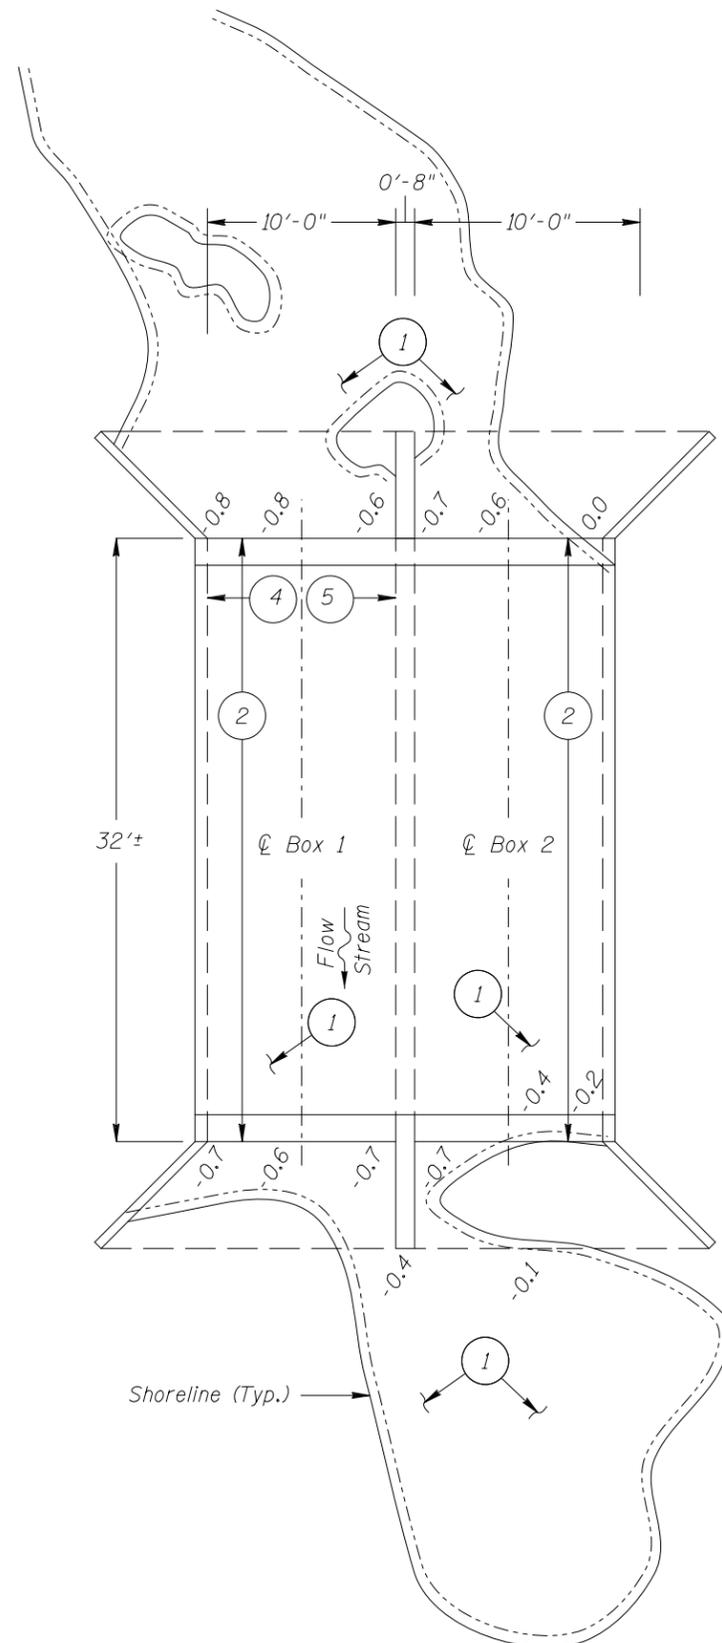
SOUNDING PLAN

- ① The channel bottom material through the length of both boxes and upstream and downstream of the culvert consisted of silt and scattered stones allowing a maximum probe rod penetration of 1 foot.

- ② Moderate scaling was observed on the walls and ceiling of both boxes with a typical penetration of $\frac{1}{4}$ inch and a maximum penetration of $\frac{1}{2}$ inch.

- ④ An area of heavy scaling was observed at the south upper wall haunch of Box 1 near the upstream opening. The area measured 3 feet long by 6 inches high with a maximum penetration of 2 inches. No reinforcing steel was exposed.
