UNDERWATER BRIDGE INSPECTION REPORT

STRUCTURE NO. 7826

GOODELL ROAD

RICE RIVER

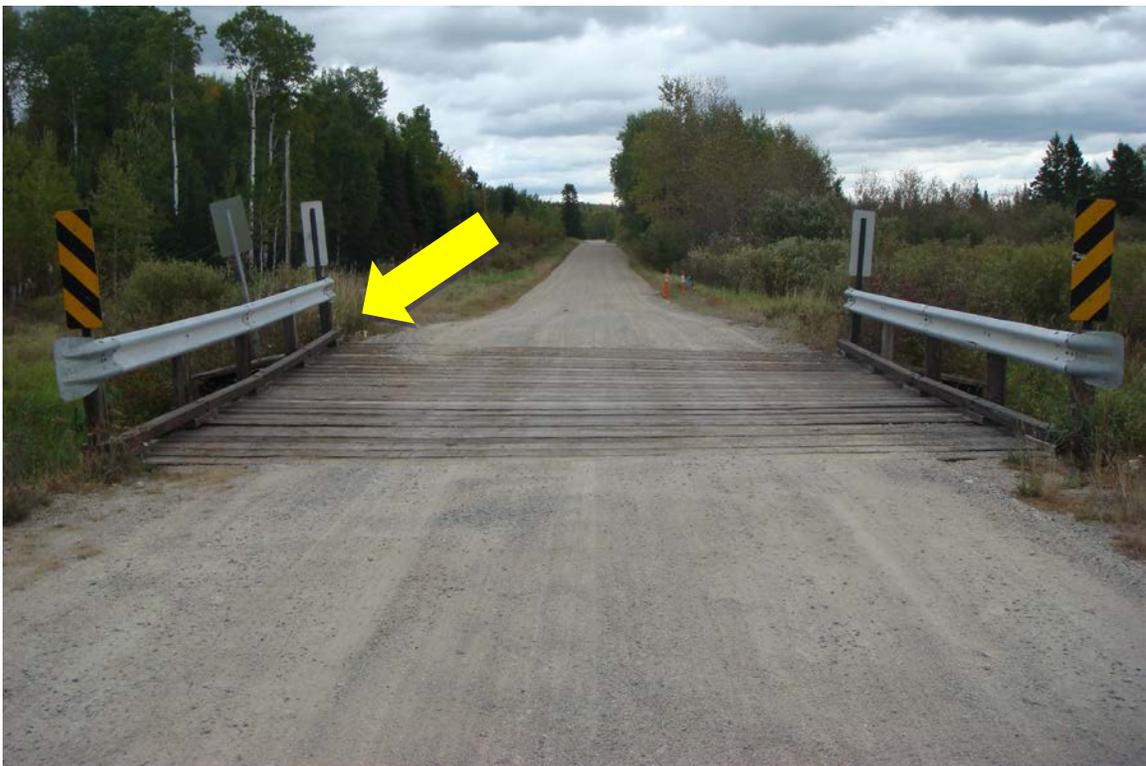
- (G) A loss of fill material was noted below the bottom backwall board at the East Abutment. No voids could be seen behind the boards, however, there was a depression in the gravel roadway adjacent to the East Abutment.

Photograph 2. View of roadway at bridge, Looking East. Note the Northeast Corner is elevated in relation to the rest of the roadway.

- (A) An above water inspection should be conducted as soon as possible at the East Abutment, and based on that inspection and further evaluation, the appropriate remedial measures for abutment and backfill stability should be implemented.
- (B) Shim Pile C of Bent 1 to restore bearing and monitor during future inspections.
- (C) Repair/replace the split cross-brace at Bent 1.
- (D) The timber debris accumulation across the upstream channel did not significantly affect the channel flow, and as a result, does not require removal at this time. If the debris accumulation increases in size or density, it may be necessary to remove the debris to reduce excessive lateral loads on the pier, limit further debris accumulation, and reduce the likelihood of channel bottom degradation resulting from obstructed flow.

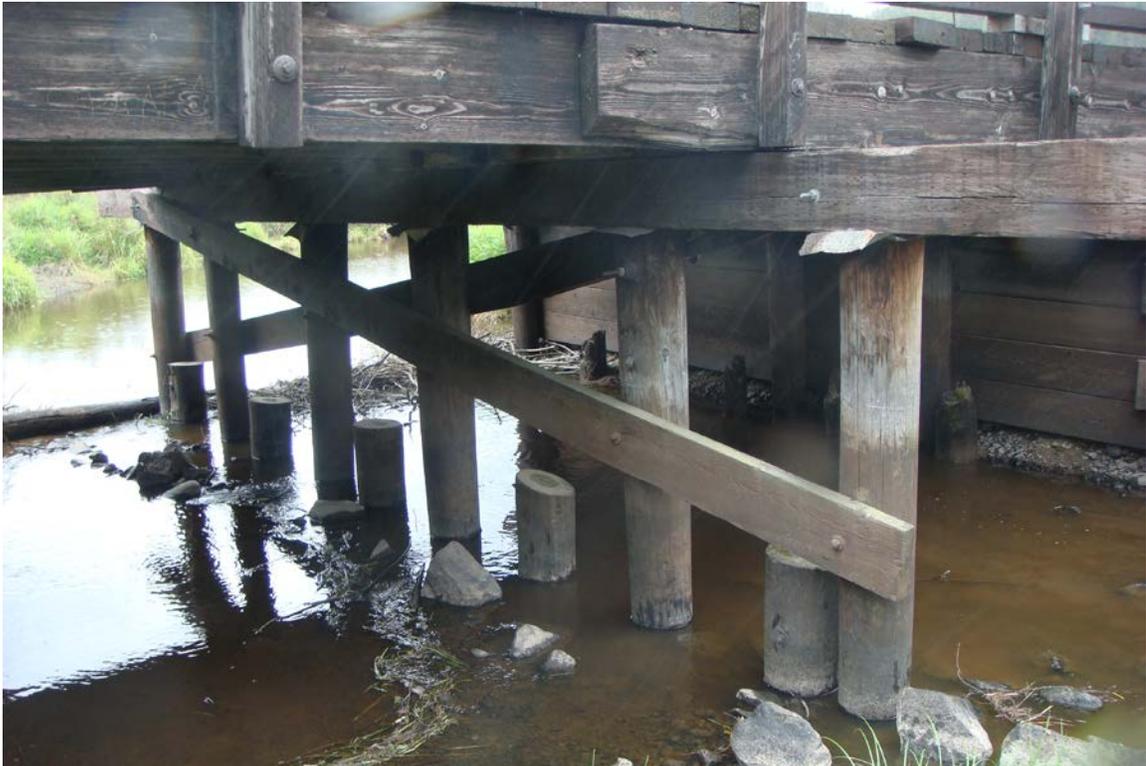
Photograph 4. View of the Bent 1, Looking Southwest.

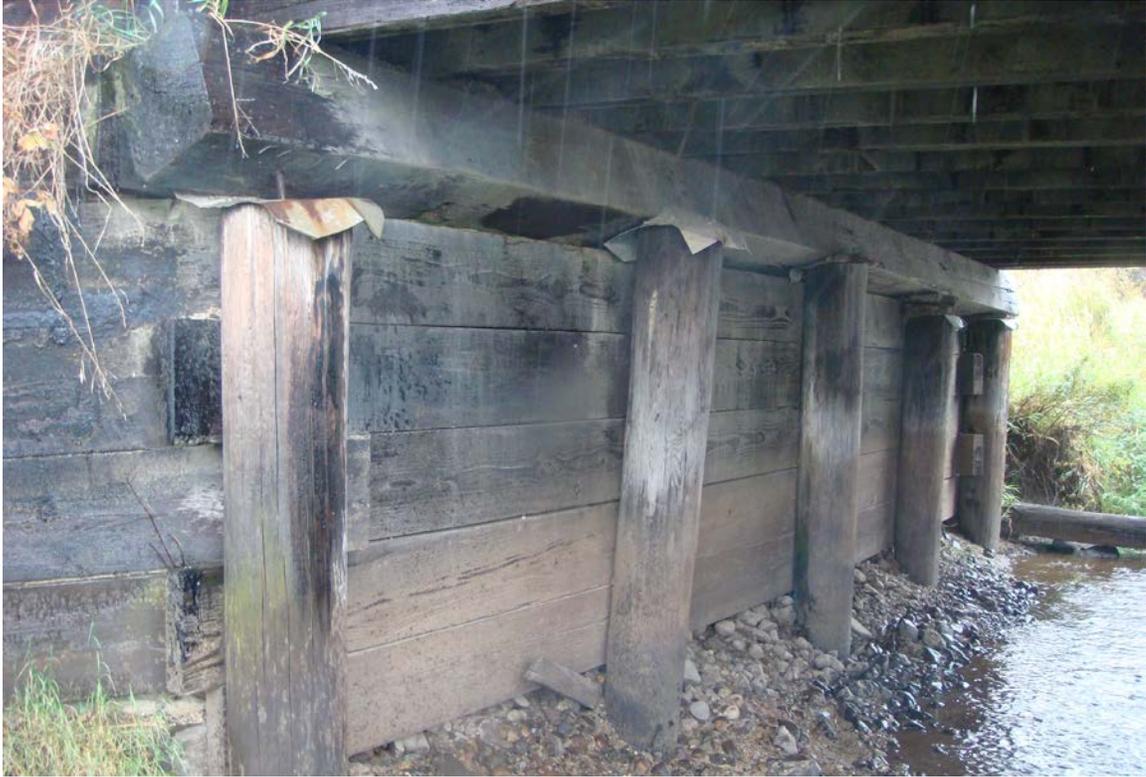
Photograph 5. View of the East Abutment, Looking Southeast.

An above water inspection should be conducted as soon as possible at the East Abutment, and based on that inspection and further evaluation, the appropriate remedial measures for abutment and backfill stability should be implemented.

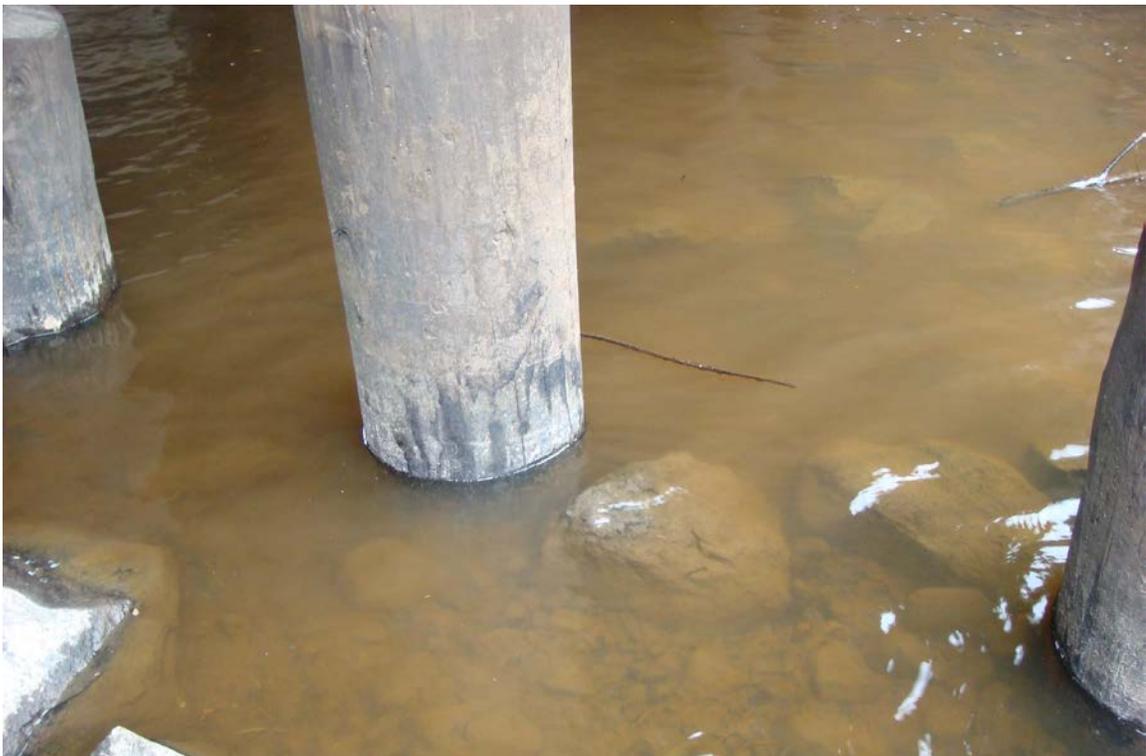
Photograph 6. View of the Typical Timber Pile Condition at the Waterline, Looking Southwest.

- 1 The channel bottom material typically consisted scattered rocks, gravel and sand.
- 2 Unless otherwise noted the timber piles were typically sound with random splits or checks up to 1/4 inch wide and 1/2 inch deep.

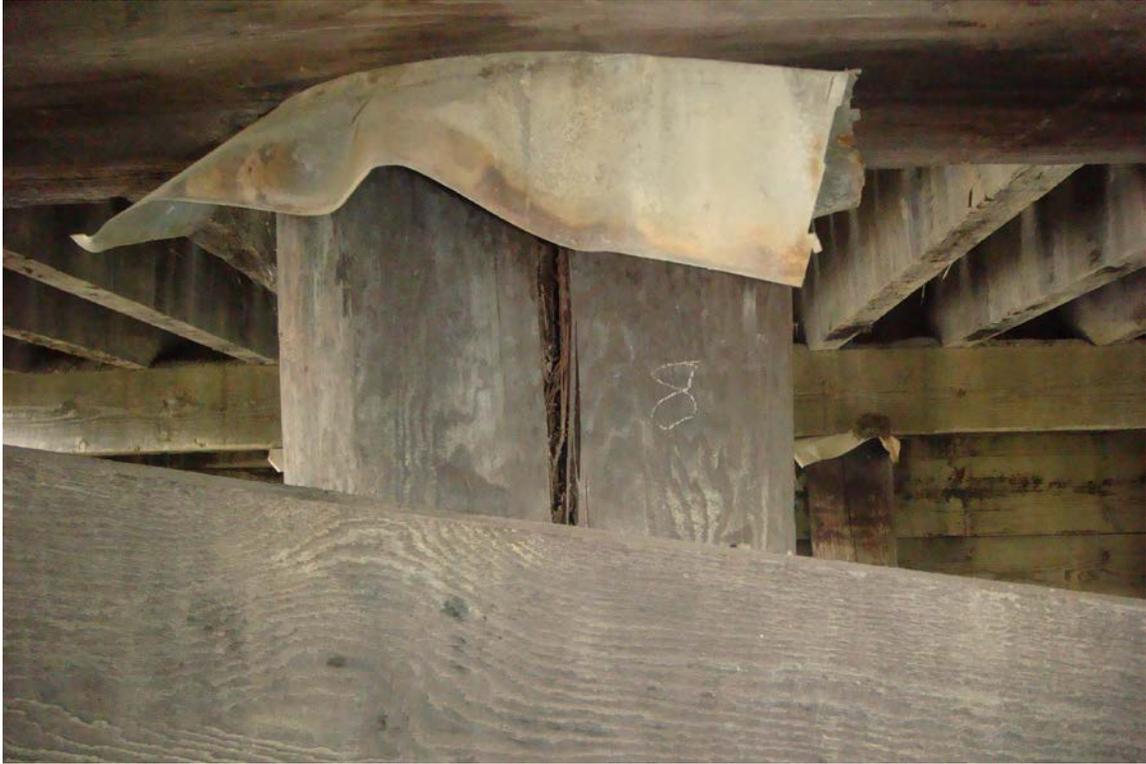
Photograph 7. View of the Split on the East Face of Pile C of Bent 1, Looking West.

- 5 Pile C of Bent 1 had a vertical split on the east and west faces extending from the pile cap down 3 feet. The split was typically 1 inch wide and 2 inches deep.

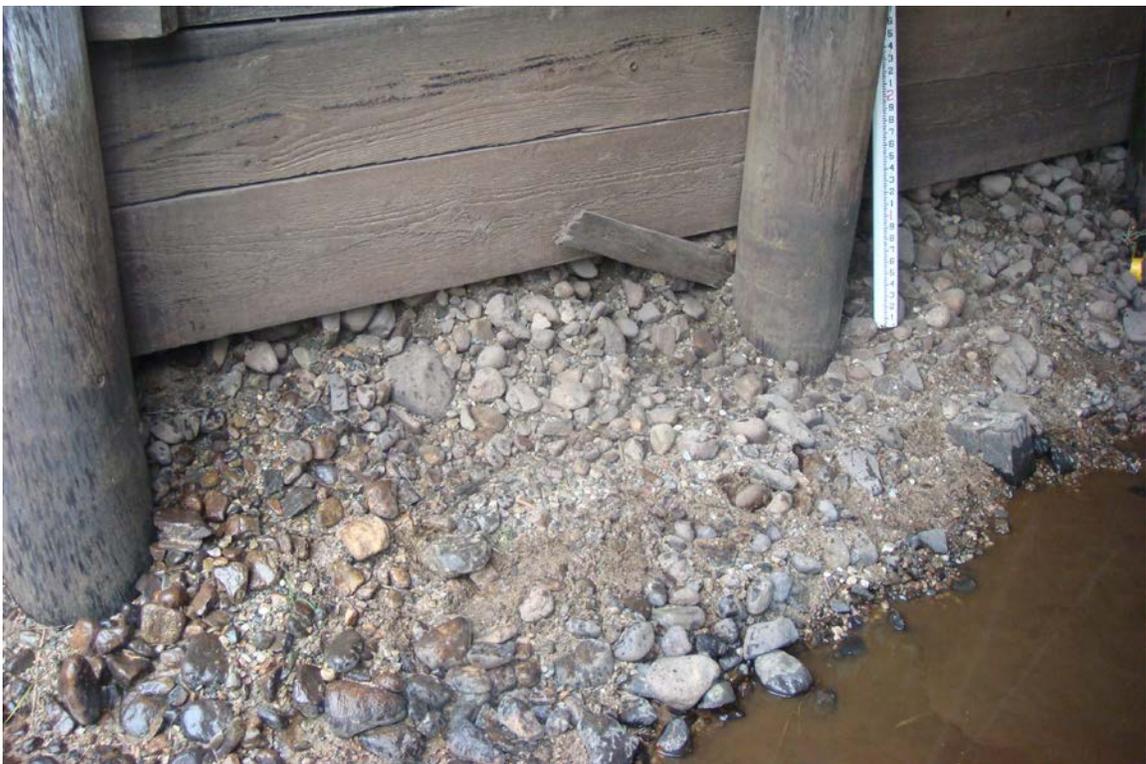
Photograph 8. View of the Loss of Fill Under the Bottom Backwall Board at the East Abutment, Looking Southeast.

- 7 A loss of fill material was noted below the bottom backwall board at the East Abutment. No voids could be seen behind the boards, however, there was a depression in the gravel roadway adjacent to the East Abutment.

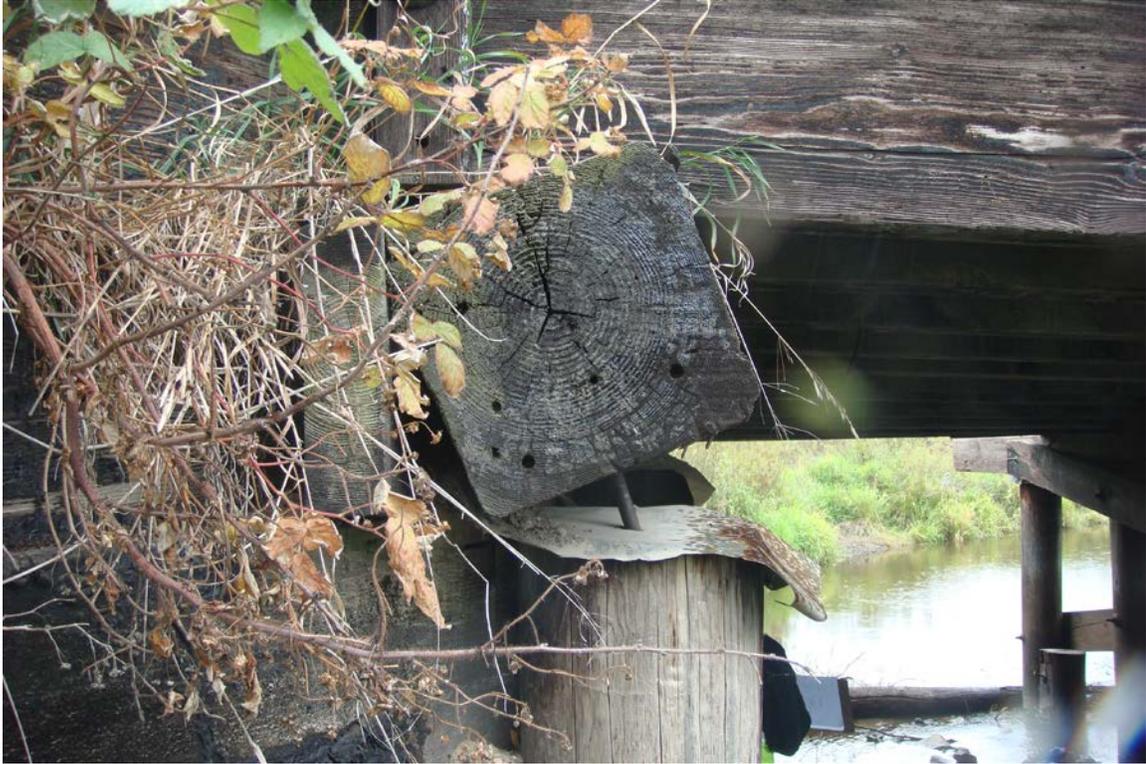
- (H) The pile cap at the East Abutment has rotated approximately 25° to the east. Due to the rotation, a gap was observed between the bottom of the west corner of the pile cap and the top of the piles ranging from 2 inches at Pile A to 5 and 6 inches at Piles E and B respectively. Piles C and D appeared to have heaved upward 4 to 6 inches causing little to no bearing at Piles B and E. The pile cap above Pile D and E is heavily split and crushed due to apparent overload. The shims at Piles A and B are no longer effective indicating that the piles have moved since the shims were placed. Due to the rotation, the pile cap is bearing on the 3 inch by 12 inch backwall boards.

Photograph 9. View of the Pile Cap Rotation at the East Abutment, Looking South.

- 8 The pile cap at the East Abutment has rotated approximately 25° to the east. Due to the rotation, a gap was observed between the bottom of the west corner of the pile cap and the top of the piles ranging from 2 inches at Pile A to 5 and 6 inches at Piles E and B respectively. Piles C and D appeared to have heaved upward 4 to 6 inches causing little to no bearing at Piles B and E. The pile cap above Pile D and E is heavily split and crushed due to apparent overload. The shims at Piles A and B are no longer effective indicating that the piles have moved since the shims were placed. Due to the rotation, the pile cap is bearing on the 3 inch by 12 inch backwall boards.

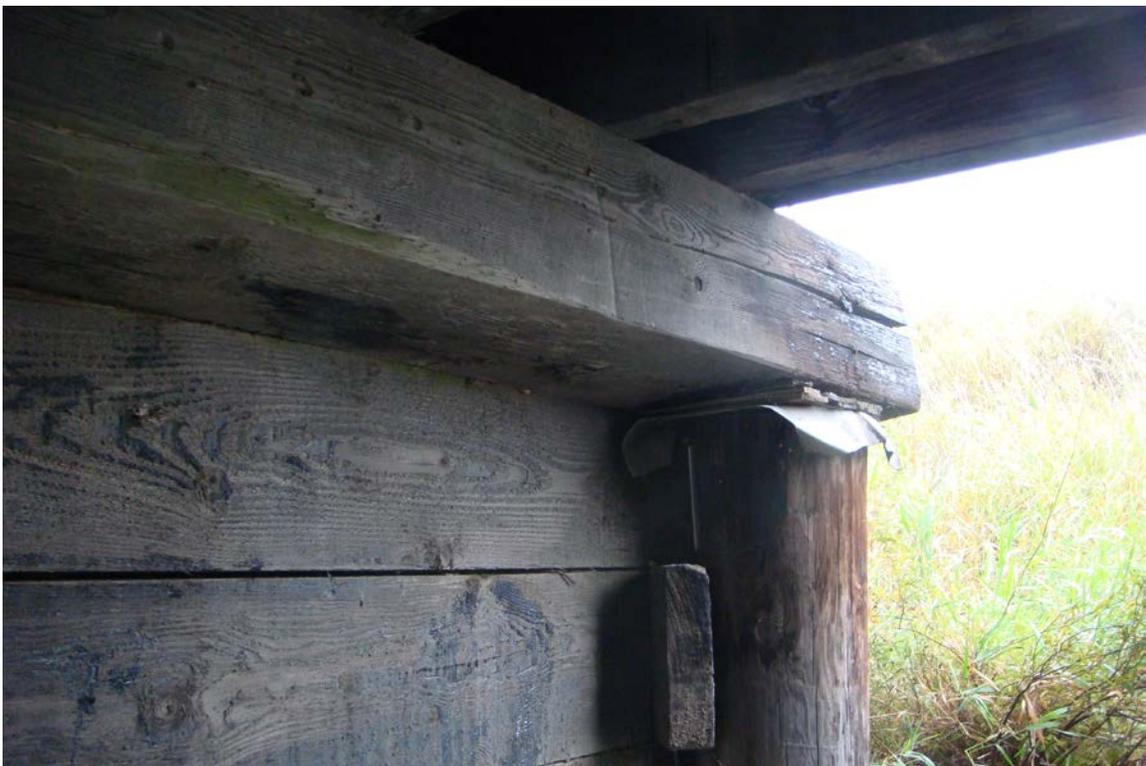
Photograph 10. View of Pile A of the East Abutment, Looking Southeast.

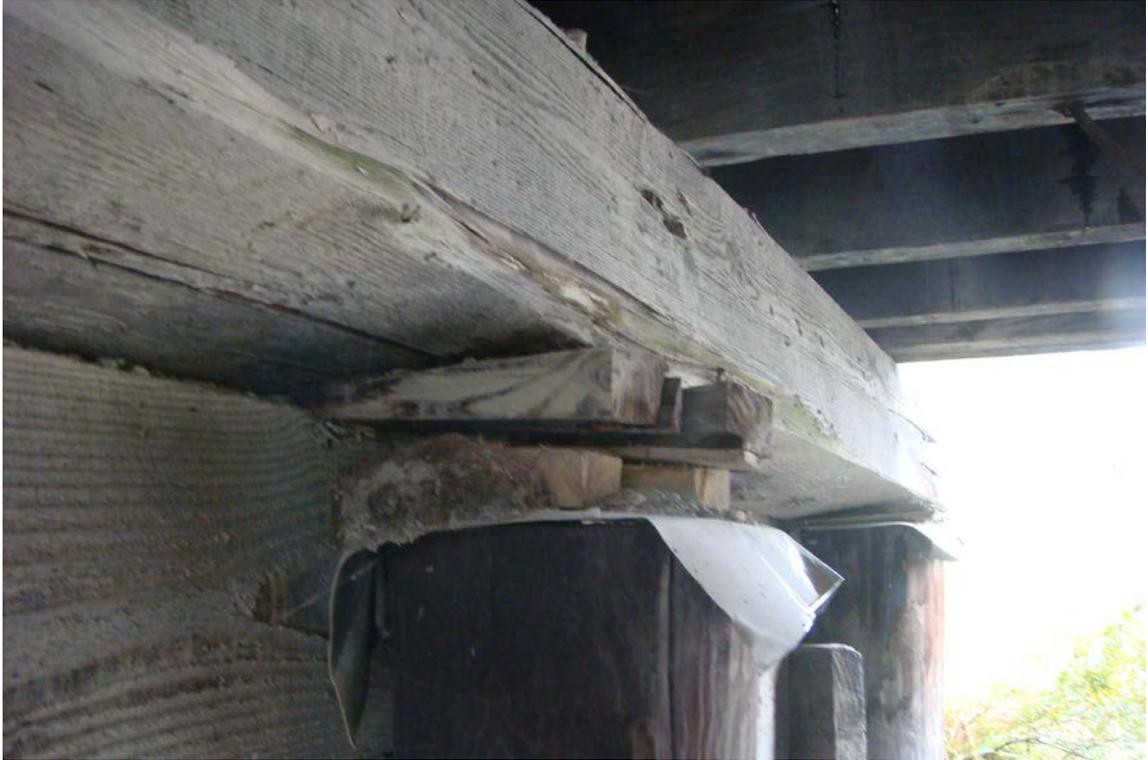
Photograph 11. View of Pile B of the East Abutment, Looking Southeast.

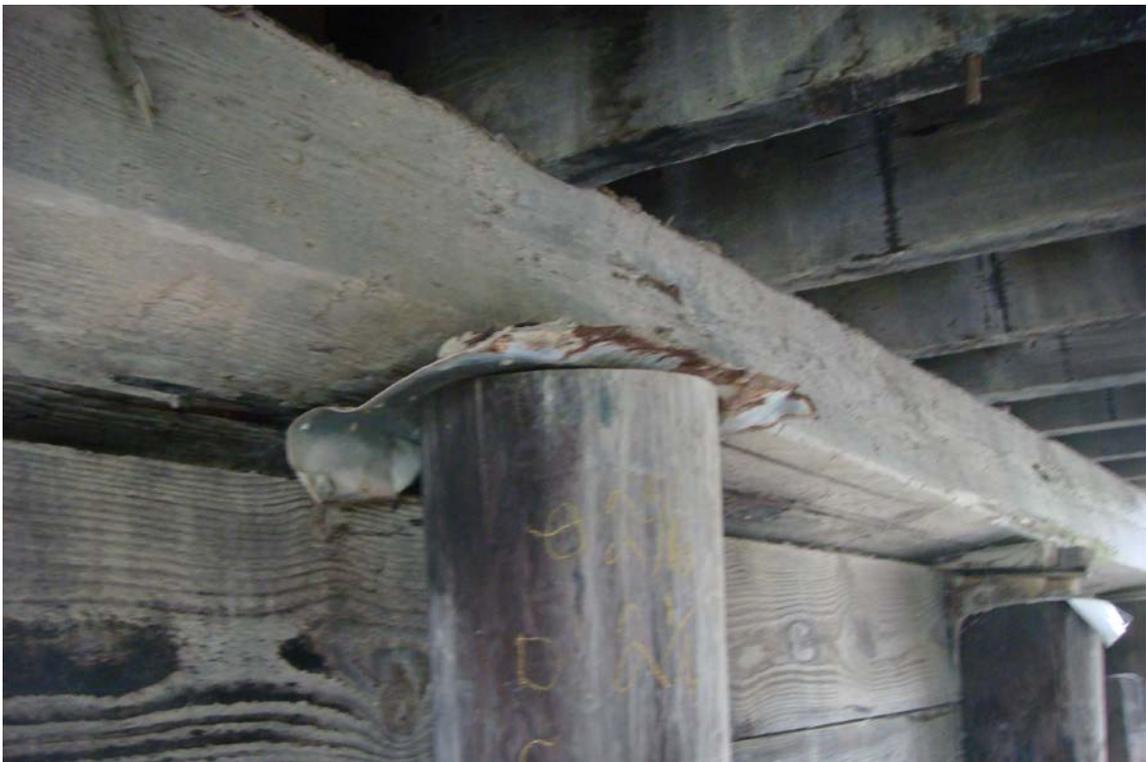
Photograph 12. View of Pile C of the East Abutment, Looking Southeast.

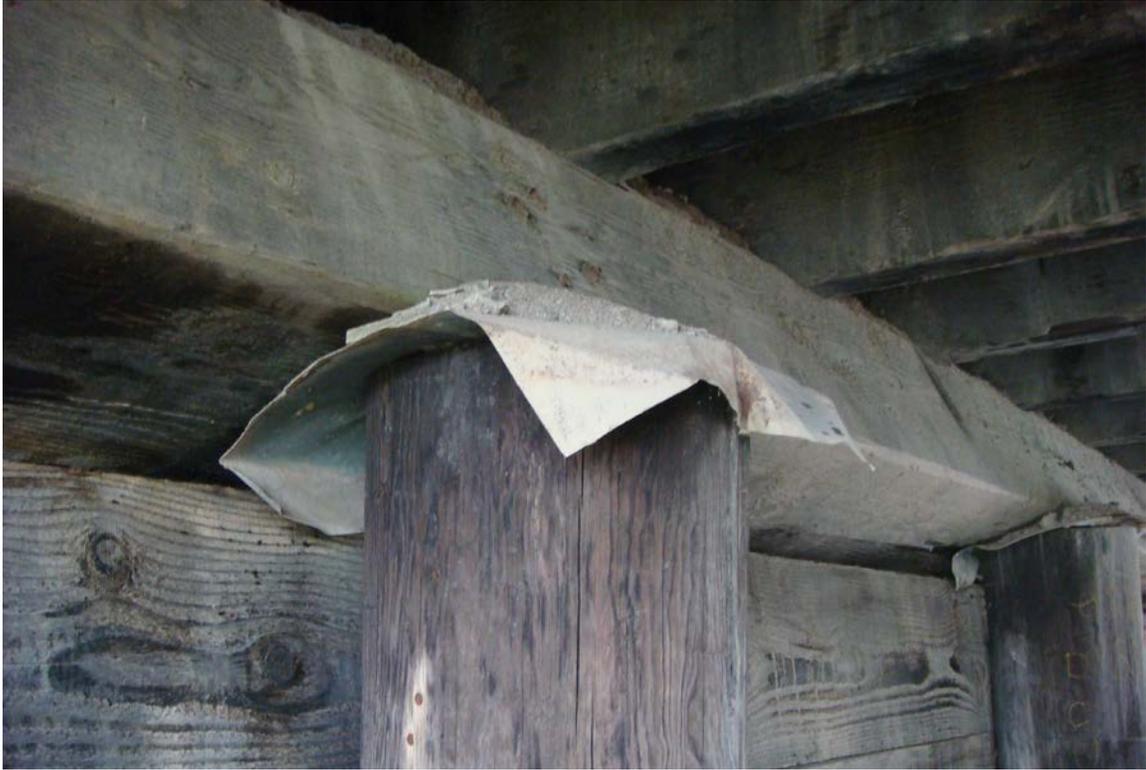
Photograph 13. View of Pile D of the East Abutment, Looking Southeast.

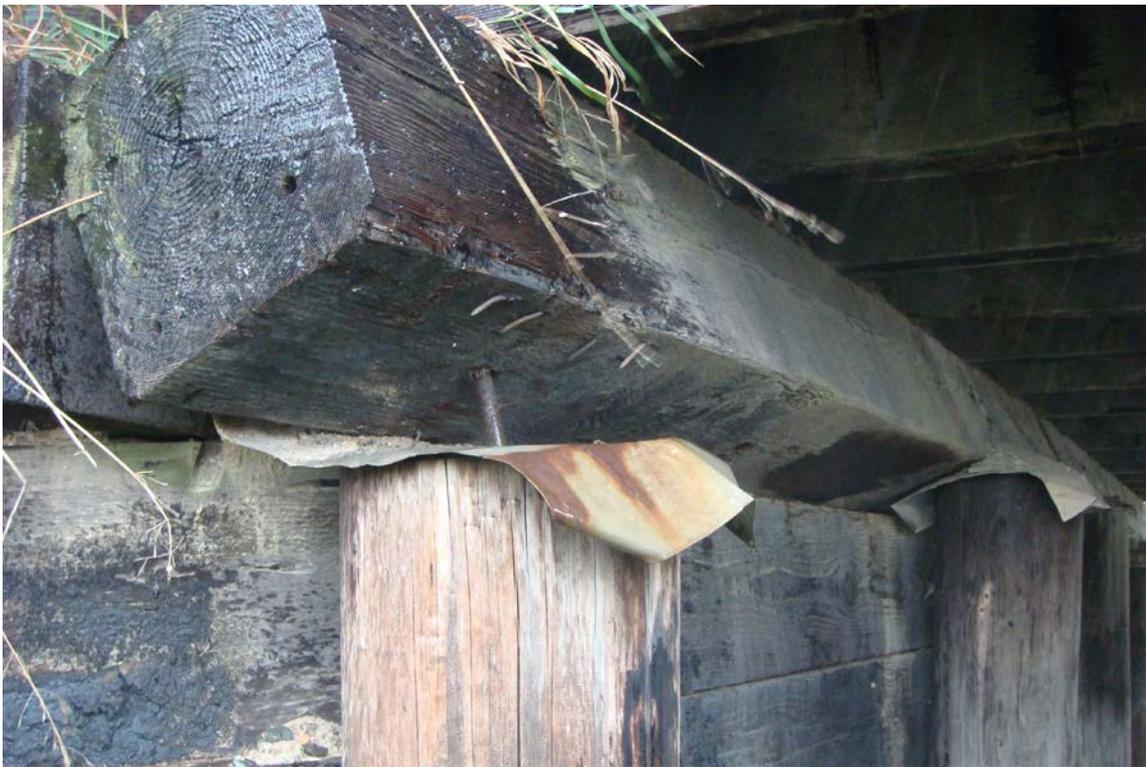
Photograph 14. View of Pile E of the East Abutment, Looking Southeast.

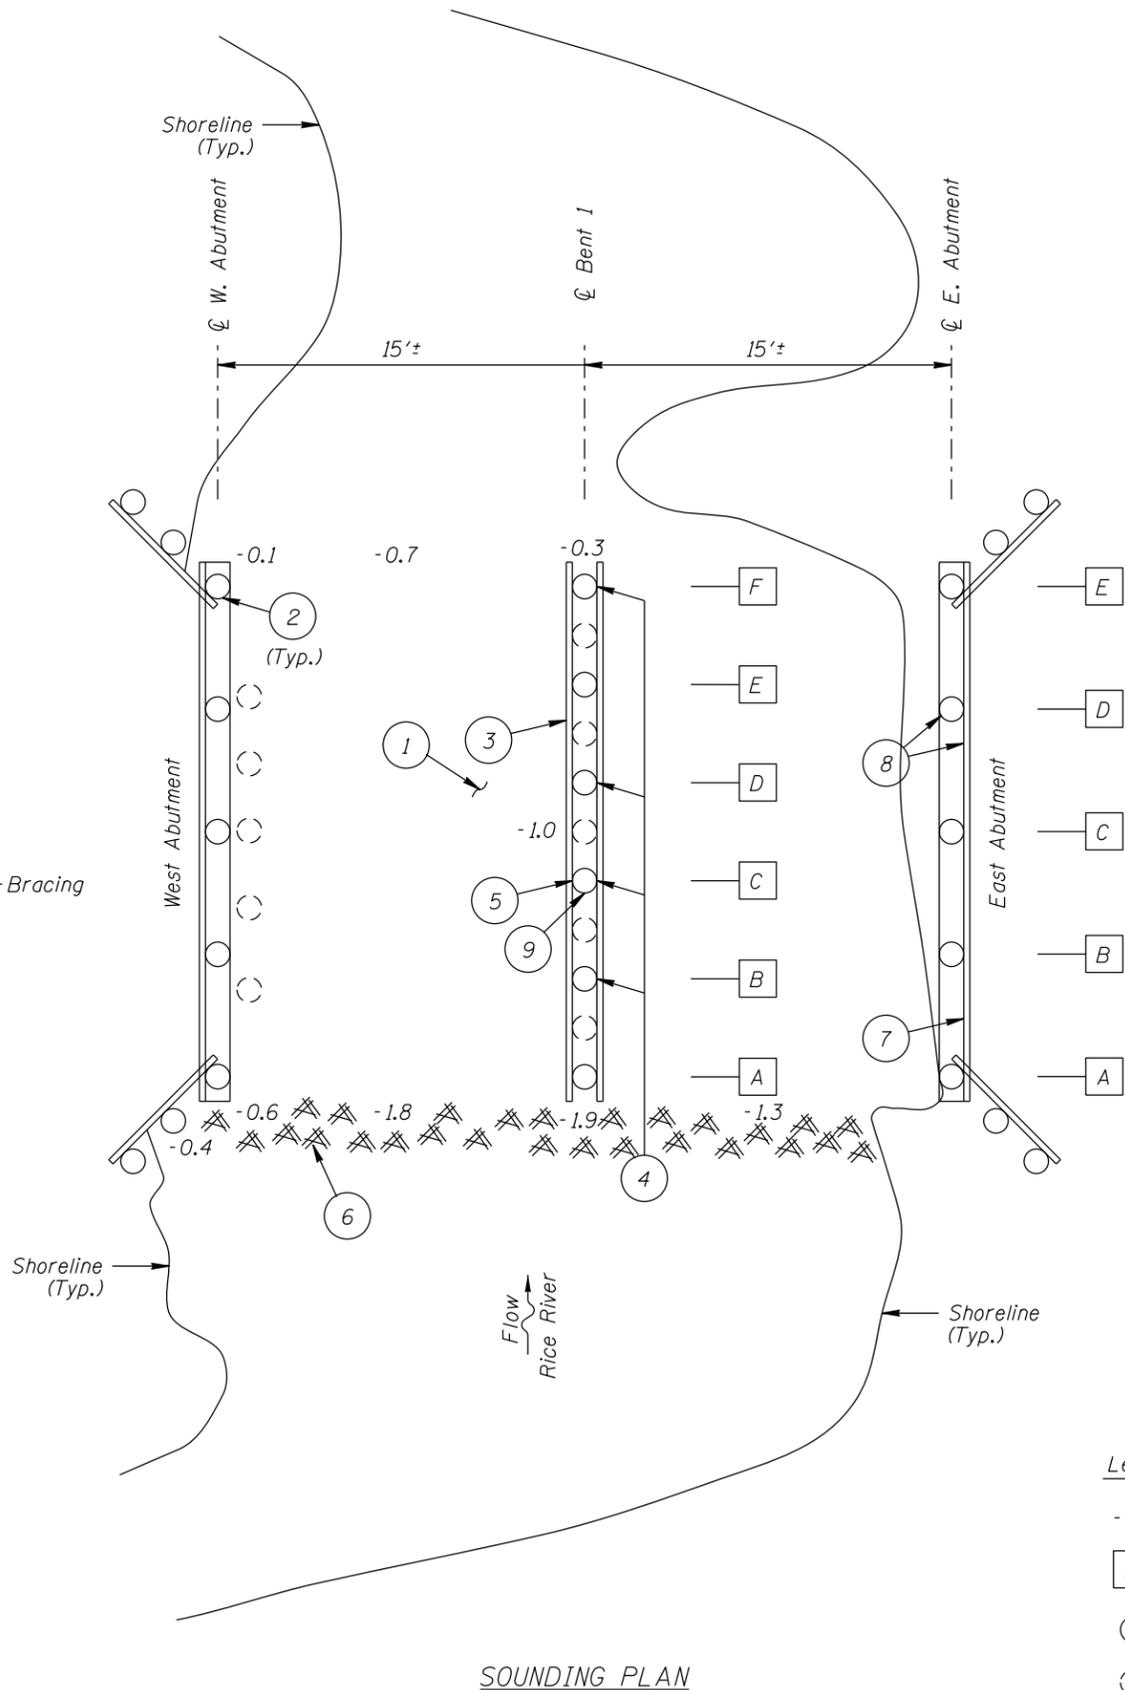
- 3 The north cross-brace of Bent 1 exhibited a split from Pile D to Pile F that is adversely affecting the pile connections.
- 4 Piles B, C, D, and F of Bent 1 exhibited a hollow sound suggesting some internal deterioration or decay extending from 3 feet to 5 feet below the pile cap.

- 6 An accumulation of timber debris, consisting of a 10-inch-diameter tree and smaller branches, was observed across the entire upstream channel. The accumulation is causing a minor damming (flow obstruction) effect.

- 9 Pile C of Bent 1 exhibited a 1/2 inch gap between the pile cap and the top of the pile resulting in no bearing at Pile C.
