UNDERWATER BRIDGE INSPECTION REPORT

STRUCTURE NO. 7877

COUNTY ROAD 367

PIKE RIVER

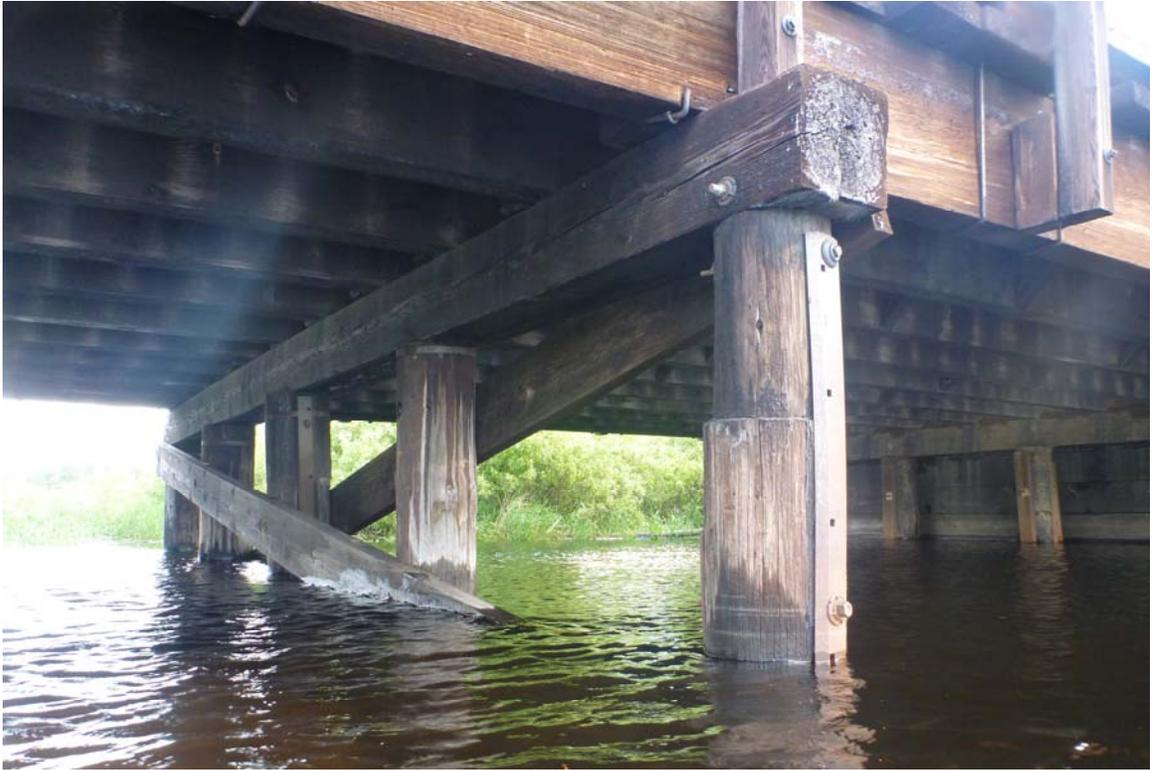
Photograph 9. View of Typical Splice-In-Pile Repair at Pile E of Bent 1, Looking Northeast.

- 5 A splice-in-pile repair of the upper pile portion was observed on several piles. The piles which were repaired are Piles C and E of Bent 1, Piles B, C, and E of Bent 2, Piles B and E of Bent 3, Piles A, D, and E of Bent 4, and Piles A, C and D of Bent 5. All spliced sections were generally in good condition with minor checking or splitting with the exception of a \*inch wide split observed on the east face of the spliced section at Pile C of Bent 2.

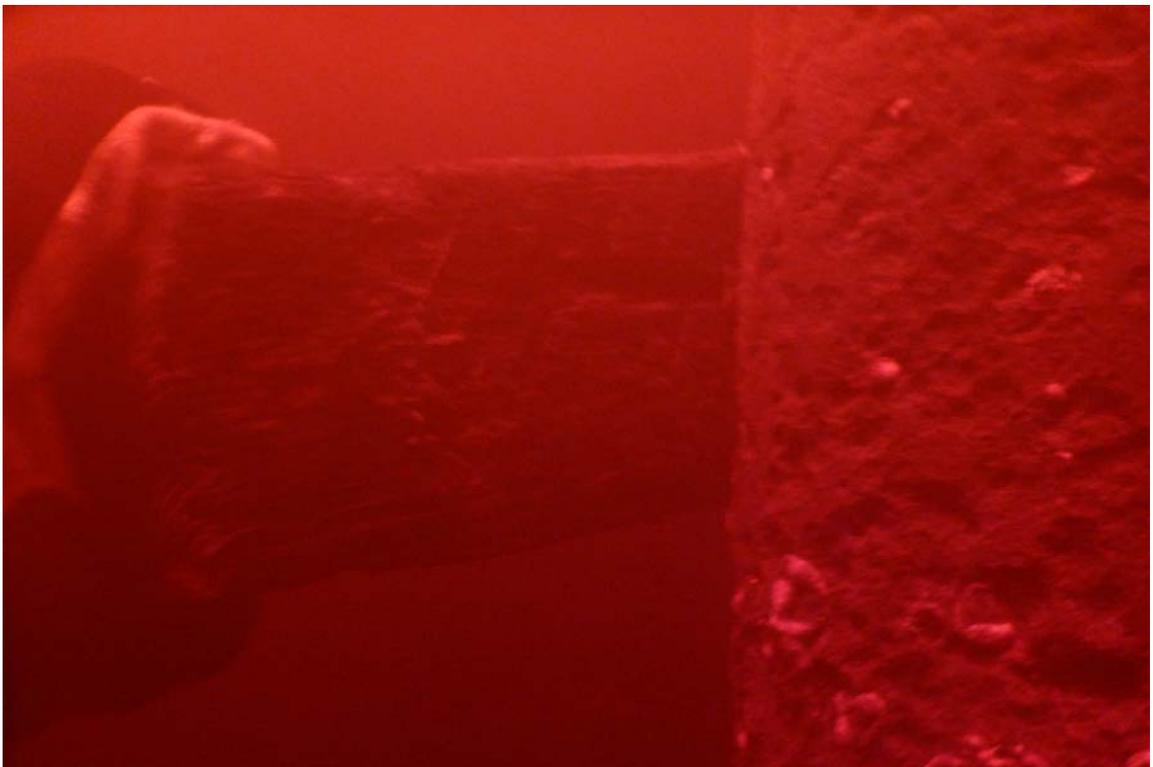
Photograph 10. View of Timber Cross-Brace Loss of Section at Pile E of Bent 4, Looking West.

- 4 The cross-brace on the west face of Pile E of Bent 4 exhibited up to 50 percent loss of section. The cross-brace is no longer connected to the pile.

- (A) Monitor cross-bracing member deterioration and/or brace-to-pile connections during future underwater inspections. If deficiencies are found to be progressing, then consideration may need to be given to repair the cross-braces or otherwise enhance the lateral stability of the structure.
- (B) Reinspect the submerged substructure units at the normal maximum recommended (NBIS) interval of sixty (60) months.

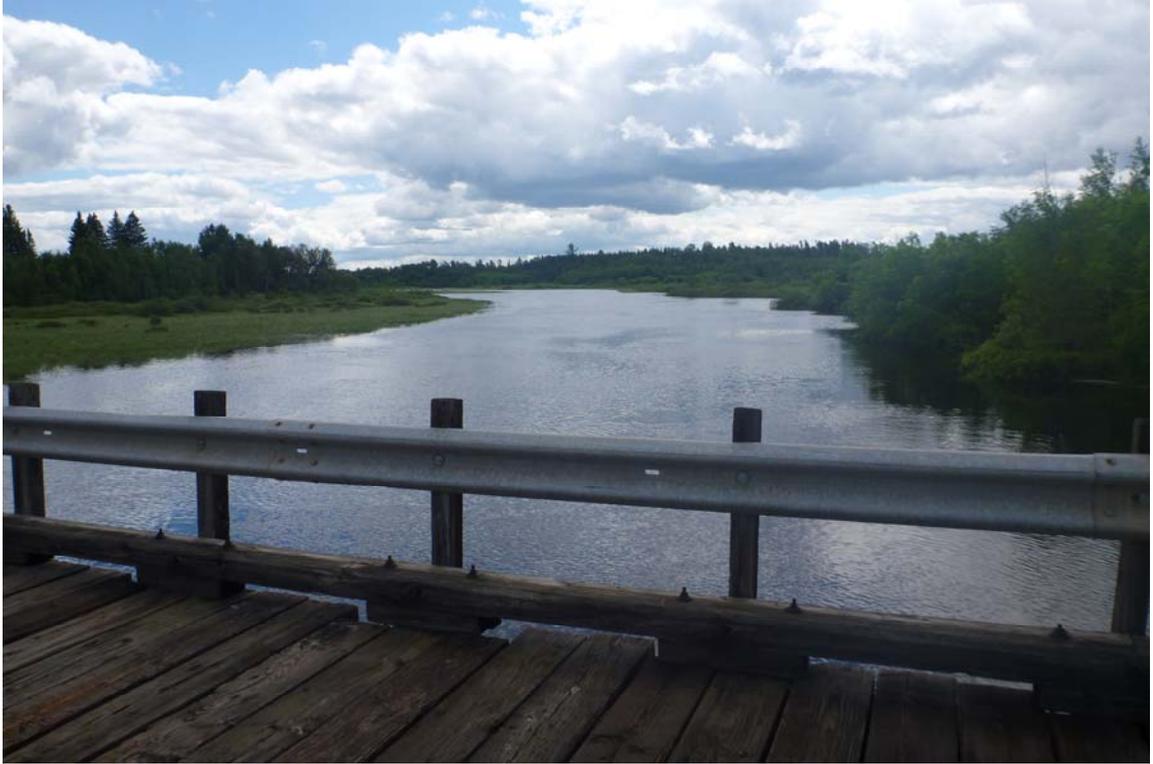
Photograph 11. View of Upstream Channel, Looking South.

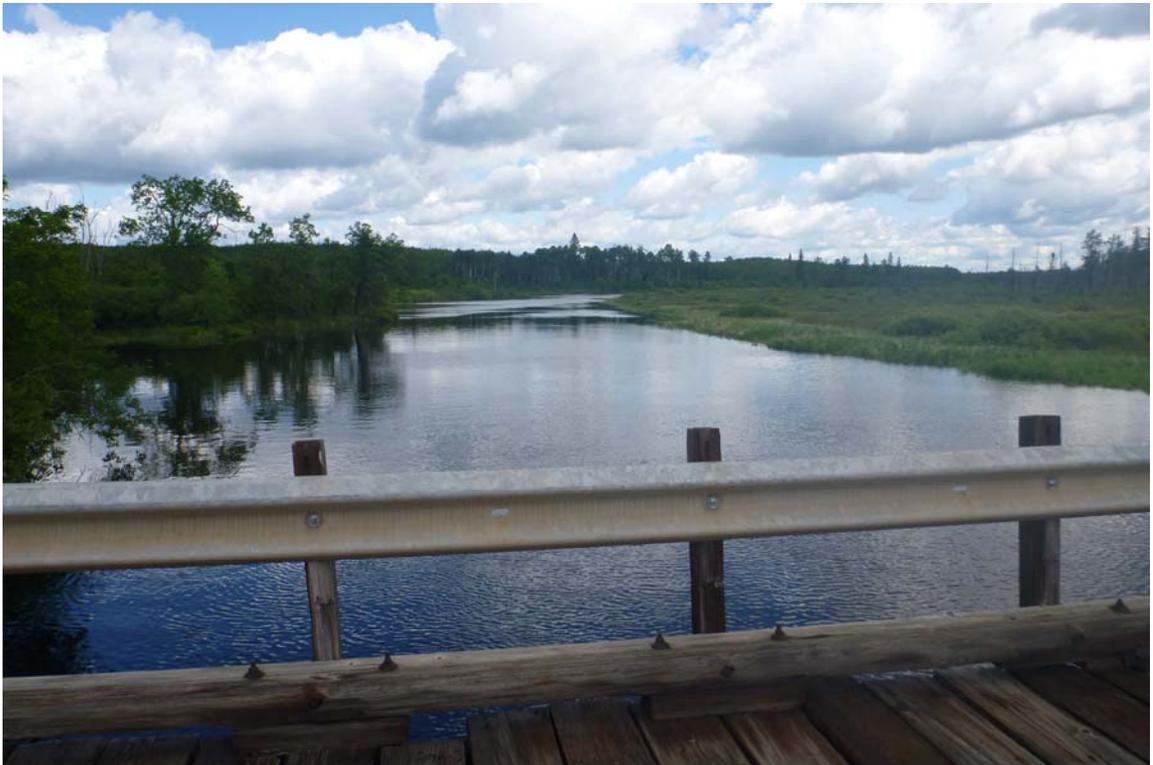
Photograph 12. View of Downstream Channel, Looking North.

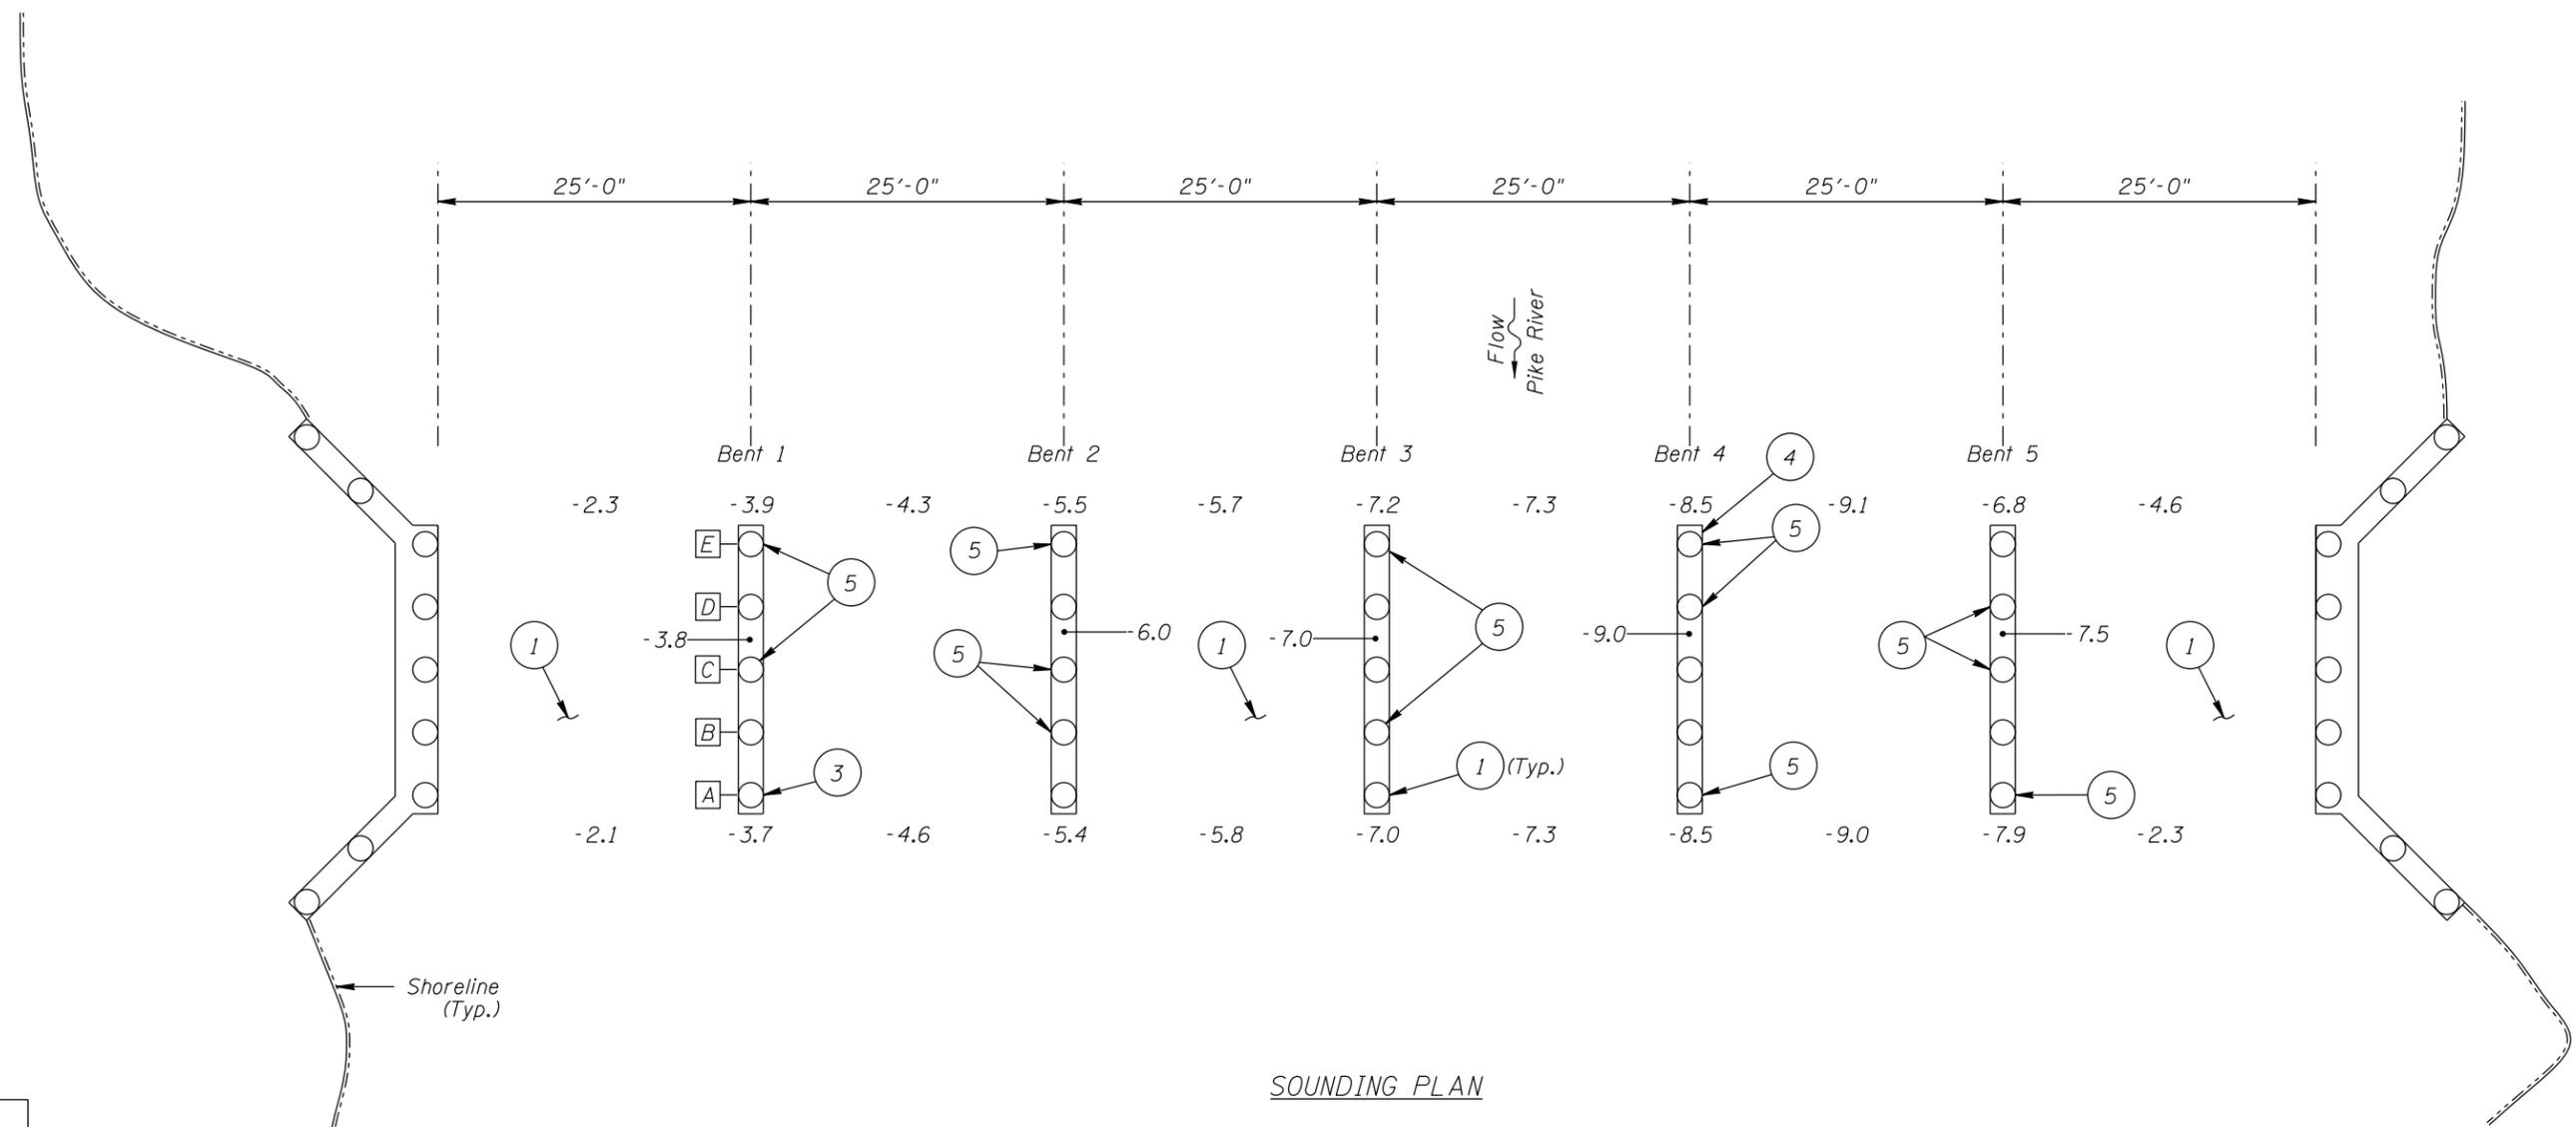
- 1 The channel bottom material consists of firm silty sand, gravel, and cobbles allowing probe rod penetration of 2 inches typical and up to 6 inches maximum penetration.

- 2 All timber piles were generally firm and sound with no indication of decay or soft areas. The timber typically allowed awl penetrations of 1/8 inch or less.

- 3 There was a split in the cross-brace at the brace-to-pile connection at Pile A of Bent 1. The Split measures 4 feet long by 1 inch wide and fully penetrates the cross-brace compromising the connection.
