UNDERWATER BRIDGE INSPECTION REPORT

STRUCTURE NO. 7883

CRANE LAKE ROAD

HAWKINSON CREEK

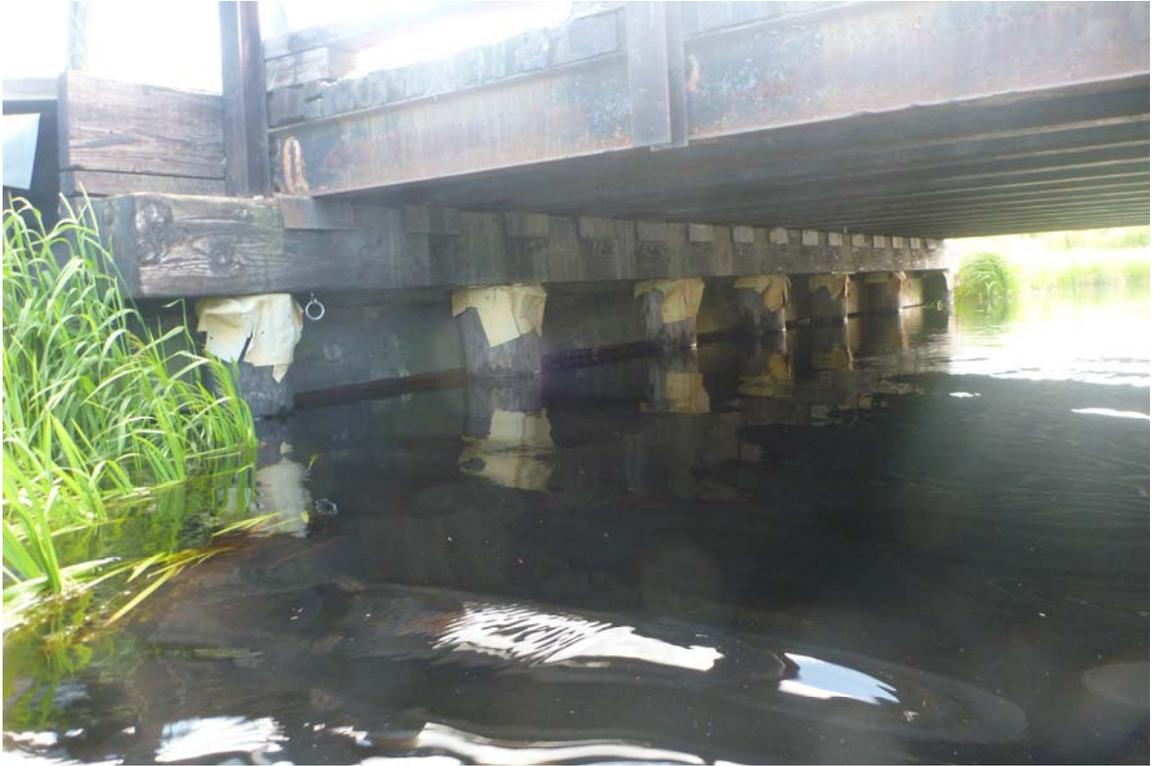
Photograph 3. View of the East Abutment, Looking Southeast.

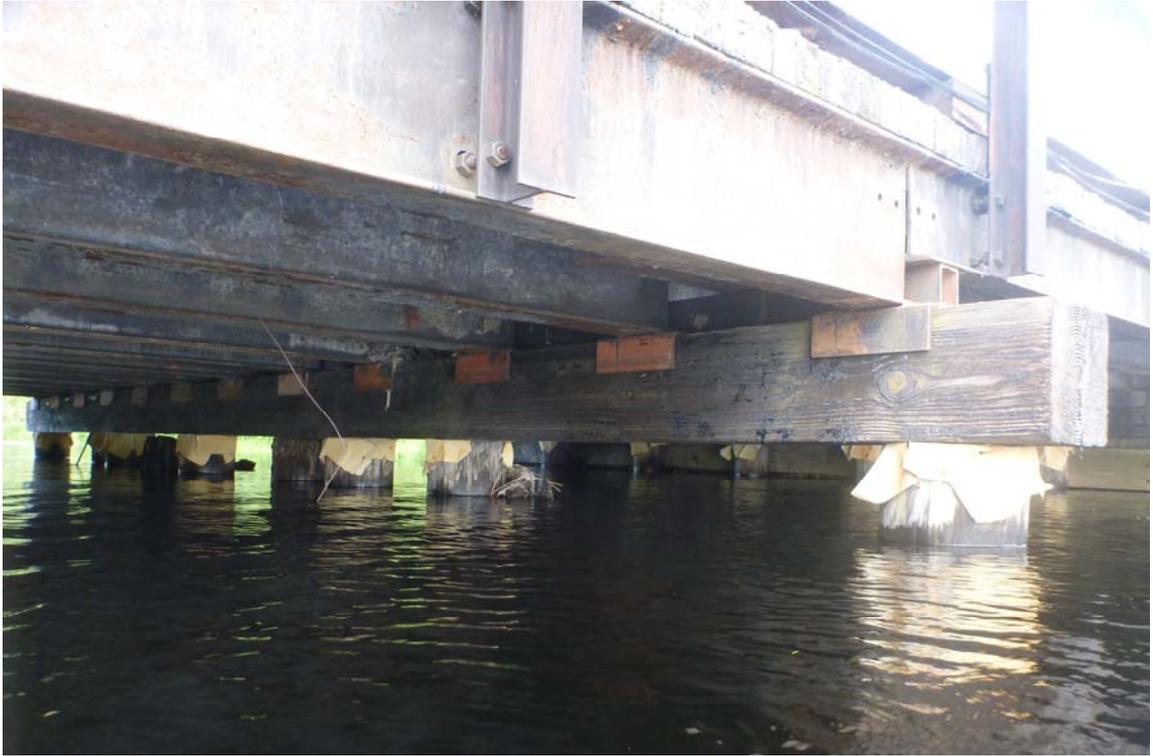
Photograph 4. View of Bent 1, Looking Northeast.

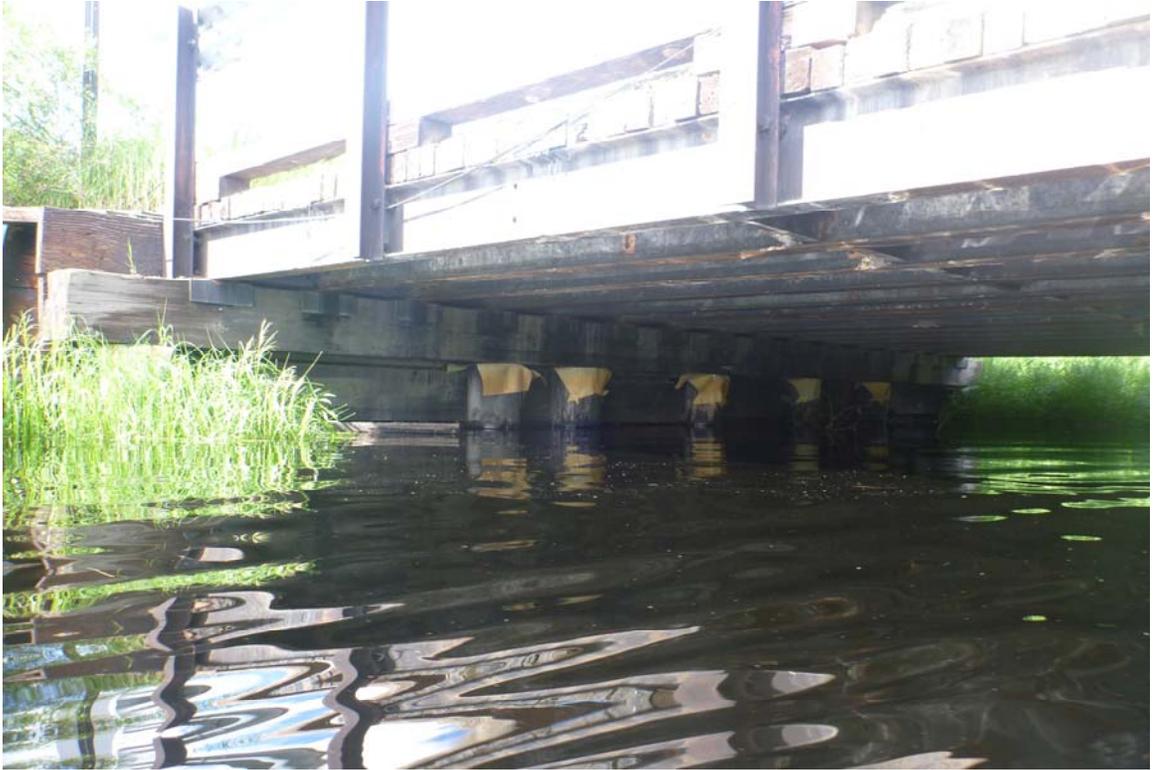
Photograph 7. View of the West Abutment, Looking Northwest.

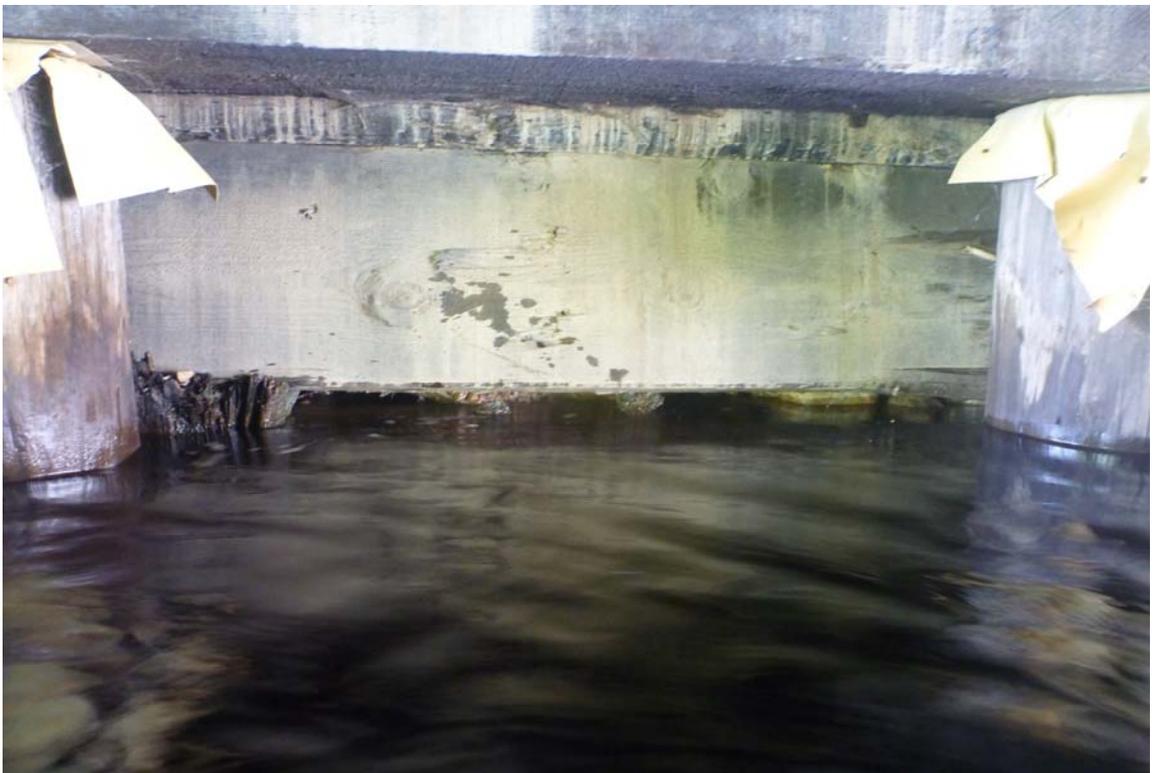
- (A) Horizontal timber lagging members at the East Abutment were often missing from approximately 2 inches above the waterline to the channel bottom. Escaping gravel and 3 inch diameter and smaller stone was spilling out. The loss of backfill has resulted in a 45 degree slope towards Bent 1.

Photograph 8. View of Missing Timber Lagging and Backfill Erosion at the East Abutment, Looking East.

- 1 Horizontal timber lagging members at the East Abutment were often missing from approximately 2 inches above the waterline to the channel bottom. Escaping gravel and 3 inch diameter and smaller stone was spilling out. The loss of backfill has resulted in a 45 degree slope towards Bent 1.

- (A) Monitor the roadway behind the East and West Abutments for any settlement related to the lack of timber lagging and backfill material loss. If notable settlement occurs, countermeasures may be warranted to arrest further backfill from escaping.
- (B) Reinspect the submerged substructure units at the normal maximum recommended (NBIS) interval of sixty (60) months.

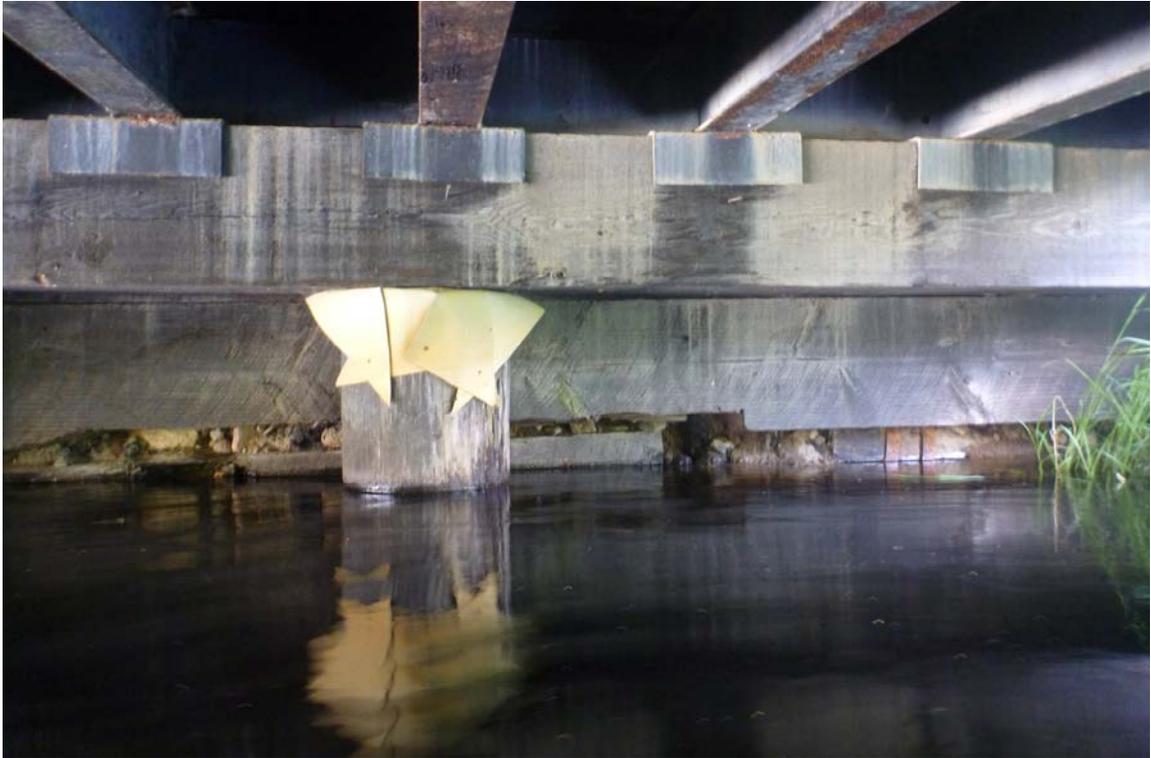
- (D) Horizontal lagging members at the West Abutment were often missing. The lack of members was causing loss of abutment backfill material, particularly between Piles A and B and between Piles E and G.

Photograph 9. View of Missing Member Lagging and Backfill Erosion at the West Abutment, Looking West.

- 4 Horizontal lagging members at the West Abutment were often missing. The lack of members was causing loss of abutment backfill material, particularly between Piles A and B and between Piles E and G.

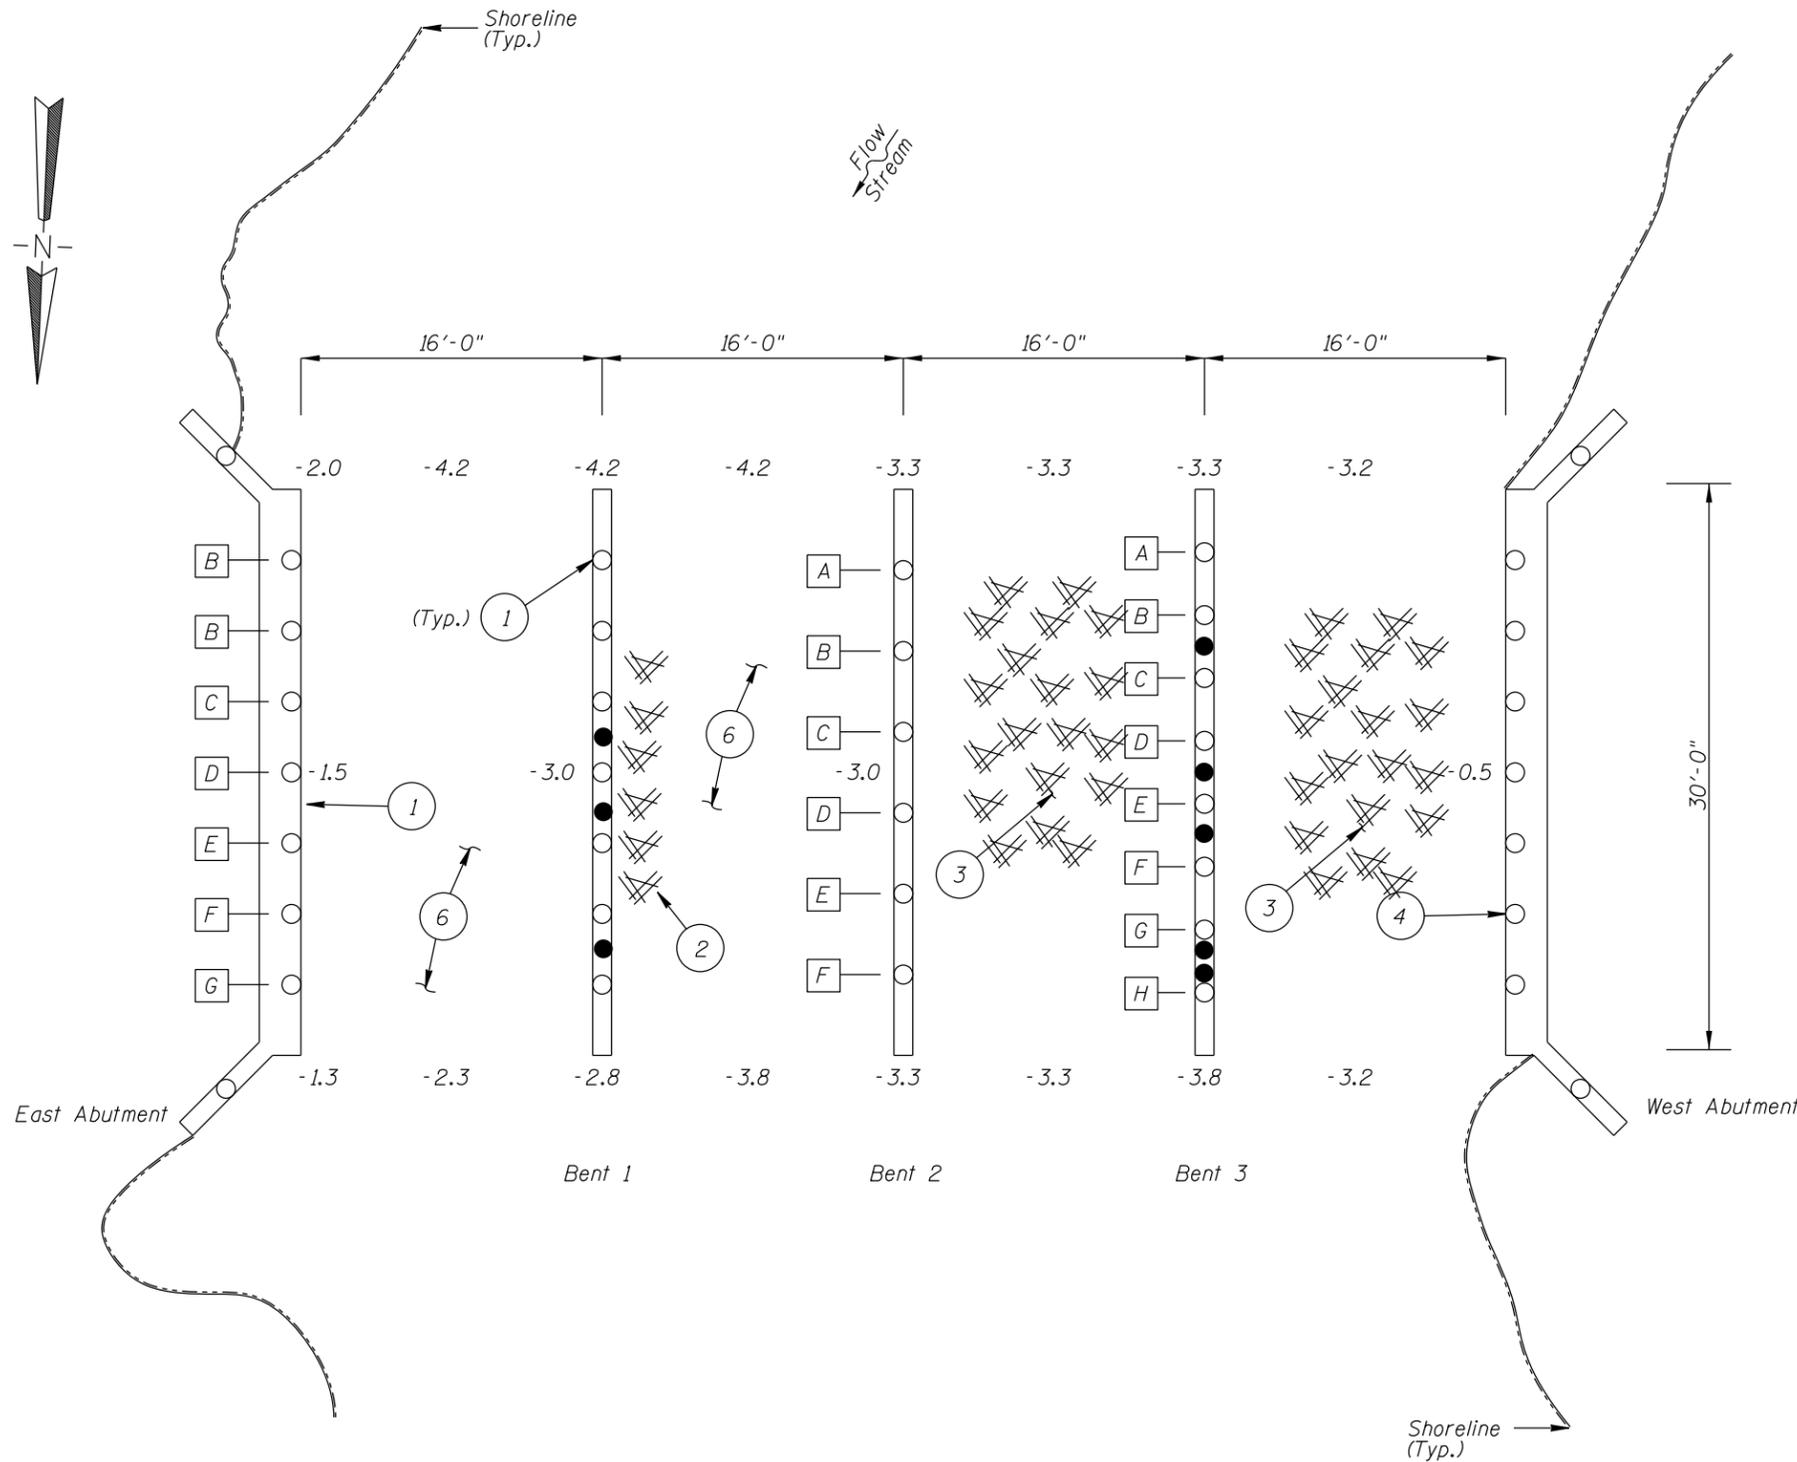
- 2 A light accumulation of timber debris, typically small diameter branches, was observed on the channel bottom between Piles B and E along the west face of Bent 1.

- 3 A light accumulation of timber debris, typically small diameter branches, was observed within the channel between Bents 2 and 3 and between Bents 3 and the West Abutment. The debris is causing some soft and silty infill to accumulate in the vicinity. In these areas the channel was shallower and allowed up to 1 foot of probe rod penetration.

- 5 Timber piles and caps were generally observed to be sound and in good condition. The timber was firm and typically allowed an awl penetration of 1/8 inch. No indication of decay was observed and piles were well protected with tin caps.

- 6 Except where otherwise noted, the channel bottom material consisted of fairly firm sandy gravel with approximately 2 inches of probe rod penetration.
