UNDERWATER BRIDGE INSPECTION REPORT

STRUCTURE NO. 88639

CR 615

JUNE 21, 2012

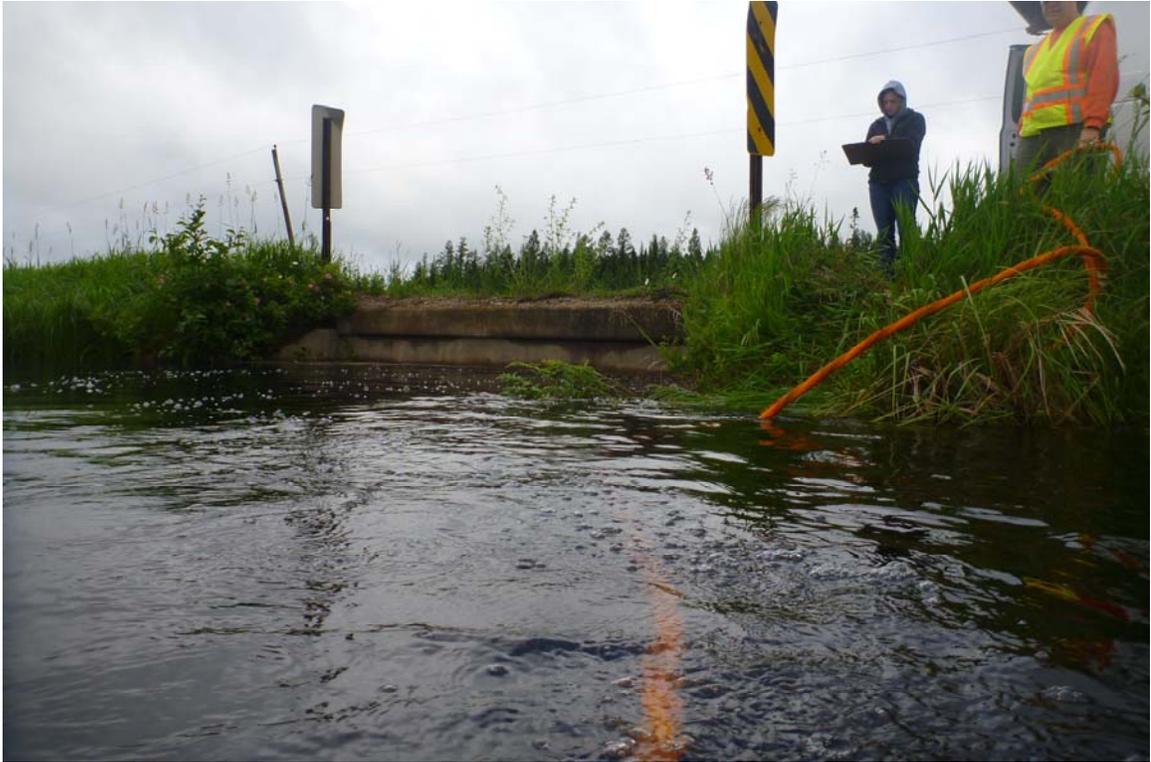
Photograph 1. View of Upstream Opening, Looking Northwest.

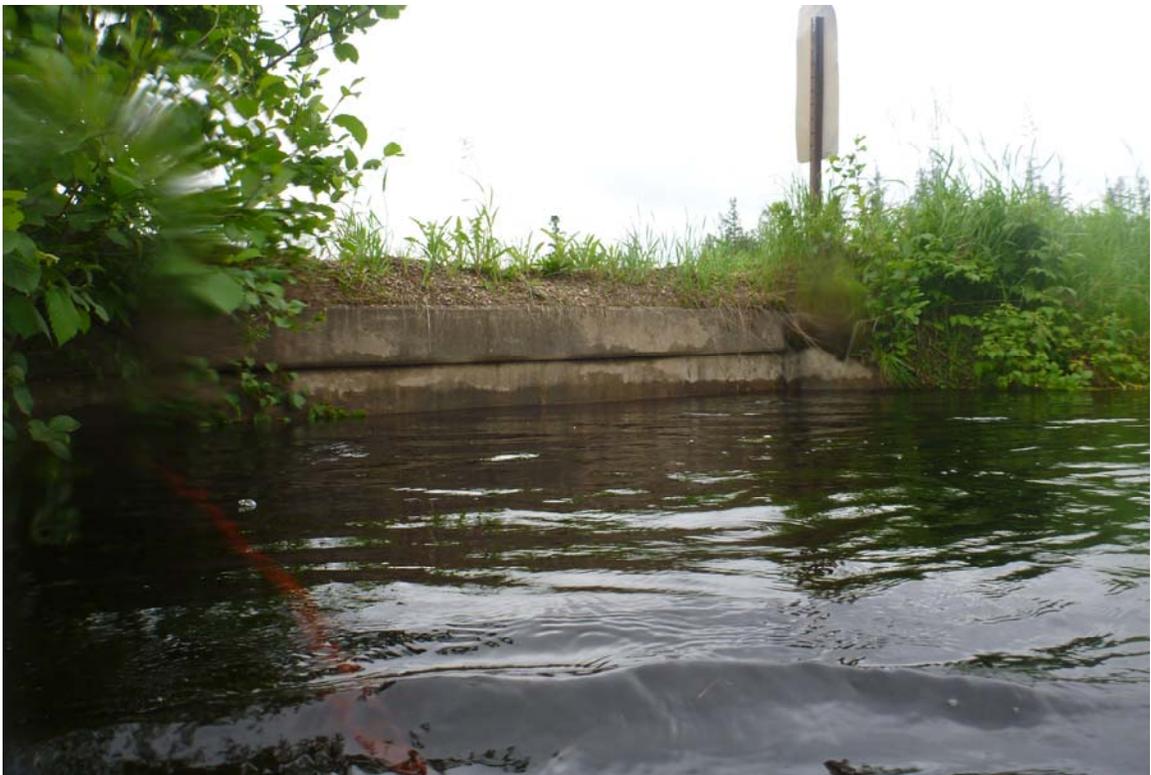
Photograph 2. View of Downstream Opening, Looking Southwest.

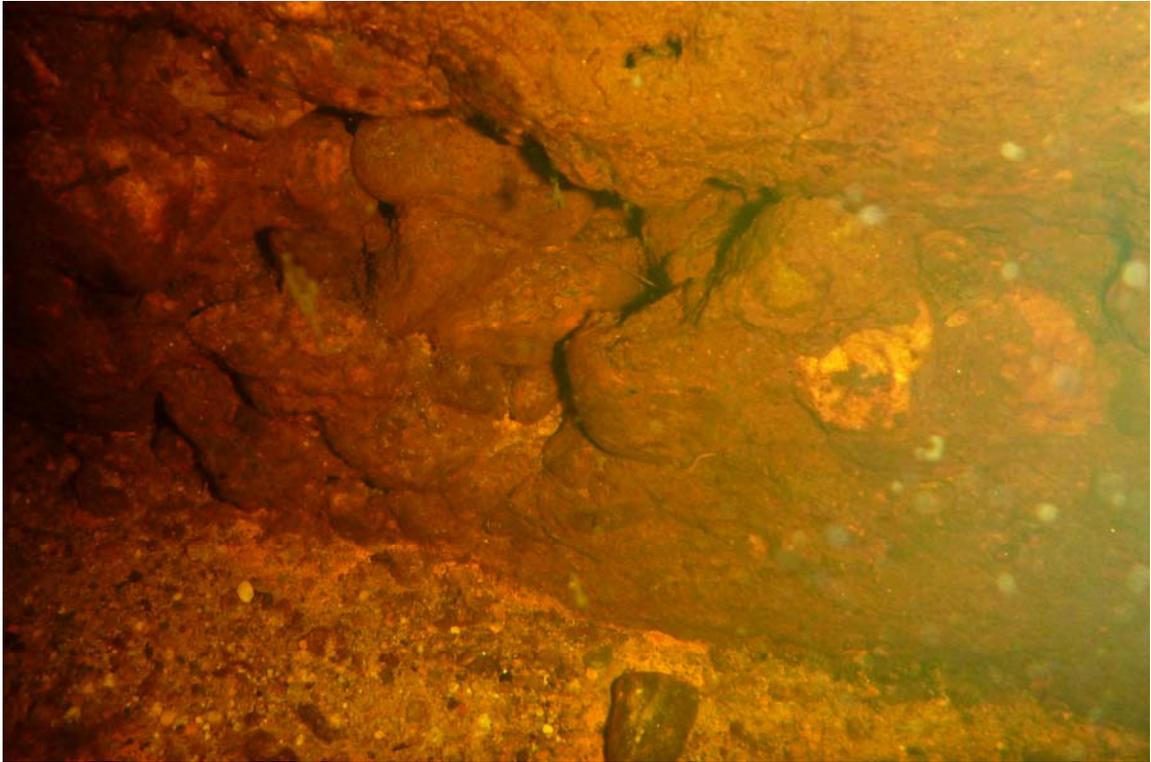
The substructure inspected at Structure No. 88639, a concrete box culvert, was found to be in good condition with no defects of structural significance. Light scaling was observed on all concrete surfaces throughout the length of the culvert with a typical penetration of 1/4 inch. An area of poorly consolidated concrete was observed near the west wall on the downstream end of the culvert. A portion of the concrete floor was covered by a 2 to 3 inch thick layer of gravel and silt.

Photograph 3. View of Poorly Consolidated Concrete at the Downstream end of the West Wall, Looking West.

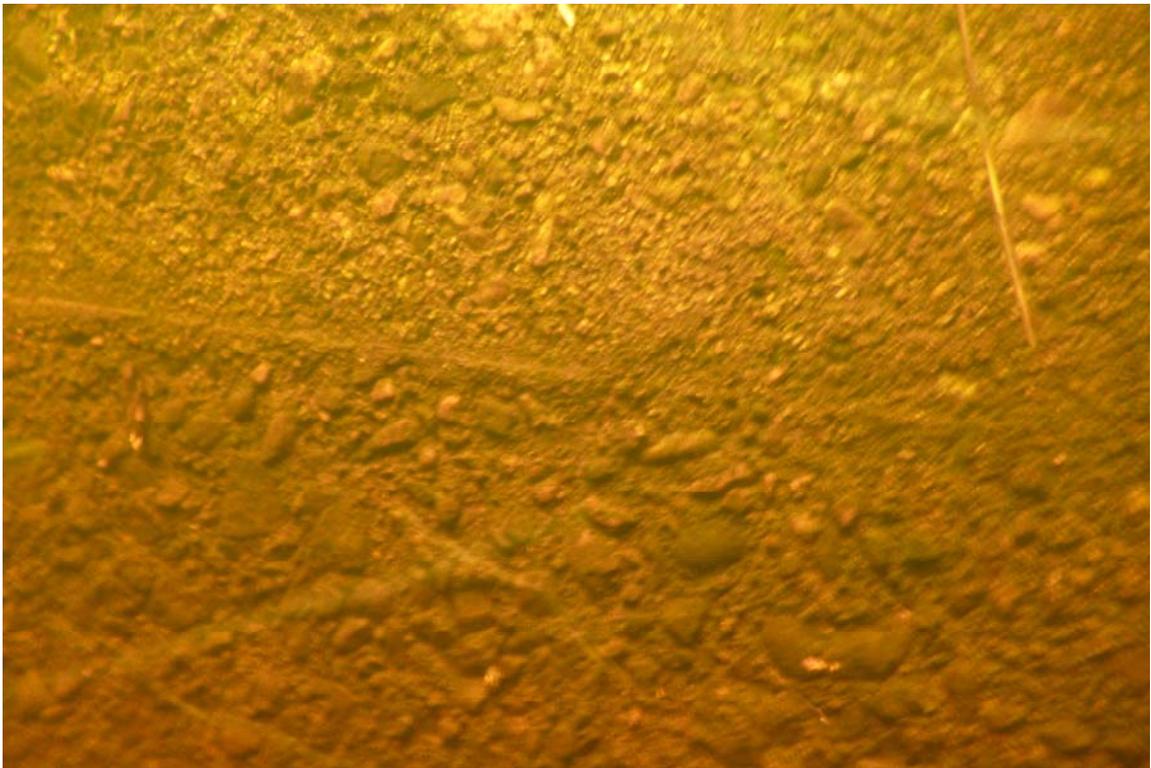
- (A) The concrete surfaces of the culvert were sound and in good condition with light scaling typically 1/4 inch deep.
- (B) A portion of the culvert floor was typically covered by 2 to 3 inches of silt and gravel infill. The build-up of material appeared to be thicker near the culvert openings with no apron exposure present. The concrete floor was exposed along the west side near the middle half of the culvert length.
- (C) An area of poorly consolidated concrete was observed on the west wall near the downstream end of the culvert with typically 2 to 3 inches of penetration.
- (D) The channel bottom material upstream and downstream of the structure consisted of fairly soft sandy silt allowing 6 to 12 inches of probe rod penetration.

Photograph 4. View of Typical Concrete Scaling Underwater, Looking West.

- (A) Reinspect the submerged substructure units at the normal maximum recommended (NBIS) interval of sixty (60) months.

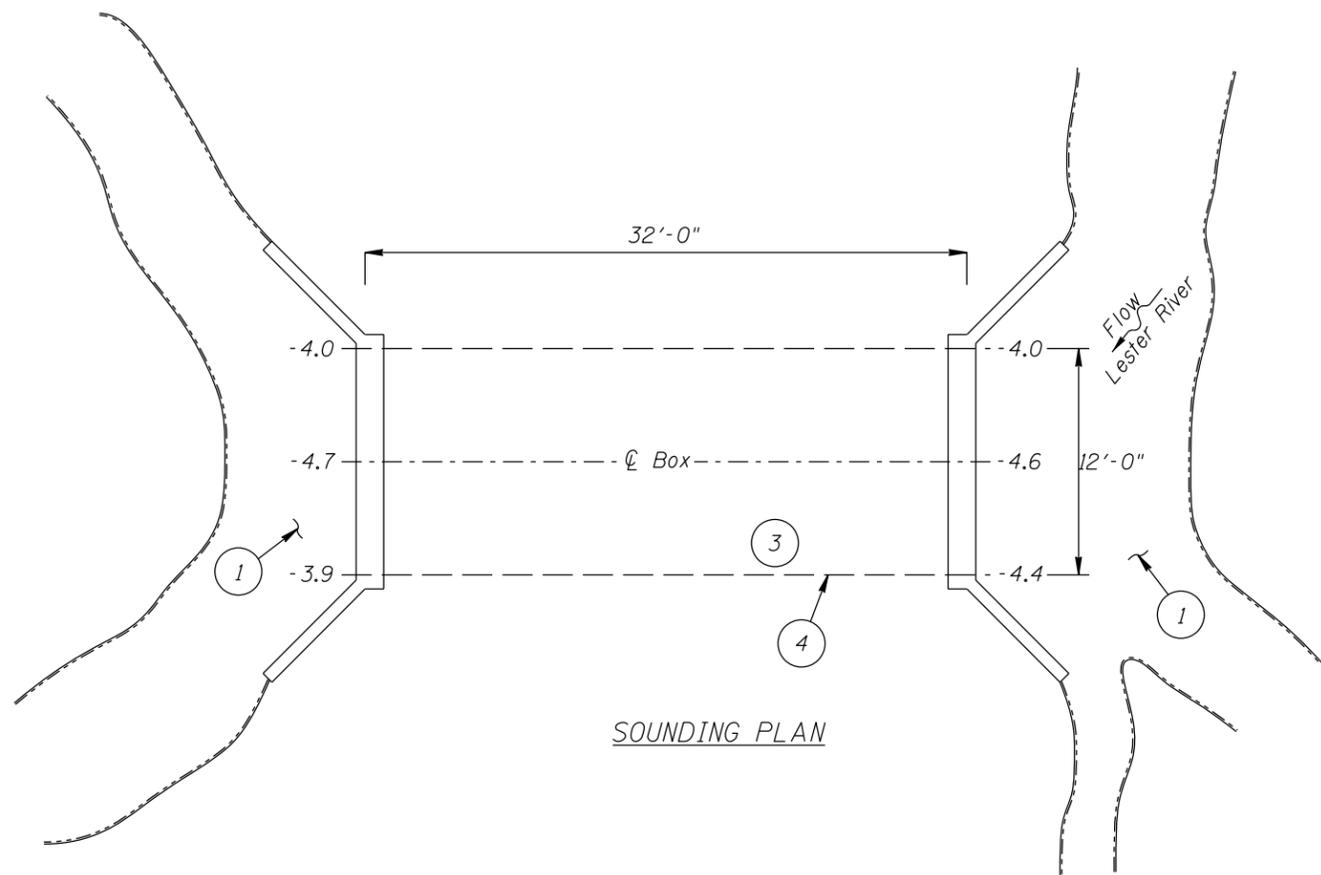
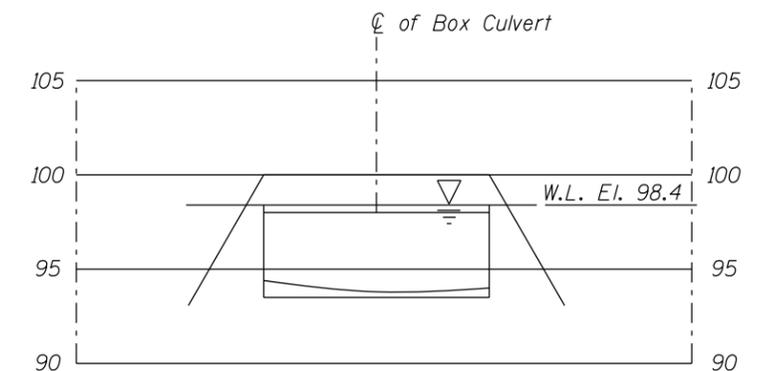
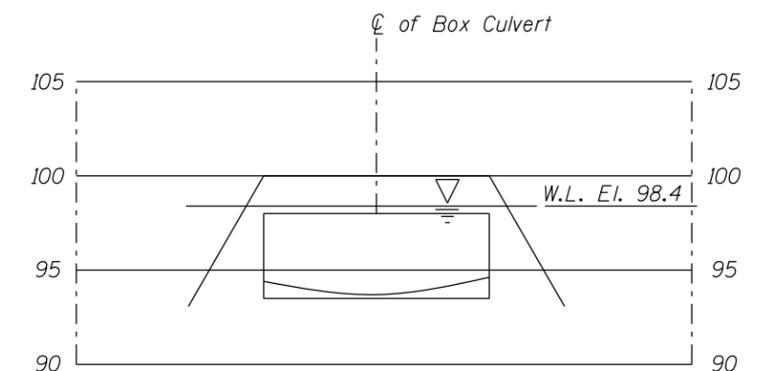
- ① Channel bottom material consisted of fairly soft sandy silt allowing 6 to 12 inches of probe rod penetration.
- ② Concrete was in good and sound condition. 1/4 deep inch scaling was observed on all surfaces.
- ③ The culvert floor was partially covered by a 2 to 3 inch thick layer of silt and gravel except along the west wall near the middle portion of the culvert, where the floor was typically free of any infill/debris.
- ④ An area of poor consolidation was observed on the west culvert wall with 2 to 3 inches of penetration.
