UNDERWATER BRIDGE INSPECTION REPORT

STRUCTURE NO. 88663
SKUNK CREEK
OVER THE
SOUTH BRANCH WATER HEN CREEK
ST. LOUIS COUNTY

SEPTEMBER 20, 2012
PREPARED FOR THE
MINNESOTA DEPARTMENT OF TRANSPORTATION
BY
COLLINS ENGINEERS, INC.
JOB NO. 7423

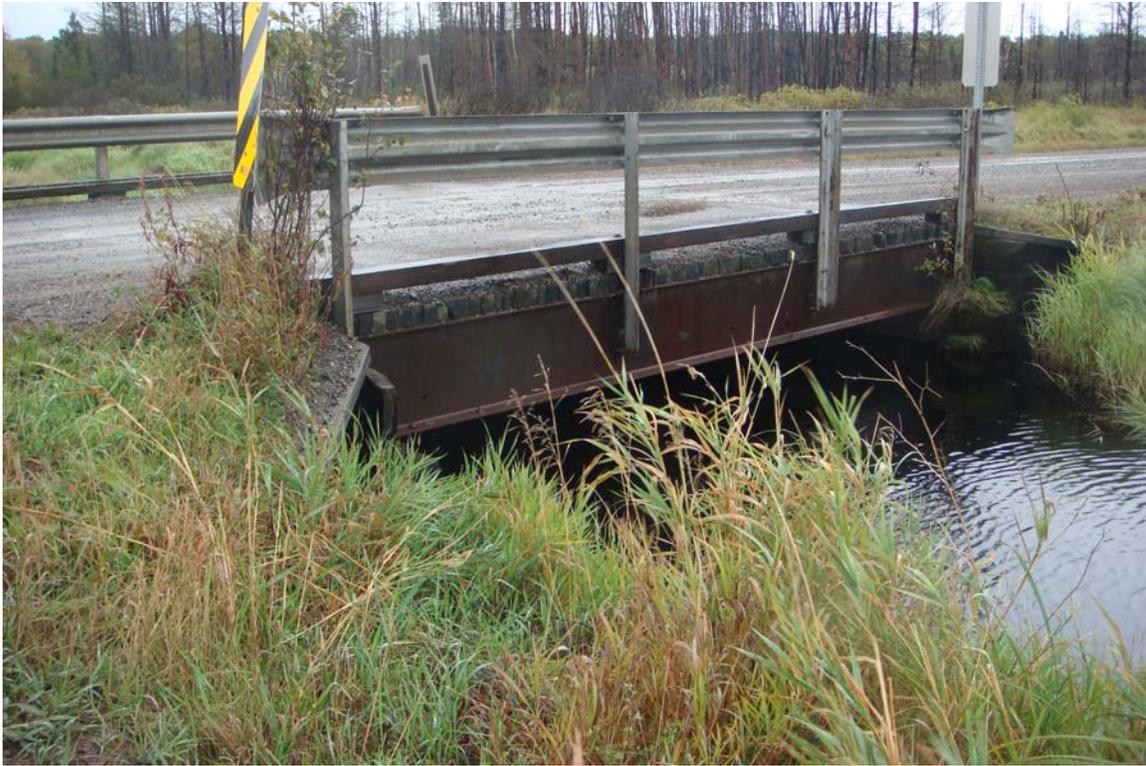
Photograph 1. Overall View of Structure, Looking Southeast.

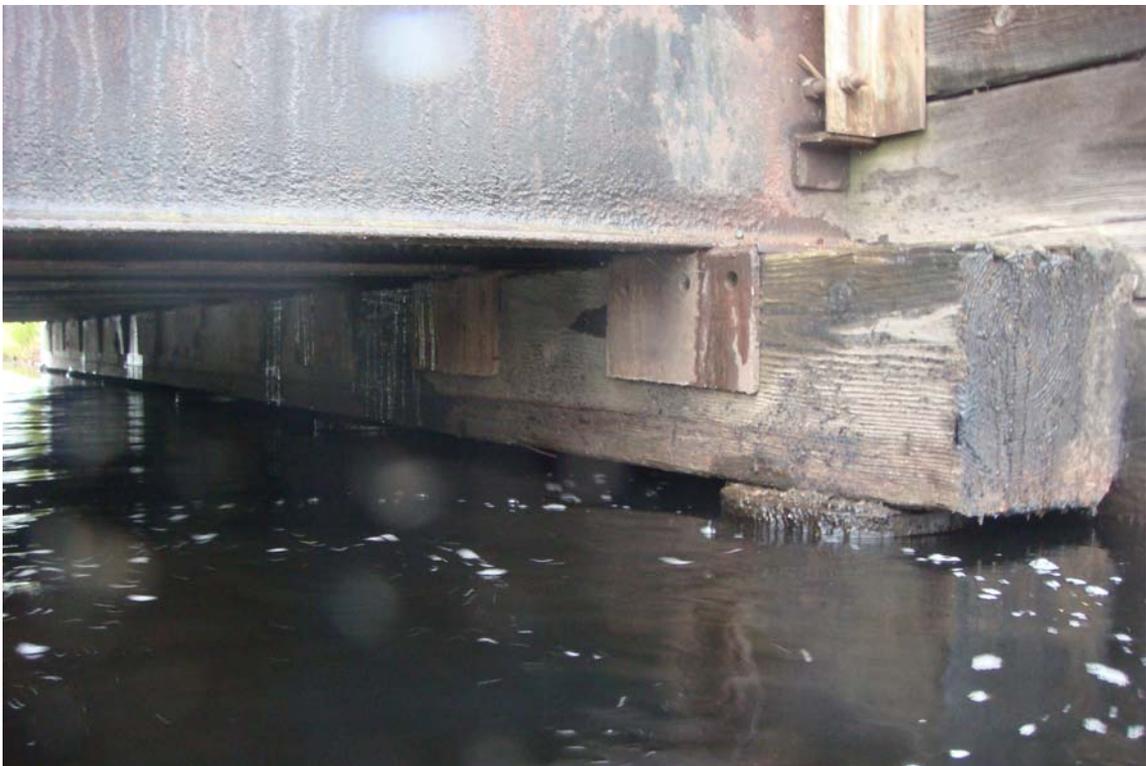
Photograph 2. View of the North Abutment, Looking Northwest.

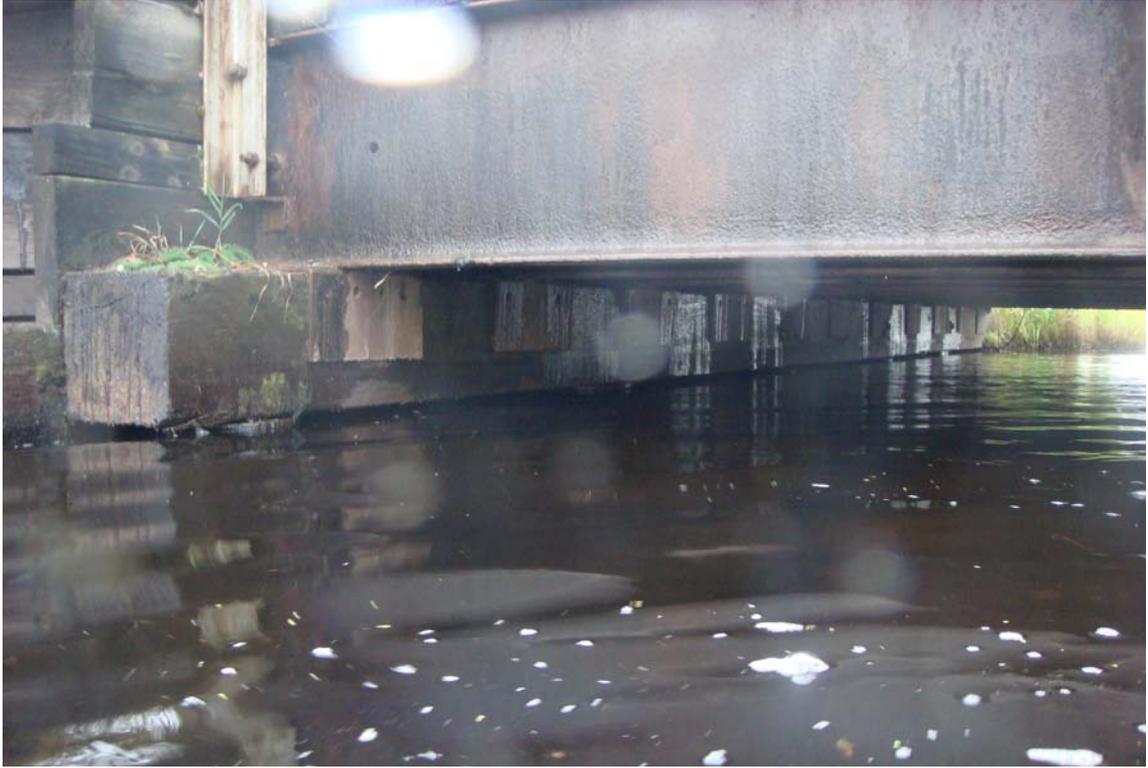
Photograph 3. View of the South Abutment, Looking Southwest.

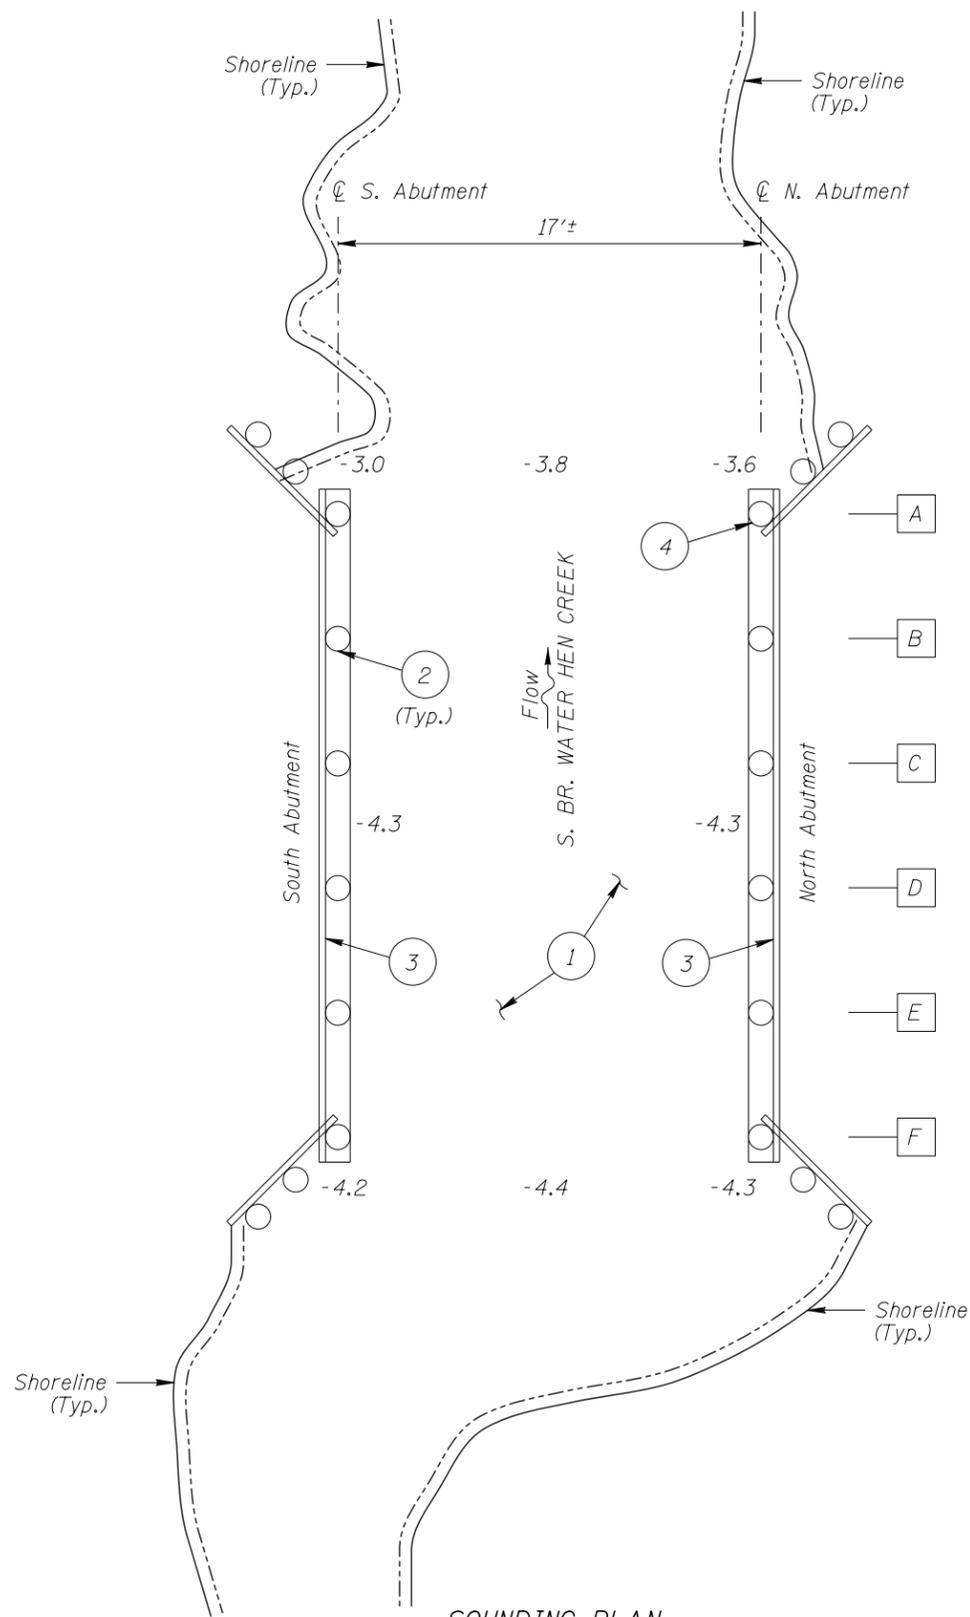
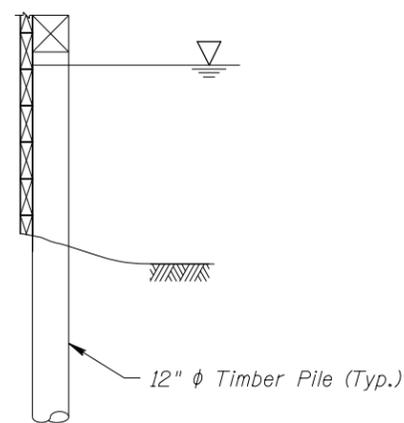
SOUNDING PLAN

- 1 The channel bottom material typically consisted of rocks and gravel with a maximum probe rod penetration of 2 inches.
- 2 The timber piles were typically sound allowing a maximum awl penetration of 1/8 inch and random splitting or checking up to 1/2 inch wide and 2 inches deep.
- 3 The timber backwall boards were typically sound with random gaps between the boards up to 1 inch wide and voids at the bottom boards with 6 to 12 inches of penetration.
- 4 Pile A of the North Abutment exhibited more widespread checking with up to 1 inch of penetration and allowing a maximum awl penetration of 3/4 inch extending from the top of the pile down 3 feet.
