UNDERWATER BRIDGE INSPECTION REPORT

STRUCTURE NO. 88798

CR 600

FLINT CREEK

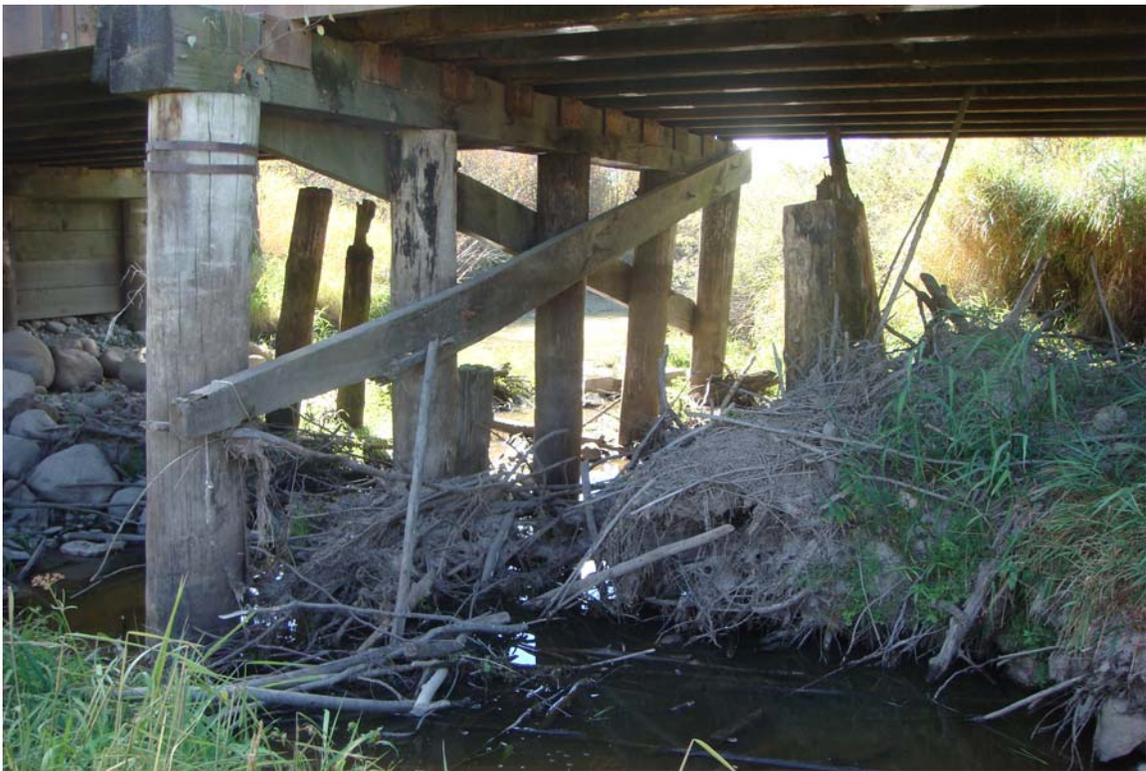
- (E) A heavy accumulation of timber debris, consisting of logs and branches up to 4 inches in diameter, was observed between Bent 1 and the North Abutment extending from the channel bottom to 5 feet above the waterline.

Photograph 2. View of the Bent 1 and Timber Debris Accumulation, Looking Southwest.

- (A) The timber debris accumulation between Bent 1 and the North Abutment did not significantly affect the channel flow, and as a result, does not require removal at this time. If the debris accumulation increases in size or density, it may be necessary to remove the debris to reduce excessive lateral loads on the structure, limit further debris accumulation, and reduce the likelihood of channel bottom degradation resulting from obstructed channel flow.

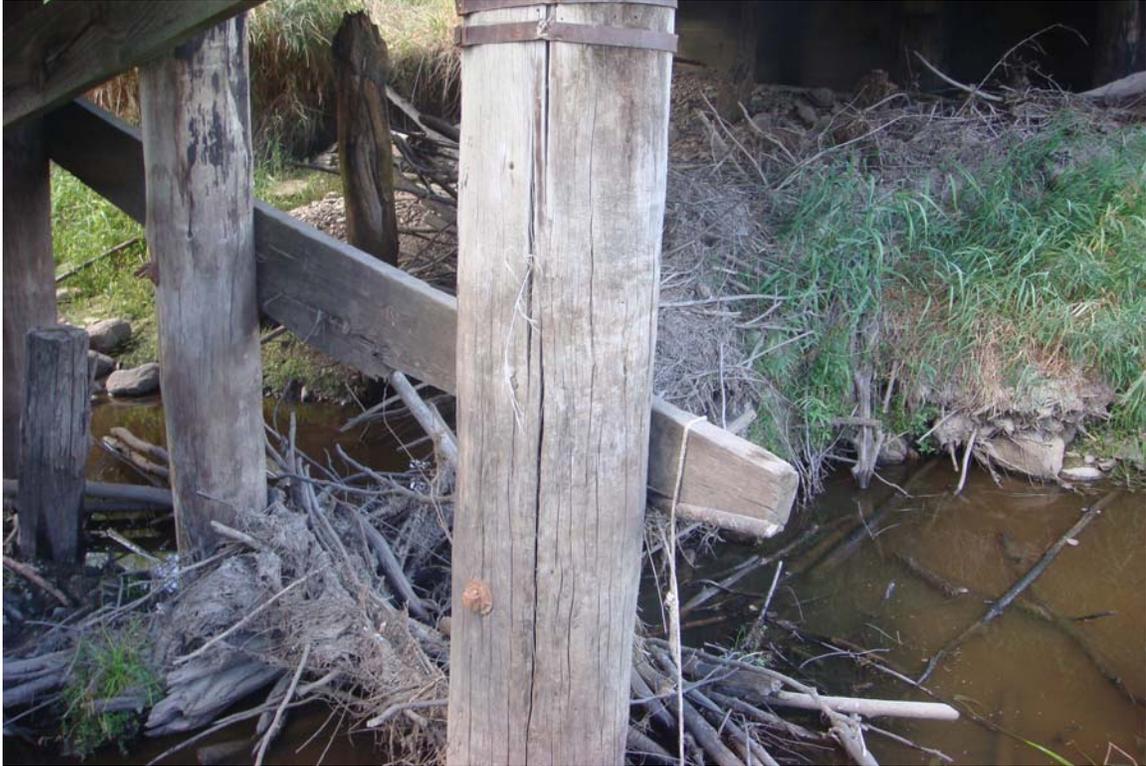
- (B) The timber piles were generally sound with random splitting or checking that was typically 1/4 inch wide and 1 inch deep.
- (C) The north cross-brace at Bent 1 was broken just east of Pile D. The brace was not connected to Pile E.

Photograph 3. View of Typical Timber Pile Condition, Looking Northwest.

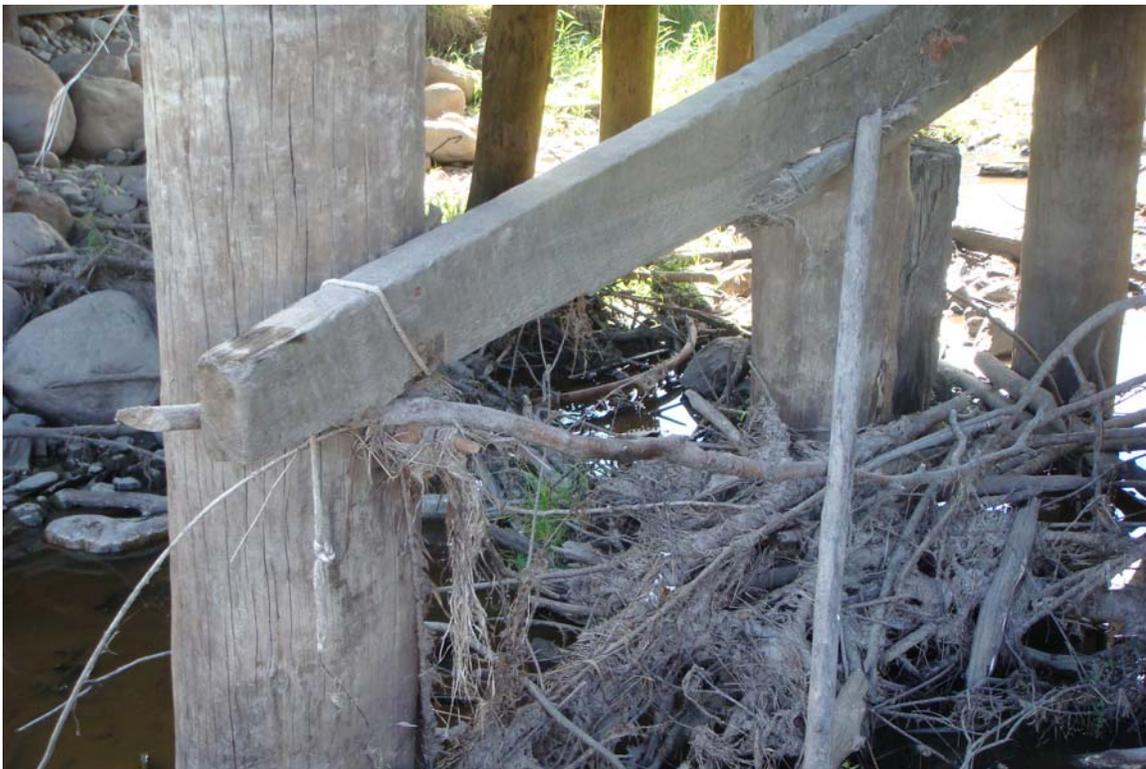
Photograph 4. View of Broken and Not Connected Cross-brace at the Pile E on the North Face of Bent 1, Looking Southwest.

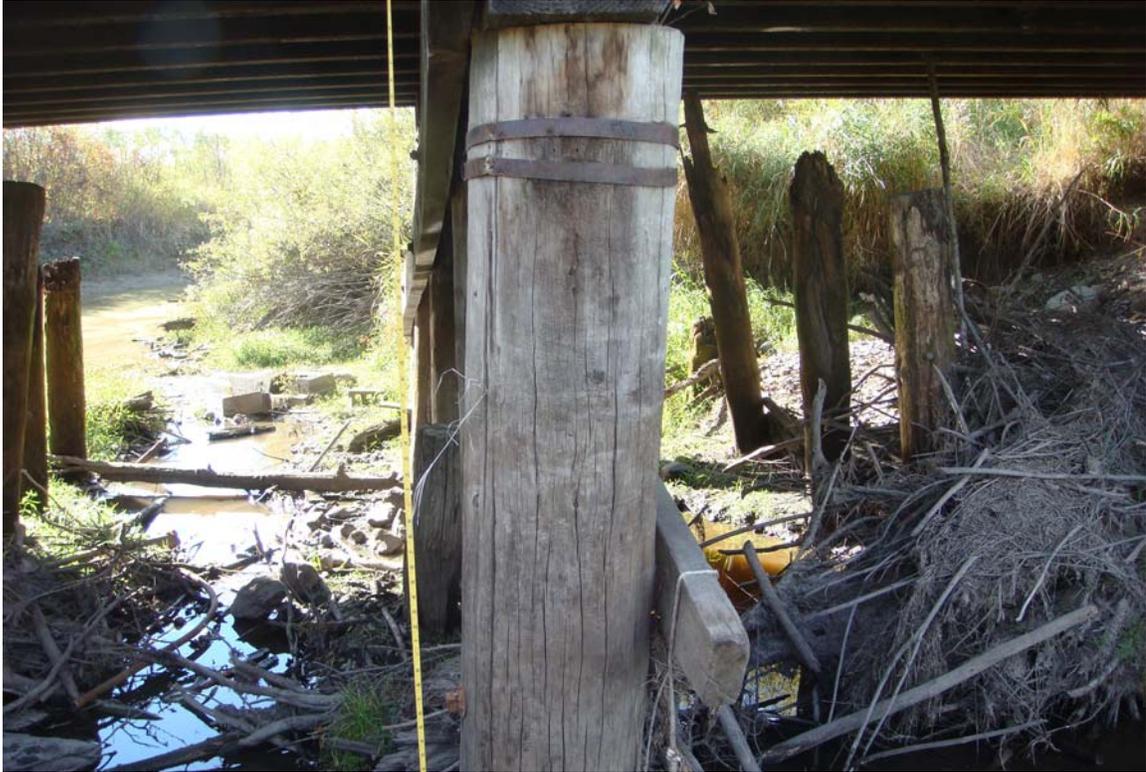
- (D) Bent 1 is leaning to the north up to 6 inches at Pile A (approximately 86.5 degrees) and 4 inches at Pile E (approximately 87.5 degrees). The pile cap is bearing fully on all piles and is square with the bridge girders. The leaning appears to be related to original construction rather than a result of any bent movement.

Photograph 5. View of Bent 1 Leaning to the North at the upstream nose (yellow tape is vertical), Looking West.

- (B) Monitor Bent 1 for any further leaning. If the bent shows signs of further leaning, loss of pile bearing, or pile cap rotation repairs may be warranted at that time.

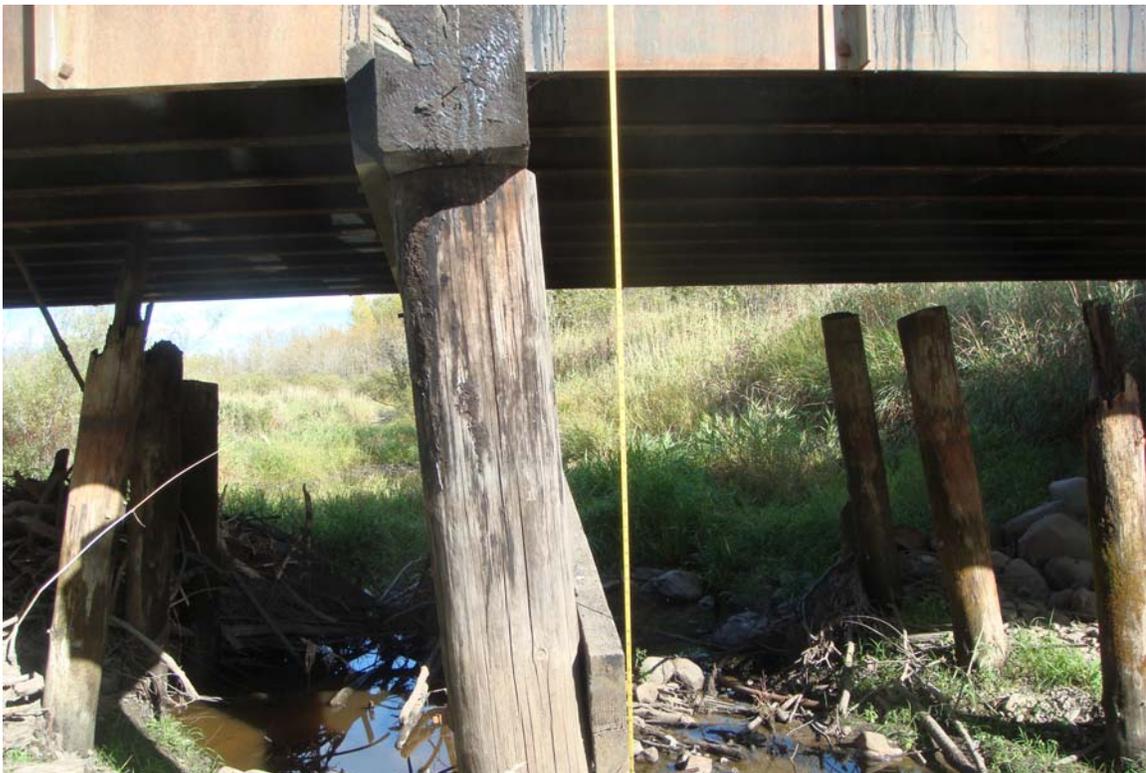
Photograph 6. View of Bent 1 Leaning to the North at the downstream nose (yellow tape is vertical), Looking East.

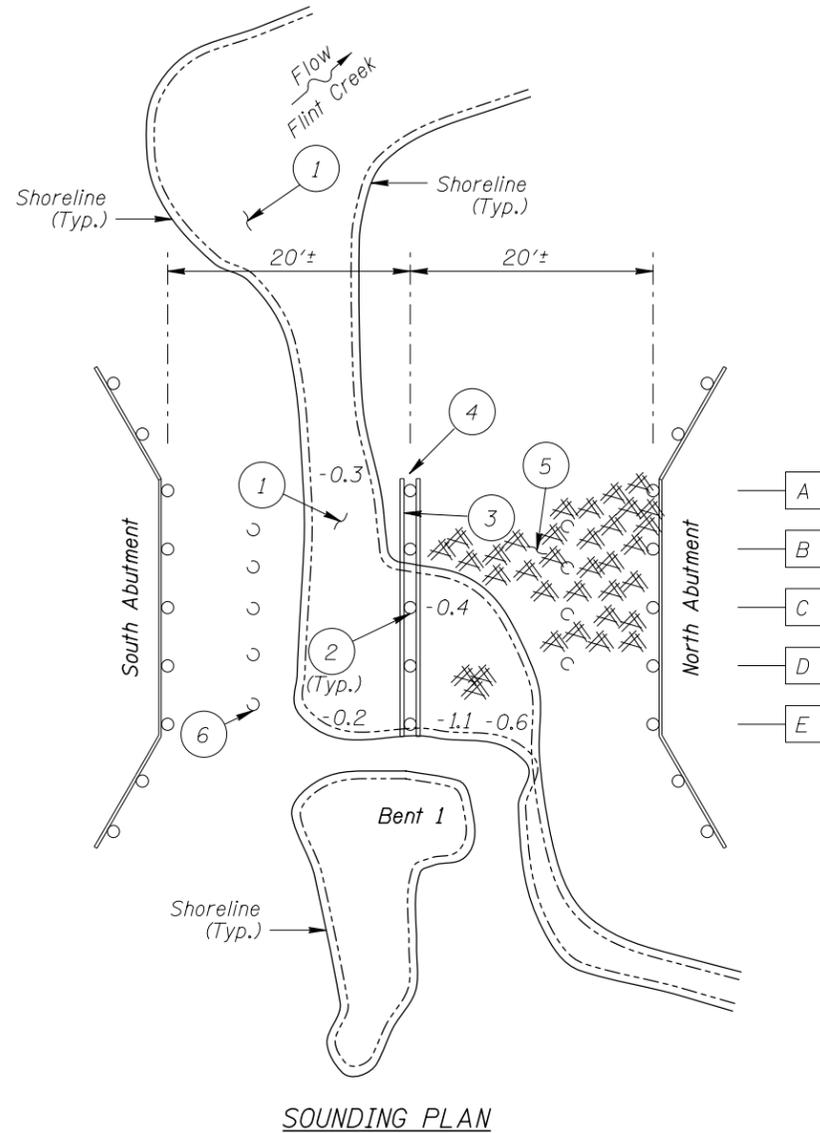
**SOUNDING PLAN**

- 1 The channel bottom material typically consisted of gravel and silt with a maximum probe rod penetration of 4 inches. Random debris was scattered throughout the channel.

- 2 The timber piles were generally sound with random splitting or checking that was typically 1/4 inch wide and 1 inch deep.
- 3 The north cross-brace at Bent 1 was broken just east of Pile D. The brace was not connected to Pile E.

- 4 Bent 1 is leaning to the north up to 6 inches at Pile A and 4 inches at Pile E. The pile cap is bearing fully on all piles and is square with the bridge girders. The leaning appears to be related to original construction rather than a result of any bent movement.

- 5 A heavy accumulation of timber debris, consisting of logs and branches up to 3 inches in diameter, was observed between Bent 1 and the North Abutment extending from the channel bottom to 5 feet above the waterline.

- 6 Random abandoned 12 inch diameter timber piles were observed in the channel.
